Consequences of thermal aging on the detection of impact damage in composite structures with PZT/FBG guided wave systems

Loïc Mastromatteo, Ludovic Gavérina, Jean-Michel Roche, Florian Lavelle, François-Xavier Irisarri

Loïc Mastromatteo, Ludovic Gavérina, Jean-Michel Roche, Florian Lavelle, François-Xavier Irisarri. Consequences of thermal aging on the detection of impact damage in composite structures with PZT/FBG guided wave systems. 11th European Workshop on Structural Health Monitoring (EWSHM 2024), Jun 2024, Potsdam, Germany. 10.58286/29816 . hal-04785713

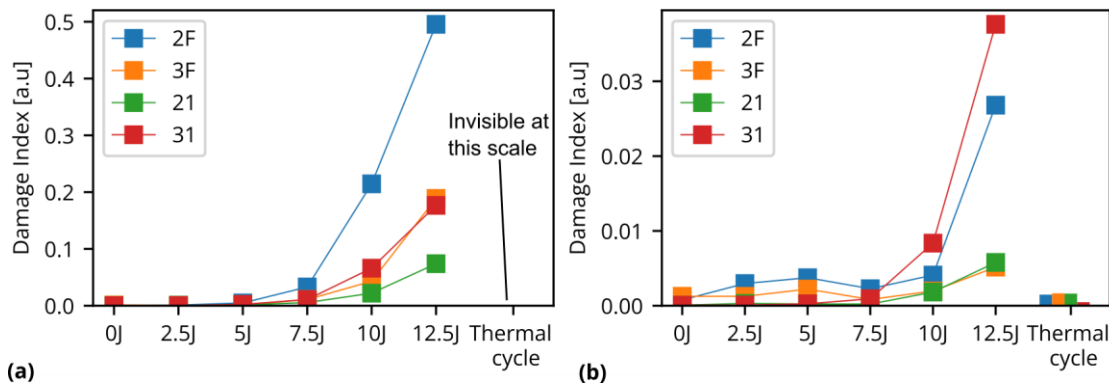
Fig. 7. DI computed for the different signal paths at different impact energy levels and after thermal cycling, at 25 kHz (a) and 200 kHz (b) for the cobonded system.

The SDC damage index is computed from the GW signals after each impact on the first plate and after the thermal cycling on the second one. The results are presented Fig. 7 for the cobonded sensors and Fig. 8 for the bonded sensors.

First, it can be noticed that the impact damage has a much higher signature at 25 kHz, ie for the A0 mode, than for the S0 mode at 200 kHz. Nevertheless, both frequencies could be used to detect the damage in that case. A larger sample size would be needed to clearly determine a threshold for damage detection taking into account all the possible uncertainties (material properties, environmental conditions etc.) however, it seems likely that the damage generated by impact energies higher than 10 J will be detected. Additionally, it can be seen

that the thermal cycle has very little impact on the DI, which was expected, as cobonded sensors did not exhibit any evolution on the diagnostic measurements. This is in stark contrast with the results for the bonded sensors visible in Fig. 8. The signature of the debondings caused by the thermal cycling on the DI at 25kHz is, for the “worst” path, of the same order of amplitude than a 10 J impact, which could definitely lead to some false alerts. The effect of the degradation from the thermal cycling is even stronger at 200 kHz with DI values reaching 0.3, which is more than ten times the value of the DI coming from the actual impact damage. Thus, it would be impossible to use the S0 mode at 200 kHz to detect the impact damage with this extent of degradation of the system. We can also note that the path 2F between PZT#2b (with no detected debonding) and the bonded FBG presents very small DI values: this path could still be used for damage detection.

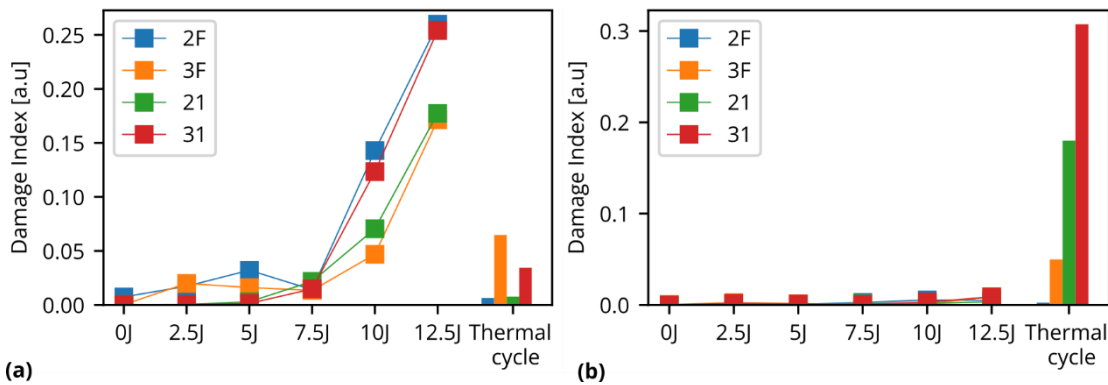
Fig. 8. DI computed for the different signal paths at different impact energy levels and after thermal cycling, at 25 kHz (a) and 200 kHz (b) for the bonded system.
