Experimental and numerical multiscale testing of CFRP bonded stepped repairs

Jean-Baptiste Orsatelli^{a,b,*}, Eric Paroissien^a, Frédéric Lachaud^a, Sébastien Schwartz^a,
Nathalie Barrière^b

^b DGA Techniques Aéronautiques, 47 rue Saint-Jean, Balma 31131, France

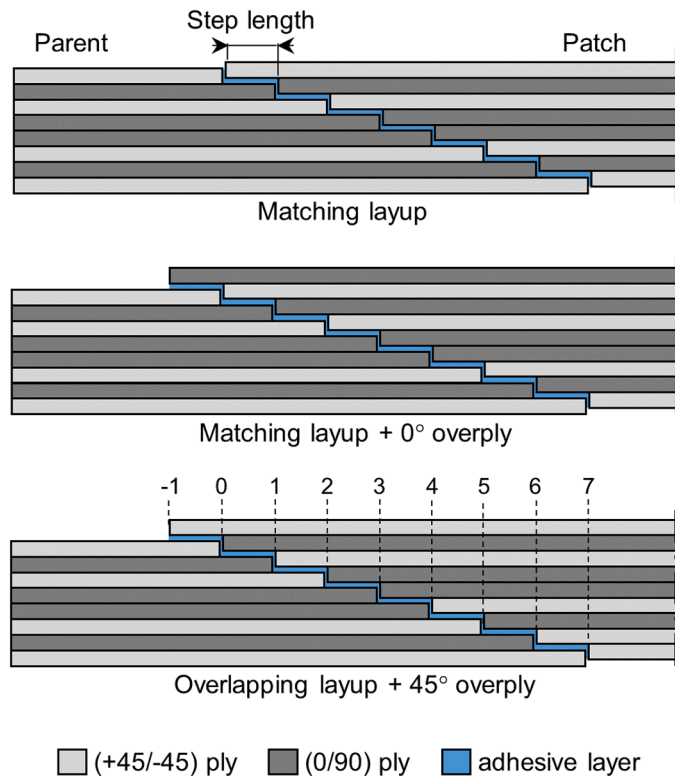
Fig. 2. Tested layups of the repair patch. A numbering of the step ends is also provided. Adapted from [31].

with an additional 0° overply, or overlapping layup with a 45° overply (Fig. 2). The idea of the overlapping layup is that each repair ply overlaps a parent ply with the same orientation. It is often mentioned as the reference technique to achieve optimal repair performance because each repair ply is bonded to a parent ply with the same orientation [38,39]. The bottom ply, also known as “filler ply”, is oriented at 45° to ensure

that the stiffness of the patch is close to the stiffness of the parent laminate. On the other hand, the idea of the matching layup is to restore the parent laminate with its original plies orientations. A numbering of step ends is provided in Fig. 2, starting at #0 at the first ply of the parent patch so that it remains applicable no matter the chosen configuration.

To give an overview of all the different failure behaviour encounter among the tested specimens, all failure types and locations that were encountered are summarized in Table 4 and compared to FE results, based on the steps numbering provided in Fig. 2. There is a good agreement between simulation results and experimental observations.

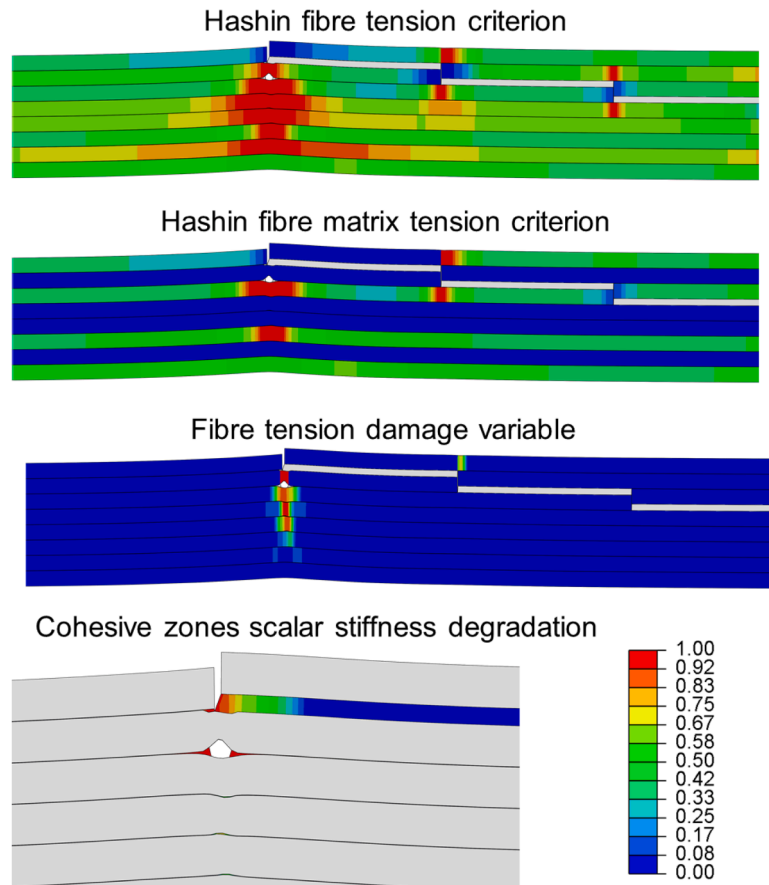
Fig. 15. Local analysis of the failure mechanisms in the C-T-8M configuration at 100 % of failure load. The 0 to 1 color scale applies to all the displayed criterion and variables.

When it comes to local effects (Fig. 15), the Hashin’s matrix tension criterion is similar to the fibre tension criterion in 45°/-45° plies. This was expected given how the woven composite material was modelled in the analysis. The top 45° ply reaches its maximum load carrying capacity at 83 % of the maximum load at step end number 1. The end part of this 45° ply going between step #1 and step #0 is visibly unloaded, redistributing the load to the rest of the structure. This effect is quite interesting, given that peeling effects at stepped and scarf repairs end are often mentioned to be significant [11]. Yet, in the present case, the end plies at the top of the repairs does not carry much load as in can be seen

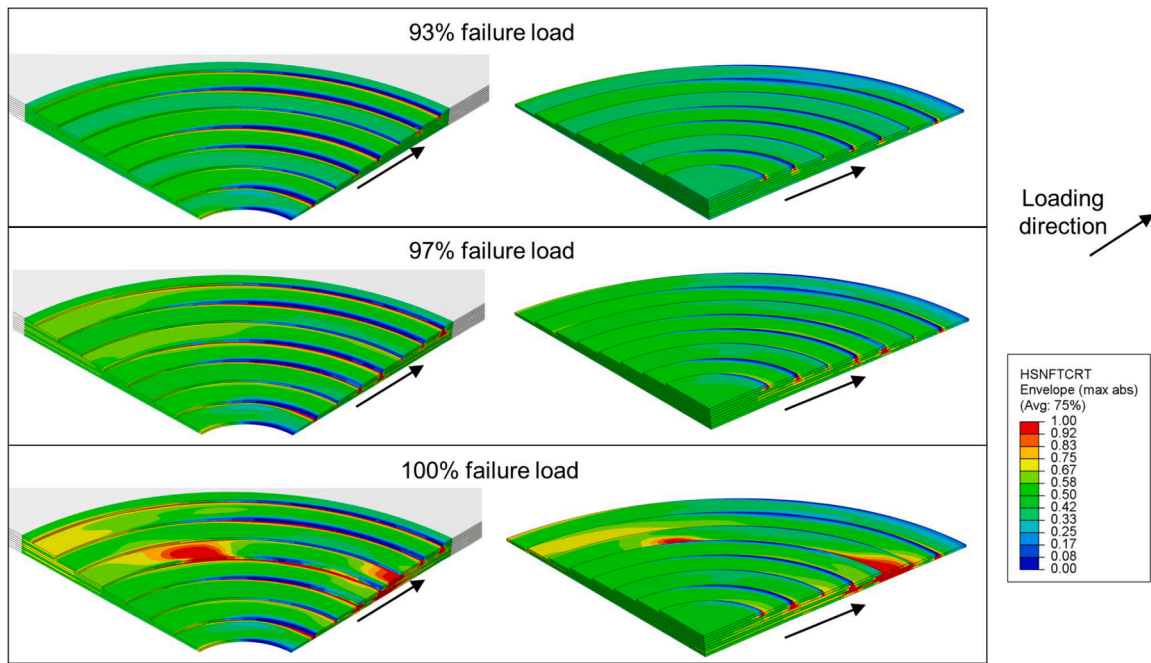
Fig. 17. Evolution of Hashin's fibre tension criterion (HSNFTCRT) in the parent structure and the repair patch when approaching the ultimate load in the P-T-8M configuration.

observations. Like in 2D GPS simulations, the fibre failure initiation criterion is met at several locations, and especially at step ends #1 #3 and #4. The local effects associated with the composite laminates failure in the 3D model are similar to the ones identified in the 2D model. In particular, the upper 45° ply at the step end #1 that reaches his maximum load carrying capacity before the final failure, unloading the end of this ply and redistributing the load to the rest of the steps. Fig. 17 highlights the evolution of the fibre tension criterion in the parent structure and the repair patch separately.

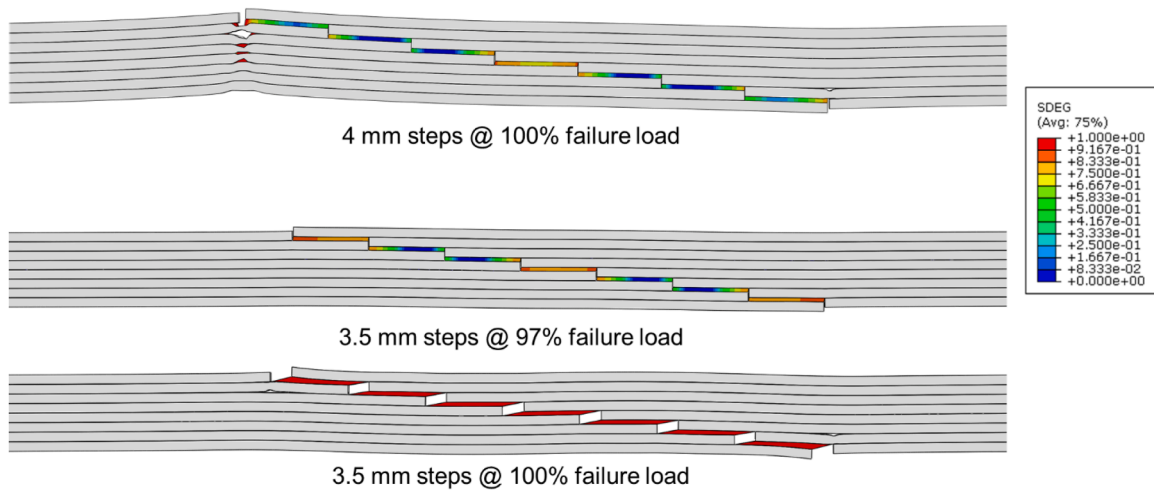
Fig. 18. FE 2D GPS failure scenario in C-T-4M configuration. SDEG is the damage variable of the cohesive elements modelling the adhesive material.

plates and inside the laminates acting together, that is not present in the FE model. Decreasing step lengths were tested in 2D GPS models until obtaining a disbonding of the patch with a 3.5 mm step length (Fig. 18). A more comprehensive analysis of cohesive failure of stepped joints simulated by FE is available in [30] and [31].

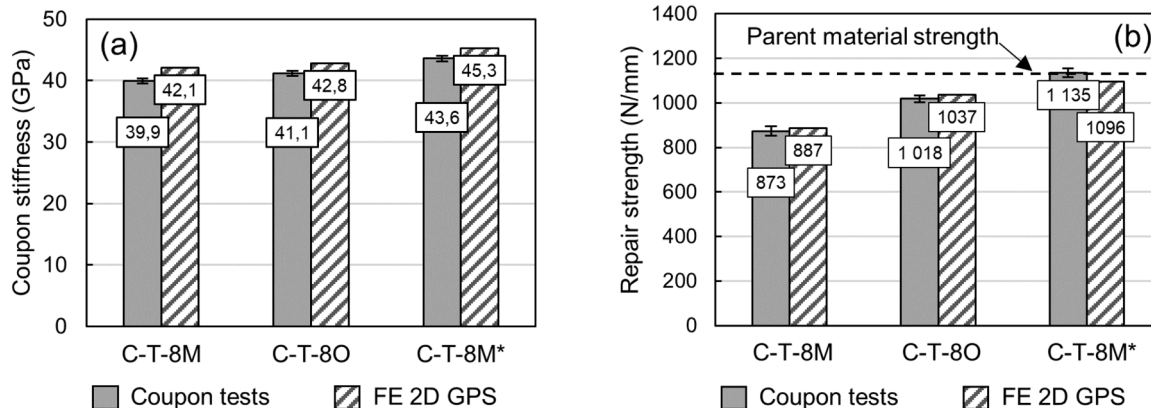
Fig. 23. Effect of patch layup on repair stiffness (a) and strength (b).

The experimental and numerical results obtained for the three sets of through repaired coupons with a step length of 8 mm and different patch layouts are presented in Fig. 23. Because these specimens are through repaired coupons, the entire load has to be transferred by the bonded joint when the specimen is loaded in tension. The C-T-8M configuration

have higher strength than the C-T-8O configuration, as shown by experimental results. In terms of stiffness, the addition of overplies contribute to make the coupons stiffer, as it can be expected. The FE simulation agree with the experimental results on that tendency, while being slightly stiffer, about 5%, than the latter.

The results of the C-T-8M* tests show that it is possible to achieve a through-repair on a coupon that can restore the initial strength of the pristine laminate. It means that the bonded joint is strong enough not to be the weak link of the repair, and that the repaired laminate is able to withstand the stress concentration at the end of the steps. These results consolidate the conclusions that the bonded joint is not always the weak link in a stepped repair [39,47]. However, this conclusion remains limited to strength recovery rate of the repair under static loading: the repair is not likely to recover fully the initial durability of the pristine laminate, when subjected to hot-wet aging for example. When it comes to the repair patch layup, the results of this study dispute the common idea that an overlapping layup (O) of the patch, where each repair ply is bonded to a parent ply of same orientation, is needed to achieve a proper repair. This could be explained by the fact that proposed matching patch layup plus 0° overply (M*) allows using one more 0° ply than the standard overlapping patch configuration with the same total number of plies.

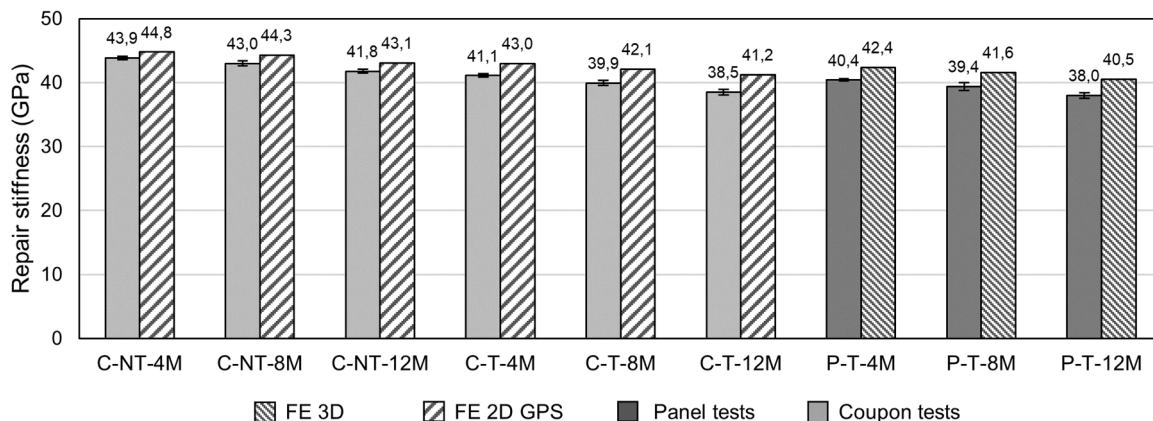
Fig. 24. Effect of step length, damage depth and specimen scale on repair stiffness.

The measured stiffness (Fig. 24) and repair strength (Fig. 25) of the C-NT-xM, C-T-xM and P-T-xM (x = 4, 8, 12) specimens was analyzed compared to FE results. Repair strength is compared in terms of force flow (N/mm) to be able to compare coupons and panels of different widths. The effect of three variables can be studied thanks to this data, being step length, damage depth and specimen scale (coupon / panels). Overall, there is only little deviation between the experimental results of the nine configurations tested and FE results are in excellent agreement with experimental data. In terms of stiffness, FE models are a little stiffer than experimental tests. FE models are likely to be stiffer that tests because of (i) perfect boundary conditions hypothesis in the FE mode, while real BC may be less stiff, and (ii) perfect specimen alignment hypothesis in the FE model, while real testing setup might not be perfect because of a small misalignment between the ends of the machine. In terms of strength, there is also an excellent agreement between tests and simulations. C-T-4 M specimens are the only exception, as they have a lower strength than the others do. This particular point is discussed at the end of the section.

The following conclusions on the three parameters studied can be drawn from the experimental data. First, there is no strength increase of repaired panels and non-through repaired coupons beyond a step length of 4 mm steps, but through-repaired coupons do have an increase of strength when going from 4 mm steps to 8 mm. There also no significant effect of damage depth on the strength of repaired coupon with step length of 8 mm and 12 mm. It shows that deeper repairs may not be weaker than shallower ones if the step length is long enough. Finally, there is a good agreement between the strength of repaired panels (P-T-xM) and the equivalent coupons (C-T-xM) for step lengths of 8 mm and 12 mm, but C-T-4M specimens have a lower strength than their equivalent panels P-T-4M. Those three points are related to the same physical phenomenon, being the level of stress concentrations at the end of the repair step. Indeed, when the step length is long enough to ensure that the bonded joint is not the weak link of the repair, the stress concentrations inside the laminates drive the behaviour of the repairs as highlighted by FE simulation (section 4.1.2). These levels of stress are directly related to the stress state along the bondline of the repair. Furthermore, it was shown by a previous study [31] on stepped joints that the levels of stress along the bondline barely depends on the step length within a range from 3 to 12 mm and are similar in the most loaded section of a repaired panel and its equivalent stepped joints.

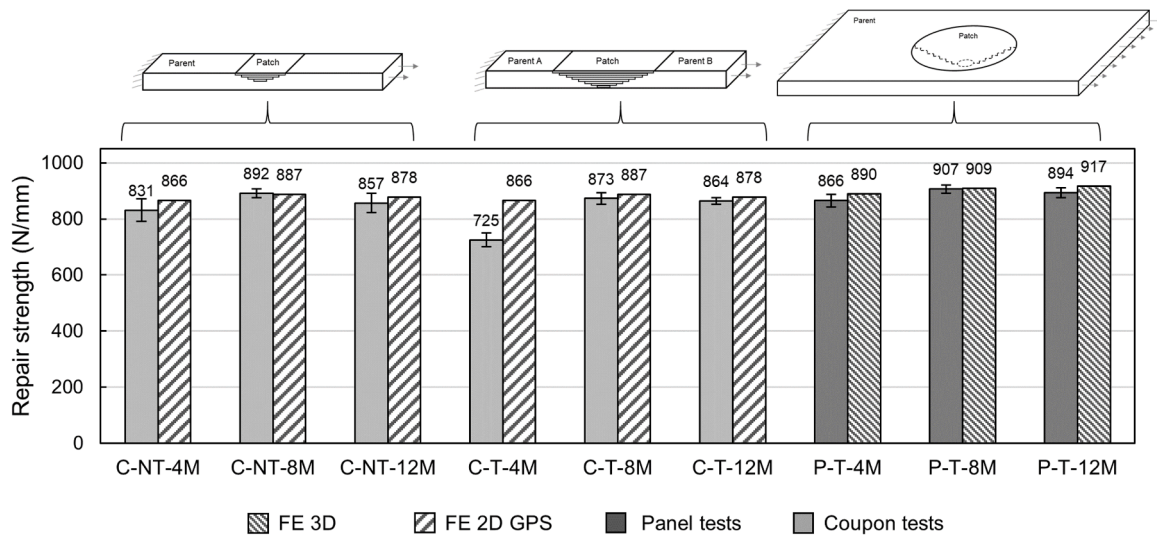
Fig. 25. Effect of step length, damage depth and specimen scale on repair strength.

The present experimental results confirm that there is step length threshold, beyond which no increase of the repair static is obtained. Regarding the “equivalent joint” question, it can be concluded that that tests at the scale of coupon allow measuring, conservatively, the strength of the associated stepped repaired panel. In addition, the 2D GPS modelling of stepped repairs is suitable to study the behaviour of a stepped repaired panel, including the strength and the failure

Yet, the lower strength of C-T-4M specimens compared to the C-NT-4M and P-T-4M ones indicates the field of validity of that last conclusion is to be discussed. This, behaviour of C-T-4M specimens can be related to C-T-4M specimens being close to patch disbonding as shown by FE results (section 4.1.2) and being the only ones with no alternative load path available than the bonded joint, which makes them more sensitive to manufacturing defects, as highlighted in section 4.1.3 (Fig. 21), and to possible coupling effects between disbonding of the joint and composite fracture. It could be reasonable to say that there is a zone around the step length where the transition between failure by disbonding of the joint and composite fracture occurs, inside which the behaviour of a coupon and a repaired panel may be more different. Moreover, repaired coupons are subjected to free-edges effect that do not exist in the centre section of a repaired panel, and it was shown by FE analysis in a previous study [31] that those effects tend to make the bondline of coupons weaker than the bondline of repaired panels, and weaker than predicted by a 2D GPS model.

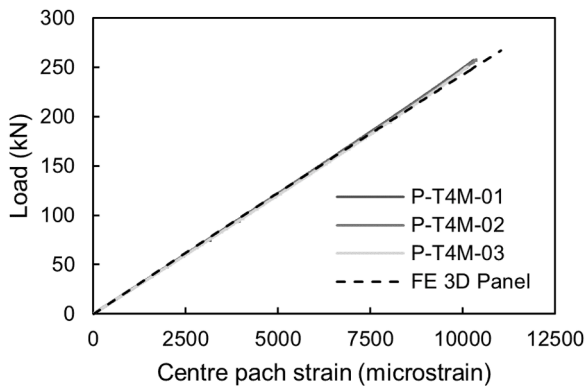
Fig. 26. Strain measured at the centre of the patch of P-T-4M specimens and comparison with FE results.

Compared to coupons, stepped-repaired panels do have alternative load paths than portion of the bonded joint aligned with the direction of the load. For example, the load can be transferred by around the most loaded section of the bonded joint by the other parts of the bonded joints, or by the parent laminate. In both cases, this effect should results in a decrease of the load going through the centre of repaired patch compared to the average load applied to the specimen. The idea of the section is to discuss this “load bypass” effect, thanks to the strain gauges that were applied at the centre of the repaired panels. The mean longitudinal strain at the centre of the patch was computed as $\epsilon_p = (\epsilon_1 + \epsilon_2)/2$, where ϵ_1 and ϵ_2 are the strains measured by the gauges at the centre of the patch. It was then compared to the results FE simulations. The results of panels with 4 mm steps are presented in Fig. 26. The strain varies almost linearly with the applied load and there is a good agreement between the experimental data and the FE 3D Panel simulation. Nonetheless, there is a slight effect visible when the load approaches the ultimate stress of the repair. The strain measured by the central gauge increases more slowly than initially, indicating that the force flow through the patch begins to increase more slowly.

The stress inside the patch may not be measured directly, but the repair patch is the only material present at the centre hole of the panel. Hence it is possible to evaluate the force flow P_{patch} going through the centre of the patch as $P_{patch} = E_p \epsilon_p t_p$, where E_p is its Young modulus computed thanks classical laminate theory, t_p its thickness, ϵ_p the longitudinal strain measured. Knowing the mean force flow applied the

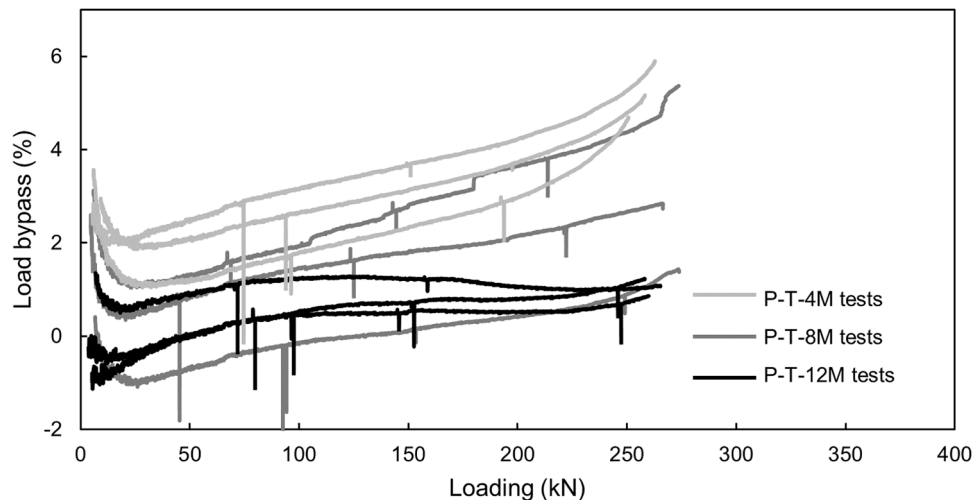
Fig. 27. Load bypass factor computed from stepped repaired panels tension tests.

$$\beta = 1 - \frac{P_{\text{patch}}}{P} = \left(1 - \frac{E_p \epsilon_p t_p}{F/b} \right) = \left(1 - E_p t_p b \frac{\epsilon_p}{F} \right) \quad (7)$$

With this definition, if β takes positive values, it means that the force flow going through the patch is lower than the mean force flow applied to the specimen. The results obtained for the nine repaired panels are presented in Fig. 27. For through repaired coupons that are equivalent to repaired panels, β will be equal to 0 because the whole load must go through to centre of the patch as there is no other path available. The obtained results for panels should be interpreted very carefully as they rely on the modulus E_p to evaluate the load going through the patch. Indeed, slight error on the value of E_p will significantly change the value of β , but it is reasonable to assume that E_p is the same for all specimens of this study, as they were manufactured with the same material batch. Thus, the variation of β during the tension tests and the deviations between each specimen can be interpreted. First, there is a lack of repeatability and no clear β variation tendency among the P-T-8M specimens, but P-T-4M and P-T-12M specimens do have clearer trends. Indeed, the load by-pass tend to increase in P-T-4M specimens as the load increases, while it remains near zero in P-T-12M specimens. The effect becomes clearly visible beyond 200 kN applied, which is about 80 % of the ultimate load. This is compatible with the fact the bonded joint of panels with 4 mm steps is pushed closer to failure than the one of panels

with 12 mm steps and leads to a higher stress redistribution effect in panels with smaller steps.
