STRUCTURE REPAIR BY ADDITIVE FRICTION STIR DEPOSITION: MECHANICAL RESPONSE OF THE REPAIRED INTERFACE

Florian Girault^(1,2), Louise Toualbi⁽¹⁾, Thibaut Bouilly⁽³⁾

⁽¹⁾ ONERA- the French Aerospace Lab, 29 Av. de la Division Leclerc, 92320 Châtillon, France,

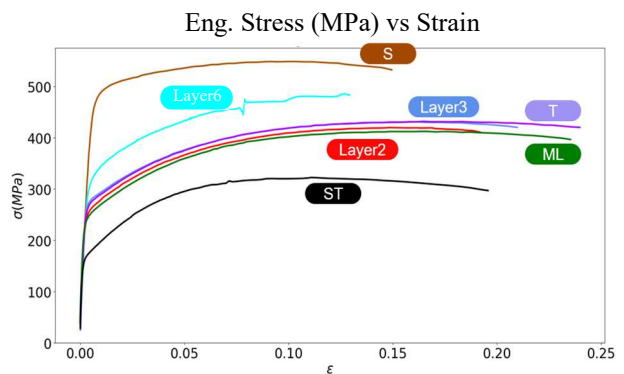
Tensile behavior was also assessed Fig. 16. Classical strain rate of $10^{-3}s^{-1}$ was imposed on specimen sampled at various heights (see Fig. 15) and orientations, until failure. The yield stress and ultimate tensile stress vary accordingly with the hardness. The HAZ features the lowest yield stress of 170MPa, while the substrate's yield stress before deposition was 460MPa. In the bulk material, no major anisotropy was detected, and the elongation reached is 20% or higher. The last layer has the highest mechanical performances with $\sigma_{0,2}=305MPa$.

Figure 16: Engineering stress versus engineering strain for specimens at several locations of the build-up. T

stands for a transverse specimen, whereas others are in the longitudinal direction.
