Chemical, Corrosion and Topographical Analysis of Stainless Steel Implants after Different Implantation Periods

Wojciech Chrzanowski, David Andrew Armitage, Jonathan Campbell Knowles, Jacek Szade, Wojciech Korlacki, Jan Marciniak

ABSTRACT: The aim of this work is to examine the corrosion properties, chemical composition, and material-implant interaction after different periods of implantation of plates used to correct funnel chest. The implants are made of 316L stainless steel. Examinations are carried out on three implants: new (nonimplanted) and two implanted for 29 and 35 months. The corrosion study

JOURNAL OF **BIOMATERIALS APPLICATIONS** Volume 23 — July 2008

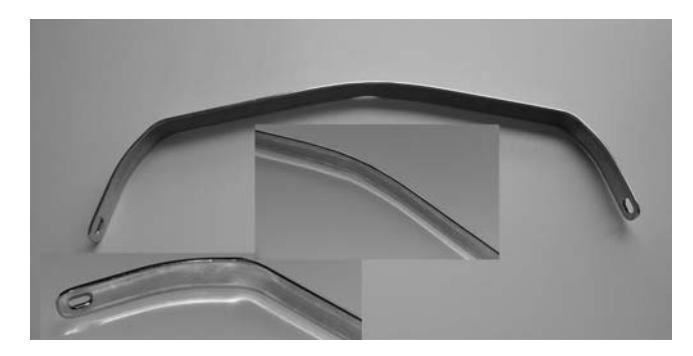
Figure 1. Geometrical presentation of the plate after shape adjustment.

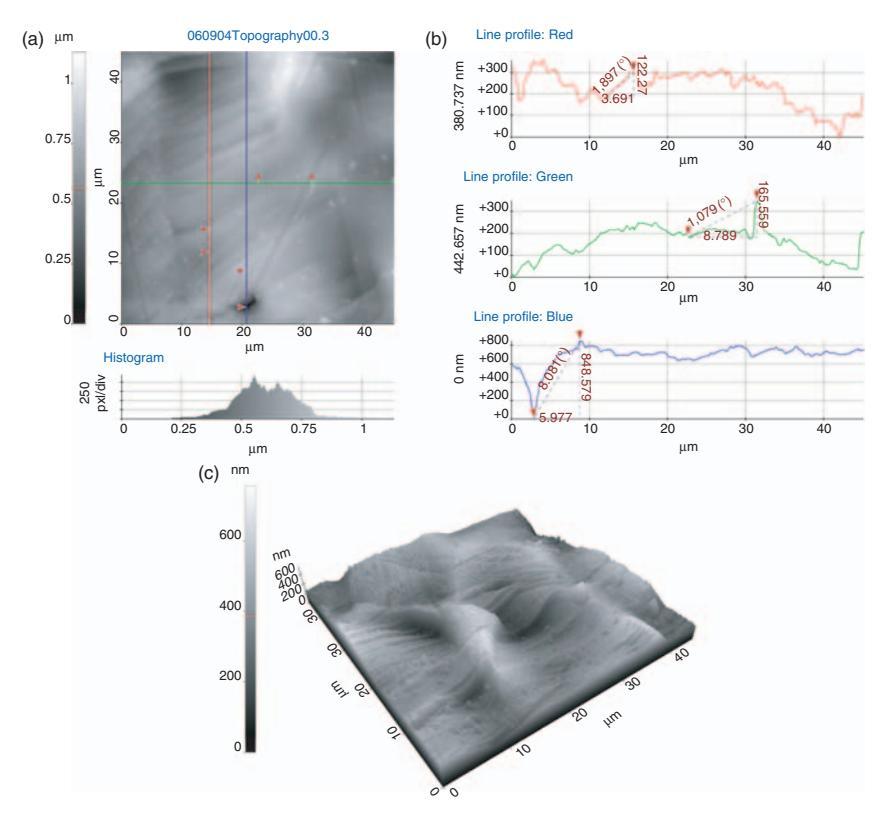
Figure 2. AFM images of deformed part of not implanted bar (a) surface topography, (b) line profiles, (c) 3D topography.

The roughness measurement and AFM observations of the straight part of the implant surface before implantation showed that surfaces were smooth and well polished. The roughness of that part was $R_a = 0.74 \,\mu\text{m}$. Observations did not reveal any significant change along the straight fragments. Parts of the implant that were deformed according to the clinical procedure (that was done by an experienced surgeon) were dull. The AFM observation revealed numerous deformation slide bands along many grains (Figure 2(a, c)). The roughness of these regions increased to $R_a = 12.47 \,\mu\text{m}$. Macroscopic examination of the implants revealed numerous of scratches on the surface. These scratches resulted from the implants shape adjustment to the patient's

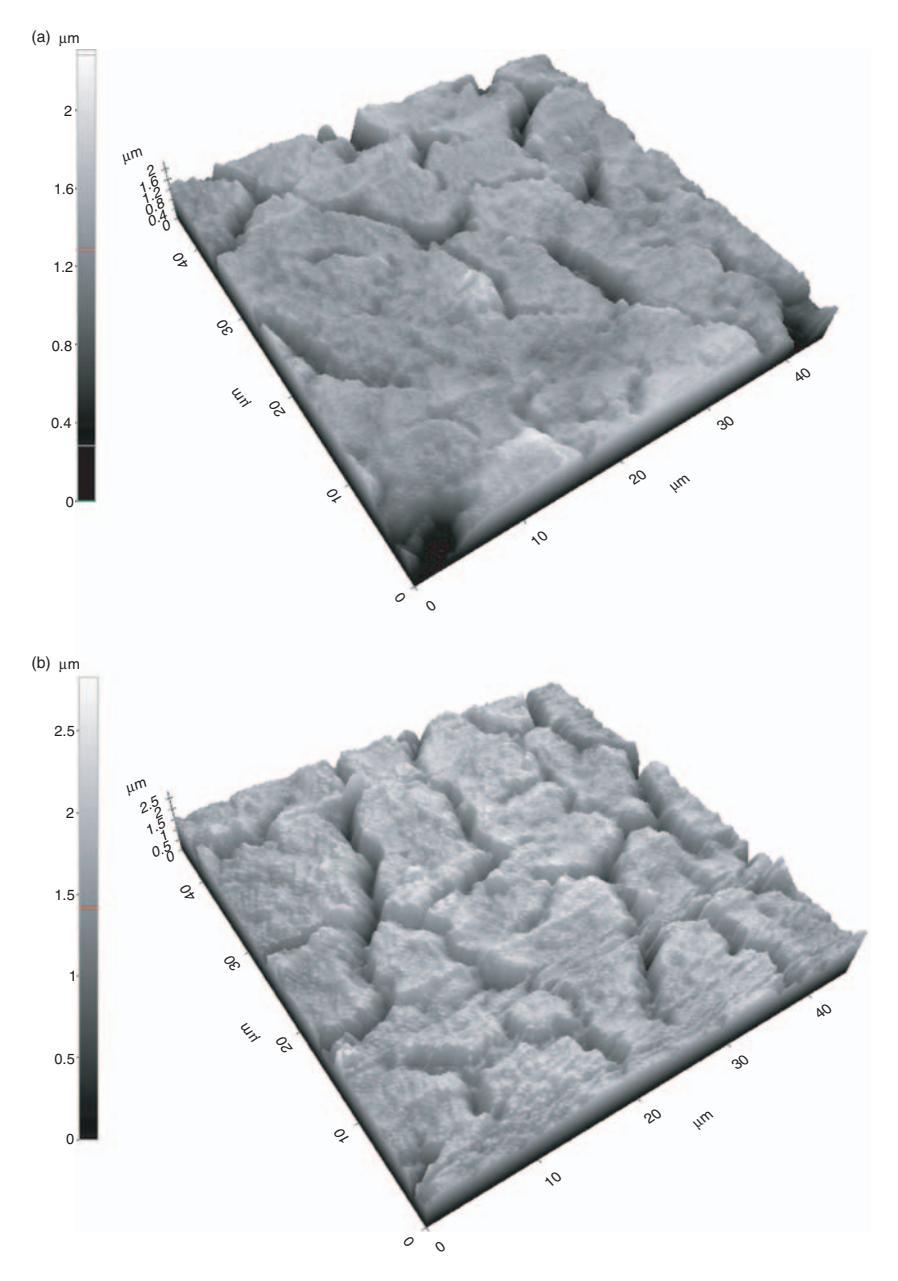
Figure 3. 3D topography images of the implant surface that were covered with film: (a) implant that stayed 29 months, (b) implant that stayed 36 months in the body.

The analysis of the implant that stayed for 35 months showed a roughness for noncovered parts of the plate of $R_a = 1.07 \,\mu\text{m}$ and that the surfaces were smooth and shiny without any significant impairment except for scratches that appeared due to operative procedure. The roughness of the parts covered with the whitish layer was $R_a = 1.2 \,\mu\text{m}$. The film was cracked, but cracks were more regular and their number and size was greater compared to the shorter duration implant. The depth of the cracks was about 1.35 to 1.72 μm . This suggests that thickness of the layer increased with implantation time.

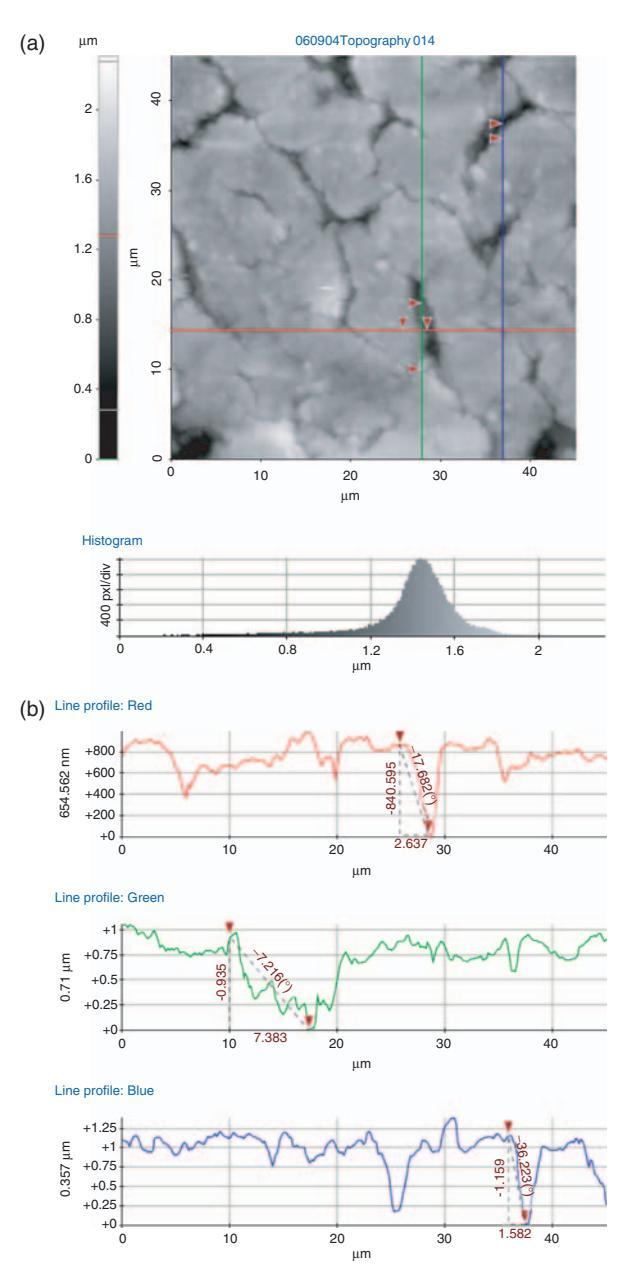
Figure 4. AFM image of the implant surface that stayed in the body for 29 month, covered with film; (a) topography image, (b) profile lines.

were covered with the whitish film part were observed either on inside and outside part of the implant. The AFM observations did not reveal any topographical differences between the different sides. The whitish film was on the surface was relatively thick and cracked (Figure 3(a), (b)). The depth of the cracks was about $0.65-0.94 \,\mu\text{m}$ which suggests the thickness of the layer is at least this value (Figure 4(b)).

difference in the deformed region For the nondeformed regions the increase of R_a with time of implantation was observed. A similar increase was observed for deformed regions but only in respect to the implanted plates. Some parts of the implants were covered with whitish layer. This appeared on both sides of the implants, especially in the areas where the implant had contact with bone. The roughness of the regions covered with the whitish film increased to 0.15 μ m with time of implantation. At the same time the organic film thickness increased, which is stated on the basis of the crack depth measurements Figure 4(b).

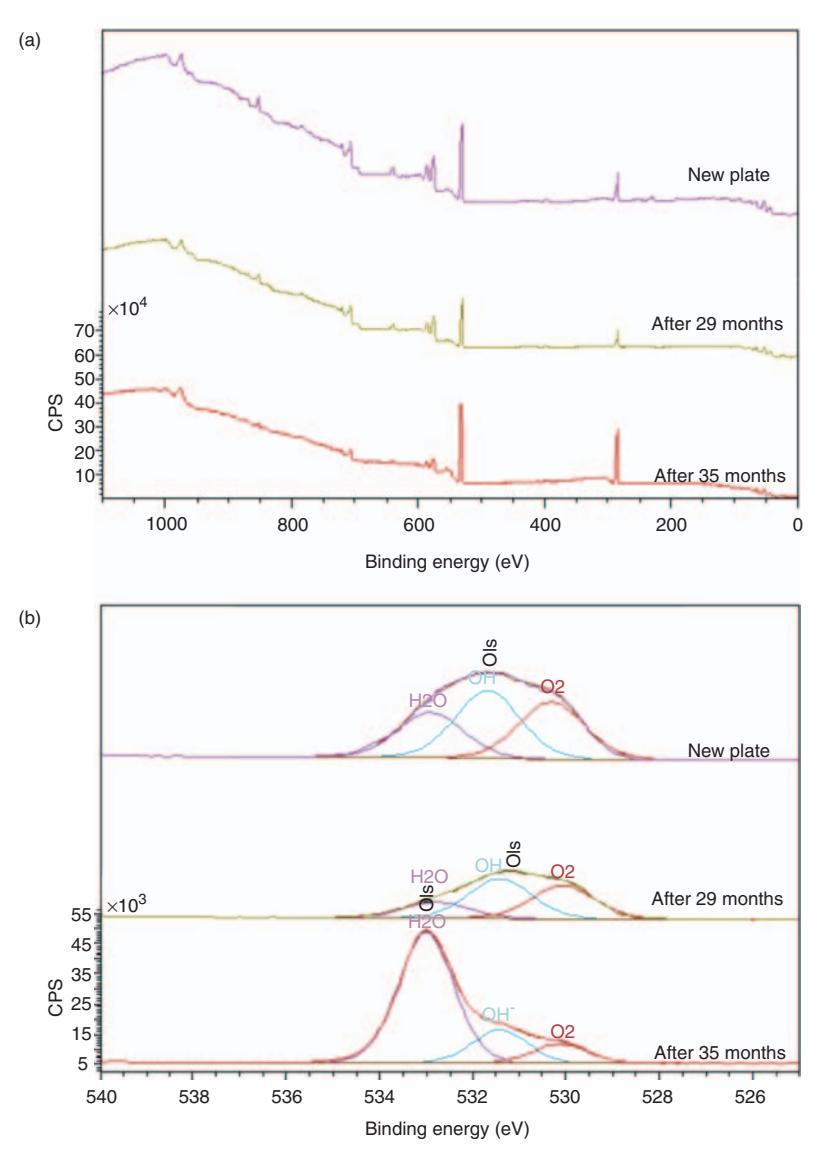
Figure 5. XPS results for the implant: (a) Survey spectra and (b) oxygen 1s spectra for new implants and implanted for 29 and 35 months.

The XPS examination for the new plate revealed the following elements on the top layer: O, C, Cr, Ni, Fe, Mo, and N (Table 2 and Figure 5(a)). The carbon peak at the energy 284.9 eV indicates that this element originated from contamination. The carbon was single bonded with hydrogen and other carbon atoms: C–H, C–C. There was also some amount of carbon bound to oxygen; peak at the energy 288.7 eV (C=O). The chromium peak at the energy 576.7 eV corresponded to Cr_2O_3 . The nitrogen energy peak 400.7 eV correlated with N₂. The molybdenum peak 227.4 eV corresponded to metallic state of this element. The iron and nickel peaks at the energies 706.7 and 852.7 eV agreed with metallic iron and oxidized nickel – NiO.

implants (Figure 5(b)). The nitrogen had one dominant peak at the 400 eV energy level, which corresponded to C–N (Figure 6).

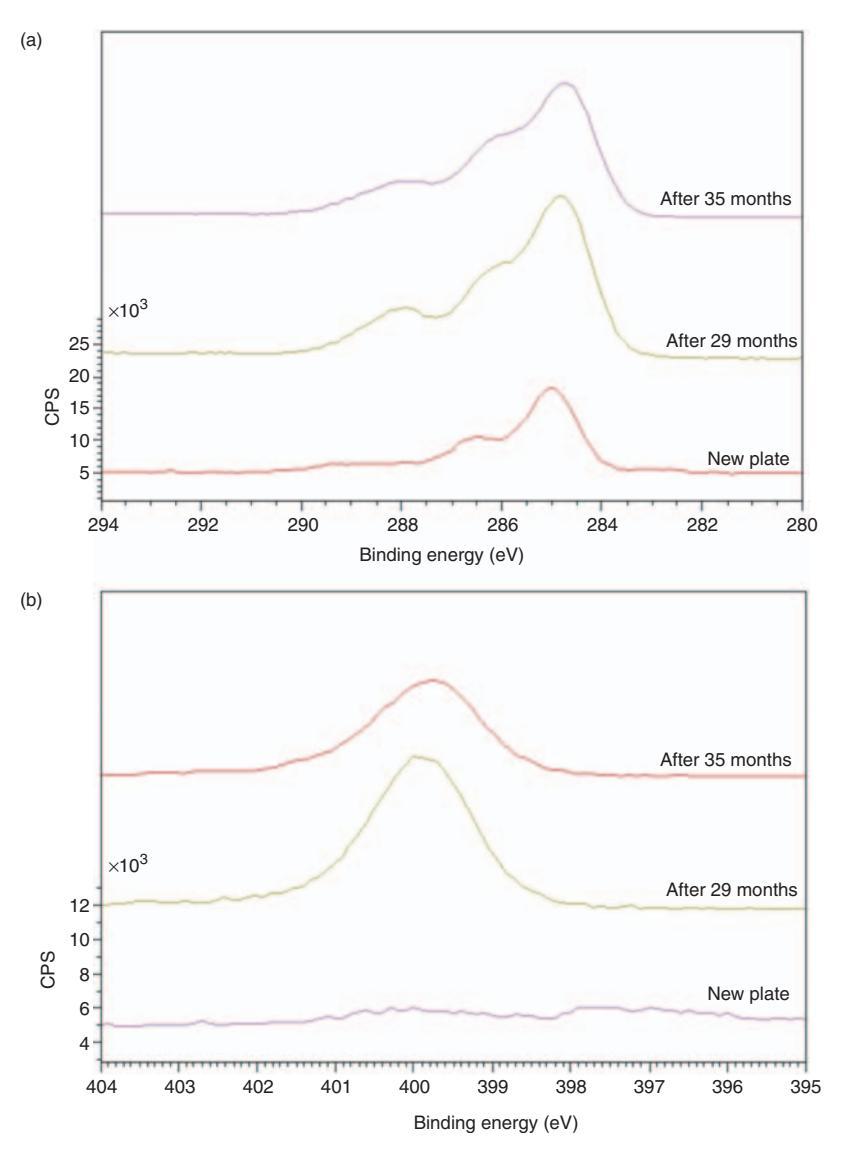
Figure 6. Detail spectra for new plates and after 26 and 35 months in the body: (a) carbon 1s and (b) nitrogen 1s.

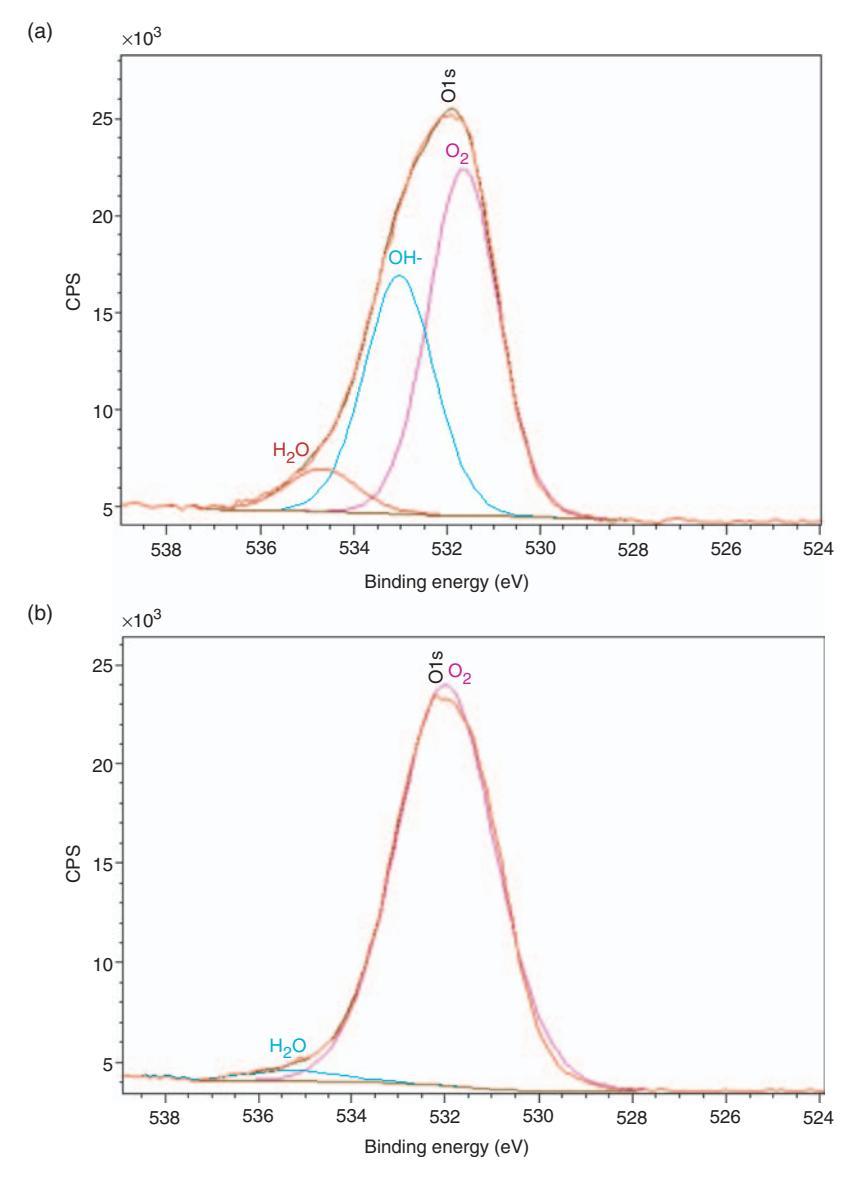
Figure 7. Oxygen spectra for parts of the implants covered with tissue after: (a) 29 months and (b) 35 months.

The plates that remained in the body for 29 and 35 months and which were not covered with the whitish layer had analogous chemical composition to the nonimplanted plate (Table 2). However there were differences in oxygen peak shape (Figure 6(b)). Oxygen component fitting showed that for the nonimplanted plate, water and hydroxyl group amounts were significantly lower than for plates staying for 35 months in the body. The oxygen components for plates that stayed for 29 months were similar to the nonimplanted plate (Figure 7(a)).

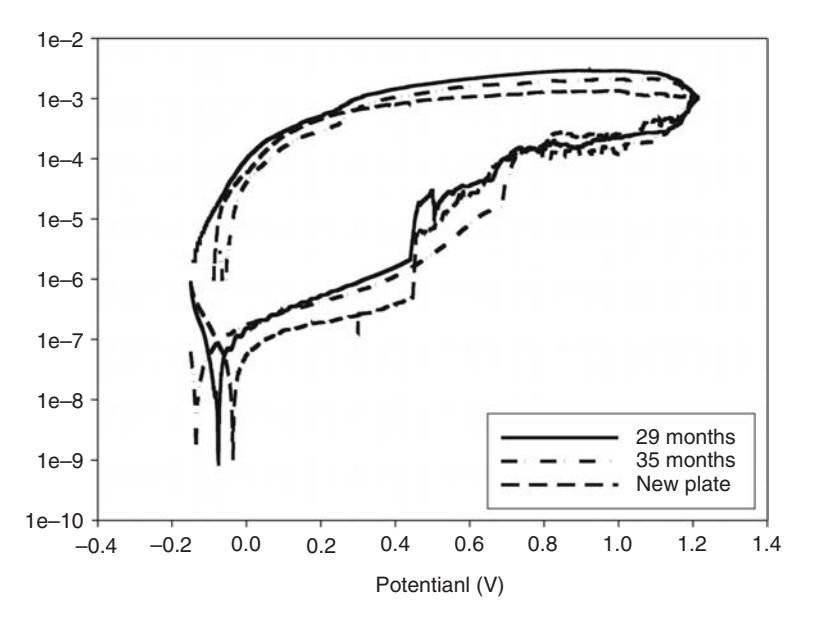
Figure 8. Potentiodynamic curves for the chest plates before and after implantation.

The results of corrosion tests are compiled in Table 3. The results for each of the plates in the deformed and nondeformed zones were analysed first. The corrosion potentials for the new, nonimplanted plate were in the range 41–48 mV. Some differences between the outside and inside surfaces of the implant were observed. The breakdown potential of the outside part was 1153 mV while for the inside part was 766 mV. The breakdown potential for the deformed part of the implant was 864 mV (Table 3). Mean deviation of the breakdown potential for the nonimplanted plate was 154 mV. The deformed area exhibited much higher polarisation resistance of $R_p = 1760 \,\mathrm{k\Omega \, cm^2}$ compared to the nondeformed parts (461 and 700 k $\Omega \,\mathrm{cm^2}$).

The differences in the corrosion potentials were observed for the plate that stayed in the body for 29 months when outside and inside parts were analysed. The deformed outside part had lower corrosion potential (-105 mV) compared with the inside part (6 mV). The mean value of the breakdown potential was 1062 mV (Table 3, Figure 8). The polarization resistance was in the range $429-1090 \text{ k}\Omega \text{ cm}^2$, mean value was $711 \text{ k}\Omega \text{ cm}^2$. The straight parts showed higher polarization resistance than the deformed part.

The bars after 35 months implantation had slightly lower corrosion potentials and their level was not dependent on the part of the implant examined. The mean corrosion potential for the bar was -29 mV. The breakdown potentials were in the range 986-1140 mV. The polarization resistance oscillated in the range of $508-930 \text{ k}\Omega \text{ cm}^2$.
