Degradation modes and tool wear mechanisms in finish and rough machining of Ti17 Titanium alloy under high-pressure water jet assistance

Y. Ayed ^{a,*}, G. Germain ^a, A. Ammar ^a, B. Furet ^b

ABSTRACT

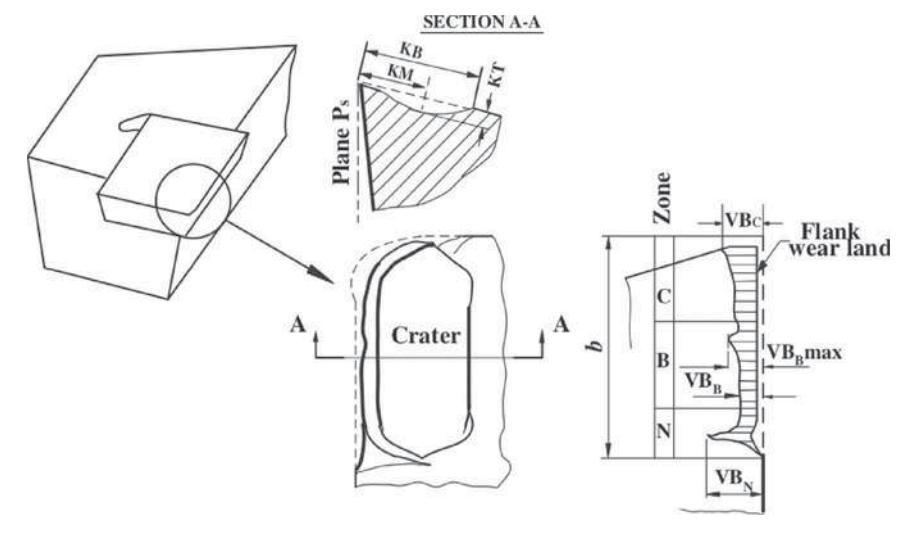
Fig. 1. Types of wear [9].

Tests were carried out to highlight the wear mechanisms and their evolution in conventional machining (without assistance) as well as under high-pressure water jet assistance. The machine used for these tests is a LEADAWELL LTC25iL lathe with a maximum power of 24 kW. Force measurement is done using a Kistler 9257B dynamometer which allows the acquisition of the three cutting force components. In order to inspect tool wear, a binocular microscope and a scanning electron microscope (SEM) were used. Fig. 1 shows the types of wear.

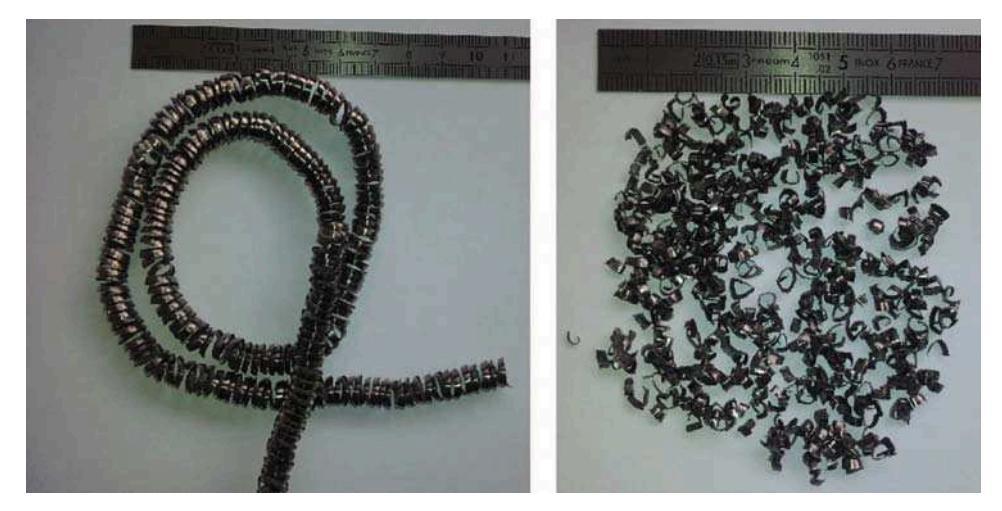
Fig. 2. Chip fragmentation at 100 bars (finishing condition).

Fig. 2 shows the morphology of the chips obtained when machining with conventional lubrication and with HPWJA at 100 bars, respectively. It can be seen that HPWJA ensures chip fragmentation.

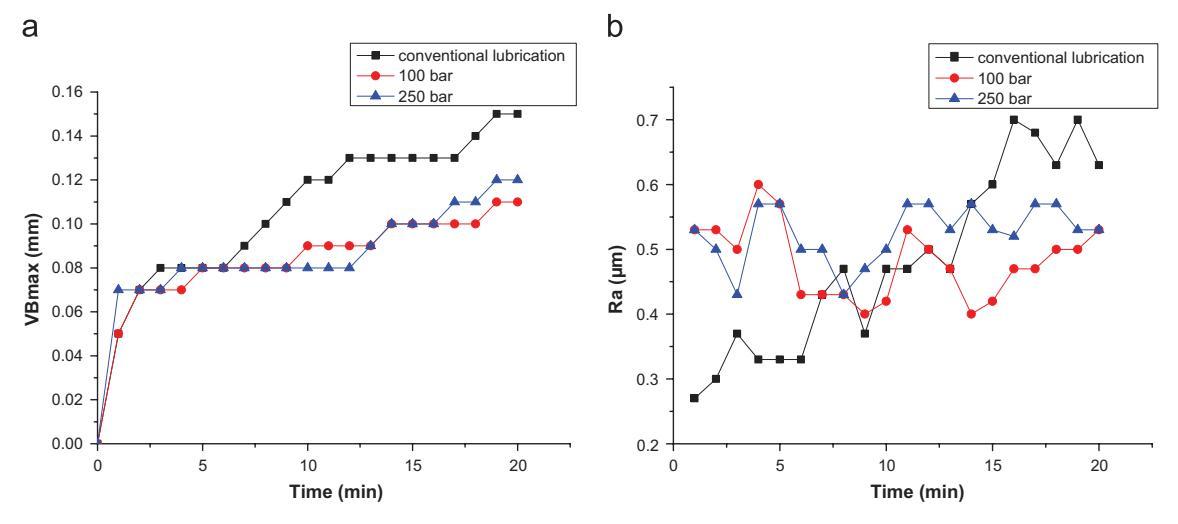
Fig. 3. (a) Flank wear (VB) and (b) surface roughness (R_a) .

Fig. 3(a) shows the evolution of the flank wear criterion (VB) and (b) the evolution of the R_a criterion. For all the configurations, flank wear (VB) does not exceed 0.15 mm after 20 min of machining, but its evolution is slower with HPWJA. Indeed, in conventional lubrication after the running-in phase, flank wear increases linearly to 0.15 mm after 20 min.

However, for the HPWJA condition, after the running-in phase, the flank wear remains constant for a significant period. Indeed, in both assistance configurations (100 bars and 250 bars), flank wear remains constant at about 0.08 mm for approximately 6 min at a pressure of 100 bars and for about 9 min at a pressure of 250 bars. After this stable regime, flank wear increases in a way similar to conventional lubrication. Fig. 3(b) shows a significant variation of surface roughness. For conventional lubrication, the surface roughness tends to increase linearly as a function of machining time, going from $R_a = 0.25 \ \mu m$ to $R_a = 0.7 \ \mu m$ (i.e. R_a reaches three times its initial value). For tests with high-pressure water jet assistance, the initial surface roughness is higher, but its value remains globally constant (between $0.4 \,\mu m$ and $0.6 \,\mu m$ throughout the test). In addition, there is no marked tendency for the surface roughness to increase even at the end of the test. The surface roughness thus appears uninfluenced by flank wear.

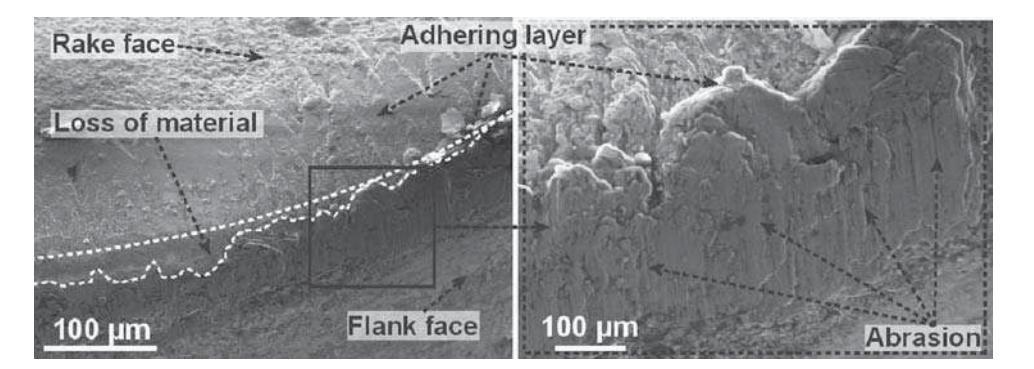
Fig. 4. SEM image of the tool rake/flank face after 20 min of machining in the finishing configuration with conventional lubrication.

Figs. 4–6 show the SEM images of the worn areas on the tool rake face and on the tool flank face for the three tests in the finishing condition. For conventional lubrication, significant flank wear at the nose radius (VBc) is observed. In addition, layers adhering to the rake face are noticed. During machining, the chip rubs on these adherent layers which appear to protect the rake face. However, when the formation of these layers reaches a stagnation level, they become instable and may be peeled-off

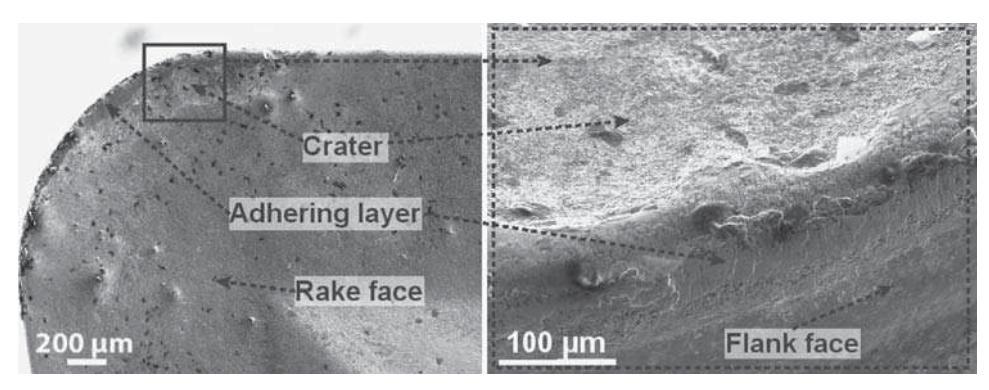
Fig. 5. SEM image of the tool rake/flank face after 20 min of machining in the finishing configuration with 100 bars.

leading to wear by adhesion [10]. Alternatively, with HPWJA, a loss of material on the tool rake face and the formation of a crater can be seen. Damage in these areas is more important at a pressure of 250 bars. In this case, it seems that the most important wear mechanism is adhesion accompanied by abrasion and erosion.

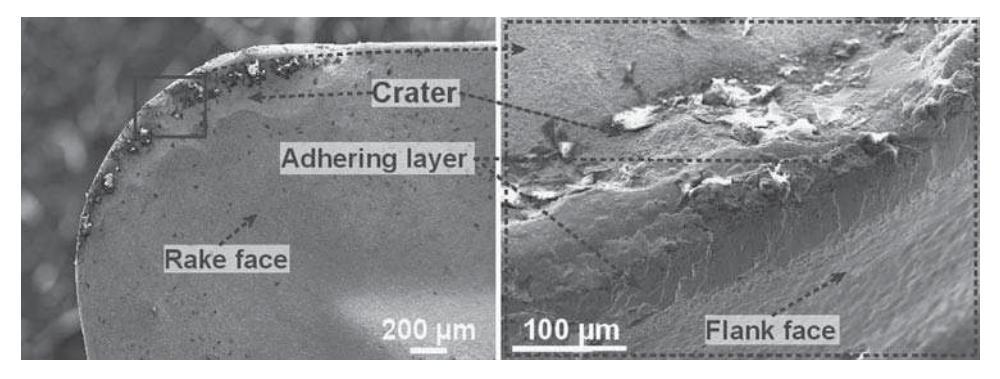
Fig. 6. SEM image of the tool rake/flank face after 20 min of machining in the finishing configuration with 250 bars.

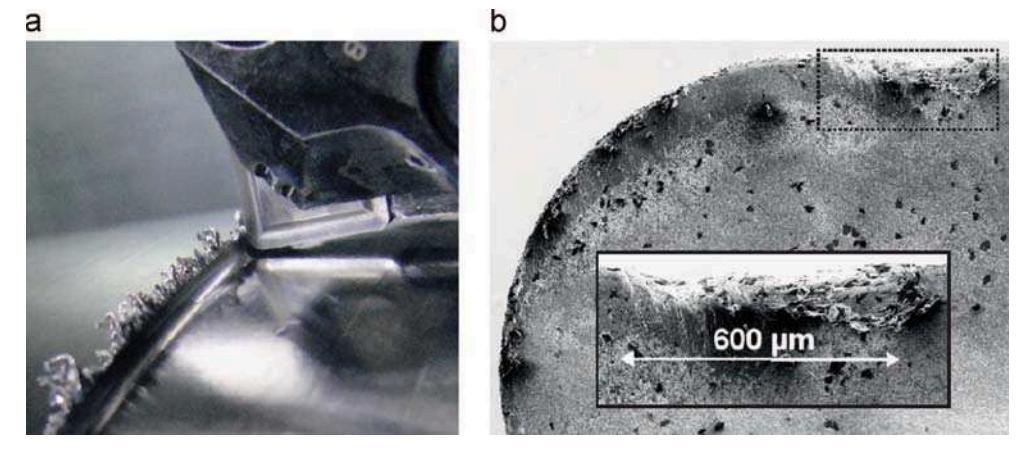
Fig. 7. (a) Formation of burr on the work-piece and (b) notch wear after 20 mm of finishing machining with conventional lubrication.

For conventional lubrication conditions, burrs are formed on the work-piece during machining, as shown in Fig. 7. At the height corresponding to these burrs, significant notch wear (VBn) is formed. The width of the notch is around 600 μ m after 20 min of machining. However, no burrs and no notch wear are visible under high-pressure water jet assistance. The specific effort has a slow and gradual evolution, but it is slightly lower in HPWJA.

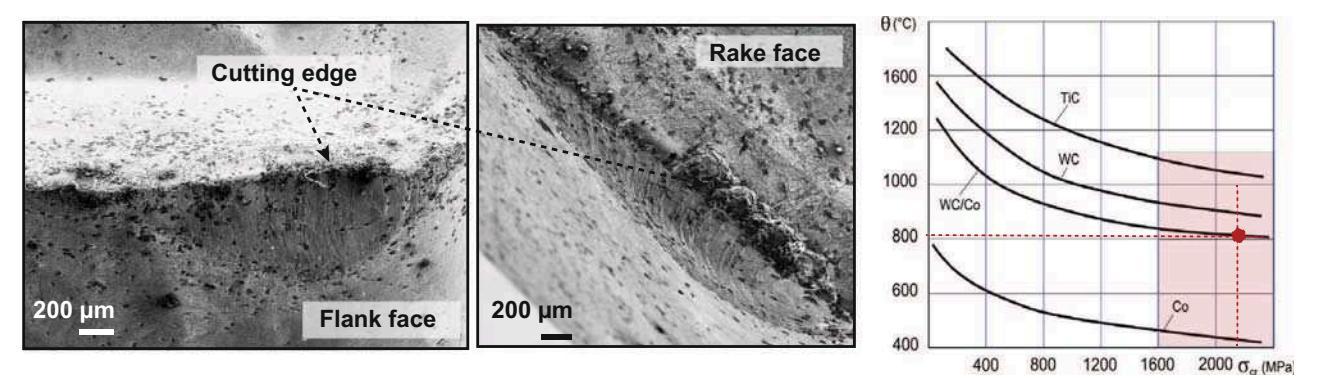
Fig. 8. (a) Image of the cutting edge after 75 s of roughing machining with conventional lubrication and (b) creep resistance [12].

Roughing tests were undertaken as per the finishing tests discussed above. Tool wear was measured every 15 s and the tests were continued until a flank wear of 0.3 mm was observed. For conventional lubrication, micro-cracks were noticed on the rake face, and are due to the thermal shock, reflecting the inefficiency of the lubrication. Tool life does not exceed 75 s. Indeed, at the end of this time, the cutting edge collapses completely. Furthermore, the degradation mode is due to plastic deformation of the cutting edge; in fact, it is the result of the combination of high cutting force and high temperature. According to Astakhov [12], plastic deformation of the cutting edge is due to creep deformation at high temperature. This plastic deformation is greater in cobalt because it does not support high creep temperatures. Moreover, this causes the tearing-off of the tungsten carbide grains of the cobalt binder. Fig. 8(b) shows the evolution of creep resistance temperature as a function of stress. When temperature becomes very high in the cutting zone, it creates thermal softening of the tool material so that it can no longer sustain the specific cutting pressure K_C (about 2100 MPa). Fig. 8(a) shows tool rake and flank faces after 75 s of roughing machining.

The measurement of the cutting force reveals that the average specific pressure is around 2100 MPa in conventional machining. Fig. 8(b) shows that, to avoid creep in the tool when exposed to a contact pressure of 2100 MPa, the cutting temperature must not exceed 900 °C for the WC and 800 °C for the WC/Co inserts. However, these temperatures correspond to those obtained when machining titanium [13–15]. This result confirms the degradation mode of the cutting edge by creep in conventional machining.

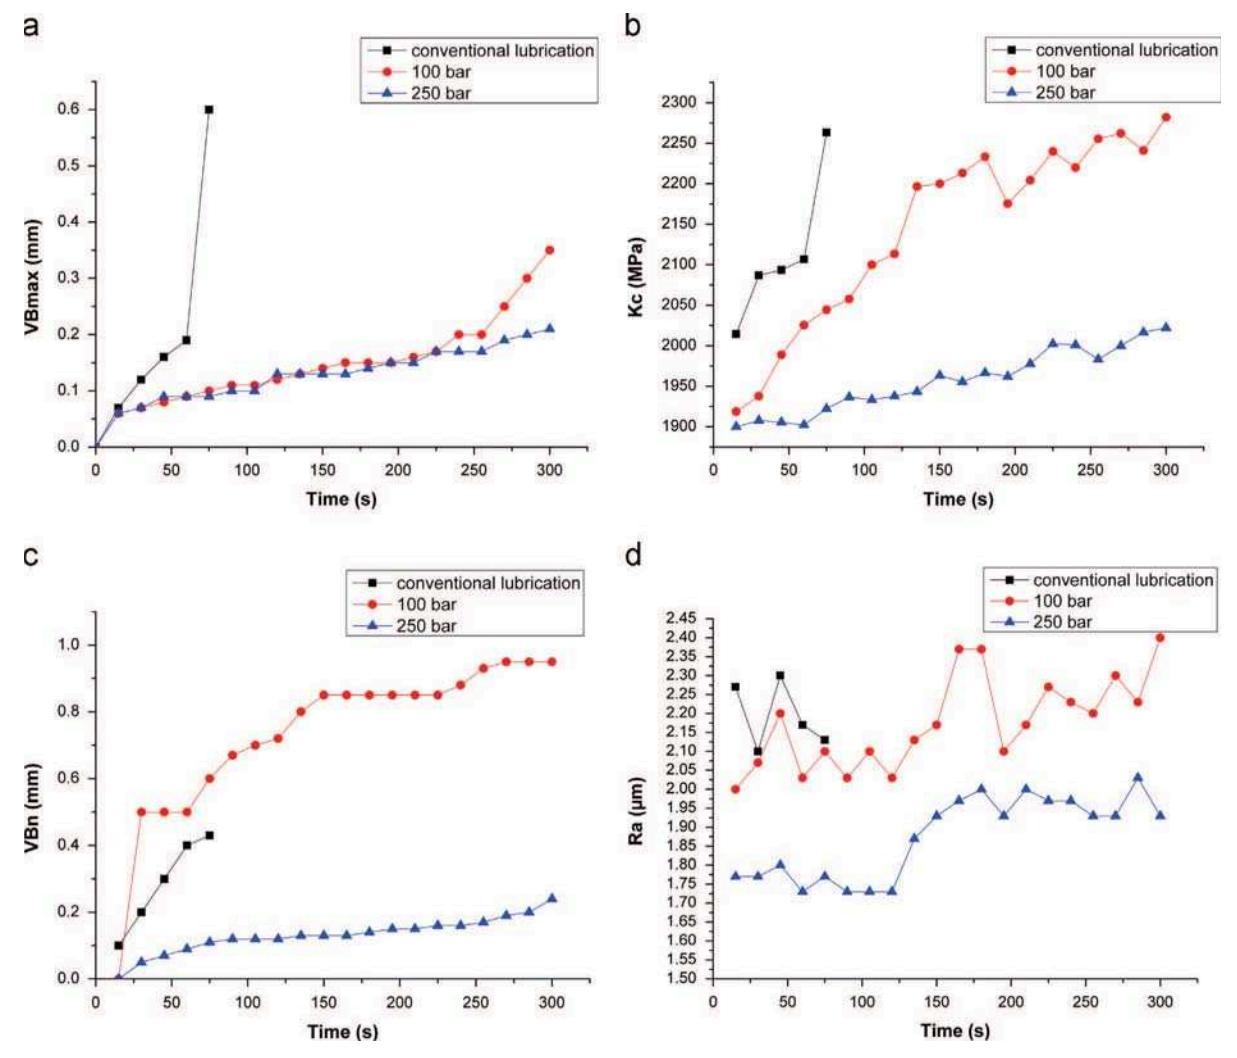
Fig. 9. Evolution of (a) flank wear, (b) specific cutting pressure, (c) notch wear, and (d) surface roughness.

This evolution is the same for both assistance pressures. However, from 4 min of machining, wear is accelerated at 100 bars. For a machining time of 5 min, flank wear is around 0.35 mm at 100 bars and around 0.21 mm at 250 bars. For a tool wear criterion set to 0.2 mm, tool life is less than 1 min in conventional machining and about 5 min at 250 bars; so, tool life is multiplied by a factor of 5.

The notch wear, VBn was also observed. Fig. 9(c) shows the evolution of notch wear for the three lubrication configurations in the roughing condition. With conventional lubrication, the notch size increases significantly with machining time. It reaches a value of 0.4 mm when the tool cutting edge collapses. Therefore, the tool degradation mode is the collapse of the cutting edge by plastic deformation, not by notch wear. With water jet assistance at 100 bars, a relatively large notch (0.5 mm) is present from the start of the test and progresses constantly until it reaches 0.95 mm after

Fig. 9(b) shows the evolution of the specific cutting pressure versus machining time. The specific cutting pressure seems to increase with increasing tool wear. It can also be noticed that the cutting force under HPWJA is lower than in conventional machining. Indeed, with a pressure of 250 bar, the specific cutting pressure K_c is about 10% lower than in conventional machining for an unworn tool. This could be due to a decrease in the friction coefficient. Indeed, the lubricant jet is inserted between the chip and the tool, which may change the coefficient of friction. The cooling is mainly localized at the tool and the tool–chip interface. The primary shear zone does not seem significantly cooled.

Fig. 9(d) shows the evolution of the surface roughness. For the three configurations, R_a is generally stable despite a slight tendency to increase over time.

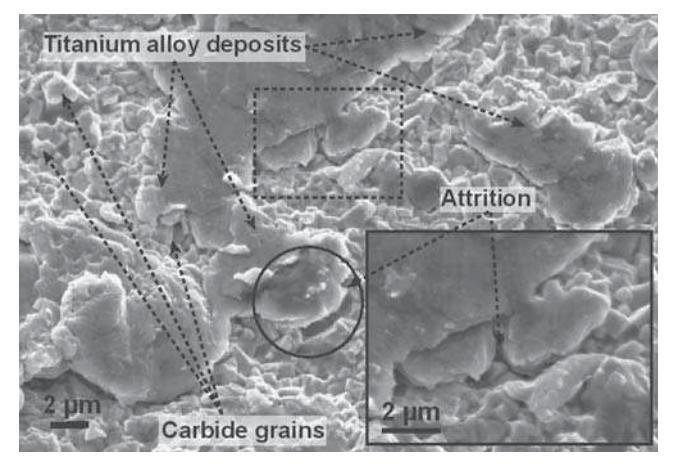
Fig. 10. Adherent layers on the tool rake face after 5 min of roughing machining at a pressure of 100 bars.

Fig. 10 shows material deposits sticking to tungsten carbide grains. Furthermore, it shows the attrition or loss of carbide grains. Fig. 11 shows that the areas with material deposits are protected and are not subjected to damage.

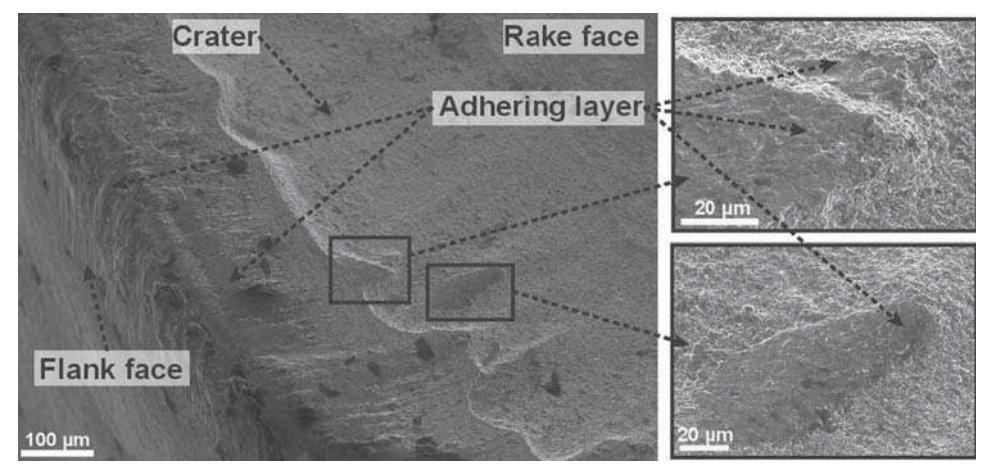
Fig. 11. Adherent layers on the tool rake face after 5 min of roughing machining at a pressure of 250 bars.

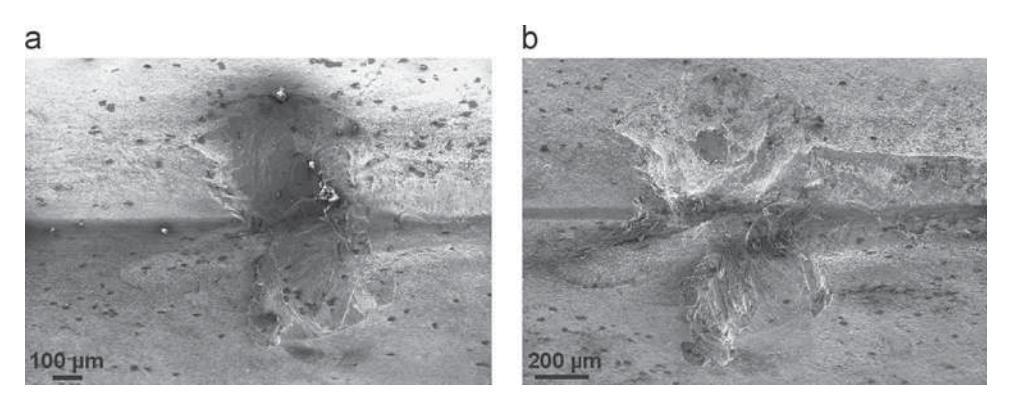
Fig. 12. Evolution of notch wear in roughing condition: (a) 4 min and (b) 5 min.

Fig. 12(a), taken after 4 min of machining, shows layers adhering to the notch. After 1 min of additional machining, the same notch is observed. Fig. 12(b) shows that the previously observed layers are pulled out, leaving a larger notch. Indeed, significant material loss was noted in the areas where material deposits were located. These observations confirm the wear mechanism by tearing-off of adhering layers.

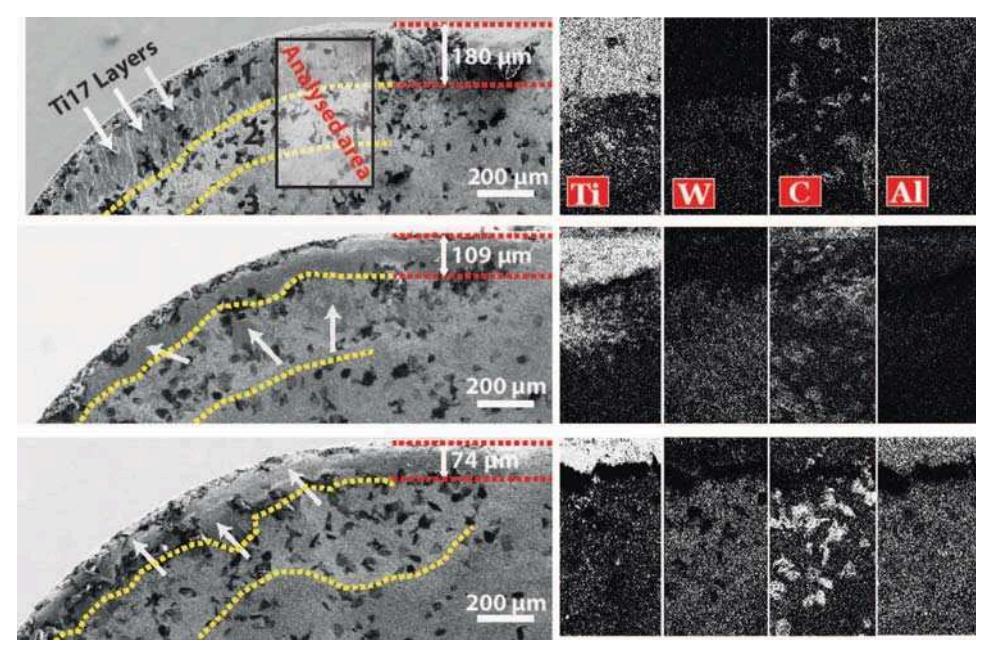
Fig. 13. Analysis of material deposits on the rake face after 15 min of finishing machining: (a) conventional machining, (b) 100 bars and (c) 250 bars.

operation, the control and analysis interval was reduced to 30 s. Fig. 13 shows the results of the qualitative analysis. Three zones can be distinguished.

• The first is formed by Ti17 layers. This is the sticking and adhesion zone;

- The second is an area of material abrasion and tearing-off, characterized by localized loss of material (and formation of a crater);
- The last zone is the area that remains intact.

In addition, the EDS analyses show the distribution maps of the elements forming the tool and the titanium alloy. The distribution maps of the elements Ti, W, C, Al are presented in Fig. 13. It can be seen that increasing the water jet pressure results in a reduction of the adherent layers zone. This reflects a decrease of the zone of strong adhesion and sticking of the chip on the tool rake face. This zone can be related to the tool/chip contact length (LC). Hence, these observations show a decrease in the tool/chip contact length with increasing pressure. The contact length decreases from 180 μ m in conventional lubrication, to 74 μ m under high-pressure water jet assistance (at 250 bars). In fact, for HPWJA, the fluid infiltrates between the chip and the tool. It has therefore the tendency to separate the chip from the tool rake face, thus decreasing the contact length, LC, and reducing friction between the tool and the chip.

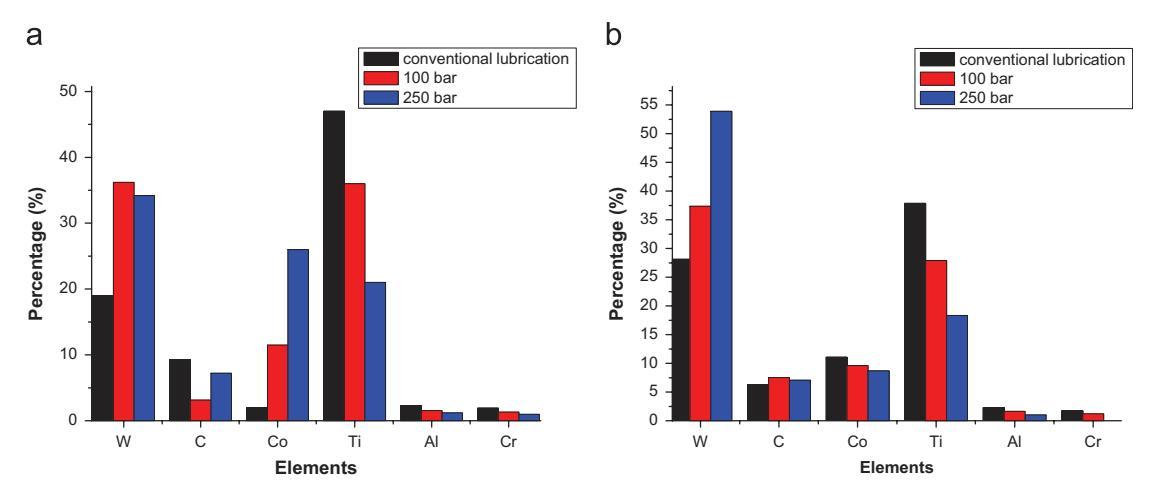
Fig. 14. Elements percentage: (a) roughing (2 min) and (b) finishing (15 min).

The same measurements have been made for the roughing condition. Fig. 14 shows the results of the analysis. Note that for the conventional lubrication condition the results are recorded after 75 s of machining. For both the roughing and the finishing conditions an increase in the jet pressure leads to a decrease in the

size of the adherent layers. For example, the percentage of the alloying elements is reduced from 45% for conventional lubrication to 21% at 250 bars for the finishing condition. In all tested conditions, the deposit rate of titanium decreases by about 25% with a pressure of 100 bars and by about 55% with a pressure of 250 bars.

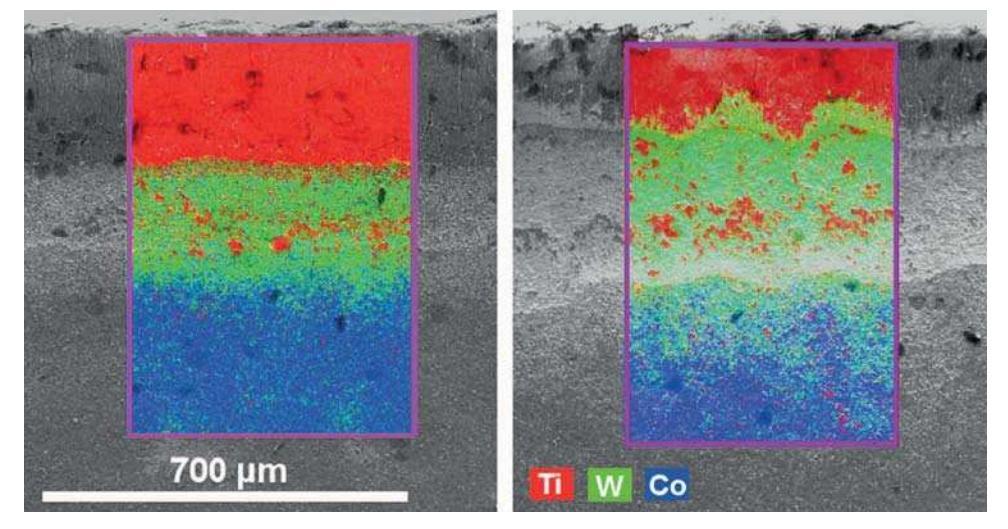
Fig. 15. EDS analysis after 4 min of roughing machining (100 bars and 250 bars, respectively).

Fig. 15 shows the tool rake face of two inserts after 4 min of roughing machining at 100 bars and 250 bars, respectively. It can be seen that the area of the adherent layers becomes smaller when the pressure is increased from 100 bars to 250 bars. In fact, the order of magnitude of the contact length is close to that found in the finishing condition.

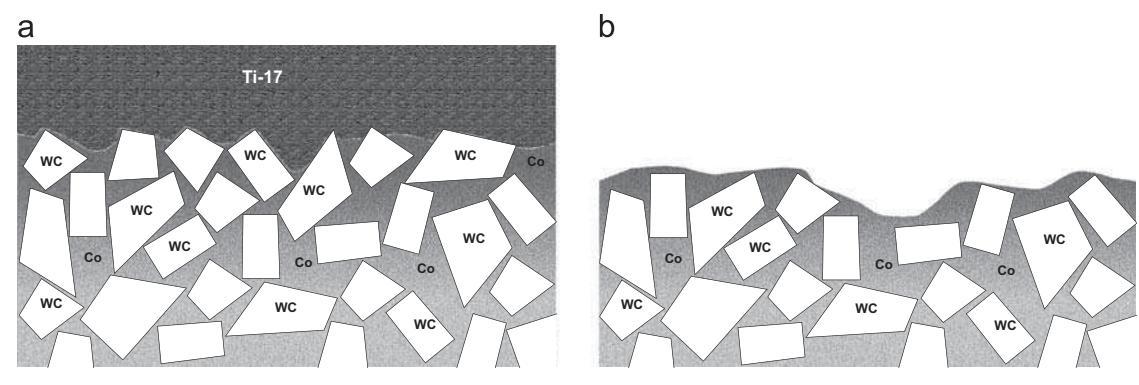
Fig. 16. Mechanism of adhesive wear.

Fig. 16 illustrates wear by adhesion. In fact, during the tool/chip contact, an interfacial layer of titanium is formed. Combined with the high temperature and high contact pressure, this layer reacts chemically with the tungsten carbide and adheres to the surface of the insert [8,11]. Thus, an increase in the cutting temperature promotes the diffusion between the tool and the chip. This deposed layer seems to protect the tool since the chip is no longer directly in contact with the carbide tungsten. However, after a period of time, the deposit may become unstable and so can be torn off by the chip. In this case, it tears fragments of the tool material leading to wear by adhesion. These findings confirm the results of other studies on adhesive wear of nickel-based alloys. Devillez et al. [19] and Bhatt et al. [11] show via SEM pictures and EDS analysis the formation of a sticky layer; it is to be noted that when this layer is pulled-out, it causes the adhesive wear.
