# **Failure Analysis of ESD-stressed SiC MESFET** T. Phulpin<sup>1,2</sup>, D. Trémouilles<sup>1,2</sup>, K. Isoird<sup>1,2</sup>, D. Tournier<sup>3</sup>, P. Godignon<sup>4</sup>, P. Austin<sup>1,2</sup>

Reliability studies are required for SiC device development. In a previous work we studied the intrinsic ESD robustness of a SiC MESFET. The failure mechanism was related to the triggering of an NPN parasitic transistor. In this work, a new MESFET layout is considered, which optionally include a Zener diode for internal protection. TLP testing and failure analysis has been carried out. Two new failure mechanisms are evidenced. Based on this knowledge, solutions are proposed to further improve the ESD robustness.

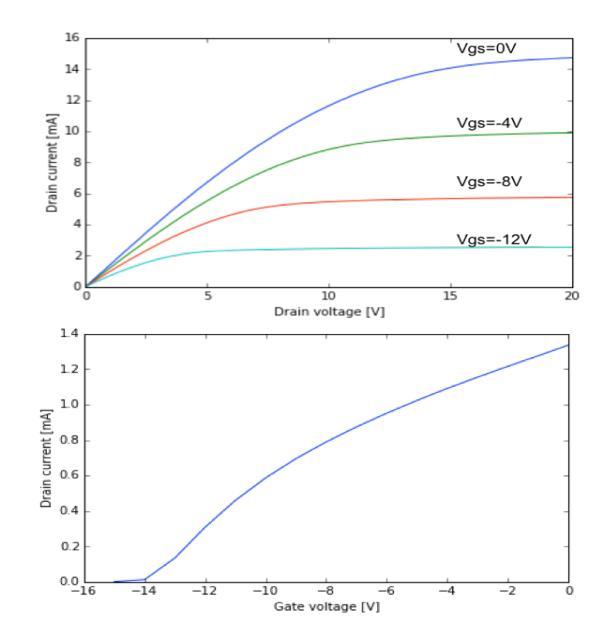
Figure 1: Id-Vd and Id-Vg static measurement at room temperature of normally on MESFET. Body and Source electrodes are grounded. Id(Vg) curve is measured for Vd=1V

The new elementary cell allows a larger flexibility for the circuit designers. For example, with this elementary cell, three types of device were generated, one buffer MESFET, one signal MESFET and one power MESFET [3]. The device is *normally on* with a -16 V pinch off voltage (**Figure** 1). The drain current saturation of one cell is equal to 16 mA and its normalized current density is  $J_{ds} = 60.6 \text{ mA/mm}^2$ . The intended operating voltage of this driver is 0-10V. The body electrode can be used as a second gate. Global area of the device is 400 µm. Despite the normally on state of these devices high performance circuitry can be design at the expense of a higher circuit complexity like oscillators, like differential pair of like totem pole [4].

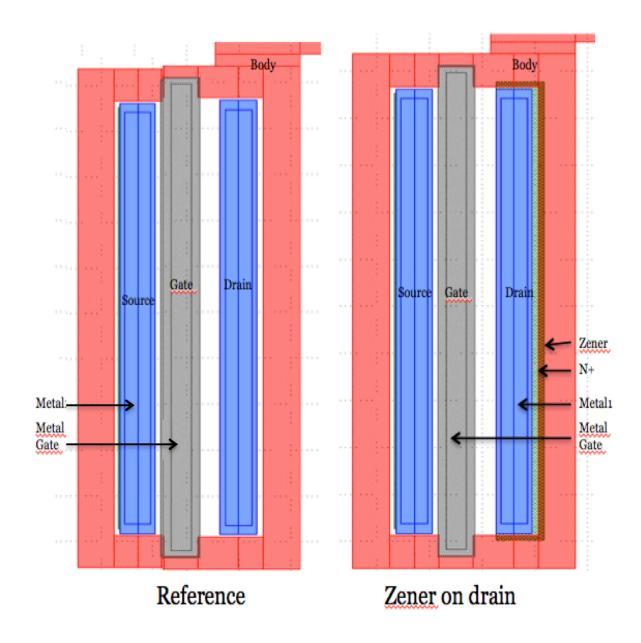
Figure 2: layout of planar Reference MESFET and Zener on Drain MESFET (MZD). In red, the P<sup>+</sup> isolation circled the three electrodes and is connected to the body pad. The Schottky metal (Nickel) is represented in grey. In green, below the blue metal, is the N<sup>+</sup> area. The two-micronlong common area between N<sup>+</sup> and P<sup>+</sup> represents the Zener diode.

Layouts of the new structures are presented in Figure 2. In red, the  $P^+$  isolation circled the three electrodes and is connected to the body pad. The Schottky metal (Nickel) is represented in grey. In green, below the blue metal, is the  $N^+$  area. The two-micron-long common area between  $N^+$  and  $P^+$  represents the Zener diode.

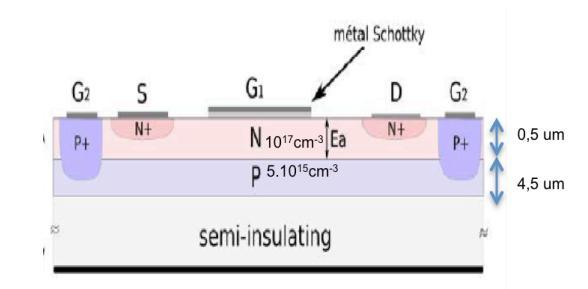
## Figure 3: Schematic of cross section of Reference MESFET.

The structure is composed of  $0.5 \,\mu\text{m}$  thick N channel doped at  $10^{17} \,\text{cm}^3$  and a  $4.5 \,\mu\text{m}$  thick P layer doped with arsenic at  $5.10^{15} \,\text{cm}^3$ . From each side of the device, we found the P<sup>+</sup> ring isolation

doped at  $4.10^{19}$  cm<sup>3</sup> (Figure 3).

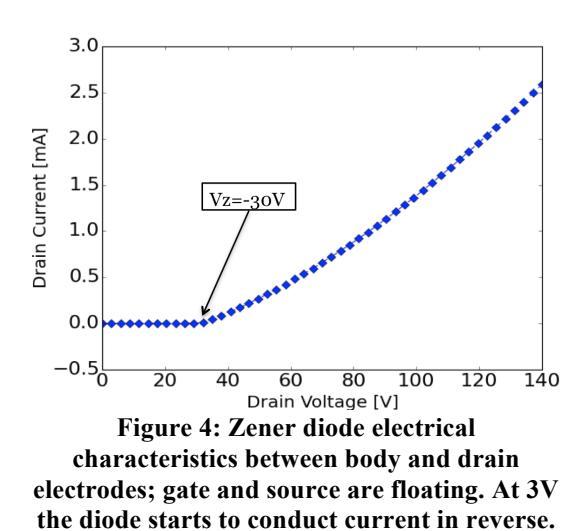
The added diode has no impact on the standard IV characteristics of the protected MESFET in the considered standard biasing operation, with gate and body floatting. The electrical characteristic of the standalone Zener diode is presented on Figure 4, measured between drain and body with gate and source grounded (same result with gate biased). A 50 $\Omega$  series resistance and a Zener voltage of around 30V is measured, that corresponds to the Zener effect in SiC Zener diode [5].

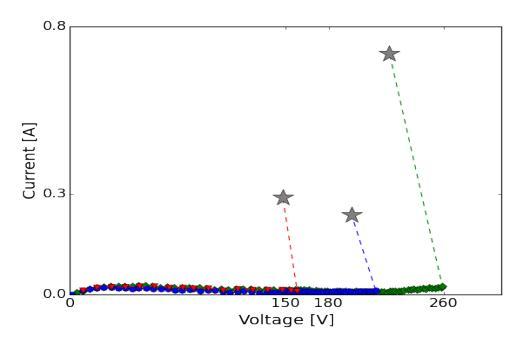
For the reference device, the characterization results of the drain to source pulsed stress are quite scattered (Figure 5). In a range of 150-260V, a large current increase occurs suddenly. Nevertheless the same damage is always instantly created and observed in the drain-diffusion corner of the device below the metal electrode (Figure 6). In a following section we will try to understand why as soon as the current increase the device is broken. As no overcurrent can be accepted before failure, the reference device is not ESD robust.

Figure 5: TLP I(V) characteristics of three experiments for the reference SiC MESFET. The grey stars indicate the point were the devices were broken.

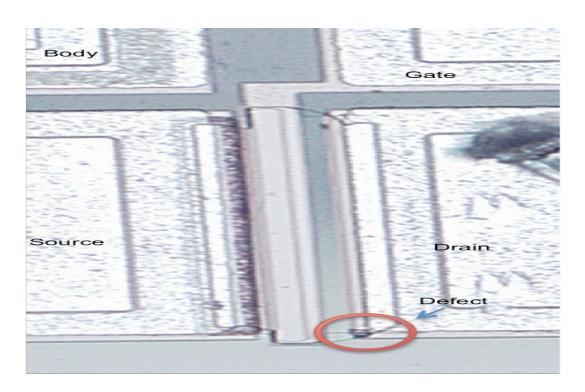
# Figure 6: Damage localization for the reference MESFET, at the drain corner after TLP test.

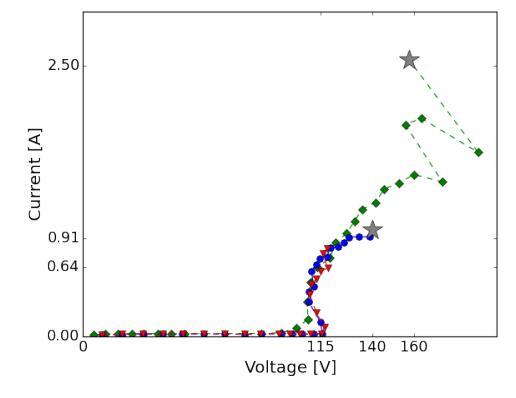
3.2. ESD Robustness for Zener on drain device The TLP measurement results for the Zener on drain MESFET were perfectly reproducible (Figure 7) on three samples. At 115V, the current starts to increase but the devices are not degraded. The Zener should drive some current in reverse even if we have seen before (Figure 4) that the Zener was trigged in static measurement for a lower voltage (~30V). The high serial resistance of the diode due to the  $P^+$  ring and the poor resolution of the TLP tester at low current levels can explain this difference. In all case the device is broken only for a current level greater than 0.91A. For MZD experimental results, the red curve shows TLP characteristic of an undestroyed device (test was stopped before any degradation) whereas for the blue one the device was destroyed at 0.91A. The Green curve device seems to present a different failure mechanism. Indeed the FIB cross section image (Figure 8) shows a defect located at the surface, in addition to the classical defect associated with MZD device failure as it is demonstrated in the following part. It is supposed that the TLP test did not capture the first failure of the device and continue the test to higher voltages, which triggered the same failure mechanism of the unprotected device i.e. oxide breakdown.

Figure 7: TLP Id-Vd for MESFET with Zener on drain. The grey stars indicate when the devices were broken (if broken).

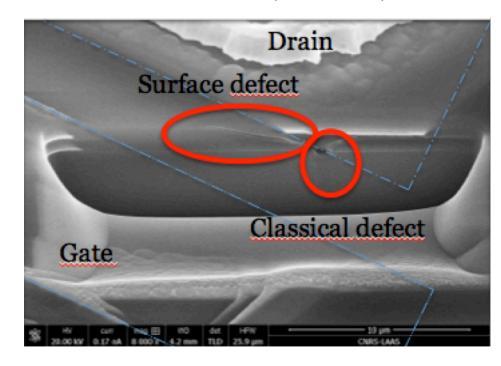
Figure 8: SEM photography of FIB analysis of unusual breakdown for MZD for MZD

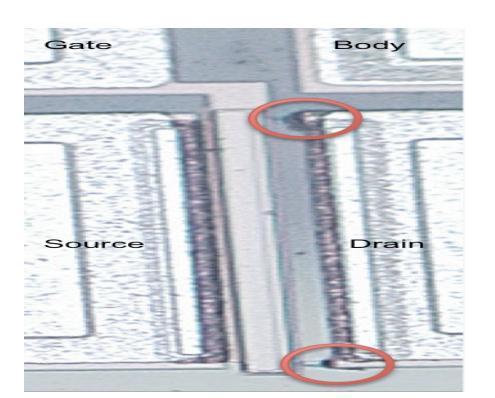
Concerning the MZD devices tested, the microscope image let suppose that the damage is an internal breakdown at the P-N junctions (Figure 9). The defect appears suddenly at one or both side of the drain and is located below the metallization at the extremities whereas for the previous defect (reference device) the oxide and metallization layer were melted.

Figure 9: Failure after TLP test on Zener on drain MESFET.

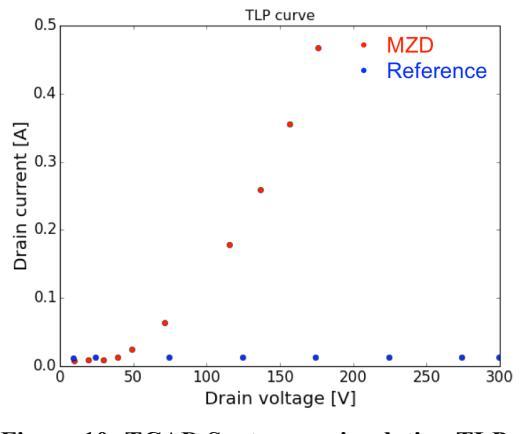
These results were analyzed with the help of Sentaurus TCAD simulations (Figure 10). Simulation allows to obtain the same triggering voltage for the standalone Zener (i.e. Vz=30 V) but as the internal body resistance is not the same in experiment than in simulation, the avalanche looks to start earlier in simulation (30 V instead of 115 V).

Figure 10: TCAD Sentaurus simulation TLP Id(Vd) result. MZD current increase at V=30V

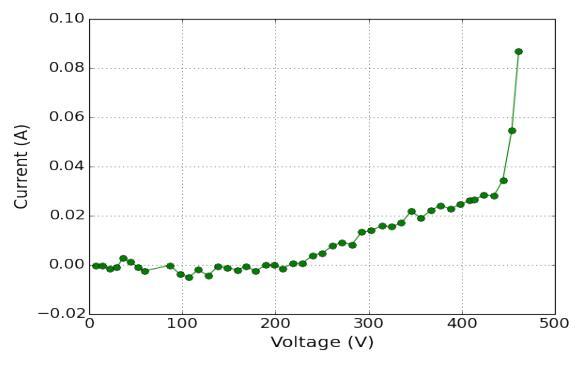
We have investigated the ESD robustness of the standalone Zener diode. It is demonstrated here that this diode is robust against ESD and is not limiting the robustness of the whole device. Indeed, before being damaged, the diode can hold around 400V in TLP (Figure 11), and its failure signature is different from the one of the protected MESFET. We biased the drain while body was grounded and source and gate electrodes were kept floating (settings with MESFET gate blocked was tested but didn't

Figure 11: TLP on the Drain Body Zener diode. Significant TLP current is detected only above 200V. The diode can sustain more than 400V before being broken but it only carries few tens of milliamps before being degraded.

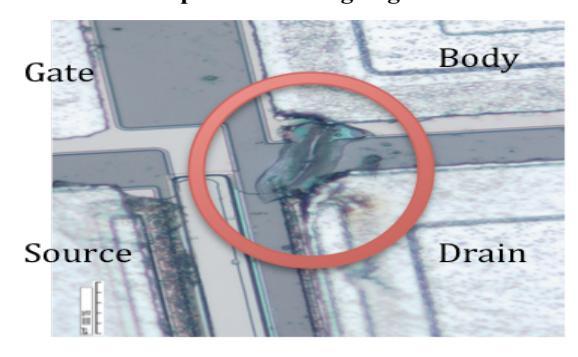
change the result). The failure is located at the surface of the device between the drain and body pads, in the P<sup>+</sup> layer (Figure 12). It corresponds to the "melting" of the P<sup>+</sup> diffusion that connects the P<sup>+</sup> ring to the substrate pad. Furthermore, the total current that this Zener diode can carry is rather low (around 400V the current is about than 20 mA). Therefore, the main current in the protected MESFET does not only flow through this diode that, therefore, cannot directly explain the observed damages of the protected device.

Figure 12: Defect created by TLP stress on the standalone Zener diode.

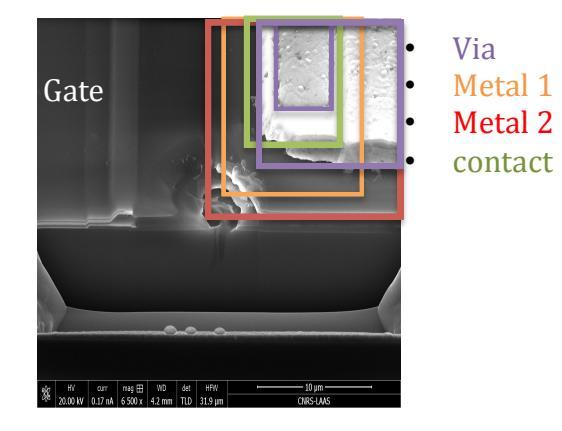
The failure of the reference device seems to be related to passivation layer damage. We have carried-out a Focus Ion Beam (FIB) and SEM analysis on one defective device. We observed a vertical hole in the passivation layer that stops before the substrate SiC layer. We have identified the observed layers with the device layout (Figure 13). Metal 2 is covering the  $P^+$  isolation. This overlap is not very large but the electric field in the

Figure 13: SEM photography after FIB operation on ESD broken MESFET.

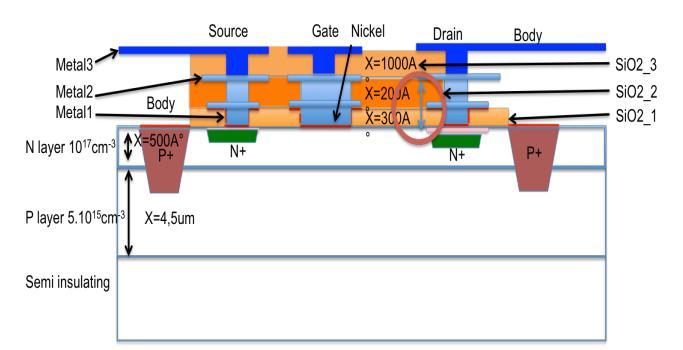
corresponding insulator region might be very high. Indeed we have an electrical-potential difference between the P<sup>+</sup> that has a potential closed to the source potential (hence at 0V) and the metal 2 where the drain voltage is applied. We know SiO<sub>2</sub> layer breakdown field is around 3 to 5  $MV/cm^2$  for this type of dielectric. The oxide layers thickness (Figure 14), from P<sup>+</sup> surface to underlying metal 2 is about 0,5 µm of SiO<sub>2</sub>. Therefore, the passivation layer can normally held around 150-250V before breaking. A hole is then created because of the temperature increase due to the high electric field and current density at this point. Simulation result (Figure 10) corroborates the high electric field in the oxidation layer hypothesis. Therefore oxide is removed and a slight hole in the SiC is produced by high temperature and sublimation process occurring with SiC.

# Figure 14: Reference MESFET device, oxide breakdown location

A way to increase the maximum voltage capability and thus the ESD robustness would be to increase the thickness of the oxide layer or to find a more robust material, and more adapted for SiC (Figure 17).

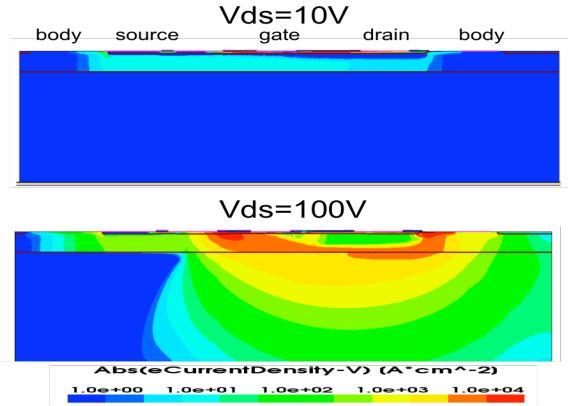
3.3.3 A parasitic NPN transistor To understand the different results and defects observed for the protected device, we will first analyze the role of the Zener diode in the protection system. The Zener PN junction near the Drain is reversed bias. When a sufficient potential is reached, The Zener diode is polarized on and a current is going through the  $P^+$  ring. Adding a Zener diode near the drain allows controlling the current discharge via the body.

Figure 15: MZD Electron current density before (Top) and after (Bottom)avalanche

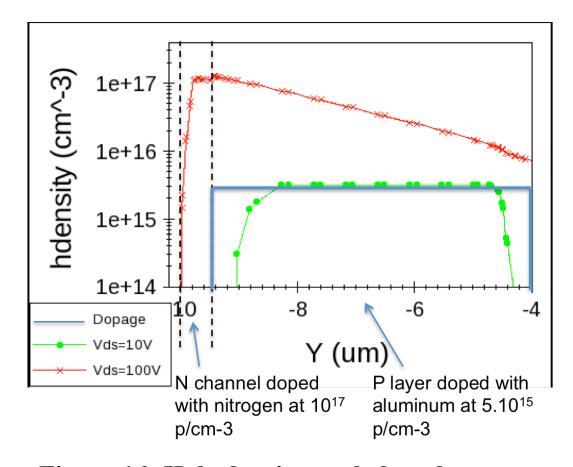
With the Zener in reverse between the drain and body  $P^+$  diffusion, the overcurrent will be driven in the body and then through the forward biased sourcesubstrate diode during an ESD. As the source is grounded, a potential difference is created between the P body and the N<sup>+</sup>. A parasitic NPN transistor will be biased with its base being the P layer and its collector being the drain region. A larger current can then be carried from the drain to the source and temperature will increase at the drain side until a damage occurs. The parasitic NPN has been triggered on as shown by TCAD simulated current density (Figure 15), impact ionization in the P layer (Base) and hole density cut below the source electrode (Emitter) (Figure 16), where holes become the main carriers in the Ν channel

#### Figure 16: Hole density cut below the source electrode, demonstrate that the NPN parasitic transitor is triggered.

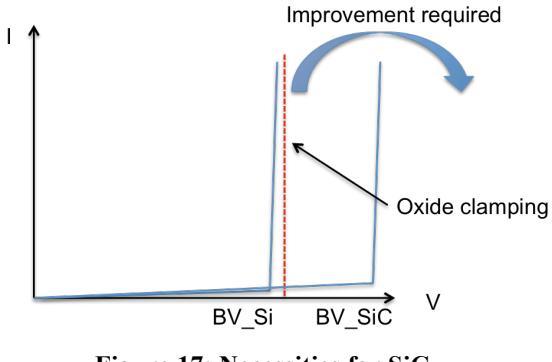
Figure 17: Necessities for SiC
