# Comparison of damage behaviour of different plant fibre composites under laser impact loading

**Abstract** – The high strain rate behaviour of the eco-composites, when submitted to laser impact loading, is not well known yet. Crucial questions are still open: influence of plant fiber length and distribution on the composite impact behaviour, types of damage induced by impact loading, the way the failure occurs, etc. We present the very first results of a collaborative research involving the institutions PPRIME- Poitiers and PIMM-Paris, and IMP PAN-Gdansk-Poland. A comparison of laser shock induced damage is realised, based on observations of sample back faces for several types of eco-composites. Spallation, residual blister and inside delamination, depending on the fibre length in tested composites have been observed. The ability of the Terahertz technique for internal damage detection is demonstrated.

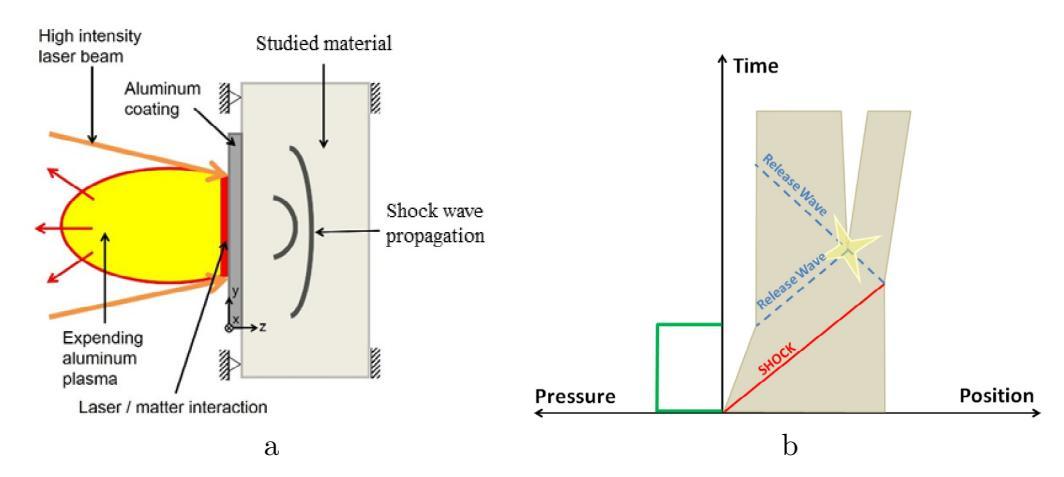
**Fig. 1.** (a) Sketch of the laser/matter interaction used to study the laser induced shock wave propagation into the studied material, (b) Time-position diagram representing the one-dimensional propagation of a shock and release waves into the studied material.

The principle of shock generation by using of laser source is described in Figure 1. The laser is focused on the specimen surface. An aluminium coating forces the laser/matter interaction to be produced on the sample surface, the created high pressure plasma expands rapidly. A shock wave is generated by reaction inside the material (see in Fig. 1a). The propagation of shock waves inside material can be simply described by a schematic 1D space/time diagram (see in Fig. 1b). Shock propagates through the material according to properties depending on its characteristics and geometry. When reaching the sample back face, this incident shock wave is reflected into a release wave propagating backward due to impedance mismatch. This release wave is crossing the incident release wave coming initiated by the end of the loading (back to the initial state). This crossing of two release waves can lead to local high tensile stresses which could damage the material if the local damage threshold is exceeded.

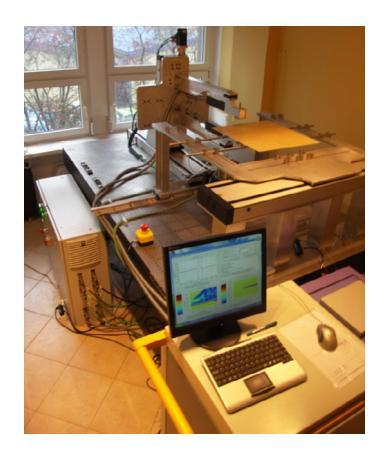
Fig. 2. Terahertz TDS spectrometer with scanning unit.

THz-TDS-system TPS Spectra 3000+ by TeraView Limited generates radiation in the form of repeated, very narrow pico-second pulses, which are focused and sent toward the investigated structure. Wide frequency content, small power and non-ionizing radiation are the main characteristics of the pulse. This approach is very interesting when the material allows for penetration at THz-frequencies, such as polymer composites. The experimental setup using THz TDS system is shown in Figure 2. The investigated samples are supported by steel bars mounted to system. They are responsible for the movement in the horizontal plane.

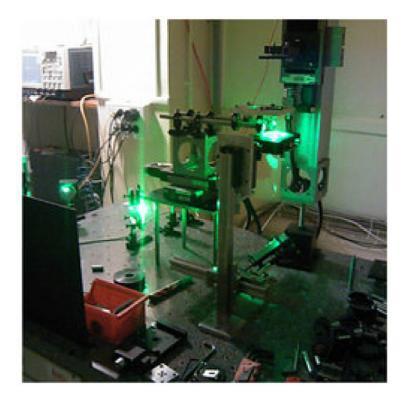
Fig. 3. HEPHAISTOS laser facility.

In this study, laser shock tests have been performed using HEPHAISTOS laser facility (Fig. 3). Laser shocks with several intensity levels have been realised on the different studied materials. The focused laser beam had a diameter of 6 mm, and the pulse duration was 10.2 ns.

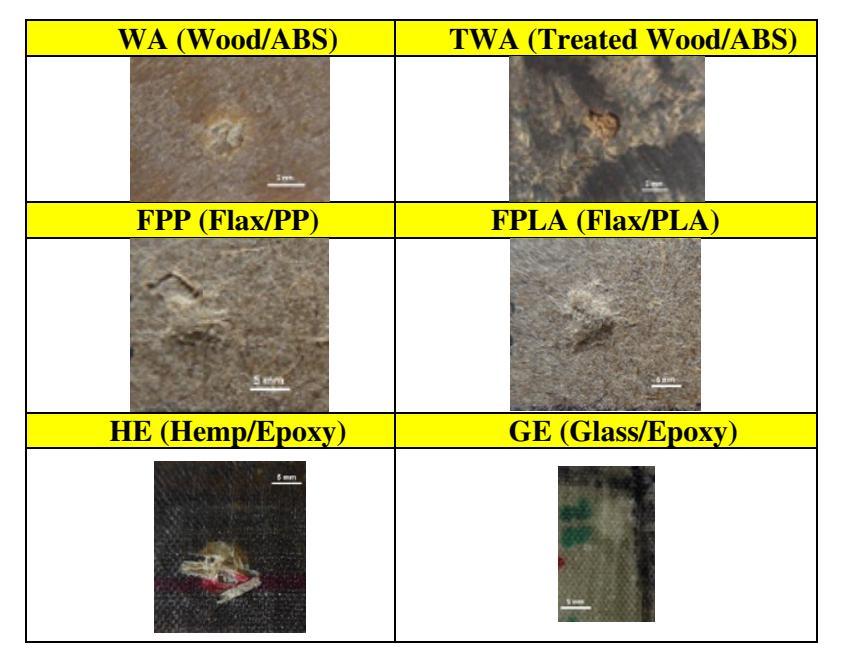
Fig. 4. Residual damage visible on back face surfaces of each composite for a laser impact with intensity of around  $4.5 \text{ GW/cm}^2$  (bar scales of 5 mm long).

In Figure 4, is shown the residual damage that are visible on back face surface of each composite after a laser impact with intensity value of around 4.5  $\text{GW/cm}^2$  are shown. In short fibre composites, WA and TWA, there is a separation and ejection of fragments from the surface, which is named the spallation phenomenon. This phenomenon does not cover the same area for the two

composites: the diameter of the spallation zone is about 4.7 mm in WA, whereas it is about 6.8 mm in TWA. This result seems to demonstrate that the thermal treatment of spruce fibres leads to a higher brittleness of the composite, when it is submitted to high strain rate loading. For composites with flax mat reinforcement, no spallation is observed (Fig. 4). The inside damage induced by the laser shock creates a residual relief, leading to small blisters on the back face surfaces of these two composites. Measurements of the diameter values of these blisters show that there is also a difference between these two composite behaviours. For the FPP sample, the blister diameter value is about 8.5 mm, and it reaches 10 mm for the FPLA sample. It shows that laser shock induces larger damage in the composite with PLA matrix than in the one with PP matrix. In Figure 4 are also presented the results obtained for the two woven composites. On the hemp/epoxy composite, a blister with partial spallation is visible, with a diameter of about 9.4 mm, whereas on the glass/epoxy material only a whitened zone can be seen, with a diameter of about 7.7 mm.

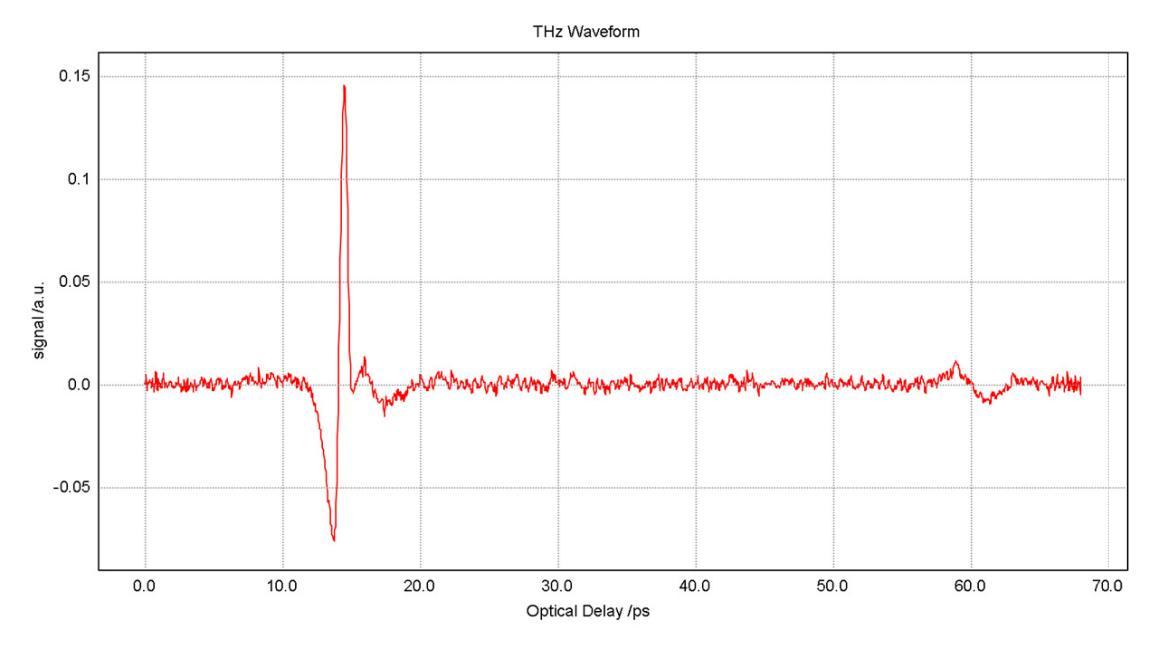
Fig. 5. Time domain signal from the terahertz spectroscopy.

First results of terahertz NDT technique were obtained for WA sample. The exemplary time domain signal registered is presented in Figure 5. The initial peak (about 15 ps) represents the strong reflection for the upper sample surface. The reflection from the bottom of the sample is visible at about 60 ps. In order to perform a NDT assessment the sample was scanned with a fine grid of measurement points spaced by 0.25 mm. The scanning result is presented in Figure 6 in a form of a C-scan. The colours represent the peak-to-peak values of time signals (Fig. 5). The strongest reflection is observed in lower left corner at which a metallic tape was placed for referential purposes. The clear presence of surface damage is visible due to sudden drop of the signal value at position (5.0 mm, -10.0 mm). The lower intensity shocks caused less pronounced damage visible at y = 0.0 mm in the range from x = 0.0 mm to 40.0 mm.

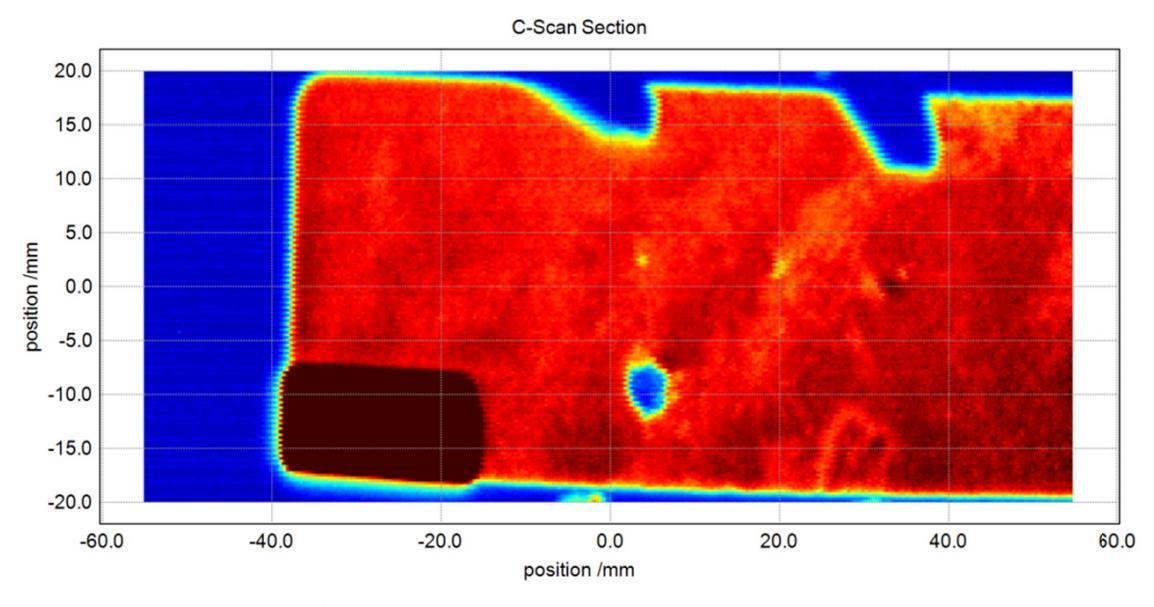
Fig. 6. Peak-to-peak C-scan of the WA sample obtained using terahertz technique.
