### INVESTIGATION OF DAMP HEAT AGING ON SODA - LIME GLASS FOR PHOTOVOLTAIC APPLICATIONS

V. Guiheneuf, F. Delaleux, O. Riou, P-O. Logerais, J-F. Durastanti

University of Paris-Est, CERTES Laboratory (EA 3481) IUT de Sénart-Fontainebleau, 36 rue Georges Charpak, 77567 Lieusaint, France Tel: +33 1 64 13 46 86; E-mail: vincent.guiheneuf@u-pec.fr;

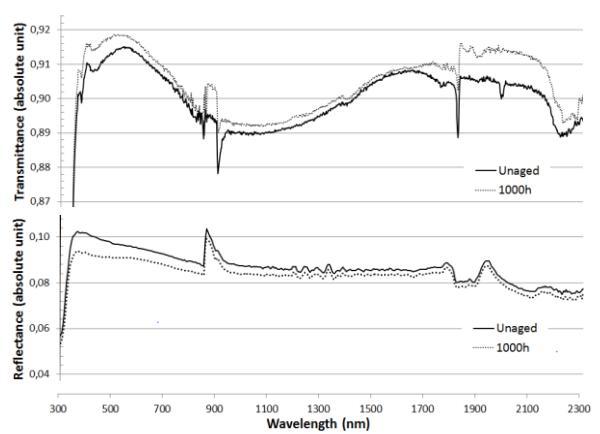
Fig. 1 exhibits the transmittance and reflectance spectra of glass samples before and after 1000 h of damp heat treatment. A significant increase in the optical transmission after 1000 h of damp heat exposition in the 300-2300 nm wavelength range can be observed. This fact is interesting for photovoltaic conversion of Si cell, typically in the 400-1100 nm range. Nevertheless, the transmittance increase in the UV range could accelerate the polymer degradation. Hence, the efficiency of the PV device would be diminished. Concerning reflectance measurements, the behavior is opposed but stays in the same proportion. So, the absorption of glass samples remains unchanged after this accelerated aging.

Figure 1: Transmittance and reflectance of glass sample before and after 1000 hours of damp heat treatment.

The increase of the glass transmittance can be explained by the fact that molecular water penetrates into the glass. One might suggest that molecular water reacts with glass network as explained below and which is confirmed by FTIR, SEM-EDX and XPS analyses.

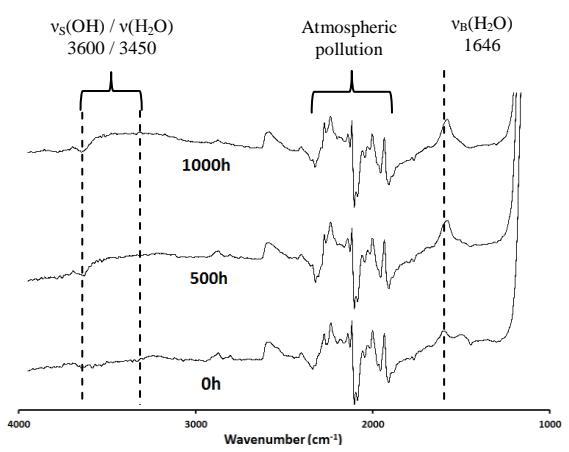
Fig. 2 shows the superposed FTIR spectra of each sample to visualize shifts of the characteristic peaks. By studying infrared reflectance spectra, structural changes can be noted during hydration of the three glass samples at different instants. The bending vibration of molecular water occurs at 1611 cm<sup>-1</sup> but it can be modified by hydrogen bond stretch [5]. The band at 1646 cm<sup>-1</sup> which is expected for molecular water (v<sub>B</sub> (H<sub>2</sub>O)), shows raised peak heights for samples after 500 and 1000 h under DH respectively. The peak shift towards lower wavenumbers can be explained by the weakening of the hydrogen bonds. The broad O-H absorption of silanol at 3600 cm<sup>-1</sup> is due to the specificity of hydroxyl groups that can be freed or hydrogen-bonded.

**Figure 2:** Infrared reflectance spectra of 3 glasses samples under damp heat conditions as a function of exposure time: 0, 500 or 1000 hours.

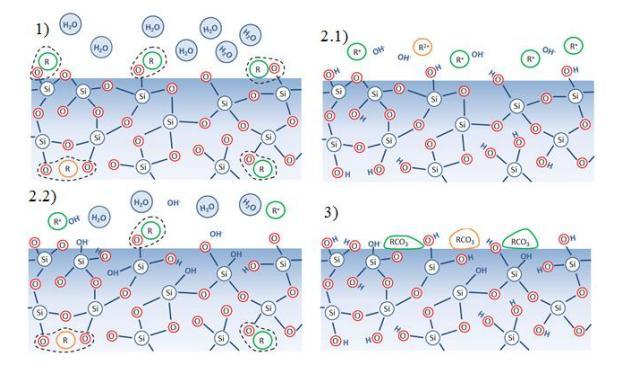
The study of glass aging during damp heat test also shows changes of surface and bulk chemistry representative of leaching process accelerated under a hot and humid atmosphere. The following model proposed by the authors and depicted in Fig. 3 is based on Schaut-Pantano's model [6]. The glass degradation mechanism can be described in three stages: 1) water gel film coating, 2) molecular water adsorption with reaction in glass and 3) corrosion and deposits of carbonates. Fig. 3 illustrates the following descriptions for each stage of glass degradation mechanism.

Figure 3: Aging mechanism of soda-lime glass under damp heat as described in Ref. [6]: 1) water gel film coating, 2.1) leaching of cations, 2.2) hydrolysis of glass network and 3) glass corrosion and deposits of carbonates.

A water film coating is formed on glass during damp heat aging by condensation and adsorption of water vapor. In this water film, we can distinguish the physisorption for which water molecules bind on glass by means of Van der Waals forces and the chemisorption at the near water/glass interface for which chemical reactions take place with cations and silica to generate new specific chemical bonds. Then free molecular water diffuses through silica network. At this moment, two types of chemical reactions can take place. The first one based on the reaction of molecular water with monovalent cations,  $R^+$ , like Na<sup>+</sup> or K<sup>+</sup> and divalent cations,  $R^{2+}$ , like Ca<sup>2+</sup> or Mg<sup>2+</sup> on non-bridging oxygen (NBO) sites. The cationic atoms are free and released apart from glass network to water film where they accumulate as soluble precipitates on a mixture of molecular water and hydroxide ions, which is the well-known mechanism of leaching:

But at the same time, molecular water also reacts with silica network on BO sites with three major chemical reactions to allow hydrolysis of silica network. They imply Si-O-Si or SiO<sup>-</sup> groups with molecular water and hydroxide ions. The latter react within silica network providing a linkage of hydrogen bonds to form silanol groups:

When liquid film reaches pH 9, degradation of glass surface becomes more important with formation of precipitates of insoluble carbonates like  $Na_2CO_3$  and  $CaCO_3$ . The formation of carbonates involves a permanent staining which reduces the optical performance of top glass. However, transmittance measurements and visual inspection do not reveal permanent staining. The cationic leaching and hydrolysis of silica network provide the corrosion layer formation with lacunas left by leaching. The increasing porosity involves a most effective removal of soluble constituents, especially of network modifiers, which probably improves the transmittance properties. This fourth step has not been highlighted in the present study and it is certainly due to a restricted aging time.
