# Surface and machining induced damage characterization of abrasive water jet milled carbon/epoxy composite specimens and their impact on tensile behavior

Akshay Hejjaji<sup>a</sup>, Redouane Zitoune<sup>a,\*</sup>, Laurent Crouzeix<sup>a</sup>, Sabine Le Roux<sup>b</sup>, Francis Collombet<sup>a</sup>

<sup>a</sup> Institut Clément Ader CNRS UMR 5312, Toulouse, France <sup>b</sup> Université de Toulouse, Mines Albi, Institut Clément Ader CNRS UMR 5312, Albi, France

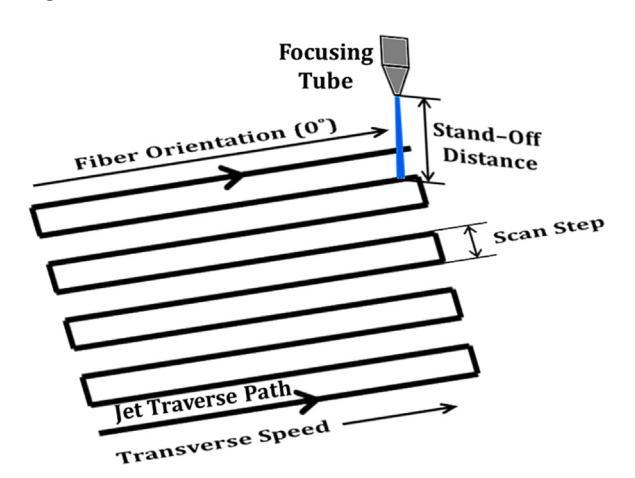
Fig. 1. Schematic view of the water jet scan pattern with respect to the fiber orientation.

The raster scan pattern was considered for the milling path strategy, and direction of milling was maintained parallel to fiber orientation (Fig. 1). The CFRP specimens were securely clamped on wood plank to avoid movement during milling. The direction parallel to fiber orientation and milling path is considered long-itudinal direction and direction perpendicular to it is taken as transverse direction.

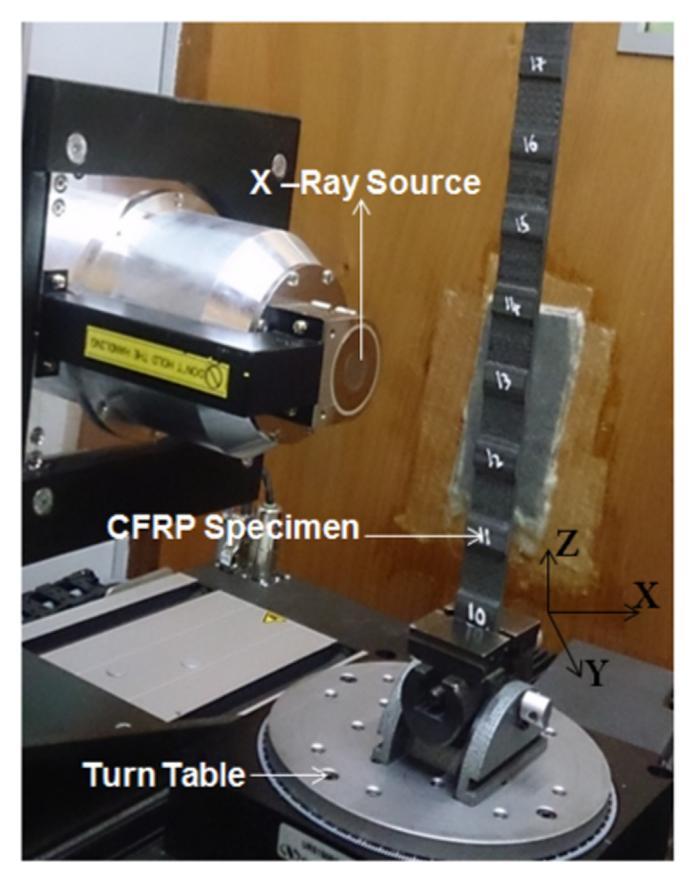
Fig. 2. Setup showing X-Ray tomography tests.

Measurements with X-ray micro computed tomography were carried out using Micro-Tomography Easy Tom 130 machine. Each specimen was exposed to radiation and rotated through 360° to capture the images from all planes. The X-ray voltage and current were set to 130 kV and 300 mA, respectively. X-rays were diverged conically from the source and received by the receiver after encountering the specimen. The source has a spot size of 3 lm. The maximum possible resolution obtained was 127  $\mu$ m. The Fig. 2 shows the X-ray tomography test setup.

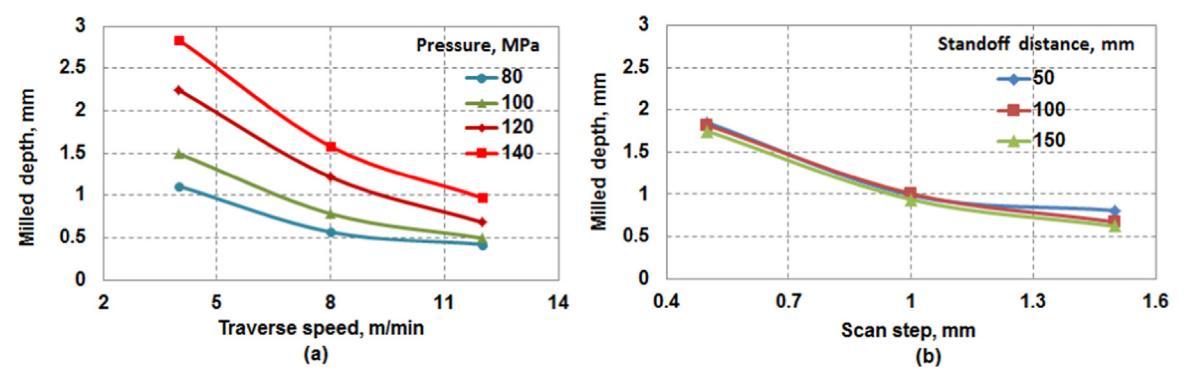
Fig. 3. The mean effect of the machining parameters on the milled depth. With: (a) influence of the pressure & traverse speed and (b) influence of the scan step & standoff distance.

The mean effects of the machining parameters on the material removal properties namely, milled depth and material removal rate are presented in Figs. 3 and 4 respectively. It can be seen that the pressure, traverse speed and scan step (Fig. 3(b)) highly influence the milled depth For example, when the scan step varies from 1.5 mm to 0.5 mm (Fig. 3(b)), the milled depth increases by 190% (compared to mean value of 0.65 mm). Also, when machining is conducted with a pressure of 80 MPa (with: traverse speed of 8 m/min, standoff distance of 50 mm, scan step of 0.5 mm) the average milled depth is equal to 1.15 mm but with the same conditions if the pressure increases to 140 MPa the depth increases by 145% (Fig. 3(a)). These results are confirmed by the statistical method such as ANOVA, it reveals that scan step is most significant factor followed by the pressure and traverse speed. The percentages of contribution of these parameters are 41.5%, 30.3% and 24% respectively.

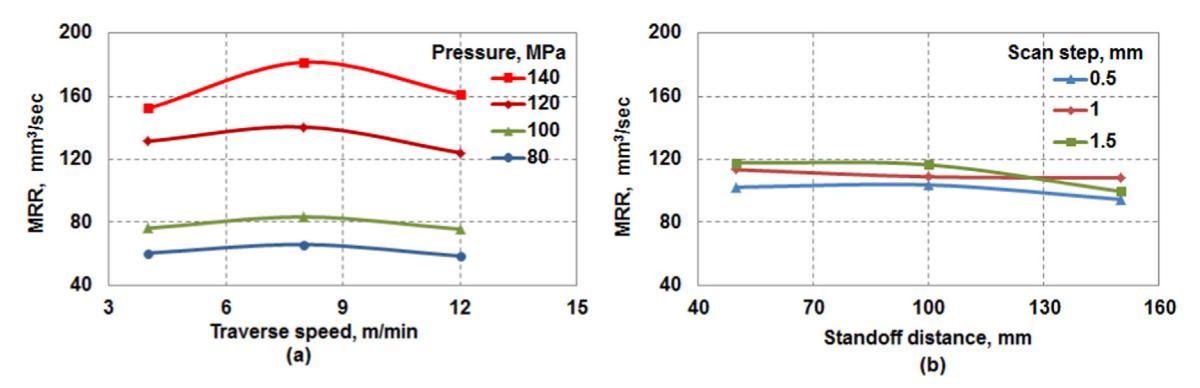
Fig. 4. The mean effect of the machining parameters on the material removal rate (MRR). With: (a) Influence of the pressure & traverse speed and (b) Influence of the scan step & standoff distance.

The variations in these results can be explained by the fact that, the material is removed in the form of a channel along the jet traverse path. Scan step determines how close the 2 adjacent channels are, and the geometry of these channels depends on the jet diameter, pressure and traverse speed. If the scan step is smaller than the jet diameter then the two adjacent scanning paths overlap, thereby removing the material at the overlapping zone twice, this implies a higher milled depth. But when the scan step is high, there will be no overlapping of the channels, which accounts for lower milled depth. In addition, when the pressure increases, the kinetic energy of the water and the abrasive particles increase, which in turn increases the impact energy. With the increases of the impact energy, the material removal rate increases too. This can be confirmed by the Fig. 4, which depicts the mean effect of the machining parameters on the material removal rate (MRR). It is clear that, when the pressure varies from 80 MPa to 140 MPa, the mean MRR varies from 60 mm<sup>3</sup>/sec to 150 mm<sup>3</sup>/sec (for a transverse speed of 4 m/min). It can also be seen that there is critical value of speed for which MRR is the highest for the given set of parameters deviating from it will result in lower MRR (Fig. 4 (a)). However, the rise in the scan step for a standoff distance inferior or equal to 100 mm induces a small variation in the MRR. In the case of standoff distance superior to 100 mm a non-negligible

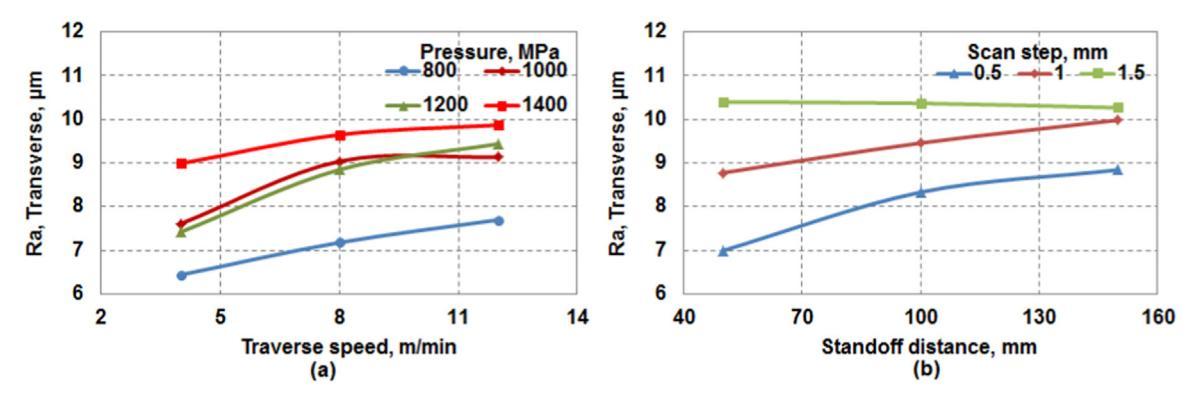
Fig. 5. The mean effect of the machining parameters (a) Pressure & traverse speed on roughness in transverse direction, (b) Scan step & standoff distance on surface roughness in transverse direction.

The mean effect of the machining parameters on the surface quality characteristics viz. average surface roughness (Ra) and root mean square waviness (Wq) along the longitudinal and transverse direction is illustrated in the Figs. 5 and 6 respectively. The surface roughness in the transverse direction of milling is highly influenced by the jet pressure and traverse speed (Fig. 5(a)). High pressure increases the energy available to the abrasive particles due to which localized material removal will be vigorous there by creating a rugged surface with high roughness compared to the surface milled with lower pressure. This can be confirmed by SEM observation that broken fibers are found in abundance on the surface milled with high pressure compared to low pressure milled surface which is elaborately discussed in later section. Also, influence of scan step on Ra along transverse direction is prominent, where increase in scan step contributes to higher surface roughness (Fig. 5(b)). The mean effect of the jet pressure, traverse speed and standoff distance on the surface roughness along the longitudinal direction follows the similar trend as in transverse direction, but the role of scan step is negligible in longitudinal direction.

parameters and damage. The broken fibers and micro craters contribute to the surface roughness and macro craters contribute to the surface waviness. From the previous section we know that increase in pressure increased surface roughness and also surface waviness significantly (Fig. (5a)).

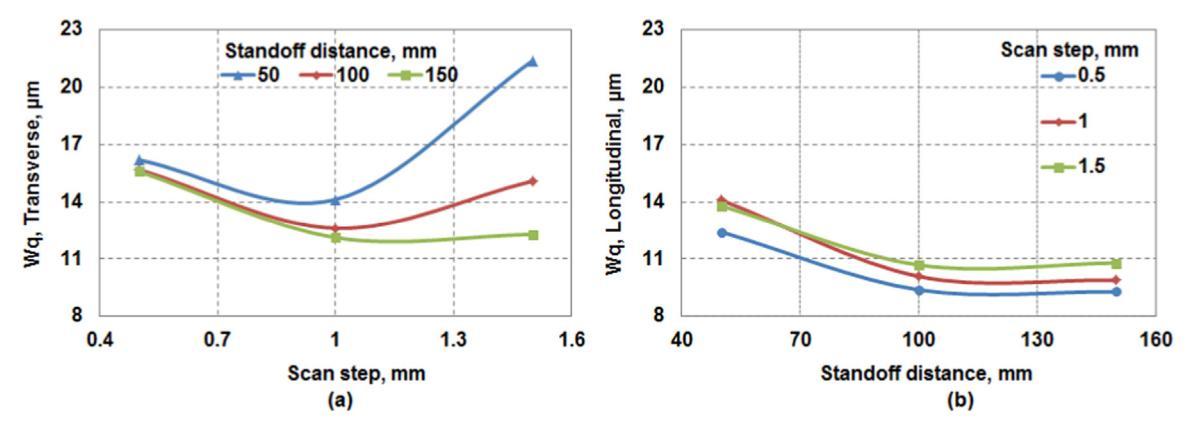
Fig. 6. The mean effect of machining parameters (a) Scan step & standoff distance on waviness in transverse direction (b) Scan Step & standoff distance with on waviness in longitudinal direction.

The mean effect of root mean square surface waviness (Wq) along the transverse and longitudinal direction is highly influenced by scan step and standoff distance respectively (Fig. 6). The evolution of surface waviness (Wq) along the transverse direction demonstrates a critical behavior with respect to scan step (Fig. 6 (a)). Here, the waviness decreases to the lower most value when scan step is 1 mm, which is equivalent to the focusing tube diameter. This phenomenon suggests that over lapping or separation of scan paths will generate surface waviness. ANOVA acknowledges this fact by showing that scan step alone accounts to 52.11% of the total variance for waviness along the transverse direction. It is interesting to note that standoff distance does not play a significant role in material removal where as it happens to be an important parameter when surface characteristics are considered (Figs. 5(b) and 6(b)).

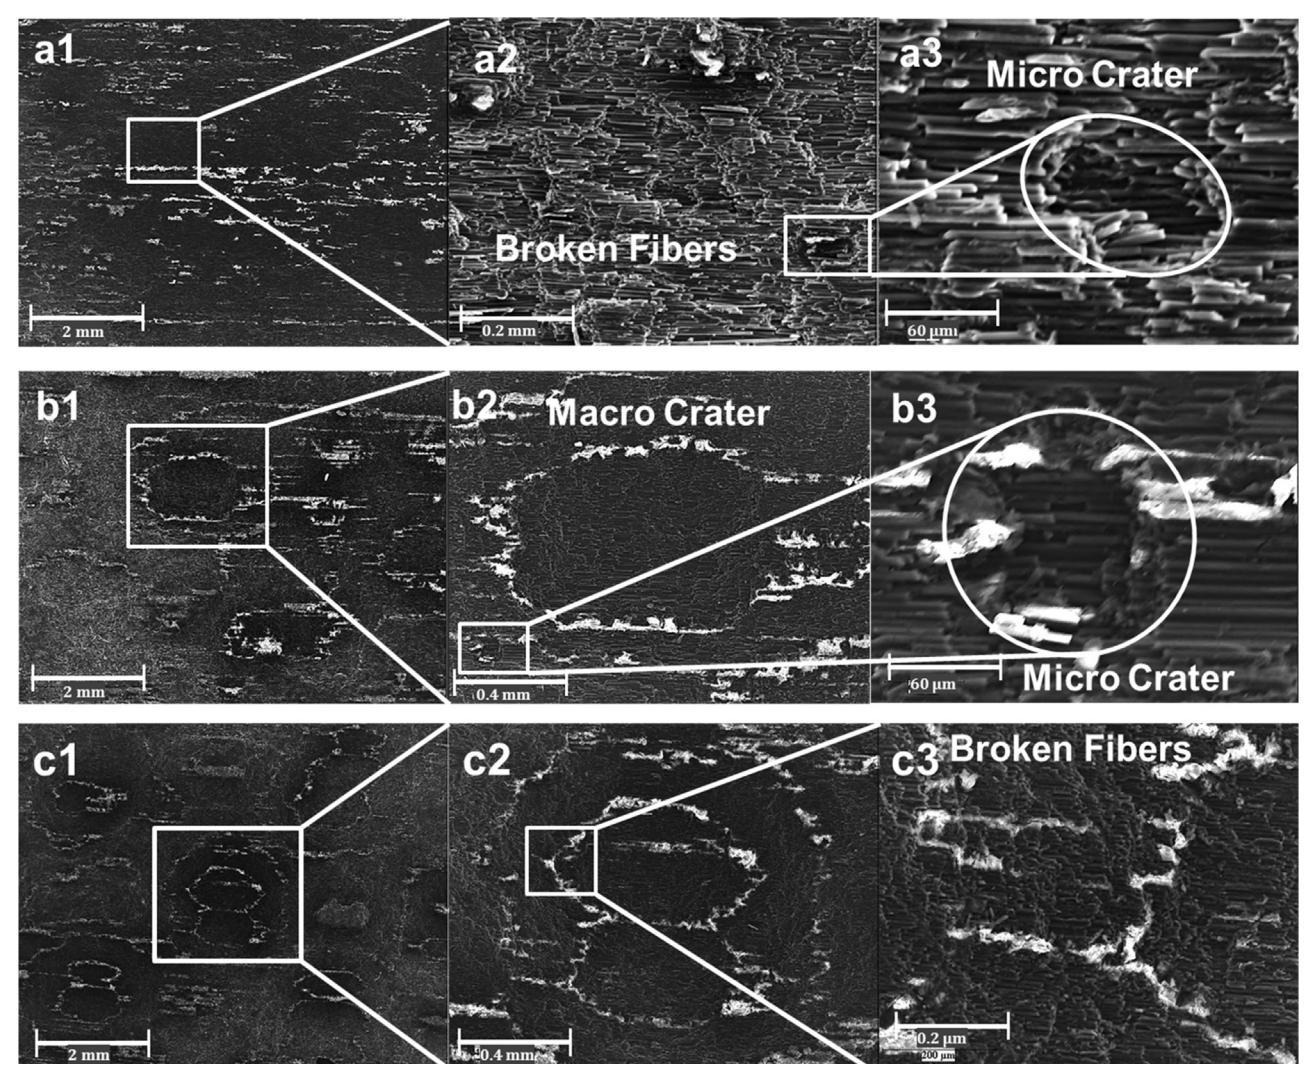
Fig. 7. SEM Images showing the nature of damage observed. Specimens milled at TS – 8 m/min, SO – 50 mm, and SS – 0.5 mm, (a) P – 80 MPa and, showing broken fibers and micro craters, (b) P – 100 MPa showing micro and macro craters, (c) P – 140 MPa showing periodically placed macro craters.

scan step was influential in defining the nature of ridges. Fig. 7 shows SEM images of section of surfaces machined with varying parameters. Presence of broken fibers (Fig. 7(a2), (b3) and (c3)) was wide spread across the milled surface and was common to all types of specimens which is also a vital damage causing a huge impact on the material integrity of the machined component. Specimens milled with high pressure (140 MPa) and high traverse speed (12 m/min) reveals damages inform of fiber-matrix debonding and embedded abrasive particles (Fig. 8(b) and (c)). This damage is due to the increased kinetic energy available to the abrasive particles at higher pressure which will in turn increase the impact energy.

The craters were present in 2 different scales which are classified as micro and macro craters. Micro craters (Fig. 7(a3) and (b3)) have a diameter in the range of 50–80  $\mu$ m and macro craters (Fig. 7(a2) and (b2)) are of diameter in the range of 1–2 mm. Micro

craters are basically formed due to brittle fracture of few fibers due to solid abrasive impact and macro craters are majorly due to the effect of jet pressure and scanning strategy. From the SEM images (Fig. 7(a2) and (b2)) we can see that macro craters appears in specimens milled with pressures equal and superior to 100 MPa and closer standoff distance (50mm) whereas micro craters are present in all specimens. Noticeably, craters placed periodically (Fig. 7(c1)) were found in specimens milled with least scan step (0.5 mm) and least standoff distance (50 mm) and their magnitude increased with increasing pressure. Craters were also found in other specimens but the size was not as significant when compare to high pressure milled specimens and they were randomly distributed. For the same pressure and standoff distance the diameter of macro craters increased with increasing traverse speed which is confirmed from the SEM images in Fig. 7(a).

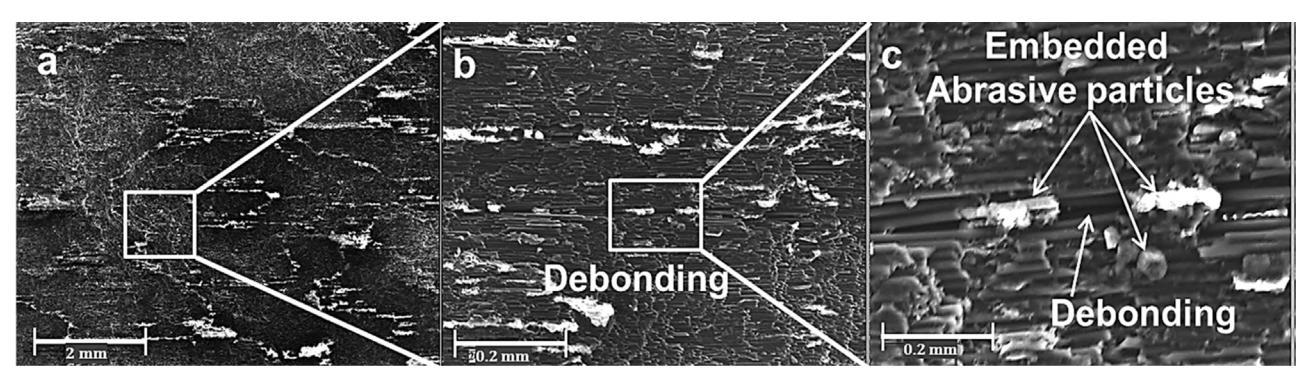
Fig. 8. SEM Images showing fiber -matrix debonding and embedded abrasive particles in specimens milled at P - 140 MPa, SO - 50 mm, and SS - 0.5mm and TS - 12 m/min.

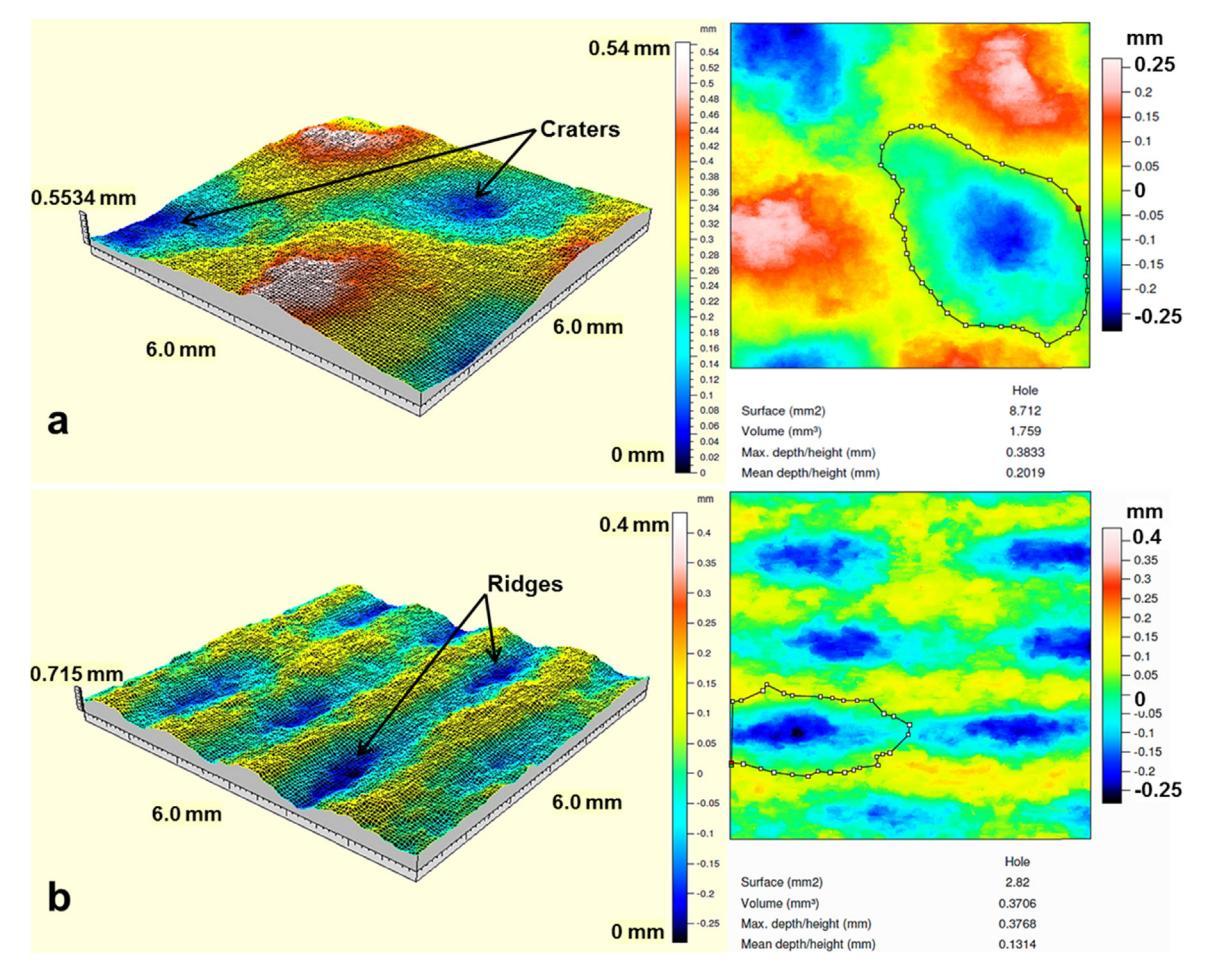
**Fig. 9.** Topography of the machined surface and crater volume measurement scheme obtained by optical profilometer system after machining with: P=120 MPa, TS=8 mm/min, SO=50 mm, (a) SS=1 mm, (b) SS=1.5 mm.

The topography profiles provide the information on the dimensions of the damage features observed in SEM images. The depth, area and volume of the craters calculated gives clear indication that their magnitudes were influenced by machining parameters. The Fig. 9 shows the topologies of surface machined at jet pressure 120 Mpa, traverse speed 8 mm/min, standoff distance 50 mm with varying scan step. Craters are formed when scan step is 0.5 mm (Fig 9(a)) also ridges and valleys are seen in specimen machined with scan step 1.5 mm (Fig 9(b)) along with the scheme of crater volume measurement. A specific pattern is observed in the crater and ridge formation as seen from both SEM images (Fig. 7(c1)) and topography contours (Fig. 9), this pattern is direct

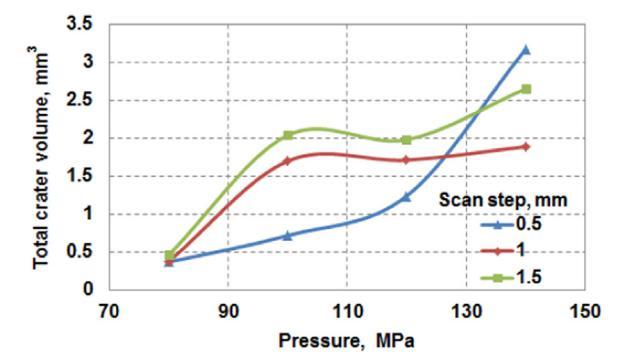
Fig. 10. Evolution of total crater volume in the scanned region with respect to jet pressure and scan step.

implication of the surface waviness. As discussed previously in section the waviness in transverse direction increases with scan step and pressure whereas in longitudinal direction it increases with pressure which is confirmed from topography analysis. The effect of jet pressure and scan step on the crater volume is shown in Fig. 10, it is very clear that jet pressure increases the crater volume. It is also seen that increase in scan step increases the crater volume however the evolution is random at values of high pressure.

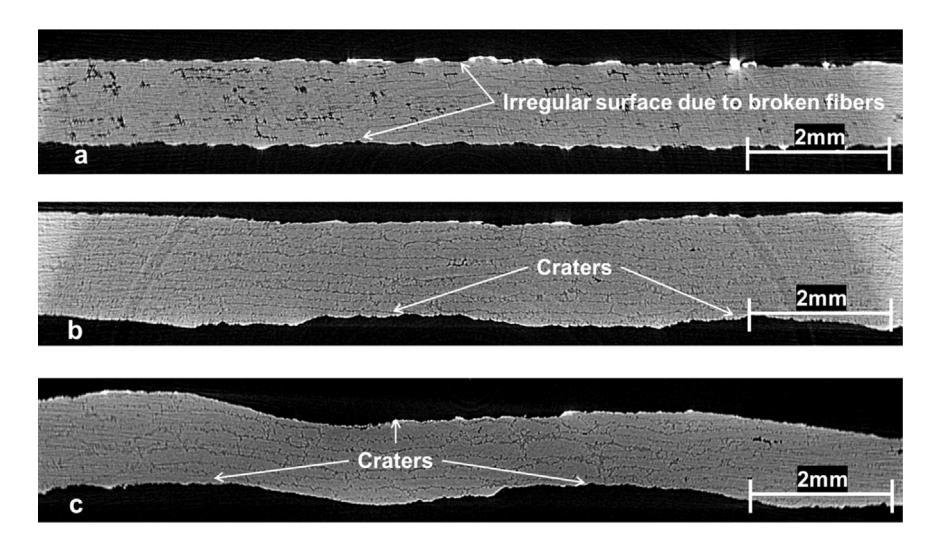
Fig. 11. X-Ray tomography images showing load bearing cross section of specimens with varying machining quality, (a) Best, (b) Medium and (c) Poor quality.

X-ray tomography performed on the AWJ milled specimens did not reveal any underlying internal damages. However this was useful in exactly calculating the load bearing cross sectional area of milled specimens used for tensile tests. Approximation of rectangular load bearing area would give rise to erroneous tensile strength results with was avoided by using the X-ray tomography images. Fig. 11 shows cross sectional X-ray images of machined specimens with best, medium and poor machining quality. The irregular milled surface (Fig. 11(a)) is clearly seen which is due to the presence of micro craters and broken fibers, also the wavy surface which is the outcome of macro craters are seen in Fig. 11 (b) and (c).

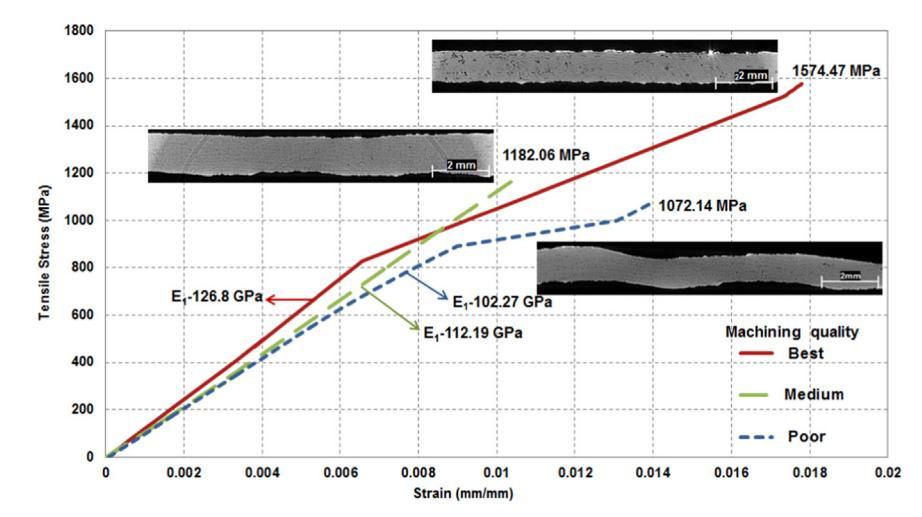
Fig. 12. Stress - Strain curve for machined specimens with varying quality under tensile loading. The inlaid images show the load bearing cross sections of the specimens.

The Stress-Strain curves obtained from the tensile tests are illustrated in Fig. 12. It is clearly noticeable that the specimen with the best machining quality yields the highest tensile strength, which is still inferior to the unmachined specimen tensile strength (2000 MPa). This can be attributed to the fact that the machined surface is full of broken fibers (Fig. 7(a3)) which in actual does not contribute to load carrying capacity. Also from the SEM images (Fig. 7(a2)) we have seen that the machined surface contains numerous micro craters which induce discontinuity in the long fibers there by reducing its strength. In the medium quality specimens

machined at 100 MPa macro craters start appearing along with broken fibers and micro craters. As discussed in the Sections 3.2 and 3.3, due to increase in jet pressure there is rise in surface roughness which represents increase in broken fibers and micro craters. These accumulated damages results in a steep 25% decrease of tensile strength compared to best quality specimen. Further, the specimen with poor machining quality, its tensile strength decreases drastically by 32% compared to specimen with good quality machining which is clearly explainable due to the fact that these specimens machined at 120 MPa have fiber-matrix debonding damages along with micro and macro craters. Also, embedded abrasive particles act as stress concentration points which further weaken the specimen. Evaluation of tensile modulus reveals that all the 3 specimens have different tensile modulus values where the specimen with best machining quality has the highest stiffness (126.8 GPa) and the poor machining quality the least (102.7 GPa). This degradation of stiffness suggests the deteriorating effect of machining quality on mechanical behavior of machined specimens. In all the cases the failure was due to long splitting along the gauge at various locations (Brittle failure with debonding and matrix cracking).
