Transmission electron microscopy study of precipitate morphology and precipitate overcoming processes in aluminum alloy 6056 T6

Keywords: Aluminum alloy 6056 T6; Precipitate morphology; Precipitate shearing; In situ straining experiments

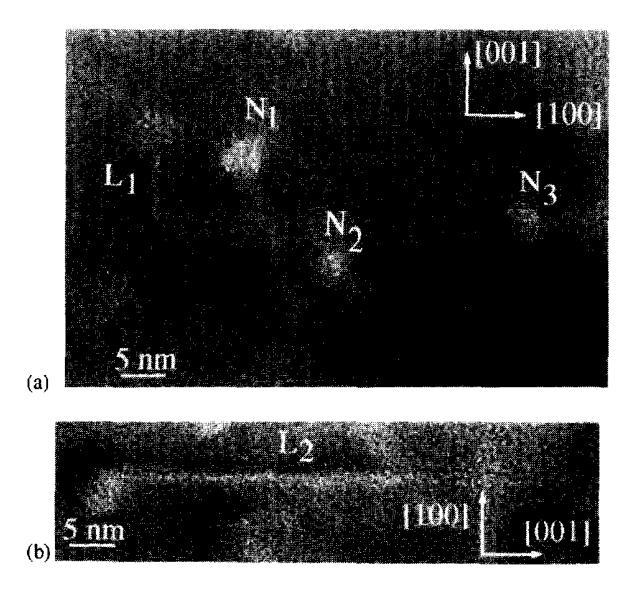
Fig. 1 shows two HREM pictures of different zones of the same specimen. Fig. 1(a) shows several precipitates: Some of them (noted N_1 , N_2 and N_3) have a roughly circular cross-section with a diameter of about 2-4 nm and another one (noted L_1) has a roughly rectangular cross-section lying along the [001] direction of the aluminum matrix. In Fig. 1(b), a longer precipitate L_2 (46 nm) is seen. It is elongated along the [001] direction of the aluminum matrix.

Fig. 1. HREM images of precipitates.

HREM pictures show precipitates with circular or rectangular cross-sections, with characteristic dimension in the range of 2-5 nm, and very elongated precipitates with the length in the range of 40-120 nm. Conventional transmission electron microscopy (TEM) pictures taken at an intermediate magnification show that the present observations reproduce well the precipitate population of the 6056 T6 aluminum alloy [5]. The number of elongated precipitates is smaller than that of circular and rectangular ones. These results are interpreted as follows (Fig. 4). Precipitates with circular (N_1) and rectangular (L_1) cross-sections are needles and laths seen edge on. Elongated precipitates (L_2) are laths with the length of the rectangular cross-section parallel to the electron beam. Laths (L_3) with the width of the rectangular cross-section parallel to the electron beam and needles (N_2) with length perpendicular to the electron beam can not be imaged because the quantity of matter crossed by the electron beam is not sufficient to provide a contrast on the HREM pictures especially as they are embedded in a rather thick matrix. These results are in agreement with those reporting the presence of needle-shaped β'' and lath-shaped L precipitates in a T6 peak aged aluminum alloy with a composition close to that of 6056 [6].

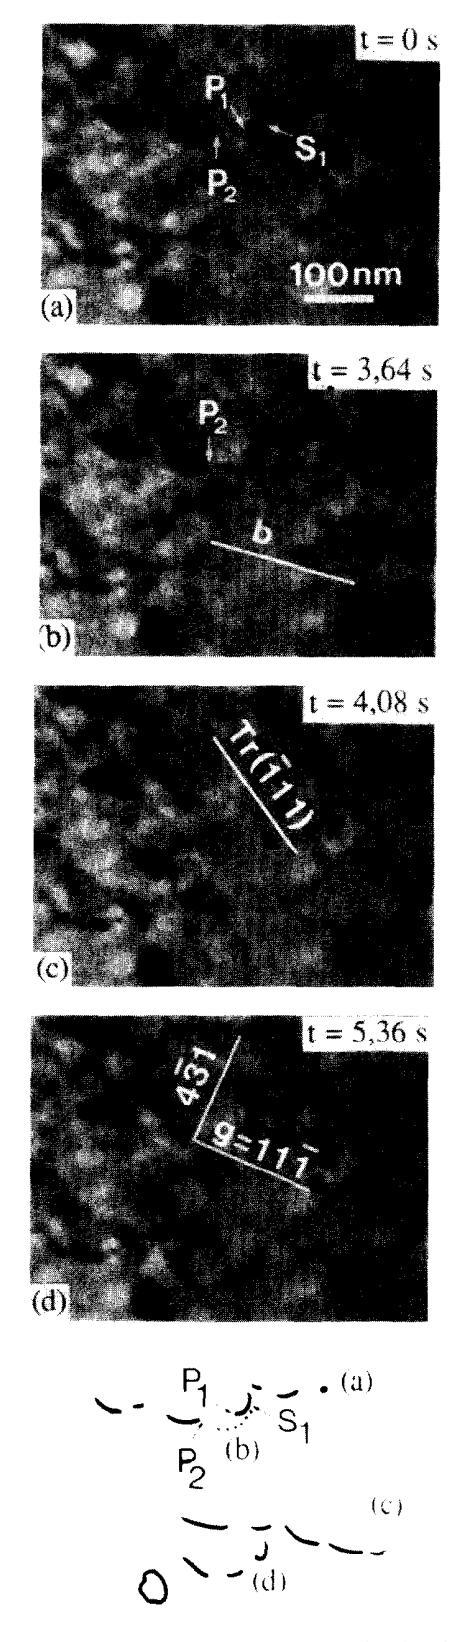
Fig. 2 shows a deformation sequence issued from a TEM in situ straining experiment performed at room temperature, which is representative of our observations. In Fig. 2(a), a dislocation is pinned at several precipitates. Under the effect of the applied stress, the dislocation is bowed out between precipitates. The con-

Balance 0.943 0.869 0.798 0.634 trast of the dislocation vanishes in the vicinity of the precipitates, owing to a compensation effect between the dislocation and the precipitate strain fields. This is particularly obvious in Fig. 3 taken under weak beam condition at larger magnification. Between Fig. 2(a) and (b), segment S_1 escapes from precipitate P_1 . Between Fig. 2(b) and (c), the dislocation escapes from all

the precipitates on which it is pinned, glides quickly and stops at the position shown in Fig. 2(c). These two positions of the dislocation are seen on two successive frames of our video tape, indicating that all this movement occurs in less than 1/50 s. Between Fig. 2(c) and (d), only a part of the dislocation escapes from the precipitates on which it is pinned.

Fig. 2. Dynamic TEM in situ straining sequence showing the shearing of precipitates by a dislocation.

Fig. 2 shows thus that the dislocations overcome the precipitates by a shearing process. To calculate the critical force corresponding to this process it is necessary to measure the breaking angles corresponding to the critical position at which the obstacle breaks [5]. Fig. 3, showing a dislocation in critical position just before it shears a precipitate, displays an example of such a determination. T_1 and T_2 are tangent vectors to the dislocation line at points A and B, where the dislocation is in contact with the precipitate. β_1 and β_2 are the angles between the Burgers vector of the dislocations and T_1 and T_2 , respectively. Values are subsequently corrected taking into account both the specimen tilt angle and the inclination of the slip plane

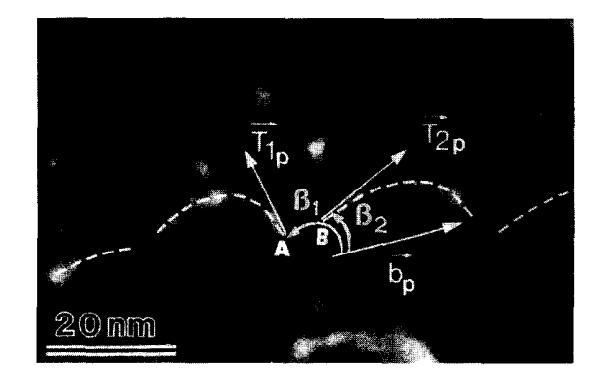
Fig. 3. Image of a dislocation in critical position just before it shears a precipitate. T_{1p} and T_{2p} are the projection in the glide plane of T_1 and T_2 .

For the case displayed on Fig. 3, for which $\beta_1 = 126^{\circ}$ and $\beta_2 = 46^{\circ}$, one has $T_1 = 0.36$ nN, $T_2 = 0.44$ nN and $F_m = 0.61$ nN. The average value of our measurement is 0.6 nN [5].

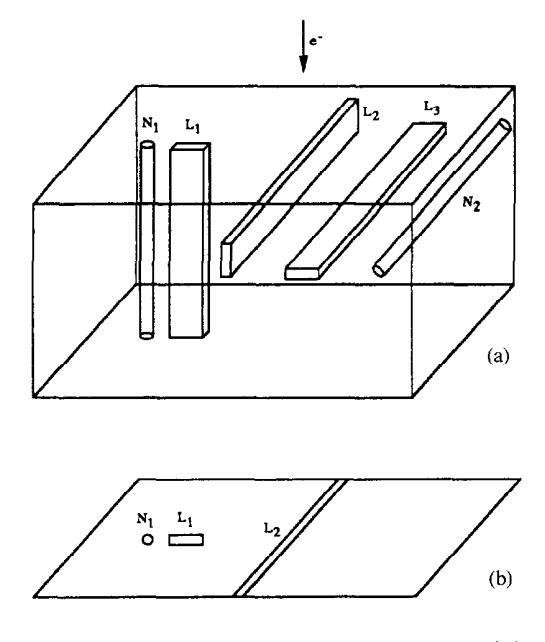
Fig. 4. Shematic representation of precipitates (a) and of the corresponding TEM picture (b). The notation are defined in the text.
