Reconstruction of the 3D crack profile in wood based structures by x-ray computed microtomography

Hamdi Seif Eddine, Rostand Moutou Pitti, Eric Badel, Joseph Gril

Hamdi Seif Eddine, Rostand Moutou Pitti, Eric Badel, Joseph Gril. Reconstruction of the 3D crack profile in wood based structures by x-ray computed microtomography. 10 ème édition JET 2018, AF3M et SMSM., May 2018, Marrakech, Morocco. 6 p. hal-01731148

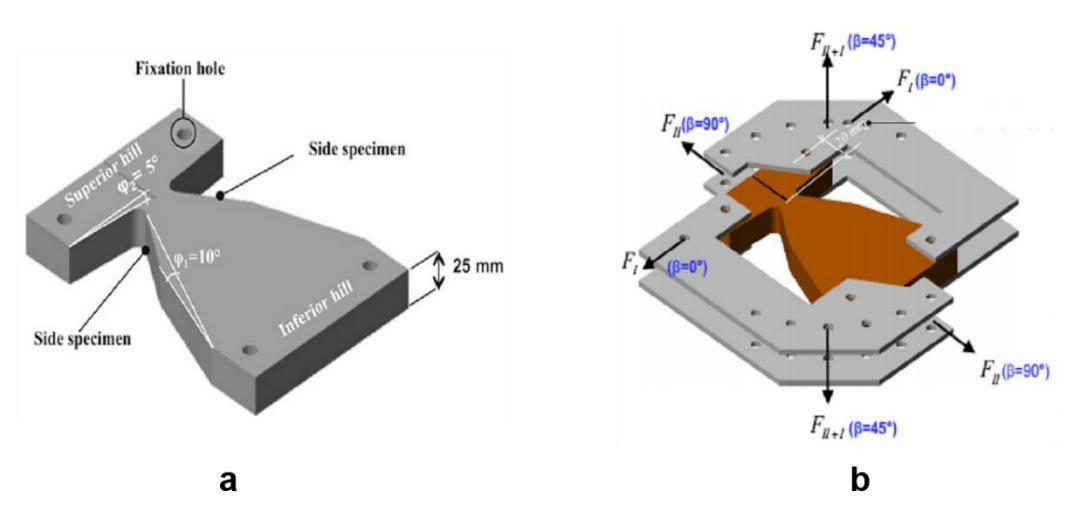
Figure 1. MMCG Padouk wood sample (a), Experimental ARCAN setup (b).

This section presents the experimental setup considered in this study. The tests were carried out on a tropical specie known as Padouk. Figure.1 (a) shows the dimensions of wood specimen, with an overall size $210 \times 140 \times 25 \text{ mm}$. The side of the specimen has inclinations with angles of 5° and 10° from the edge and the inferior hill, respectively, as shown in Figure. 1 (b). On both hills, four holes were perforated in order to fix the steel Arcans. The distance between the hole's centers is 110 mm. The steel Arcans, were performed to allow for mixed-mode configurations. An initial crack of 20 mm is machined in the wood specimen in the direction of the fibers.

The MMCG specimen, shown in Figure 1 (b), is defined by the combination of a modified DCB specimen, and CTS specimen, on the one hand, and the observation of stability range of energy release rate versus crack length computed numerically with M θ [8], on the other hand. The main objective of this specimen is to allow for the decrease in the energy release rate during the tests. The wood specimen presented in Figure. 3 (a), is fixed in a framed structure with Arc-formed handles containing symmetrical holes for load application according to various crack mode ratios β . The application of symmetric loads FI with angle $\beta = 0^{\circ}$ is equivalent to the opening mode, and the application of FII, with angle $\beta = 90^{\circ}$ corresponds to the shear mode as shown in Figure 1 (b).

The force F is separated into two forces Fx and Fy corresponding to the axis orientations (x, y) and the mixedmode ratio in plane configuration. In this work, the mixed-mode fracture tests are obtained by applying the loads FI and FII with angles $\beta = 45^{\circ}$.

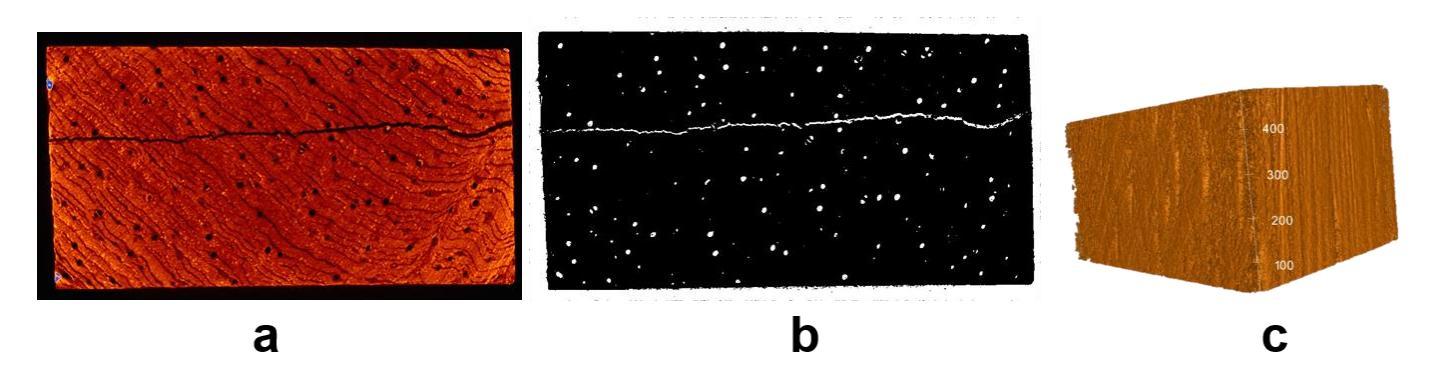
Figure 2. Internal evolution of the crack growth (a), Extraction of porosities by image analysis (b), 3D volume of the cracked Padouk sample (c).

After reconstruction, a 3D volume was obtained in consecutive slices from the 2D cross-sectional images of the investigated sample, as shown in Figure 2(a-c). The entire acquisition process took approximately 120-160 min, with an exposure time of 3 500 ms per projection. Once the region of interest (ROI) of the Padouk sample was chosen (Figure 2 (a)), the fibre elements were then segmented and binary images were obtained (Figure 2 (b)). Three-dimensional rendering of the wood sample, as shown in Figure 2 (c), was used to obtain information regarding the crack orientation, wood porosity, density and size distribution. All the 3D volume-rendered images of the Padouk, carried out along this study, had a fixed size of 900 x 800 x 750 voxels for a specimen with a volume of 33 mm³ and a voxel size of $6.9 \,\mu m^3$.

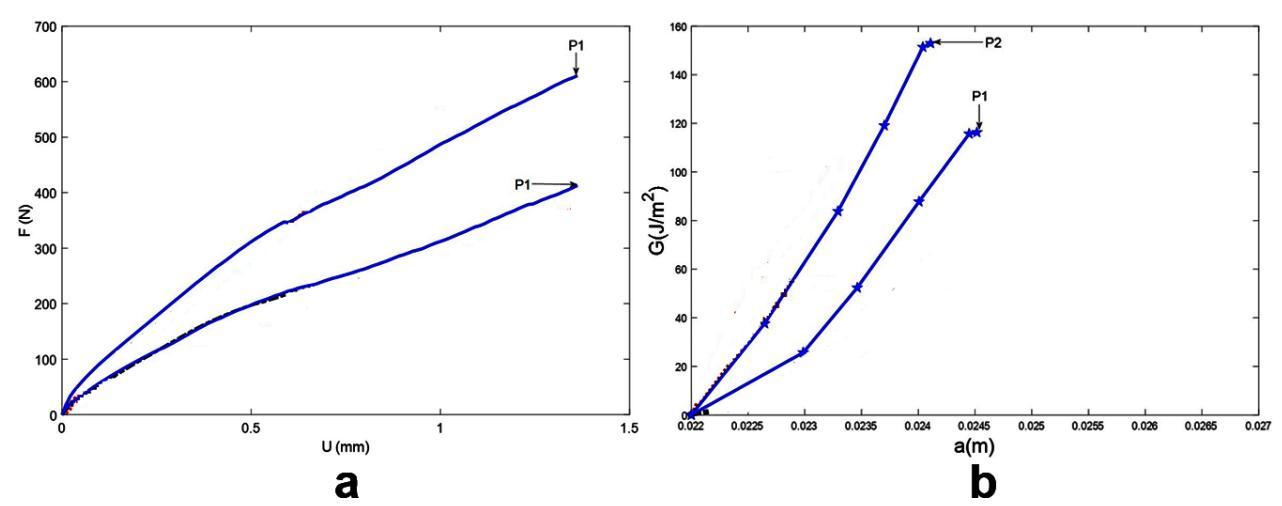
Figure 3. Force versus crack opening evolution (a), Energy release rate evolution according to crack tip advance (b)

In this section, mechanical testing was conducted on two MMCG Padouk (P1 and P2) specimen. Figure .3 (a) present the applied force versus crack opening evolution. Figure .3 (b) illustrate the viscoelastic energy release rate evolution versus crack growth process for mixed mode configuration. The crack growth process can be interpreted as brittle or ductile. If for all cases, the crack growth or damage evolutions in the process zone induce a rigidity decrease, we can note an energy release rate increase during the crack growth advance. With these considerations, for mixed mode configurations, Figure .3 (b) shows a progressive growing of the process zone (phase of energy release rate increasing) and, in the other hand, Figure .3 (a) a stationary phase with a stabilization of its evolution. More precisely, we can observe, for the second Padouk (P2) specimen, a greater energy release rate then the first Padouk (P1) specimen, which correspond on brittle crack tip advance with an approximately peaks values around 120 J/m-2 for P1 and 157 J/m-2 for P22. Energy steady state evolution after these peaks illustrate crack growth stabilities for mixed mode.

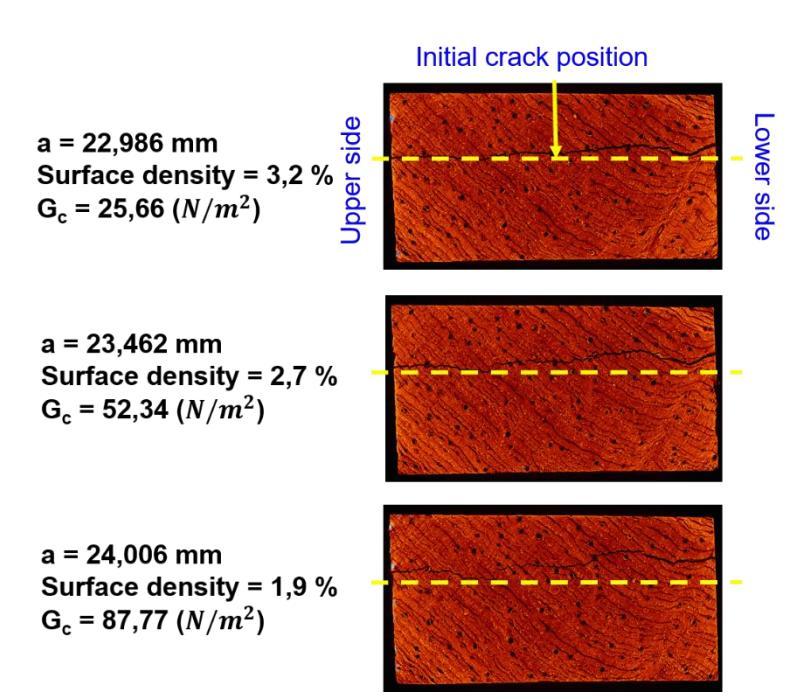
Figure 4. Crack growth path according to surface density of Padouk sample: 2D Cross sectional images extracted from 3D volume of Padouk P1 sample.

Although crack length comparison performed by the experimental method and 3D image analysis cannot be directly related to the specific features of the applied methods with regard to the analyzed crack length distribution, it provides some useful information. In fact, the mean length of the crack evolution is a good indicator of the damage level on MMCG wood samples, which is suitable for comparing the values obtained using different methods. Comparison of individual crack-based measurements is possible by relying on segmented images correlated by the surface density of the analyzed samples, as shown in Figure 4.

The volume-weighted crack length distribution of the analyzed tropical wood samples is calculated from 2D cross images (see Fig. 4). The results showed that crack progress continues inside the MMCG wood samples most likely after this progress ends in the surface of the specimens. In addition, we notice in first hand, that the surface density distribution inside a specific Padouk sample is not homogenous, wich tends to accelerate the crack growth speed. In the other hand, X-ray CT showed that Padouk wood presents a high surface density. This can be explained by, the fact that Padouk wood fibers and particles diameters, estimated using the X-ray CT method (Figure 2b), showed a dispersion smaller than 60 µm and larger than 800 µm. Indeed, the conditions of fiber repartition inside the wood material affects the crack growth speed and direction as depicted in Figure. 4. The observation using the 3D scanning method showed that the crack tip progress tends to move towards larger fibers porosity all along crack path.
