Timber seismic bands: correlating their characteristics with local seismic activities and understanding their effects under seismic loads

Eugénie Crété, Santosh Yadav, Milo Hofmann, F. Vieux-Champagne, Yannick Sieffert, Olivier Moles, Philippe Garnier

Inter-ISC'18 ICOMOS Inter-ISC Meeting & Colloquium Anti-Seismic Vernacular Heritage of Anatolia and Beyond 10-13 JULY 2018 - KASTAMONU - TURKEY

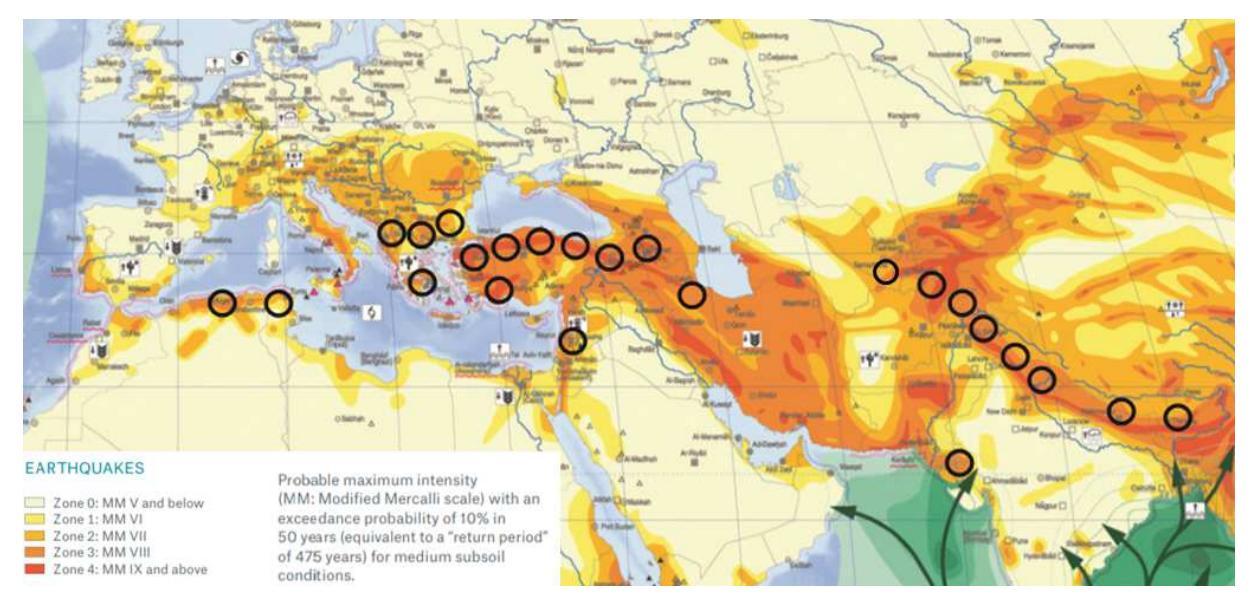
Figure 1: Map of the ladder-like timber bands technique geographic distribution and its correlation with seismic probable maximum intensities. This map results from the research carried out by M. Hofmann [6], background map by Munich Re Group.

Continuous and numerous exchanges between populations throughout the Alpine-Himalayan belt resulted in a wide geographical dissemination of aseismic technics and practices (Figure 1). More specifically, the most famous masons and craftsmen corporations were asked to build major constructions in broad areas whose delimitations were highly connected to the prevailing political domination, from the Byzantine Empire to the Ayyubid domination, the Mongol Empire, and finally the Ottoman Empire. In some cases, local corporations were then influenced by the work of these famous corporations, thus contributing to a dissemination of aseismic features at all society levels; this dissemination was even sometimes directly supported by political authorities through legal tools or the organization of trainings [6]. But these exchanges did not prevent local variations of these technics.

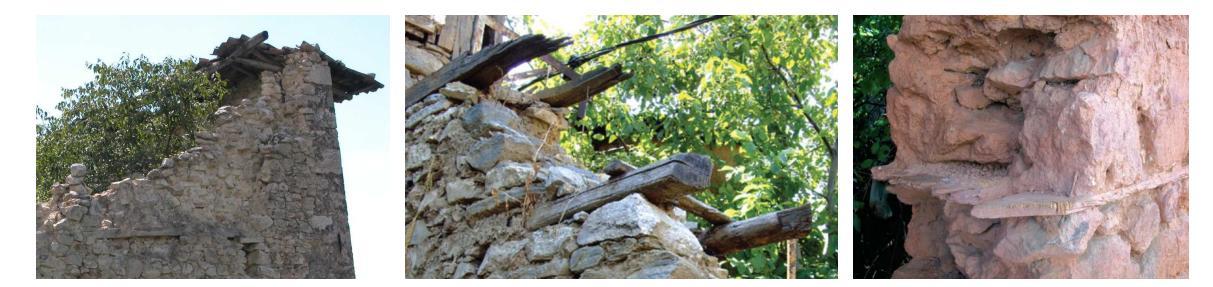
Figure 2: a) massive timber logs embedded in a partially collapsed masonry wall at Poggio Picenze (Italy); b) ladder-like timber bands inserted at regular spacing in Cumalikizik (Turkey) and c) planks insertion in a masonry wall in Kastamonu (Turkey) (Credit: Hofmann) And for each of these technics, variations were observed regarding the connections inbetween the elements themselves, the dimensions of the timber elements and the vertical spacing between the insertions.

This study does not refer to structural systems mixing horizontal and vertical timber elements, as the authors assume that this mixing often entails major changes in the seismic behaviour of the structure. It thus focuses on horizontal timber insertions, and three main technics were documented in masonry load-bearing walls:

- a. A massive timber log embedded into the wall and connected to metallic anchors in façade;
- b. Ladder-like timber bands inserted at regular spacing;
- c. Several planks or logs placed next to each other on the whole wall section.

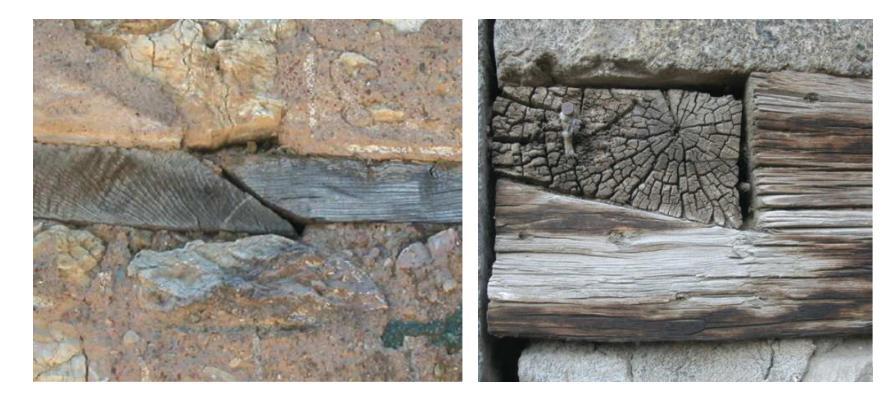
Figure 3: a) a chamfered joint in Vevçani (Macedonia) and b) a dovetail joint in Erzurum (Turkey) (Credit: Hofmann)

Moreover, connections between elements are very interesting to compare. Planks are usually connected by overlapping and basic nailing, while in case of ladder-like insertions, connections are more sophisticated: halved or chamfered joints, and in case of recent high seismic activity, dovetail joints were more likely to be observed.

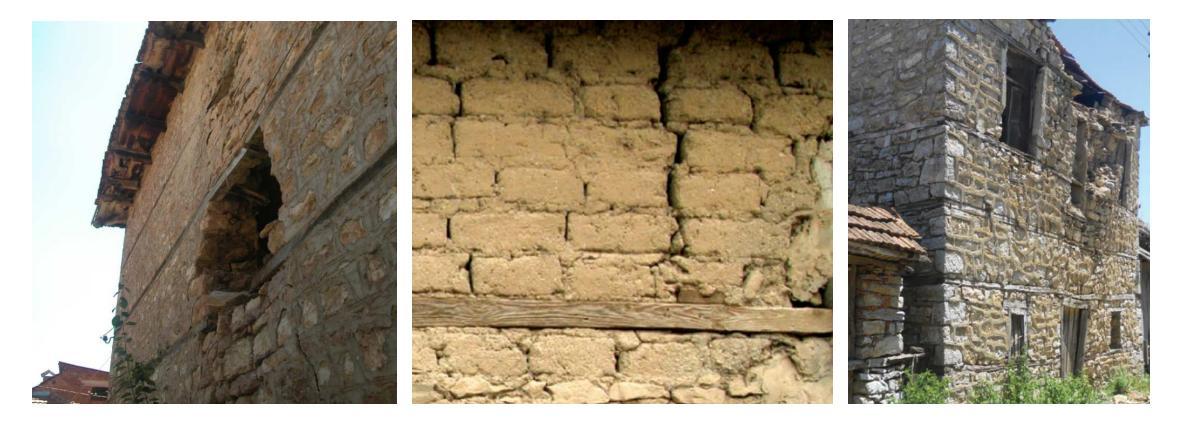
Figure 4: a) ladder-like insertions acting as lintels when partial collapse of a masonry wall occurred; b) preventing cracks propagation and c) restricting bending deflection (Credit: Hofmann)

Both ladder-like and planks insertions (referred respectively as techniques b and c in previous section) have several common effects providing a better behaviour to structures submitted to earthquake solicitations. They act as lintel in case of partial failure of the masonry (Figure 4a). Thanks to timber ability to resist traction, they prevent vertical and diagonal cracks from spreading (Figure 4b). Moreover, they confine the masonry elements, thus giving the wall extra resistance to out-of-plane solicitations (Figure 4c), while it is thought that they allow for movement between the wall portions and thus maintain a relative flexibility of the structure, which is of major importance to reduce the building vulnerability. Moreover, this confinement changes the structural behaviour of the wall, dividing it into several smaller portions embedded at both ends and thus changing its slenderness and resonance frequency. This confinement also increases the static compression resistance of walls [6].

Ladder-like insertions are even more efficient as confining devices of masonry elements – providing the wood and connections are resistant enough to traction - thus increasing compression resistance [6] and restricting bending deflection (Figure 4c). However, this confinement of walls subdivisions does not prevent movements between them and thus dissipation of energy, and may be an interesting balance between a relative stiffness of walls subdivisions and a relative flexibility of the whole building. Moreover, it was noticed that two-leaf walls without proper bound stones or corner stones are more likely to be found with ladder-like insertions: this observation supports the hypothesis that ladder-like insertions improves the connection between the different vertical leaves of a masonry wall - but authors would nevertheless recommend the use of bound stones to connect properly the masonry layers. As explained in next section, ladder-like insertions improve the wall resistance to shear solicitations. Moreover, the timber elements composing these insertions usually are well connected enough to act as a belt preventing corner separation and spreading the solicitations to the building as a whole, while maintaining a relative flexibility. Finally, contrary to planks insertions, ladder-like insertions do not create water stagnation zones in the walls- accelerating wood decay and rotting – and may thus be more adapted in areas where the timber mechanical properties are affected by frequent seismic solicitations.

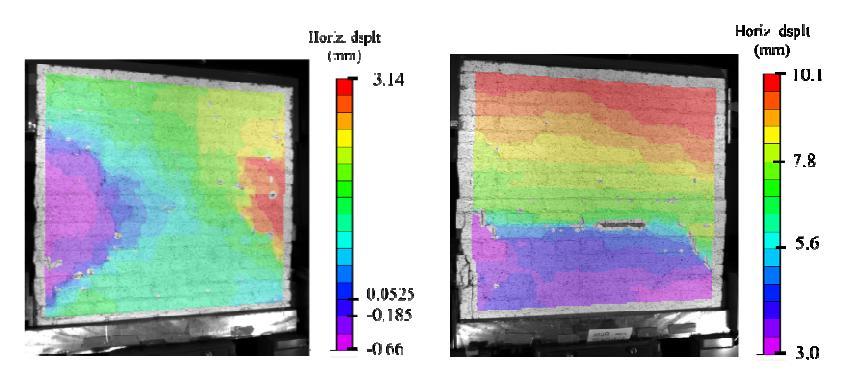
Figure 5: Horizontal displacement field obtained with DIC: from left to right; (a) UM, (b) RM.

Figure 5 shows the horizontal displacement field in the reinforced and unreinforced masonry walls before failure. In the case of the unreinforced masonry adobe wall (UM) (Figure 5a), contours show a typical diagonal crack pattern. The contours of the reinforced shear wall (RM) (Figure 5b) show the apparition of a friction plane along the bed joints. Two types of failure can be observed here. The unreinforced wall experienced shear failure as shown by the presence of diagonal cracks in the joints and through some adobe units. During the first cycles of the quasi-static test, the horizontally reinforced wall showed a behavior similar to the first wall: diagonal cracks appeared at the corners of the wall. However, when the lateral force magnitude increased, a horizontal failure plane developed two beds of bricks below the timber insertion, and sliding occurred along this plane. Additionally, very few cracks appeared above the reinforcement.

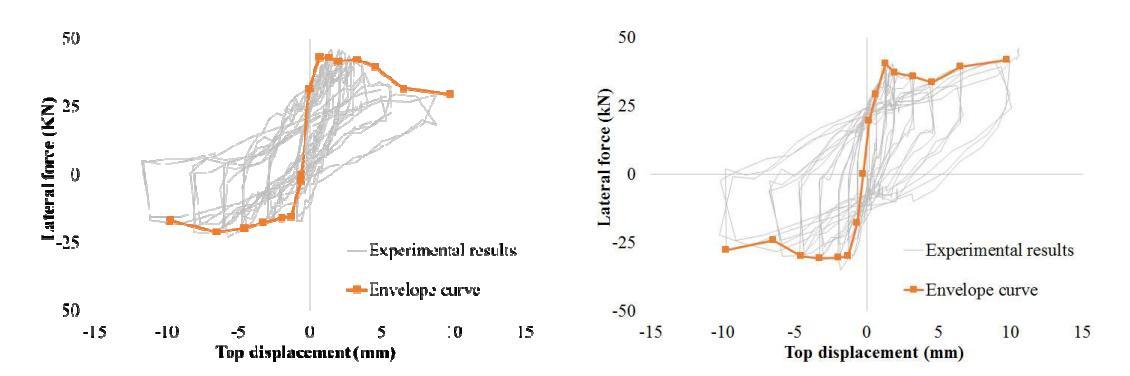
Figure 6: Hysteresis curves lateral force VS displacement for quasi static cyclic tests on: from left to right; (a) UM (b) RM

The hysteresis curves lateral force VS displacement, corresponding to the quasi-static cyclic tests on UM and RM, are presented on Figure 6. The envelope corresponds to the points of maximal force and maximal displacement for each series of three cycles of same magnitude.

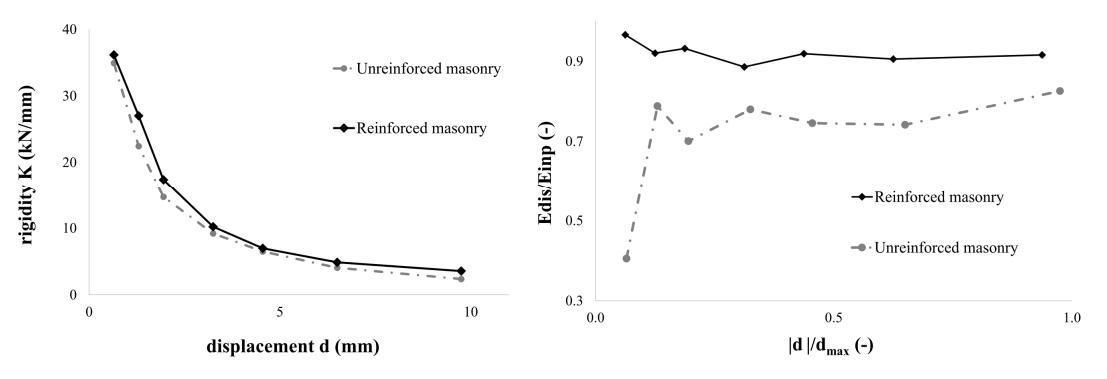
Figure 7: From left to right; (a) Stiffness degradation, (b) Energy dissipation.

The stiffness degradation of the walls was evaluated by computing the slope between two points of maximal force and displacement of two loading series, which corresponds to the slope between two points of the hysteresis curves. The stiffness degradation curves (Figure 7a) illustrate similar responses for the two walls. Most of the degradation happens during the three first loading cycles, and then the stiffness stabilizes. It can be noticed that the stiffness of the reinforced shear wall degraded more progressively, which fosters the hypothesis of a more ductile behavior of reinforced masonry pointed out by the hysteresis curves.

The hysteresis curves also reveal some information about dissipated energy in the system. The dissipated energy E_{dis} is defined as the area inside a cycle of hysteresis. The input energy E_{inp} is defined as the area under the curve, down to the x-axis. Figure 7b presents the variation of the ratio E_{dis} / E_{inp} depending on the displacement, normalized with the value of maximum displacement during the test d_{max} . The plot shows more significant energy dissipation in the case of the timber reinforced masonry wall (90%) compared to the unreinforced wall (80%). This could be explained by the friction phenomenon which is probably more important for the crack pattern depicted in Figure 5b. This dissipation of energy due to the ladder-like timber insertions is the subject of the second experimental campaign that is further explained in next section.

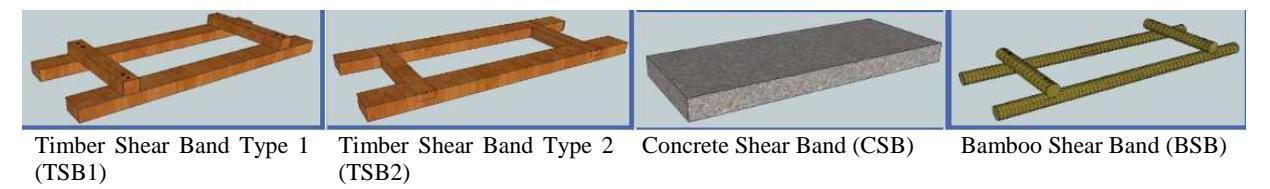
Figure 8: Different types of shear bands as recommended in DUDBC guidelines for reconstruction

Four types of shear band were prepared following the Department of Urban Development and Building Construction (DUDBC) guidelines [12], using timber, concrete and bamboo (Figure 8).

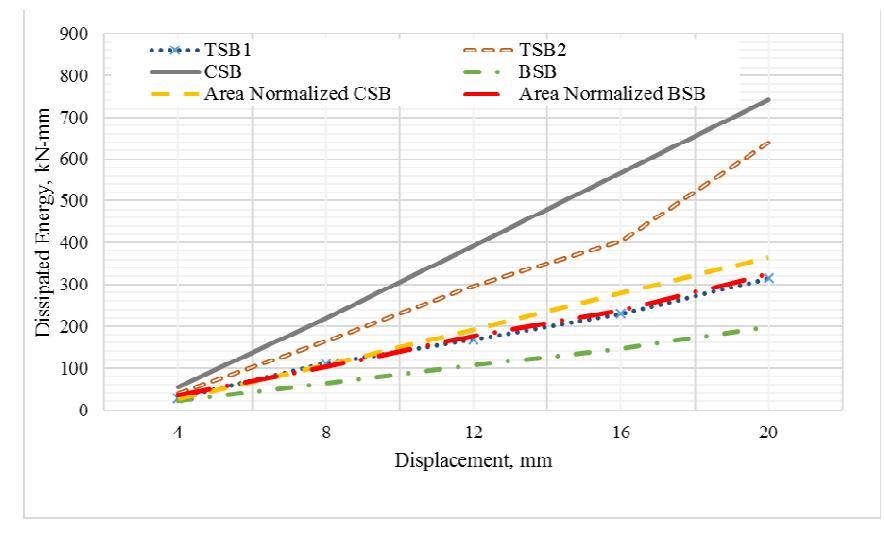
Figure 9: Comparison of energy dissipations by various types of shear band

The obtained data from the experiment was the displacement and the corresponding force needed to reach that displacement. A hysteresis curve is obtained by plotting the data. The area under the hysteresis curve provides the value of the energy dissipated during each cycle. The dissipated energy was measured using OriginPro 2017 software (http://www.originlab.com/2017), taking the average between the results obtained from the similar shear bands. Comparison of energy dissipation by various type of shear band is shown in Figure 9.

From the comparison, we can notice that more energy is dissipated with CSB compared to other materials and least energy is dissipated by BSB. The amount of energy dissipated also differs depending on the connections between timber elements. TSB2 could dissipate more energy than TSB1. In order to observe the significance of the contact surface area, the results for the CSB and BSB were normalized taking the contact surface area of TSB1 and 2 as the reference. The energy dissipated by the normalized CSB and normalized BSB are similar to that of TSB1. The energy dissipation patterns obtained tend to follow linear form for each of the shear band materials.
