# Some Hard or Soft Coatings to Protect the Pristine Biometallic Substrates under Fretting-Corrosion Solicitations: What Should Be the Best Solution?

Jean Geringer <sup>1,\*</sup>, Vincent Fridrici <sup>2</sup>, Haohao Ding <sup>2</sup>, Kyungmok Kim <sup>3</sup>, T. Taylor <sup>4</sup>, Lerato Semetse <sup>4</sup>, Sara Ehsani-Majd <sup>1</sup>, Peter Olubambi <sup>4</sup>, Julien Fontaine <sup>2</sup> and Philippe Kapsa <sup>2</sup>

Keywords: tribocorrosion; coatings; metallic biomaterials; PEEK; DLC

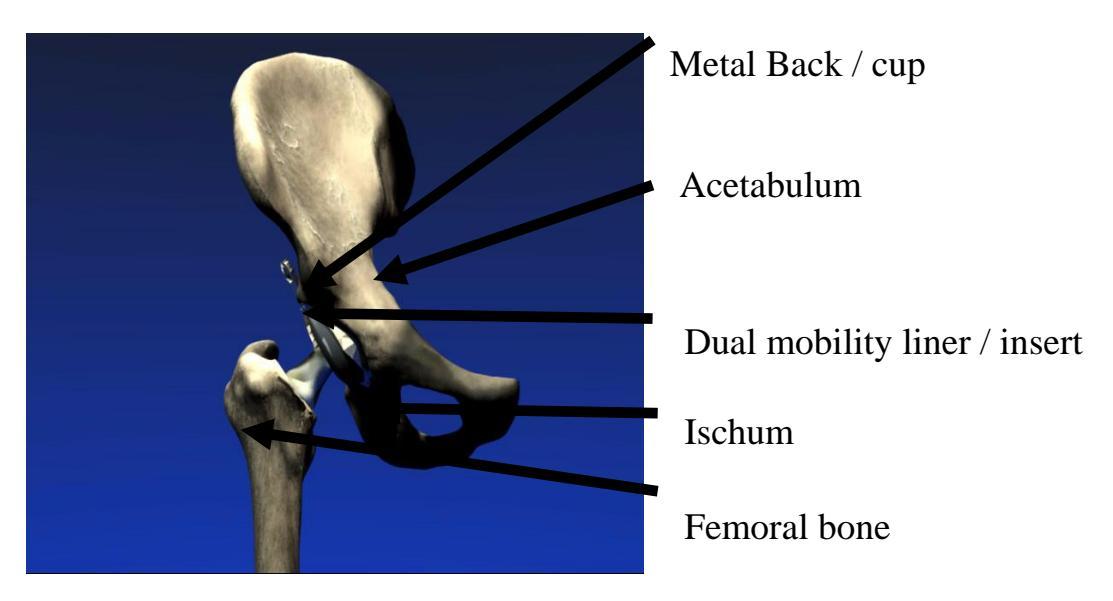
Figure 1. Total hip joint, schematic view, dual mobility.

Hip joint, Figure 1, is one of the most practiced surgical operations, i.e., 160,000 total hip arthroplasty (THA) operations in France (order of magnitude coming from [1]). All over the world, there are more like than 1.5 million every year.

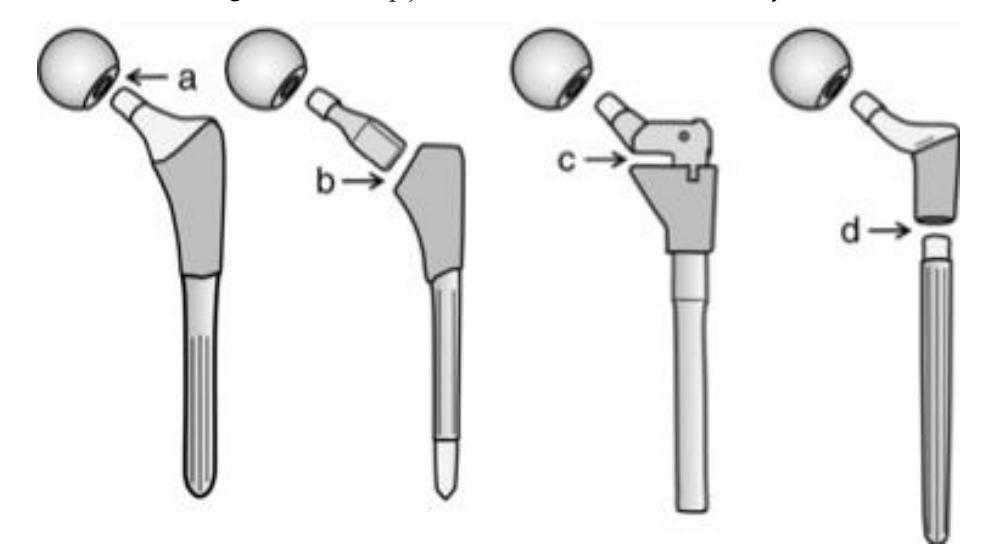
**Figure 2.** (a) Usual femoral component as hip joint; (b) modular hip joint as adapting the size; (c) modular hip joint as adapting the angle of the femoral neck; (d) modular hip joint as adapting the stem length [2].

As shown in Figure 2, one may notice the metallic junction that is occurring on every implant. During the human gait, some alternative loadings will be imposed on every metallic junction. By having a look at the ISO 14242 standard and the ASTM F1714 [3,4], the load amplitude should reach from 300N to 5000N. Every metallic junction does not match disassembling, except the positioning issue; however, some small relative displacements will occur on every metallic junction, i.e., few dozens of microns. Moreover, total hip joints are immersed among physiological liquid protein solutions. First, one may imagine some metals involved in a metallic junction. The mechanical properties are quite different, 115 GPa concerning the Ti-6Al-4V and 200 GPa concerning the 316L stainless steel or the Co-Cr-Mo, between materials in contact. Under applied stress, the deformation should be different and the friction/fretting (friction under small displacements) should take place. Second, even if the material is quite the same, Ti-6Al-4V concerning femoral stem, the junction roughness, Sa value, will vary from 1650 nm to 2250 nm  $\pm$  30 nm [5]. On some surface peaks (small contact area), the contact stress may also reach some GPa. Due to metal plasticity the mechanical properties on the top surface should be different from the ones related to the bulk material. Under applied stresses some micro relative displacements may also occur. This last phenomenon is not predominant through

With the modular junctions related to Ti-6Al-4V/Ti-6Al-4V, shown in Figure 2d, the expected coatings should be a benefit according to avoiding some fretting corrosion degradations. The fretting corrosion experiments were investigated for 16 h in bovine serum solution in order to mimic the physiological liquid. The protein concentrations respected the ISO 14242 [4], i.e., 30 g·L<sup>-1</sup>. First of all, some interesting behavior about Ti-6Al-4V/Ti-6Al-4V contact will be presented (sometimes stick sometimes slip). Second some DLC coating effects will be described and commented according to Ti-6Al-4V/Ti-6Al-4V behavior. Third some comparisons with PEEK coatings will be investigated.

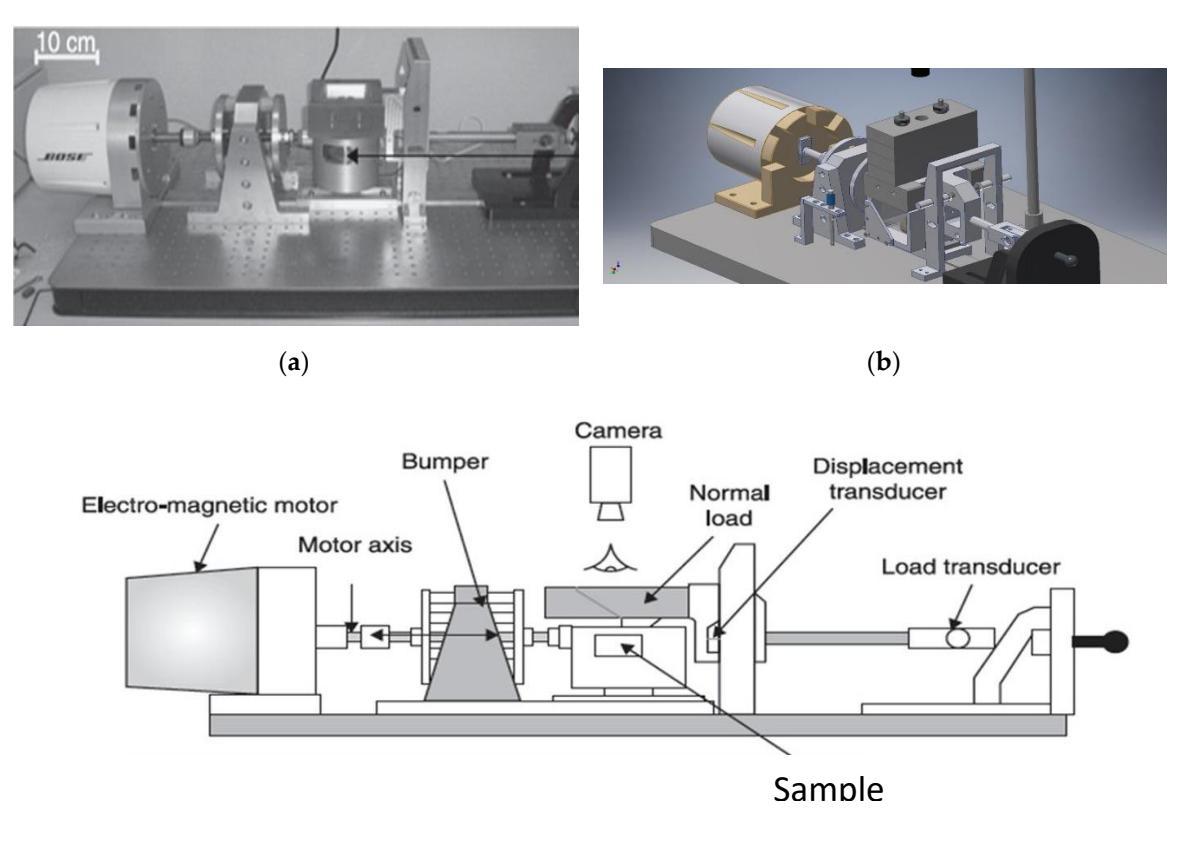
**Figure 3.** (a) The fretting corrosion machine; (b) schematic view, right side; (c) fretting corrosion machine with legends.

The Figure 3 is showing the fretting corrosion machine (TA instruments Inc, New Castle, De, USA) and some elements around. The motor is electromagnetic, ex. Bose<sup>™</sup> TAinstruments<sup>™</sup>. The displacement transducer capacity is maximum ±400 µm.

The Figure 3a,b are representing the global overview of the device. The Figure 3c is showing a scheme with legends. The bumper is a key element in order to accommodate the relative displacement during the friction process, i.e., few microns. The fixed sinusoidal displacement amplitude is  $\pm 40 \mu m$  during the whole campaign dedicated to this survey. The normal load is driven through the contact

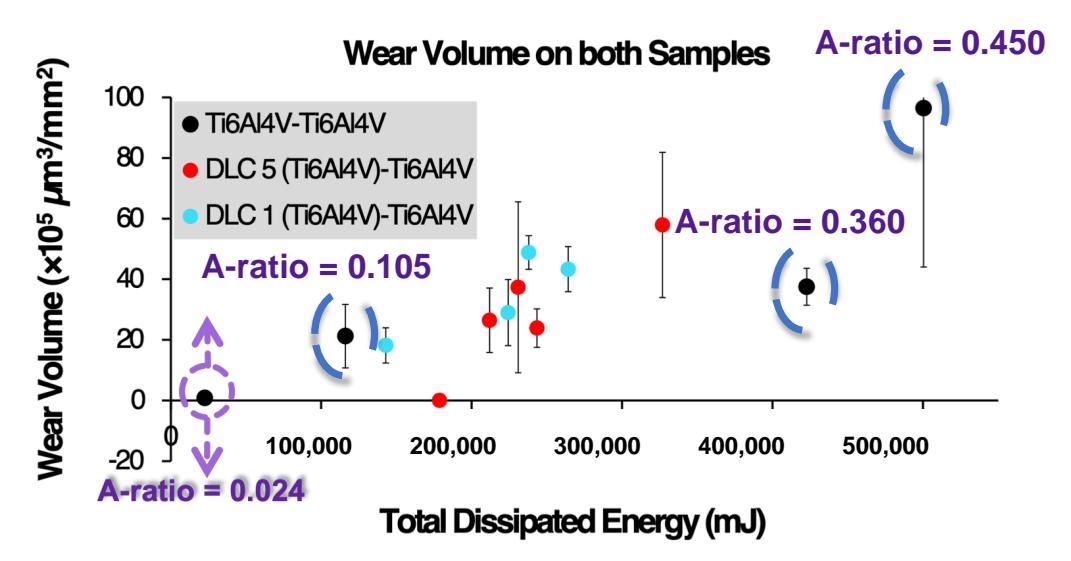
**Figure 4.** Evolution of the total wear volume ( $10^5 \mu m^3/mm^2$ ), both samples in contact, according to the total dissipated energy (mJ).

Before studying the coating impact on Ti-6Al-4V, one paid attention on the pristine contact Ti-6Al-4V/Ti-6Al-4V. Under fretting corrosion in bovine serum solution during 16 h, the curve wear volume vs. dissipated energy provided both behavior tendencies. The Figure 4 is highlighting the total wear volume, i.e., the cylindrical sample wear volume (Ti-6Al-4V) and the flat sample wear volume (Ti-6Al-4V and Ti-6Al-4V + diamond-like carbon coating), according to the total dissipated energy. The area of the cycle tangential load vs. displacement means the dissipated energy. Every second, 1Hz of frequency, is corresponding to an amount of dissipated energy. By adding every energy through 57,600s, i.e., 16 h, the total dissipated energy was obtained. The black dots correspond to Ti-6Al-4V/Ti-6Al-4V contact. It is worth noting that the mechanical contact conditions are exactly the same between the four highlighted dots on the graph. The electrochemical conditions are quite smiliair, open circuit potential (OCP) conditions and solution composition. We are going first to focus on Ti-6Al-4V/Ti-6Al-4V contact. First of all, the physical fact that the wear volume increase is linear, according to the total dissipated energy, is highlighted in Figure 4. The tremendous evolution is related

to a drastically different trend. First, it is worth noting that A ratio is defined as dissipated energy (area of the tangential load vs. displacement / parralelogram) over the total energy (area of the rectangle max-min tangential load multiplied by min-max displacement). Both behaviors, corresponding to the lowest and the highest dissipated energies, show that behind the pseudo linear evolution, i.e., wear volume vs. total dissipated energy, a material issue is occurring.

Based on Figure 4, two DLC coatings were tested. The red and blue dots corresponded to the ongoing contact study. The first point is related to the dot with a dissipated energy lower than 20,000 mJ which has a wear volume of 0. It was not related to a measurement; it was due to the discrepancy. From the experimental protocol the wear volume measurements were not achieved by giving actual data. This matter of fact is due to adhesion. It was happening one time over five with DLC 5 coating. The wear volume vs. dissipated energy cloud is located in the same area. The results make sense and the relative straight-line growth is in accordance with other DLC coatings on Ti-6Al-4V vs. Ti-6Al-4V in dry conditions with multiple normal stresses [35–38].

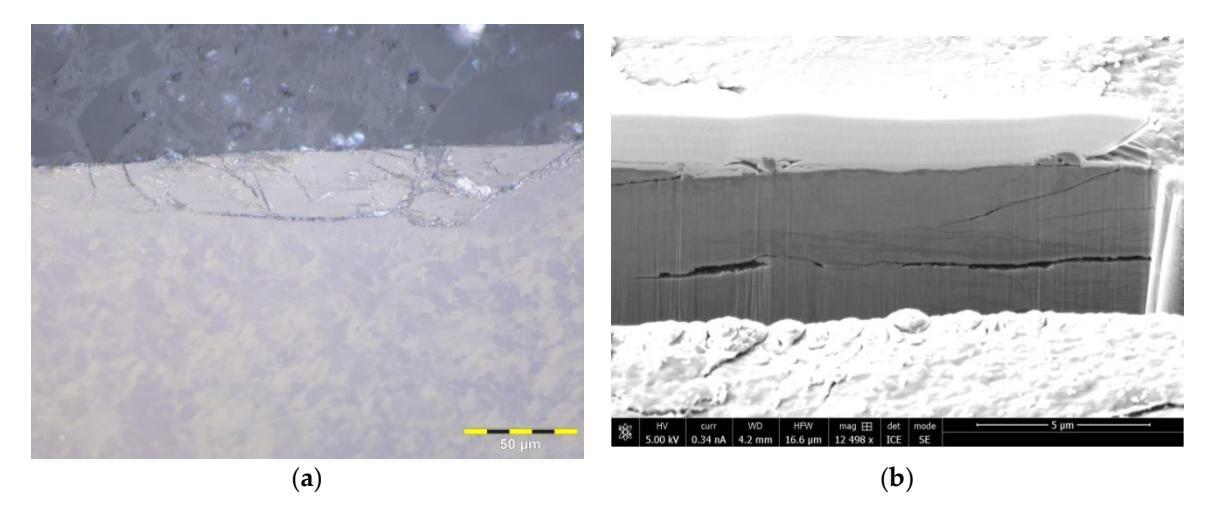
**Figure 5.** Ti-6Al-4V: (a) cross section image of the wear track area of the A = 0.024 sample, smooth polishing technique; (b) focused ion beam (FIB) cross section of the same wear track area.

The Figure 5 is showing the cross section, partially, of the flat sample corresponding to the A = 0.024 case. The Figure 5a is corresponding to a cross section corresponding to the wear track area. It is worth noting that the sub surface cracks are particularly prominent. The stick behavior enhanced some crack formations from the top surface until the maximum of the contact stresses was reached. From contact mechanics [34], the maximum contact pressure is located under the contact surface. Figure 5b highlights a crack, 2 µm under the surface level, that dissipated the energy through a parallel orientation compared to the surface. It is more difficult to go from the top of the bulk material than to propagate in parallel with the material surface when considering a crack. About the case of A = 0.105, the stick behavior was promoted. It is worth noting that all mechanical data are consistent with the metallographical observations, Figure 5.

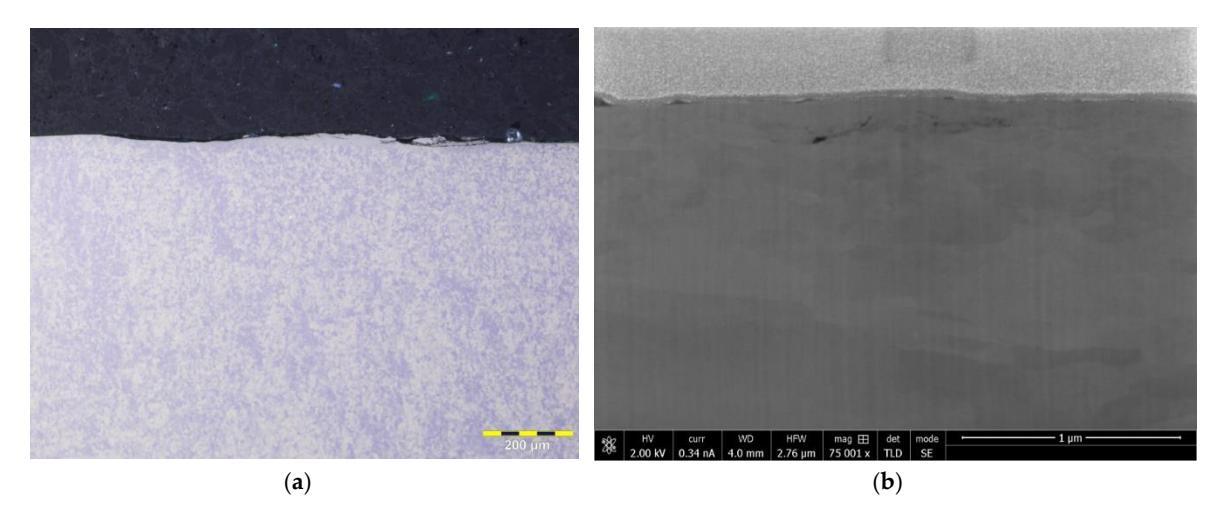
**Figure 6.** Ti-6Al-4V; (a) cross section image of the wear track area of the A = 0.36 sample, smooth polishing technique; (b) FIB cross section of the same wear track area.

Concerning other experimental data, high wear volume-high total dissipated energy, the metallographical data are consistent with gross slip regime. A ratio is higher than 0.2. Moreover, Figure 6 is highlighting no crack on the subsurface of the material. Some wear debris are visible on the top surface without generating any crack.

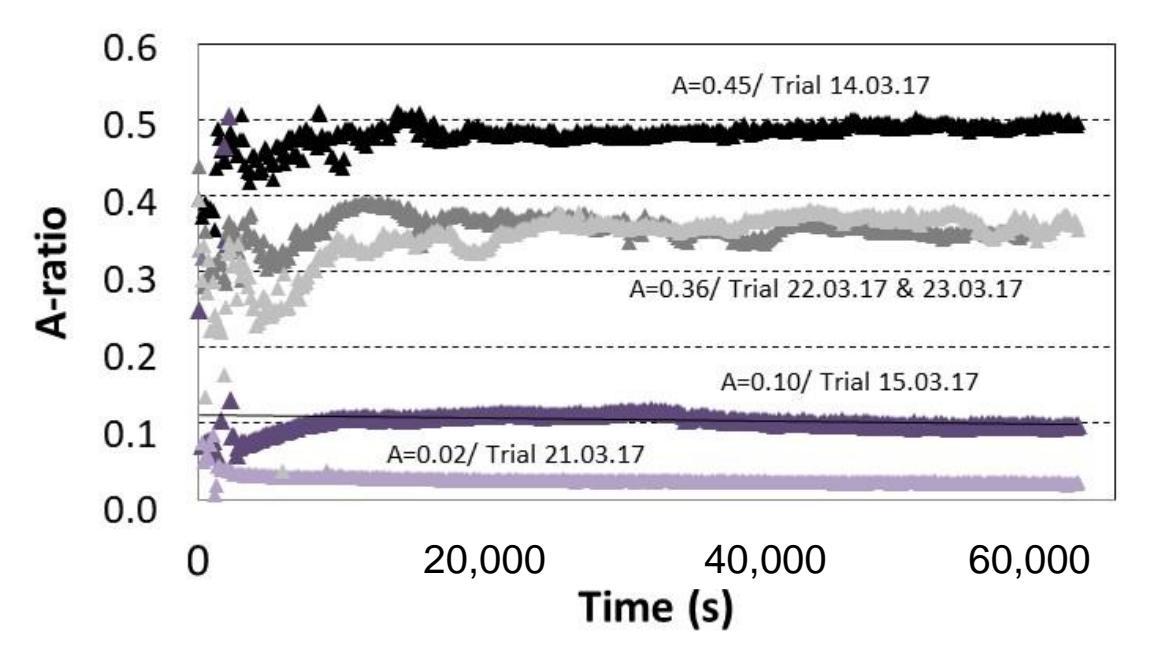
**Figure 7.** A ratio vs. time concerning Ti-6Al-4V/Ti-6Al-4V contact. A: Ed/Etot; Ed: dissipated energy, Etot: total energy, reciprocal displacement between materials in contact.

Figure 7 is representing the A ratio evolution vs. duration of the experiment. Higher than 0.2, it is corresponding to 0.36 and 0.45 experiments on the Figure 4, gross slip regime.

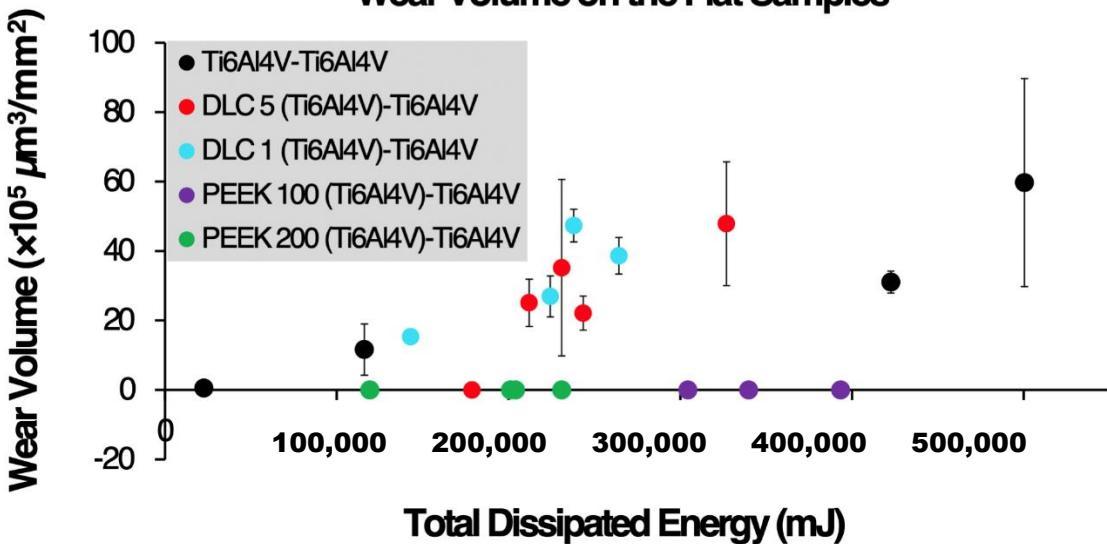
## Wear Volume on the Flat Samples

**Figure 8.** Evolution of the total wear volume ( $10^5 \mu m^3/mm^2$ ), Ti-6Al-4V + coatings, according to the total dissipated energy (mJ). Polyetheretherketone (PEEK) xxx coating is representing roughly the thickness of the PEEK coating.

The Figure 8 is highlighting the wear volume vs. the total dissipated energy concerning the flat sample, i.e., Ti-6Al-4V + coating. The coating should be DLC, i.e., diamond-like carbon, and PEEK, polyetheretherketone.

It is worth noting that wear volume measurement was not possible on the coating of PEEK. The wear phenomenon is not the physical phenomenon that is relevant concerning the key point of friction. Through the experimental conditions the competition between adhesion and relaxation processes is occuring, i.e., Ti-6Al-4V/PEEK contact. No experimental wear volume is measurable on PEEK coating. Inside part 3 the Schallamach waves were evoked. The difference of elastic modulii between materials in contact was between 100 and 1000 ( $E_{Rubber} = 1-0.01$  GPa and  $E_{Glass} = 70$  GPa [39]); some Schallamach waves are generated and this physical phenomenon is well described [26,40]. In our case  $E_{PEEK} = 4$  GPa and  $E_{Ti-6Al-4V} = 115$  GPa, roughly a ratio of 30 is exhibited. The ratio value between

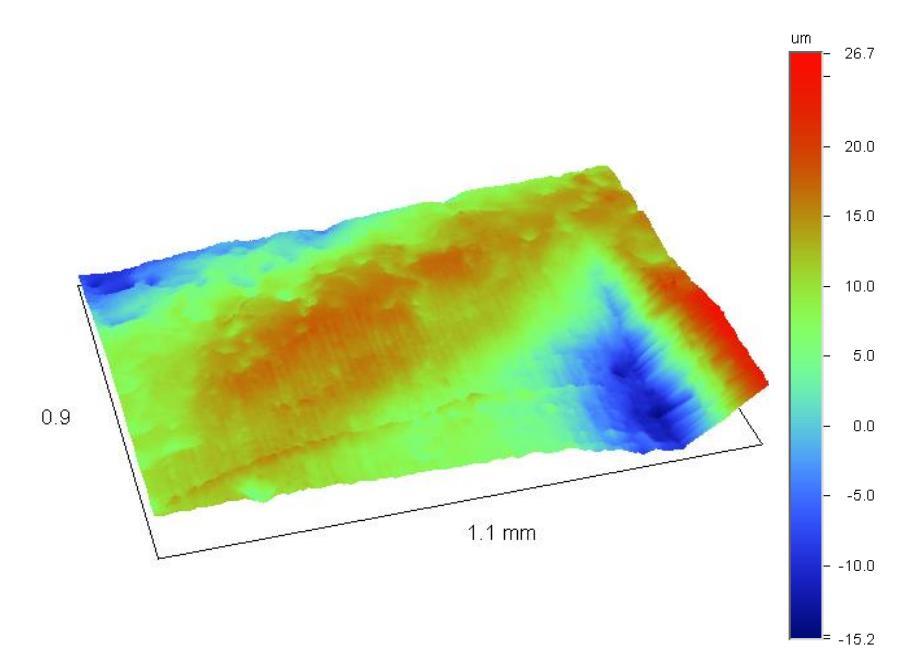
**Figure 9.** PEEK 200 on Ti-6Al-4V after 16 h of fretting corrosion in bovine serum, inside the wear track area.

The Figure 9 shows the surface of PEEK 200 on Ti-6Al-4V after 16 h of fretting corrosion against Ti-6Al-4V in bovine serum. Some waviness appears on huge valleys ( $-15 \mu m$ ) and huge mountains (+26  $\mu m$ ). The initial roughness was about 0.5  $\mu m$ . That is the reason the authors suggest that measuring wear, i.e., issued from debris, is not feasible. No debris were highlighted after the experiment on the top surface of every material in contact.

The PEEK material is deformed but no wear is visible and measurable on this face and on the Ti-6Al-4V. In order to assess this experimental fact, one might have a look at the evolution of Open

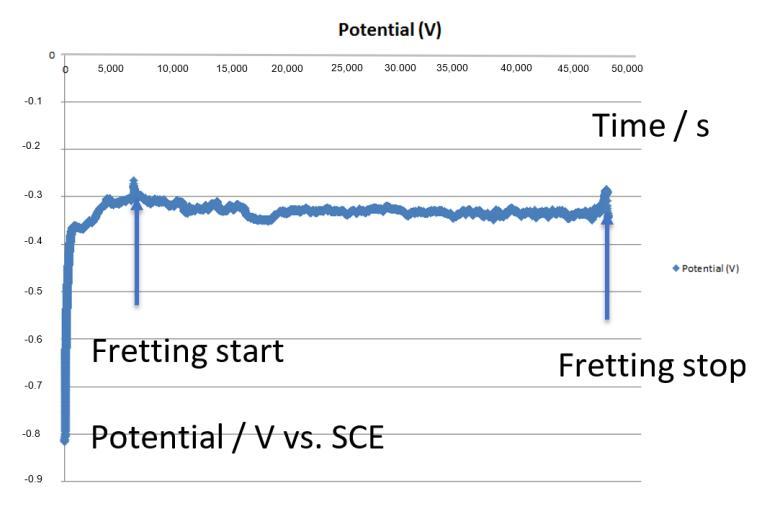
**Figure 10.** Open Circuit Potential vs. Standard Calomel Electrode (SCE) of the PEEK 200 on Ti-6Al-4V and Ti-6Al-4V assembly. A wire connection is fixed between both materials involved in the contact.

Circuit Potential vs. the Standard Calomel Electrode as a reference electrode. Figure 10 is showing the OCP evolution concerning one test PEEK 200 µm on Ti-6Al-4V against Ti-6Al-4V.

At the fretting start, it is worth noting that no OCP decrease is occuring, arrow fretting starts on the graph of Figure 10. Usually, as reported in [43,44], the OCP decreases according to the time when some friction occurs between materials solicited under friction conditions (Figure 11). Destroying the oxides layer involves 'naked' metal in contact with solution. Thus, the corrosion and dissolution of metal, was ongoing. However, from Figure 10, because the OCP is not decreasing according to the time, it means that the oxide layer is not destroyed during the fretting phase.

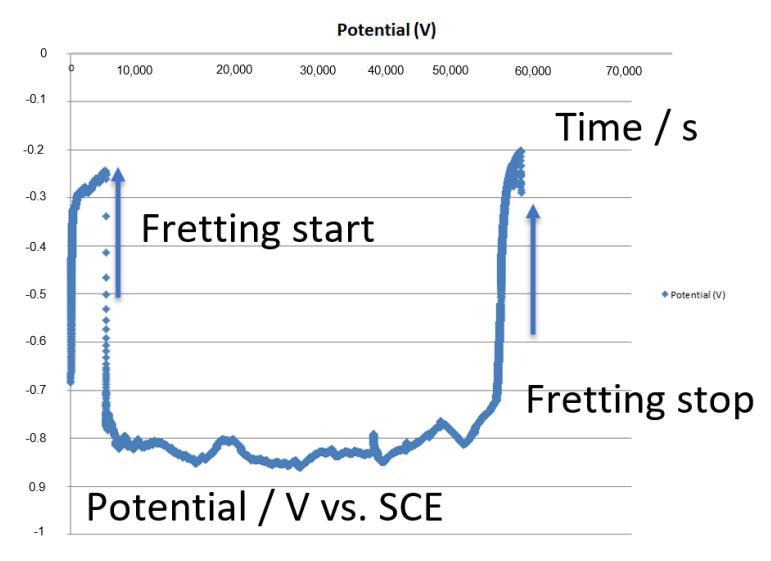
**Figure 11.** Open Circuit Potential vs. SCE of the Ti-6Al-4V and Ti-6Al-4V assembly. A wire connection is fixed between both materials involved in the contact.

The Figure 11 is highlighting the usual OCP evolution when some friction and/or fretting is occurring between metallic materials. The OCP drop is characterized as 600 mV. The major benefits of the PEEK coatings are the lack of mechanical and corrosive wear.
