# Using of Bond-Wire Resistance as Ageing Indicator of Semiconductor Power Modules

A. Ibrahim, Z. Khatir, J.P. Ousten, R. Lallemand, N. Degrenne, S. Mollov, D. Ingrosso

Abstract – This paper investigates the use of wire—bonds contact resistance as indicator to diagnose the health state of power electronics modules. This technique is especially dedicated to monitoring the degradation of the topside interconnection (metallization-wire bonds) when the module is wired with a Kelvin point. One advantage of this indicator is that it can be followed online, without being disturbed by current or voltage, to diagnose the state of health and, possibly, the prognosis of the remaining lifetime of the power module by associating it with a lifetime model. For this purpose, based on power-cycling tests in different conditions, a comparison between this indicator and the one commonly used, i.e. the collector-emitter voltage Vce, shows that the first one is much more sensitive to the degradations, easier to use online and finally should be more suitable for lifetime prognosis.

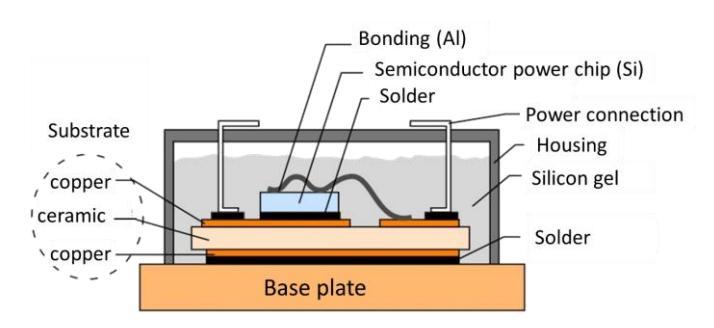
Fig. 1: General structure of power module.

Power semiconductor modules are the key elements in the chain of power conversion. Nowadays, they are widely used in various applications but these components remain also the weak element of power conversion systems in terms of reliability. In fact, power modules constitute an assembly of various materials (Fig. 1). Generally, the power chips are carried on a ceramic substrate which must ensure good electrical insulation and good thermal conduction. The substrate could be welded on a base plate to be cooled. The assembly technologies are various. This includes materials and process for insulation or passivation, interconnections, and die attach. Due to power and thermal cycling, the power modules are subjected to thermomechanical stresses which affect their lifetime and reliability [1]. The topside interconnections, consisting of the metallization and the wire bonds, are subjected in operation to high functional stresses. This is the result of an important difference between the coefficients of thermal expansion (CTE) of the materials in contact: metallization and wire bonds (aluminum) and dies (silicon). The metallization layer (around 5 µm) deposited on the chips becomes very distorted with temperature, leading to large inelastic strains [2]. It has been reported that two main types of degradation can take place in the topside of power chips under effect of thermomechanical cycles: the metallization reconstruction (Fig. 2) and degradation bonding of contacts [2], [3], [4]. The last one may itself be either heel-cracks or cracks propagation followed by lift-off [5] (Fig. 3). Various works have been conducted to propose scenarios of degradation mechanisms using thermal and power cycling tests [6], [7]. Although it is quite clear that the wire-bond lift-off contributes mainly to the module failure [8], this link is not obvious with the metallization degradation [8].

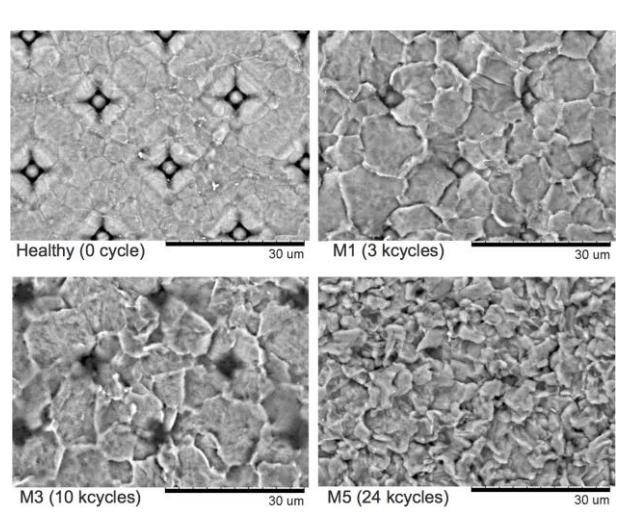
Fig. 2: Topside metallization: before and after aging.

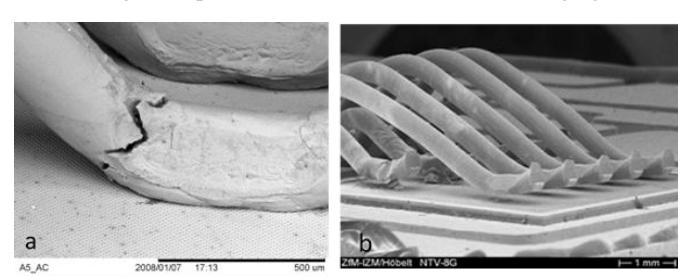
Fig. 3: Heel crack (a) and Lift off (b) of bond wires

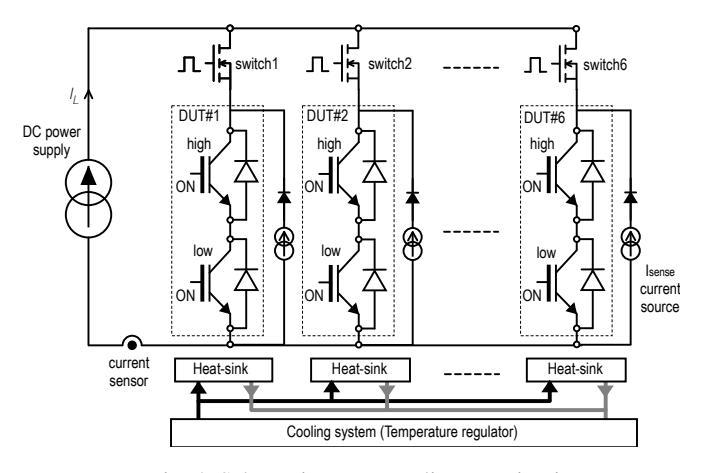
Fig. 4: Schematic power cycling test circuit.

Accelerated aging tests have been performed on standard sixpack modules IGBT power modules (1200V-150A). Only high side IGBT's have a Kelvin connection. The power cycles are performed on 6 modules at a time for which only the central leg is tested. This constitutes 2 DUTs respectively high side and low side switches per power module. The power modules are mounted in a water-cooler heat-sink device with a thermal grease interface. The circuit schematic of the test bench is shown in Fig. 4. The aging consists on repetitive cycles of self-heating and cooling phases. The power devices undergo thermal stresses due to temperature swings  $\Delta Tj$  between a maximum ( $T_{jmax}$ ) and a minimum junction temperature ( $T_{jmin}$ ) depending on the setting parameters.

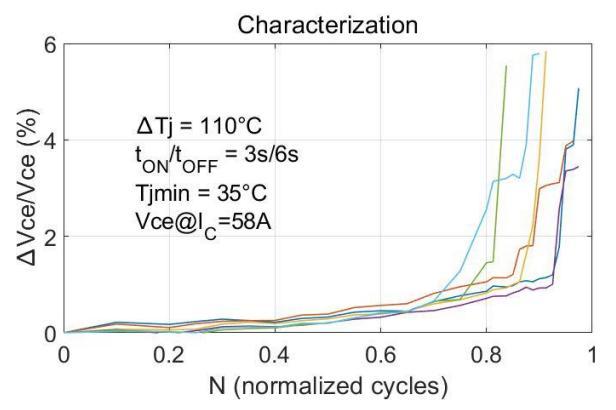
Fig. 5. Monitoring of VCE during static characterizations.

Fig. 5 illustrates the evolution of the relative variation of  $V_{CE}$  of high side IGBT's during power cycling for the six tested modules at  $\Delta T_i = 110$ K. It can be seen for all components that the relative voltage increase is quite linear till 1%, due to the metallization degradation and to the crack propagation in the wire-bond interconnection with the metallization, then there are multiple jumps until 5% which is the failure criteria. However, there is no significant evolution in the  $V_{CE}$  of low side IGBT's, it's still around 0.5%. All tested devices have failed by bondwire lift-off due to crack propagation in the high side IGBT chip. Moreover, microscopic analyzes have shown that the degradations on the high side are located essentially in the red ellipse, shown in Fig. 9. No significant variation in thermal resistance was detected, indicating that no delamination or degradation has occurred in the structure. This has been verified and confirmed by scanning acoustic microscopy (SAM) analysis as shown in Fig. 6 (By comparing the state of the central part (aged part) and the other two parts on both sides).

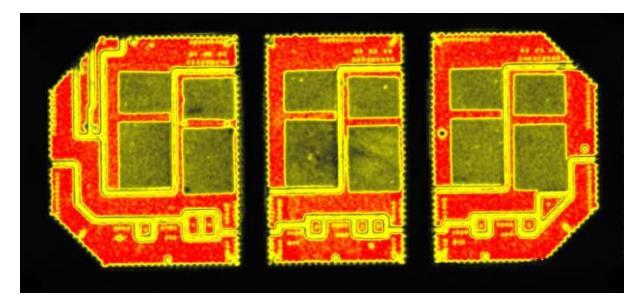
Fig. 6: Scanning acoustic microscopy of module after aging.

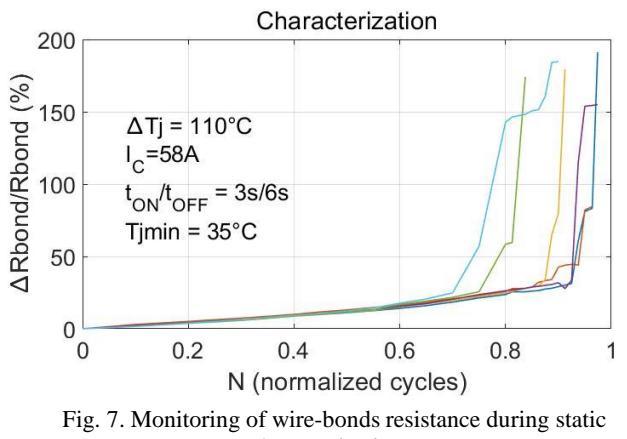
The degradation of wire-bond interconnection with the metallization is investigated by optical microscope analysis. This result is consistent with the measurements of bonding resistance during static characterization phases (Fig. 7) and "on the fly" measurements (Fig. 8). By comparison of Fig. 5 and Fig. 7, they have the same tendency and we can establish a correlation. For example, a threshold of 1% and 5% in  $\Delta V_{CE}/V_{CE}$ matches with 25% and 180% in  $\Delta R_{bond}/R_{bond}$  respectively. The Fig. 8 shows that the "on the fly" measurements (for  $\Delta T_j = 110K$ and  $\Delta T_{j} = 70K$ ) are as accurate as static characterization ones but with a continuous sampling because the monitoring is easily and accurately performed continuously during aging. So, based on this results, this parameter could be advantageously used as aging indicator for the top interconnection.

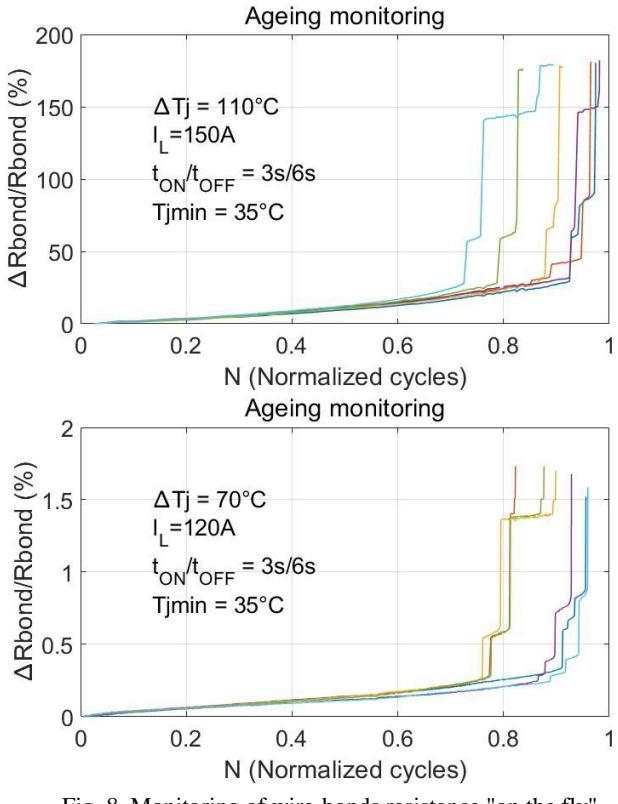
Fig. 8. Monitoring of wire-bonds resistance "on the fly".

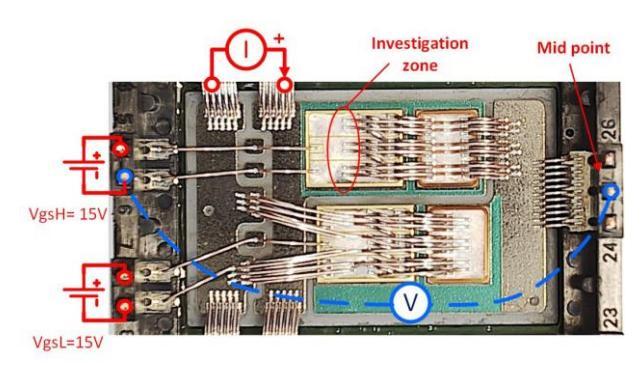
Fig. 9. Measurement of the resistance of the top interconnection.

Some measurements have been performed on a healthy half bridge to understand the impact of bond-wires lift-off. The study focuses on the six bond-wire contacts as represented by the red ellipse in Fig. 9. These contacts are causing the module failure apart from the degradation of the metallization. A current of 1A  $(\pm 2.3 \text{mA})$  is applied using a Source Meter Unit on the DC bus of the half bridge where the two IGBTs (high and low sides) are in the on state ( $V_{GS}=15V$ ). The current is chosen relatively low to avoid self-heating of bondings and dies. The voltage is then measured between the kelvin point of the high side IGBT and the midpoint, avoiding the effect of bonding of mid-point. The resistance of the top interconnection corresponds to the voltage and current ratio. All measurements are made at 25°C.

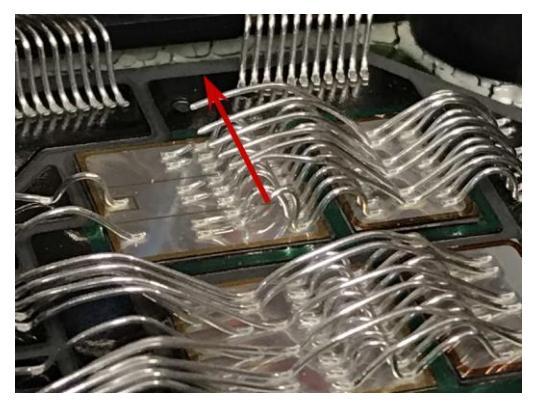
Fig. 10. Manually open contact of wire bonds

The bond-wires were cut out successively one by one from one edge to the other as seen in Fig. 10. Given the location of the high and low chips, it is intuitive to deduce that there will be a mutual heating effect which induces an inhomogeneity in the temperature distribution because the dies are warmer in the direct vicinity. As the damage also depends on the temperature, the degradation of the contacts will be more pronounced on the edge near the low side chip and consequently the lift-off of wirebonds should begin from this edge. This hypothesis has been confirmed by microscopic observation. The equivalent resistance, given in Table II, has been noted each time a contact was opened. These measures are strongly correlated to the aging tests. Indeed, there is an increase in  $\Delta R/R$  of 26% for the disconnection of one contact and 176% for the loss of 5 bond wires. In fact, the resistance is very sensitive to the position of bond wires on the metallization with regard to the Kelvin point. The metallization consists of three parallel pads (see Fig. 10). The lift-off of the two wire bonds from the common pad with the Kelvin point forces the current to pass through the metallization that represents a higher resistance and consequently a strong increase in the overall electrical resistance of the contact. This explain some variabilities in the progress of  $\Delta R/R$  for the six DUT's as shown clearly on Fig. 8. But whatever the order of detachment of wire-bonds, we can always determine the moment when the wire-bonds start to lift-off, and also the increase of  $R_{bond}$  to 175% always corresponds to an increase in the  $V_{CE}$  to 5% and to the end of life of the module.

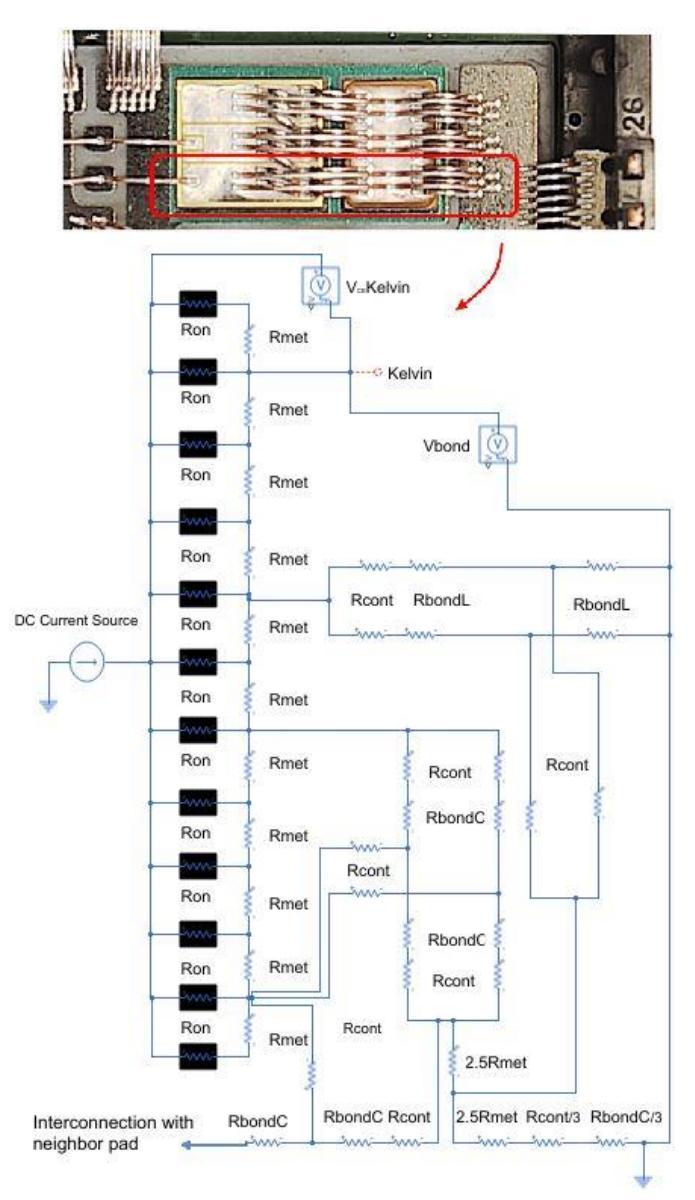
Fig. 11. Electrical model of metallization and top interconnection.

In this part, a 2-D model was built using Simulink in order to reproduce what is done by experimental study and to quantify the effect of metallization and contact degradations. Fig. 11 shows a part of the model that represents one pad of the metallization. Where:

- Bond-wires are represented by *Rbond* and *RbondC*, it depends to the length of bond-wire.
- Rcont represents the resistance of contact bondmetallization, it was deducted by experimental

- *Rmet* is the resistance of the metallization and is determined by 4-wires measurement at the extremity of the pad and confirmed by a theoretical approach.
- *Ron* represents the On-State resistance of IGBT
- *Vbond* is the measure of potential difference between the Kelvin connection and the output of the circuit.
- *VceKelvin* is the collector emitter voltage measured between collector and Kelvin connection.

Table III summarizes the different parameters used in this model. To estimate all of them, an optical profilometer is used to determine the dimension of the metallization and the position of contacts on the metallization area. Based on that, each pad is represented by a network of 10 elementary cells (Rmet/2 - Ron - Rmet/2) and then it has been grafted a connection wires which are represented by a contact resistance and a bonding resistance. Admittedly this model is simplified but it makes it possible to validate some experimental measurements and to link the variation of the  $V_{CE}$  to the degradation of the metallization and the contacts. All results are given in a steady state under constant temperature.
