Valorization of Fine Recycled Aggregates Contaminated with Gypsum Residues: Characterization and Evaluation of the Risk for Secondary Ettringite Formation

Charlotte Colman^{1,2,*}, David Bulteel¹, Sébastien Rémond³, Zengfeng Zhao² and Luc Courard²

Received: 2 October 2020; Accepted: 26 October 2020; Published: 30 October 2020

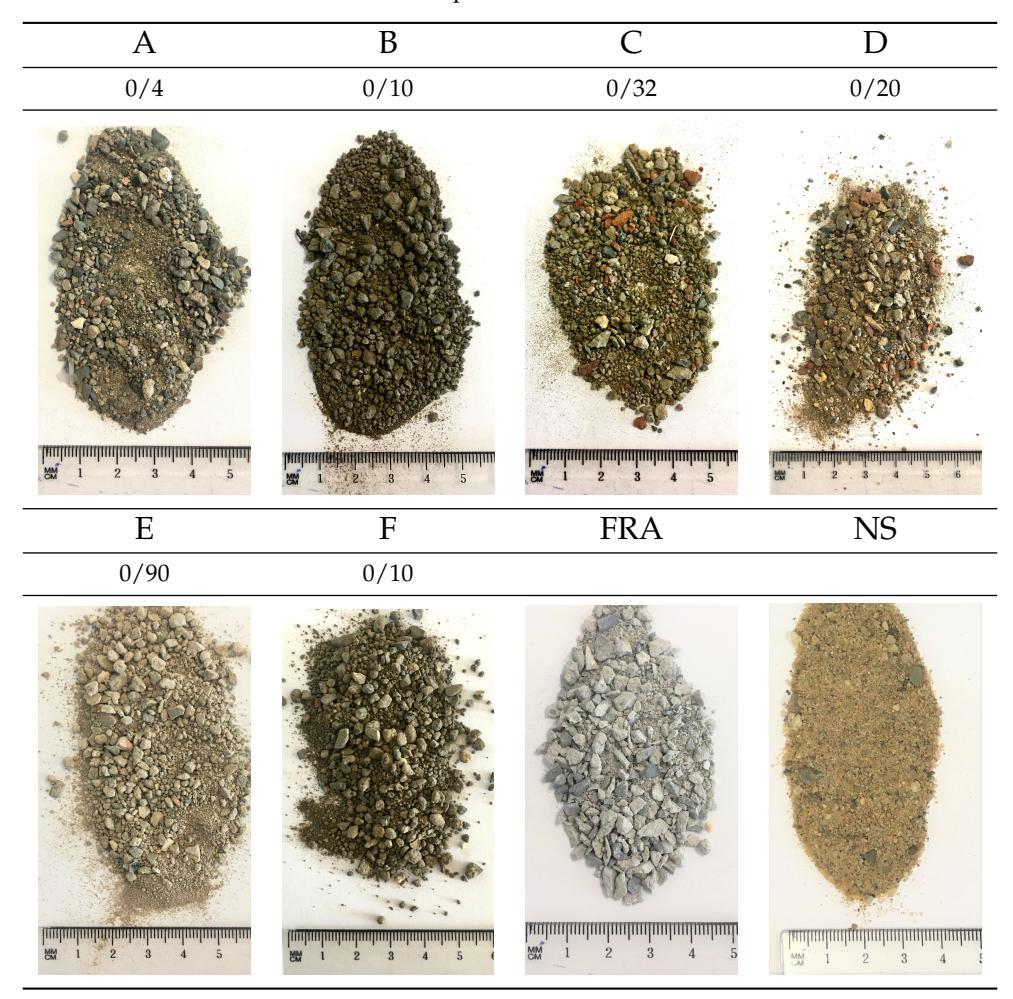
Table 1. The different samples of aggregates and their original size distribution. Pictures shown are after drying at 40 °C and separating of the 0/4 mm fraction. The "model" FRA and natural aggegrate that were used for reference mortars are also presented.

Of the six collected FRA samples, four were from different batches of the same recycling plant. Because of their small particle sizes, it was not possible to obtain a detailed composition of these materials. The industrial sources named these samples "mixed aggregates", indicating that next to concrete also bricks and other construction materials can be present. Their original characteristics are shown in Table 1. To obtain FRA samples ready for characterization and subsequent incorporation into mortars, they were dried at 40 °C and sieved to keep the 0/4 mm fraction. From the pictures in Table 1, a large variability between the different sources can be seen, and contaminations with soil, brick, wood, plastic, or gypsum particles. Their impurity becomes especially clear when compared to the pure crushed concrete "REF".

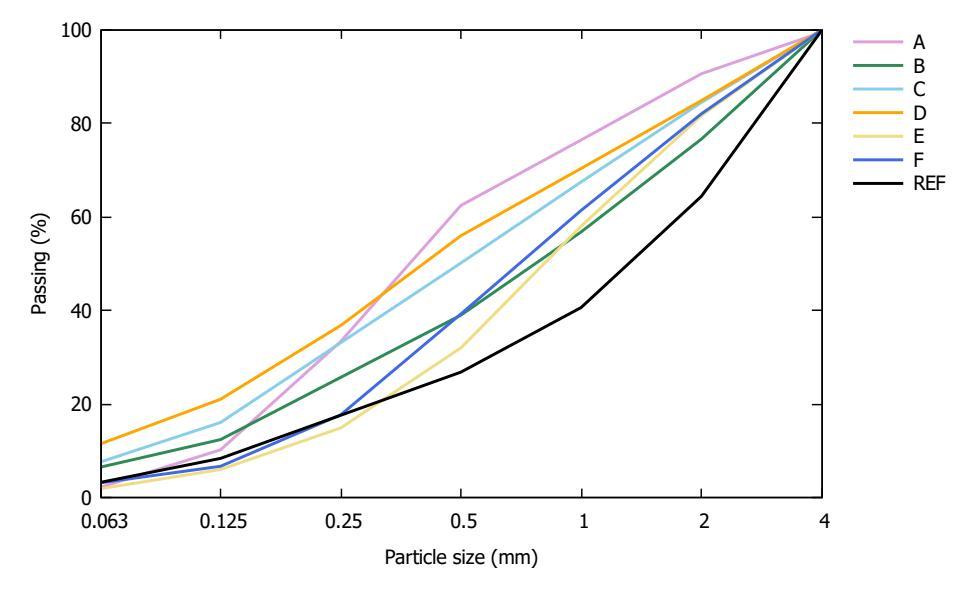
Figure 1. Particle size distribution of the used fine recycled aggregates (FRA).

The particle size distribution of the FRA samples is shown in Figure 1. A very high variability in characteristics was found between the different industrial sources.

Table 2 summarizes other characterization results. Again, a large difference in characteristics was noticed, proving the necessity of a thorough characterization of FRA before incorporating them into a mix. An elevated water absorption is one of the key aspects of recycled aggregates, and these ranged from 6.1% to 14.6% over the different samples. No apparent correlation was found between this water absorption and the sulfate content (Figure 2) or the amount of fine particles (Figure 1).

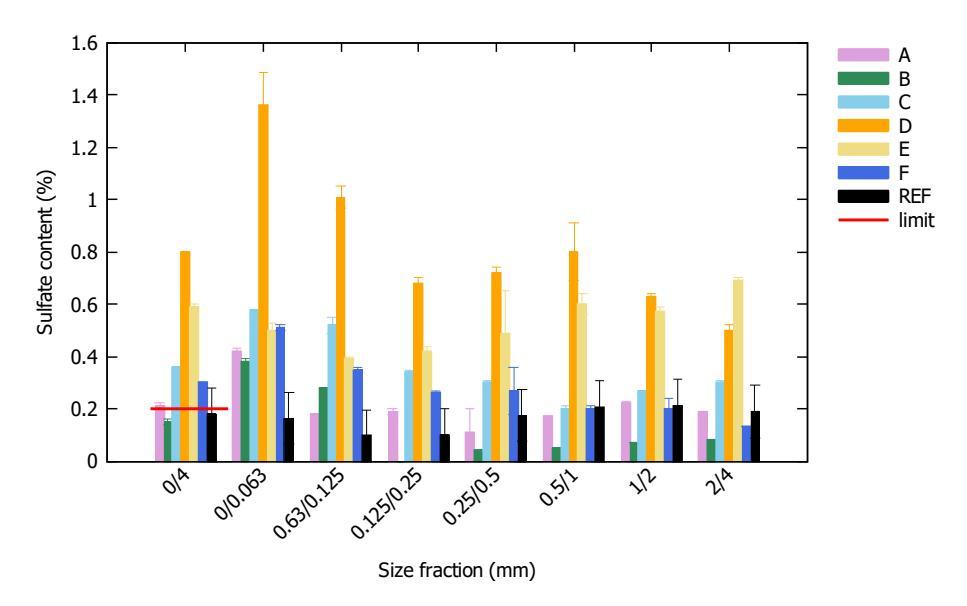
Figure 2. Water soluble sulfate content of the FRA in total and per size fraction.

In Figure 2, the water-soluble sulfate content of the FRA is shown for the total 0/4 mm sample as well as per size fraction. All but one source of FRA surpassed the maximum allowable sulfate limit of 0.2% specified by EN 206 [29], indicating they would be rejected for use in a new concrete. The reference FRA, which was a pure uncontaminated crushed concrete, also contained 0.18% of sulfates, which originated from the leaching of cement particles.

Sulfates are predominantly present in the smaller size fractions, except for sample E and REF. This is explained by the brittleness of gypsum during the handling process of construction and demolition waste, and by the increasing presence of cement particles in the finer size fractions [42–44]. The sulfates accumulating to the finer fractions partially explains why—contrary to coarse recycled aggregates—FRA are not valorized.

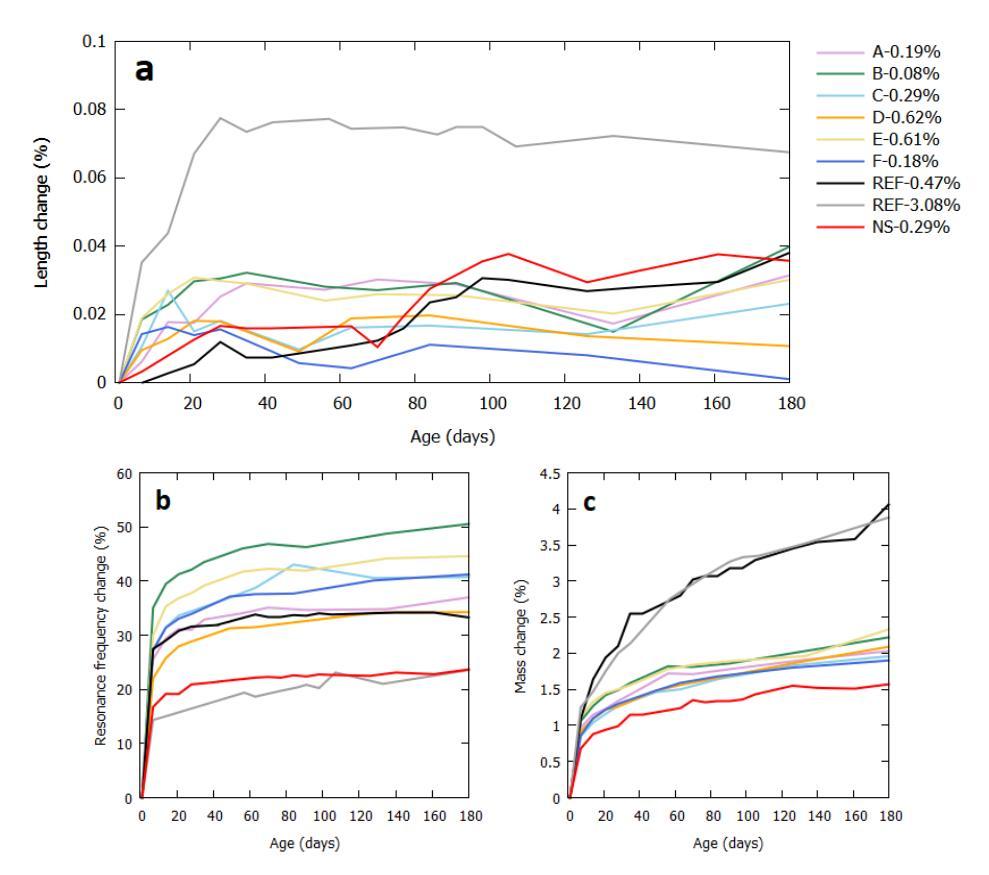
Figure 3. Six-month swelling behavior of the mortar samples, including their length change (**a**), resonance frequency change (**b**), and mass change (**c**).

The 6-month swelling behavior of these mortars is shown in Figure 3. Except for "F-0.18%" which showed a lower expansion, no statistical differences (p < 0.05) were found between the length changes of the industrial FRA sources and the 2 reference mortars with similar sulfate contents. More information about statistical differences between the results can be found in Table S1 and Figure S1 in the Supplementary Information. There was also no correlation between the absolute swelling amount and the sulfate content of these mortar mixes. It was, however, very clear that sulfates do indeed cause a swelling reaction—as can be seen from the curve of REF-3.08%, but an exaggerated contamination level was needed for this result. The sulfates present in the industrial FRA were not enough to provoke a significant swelling reaction even though they largely surpassed the 0.2% limit. The length change curve of sample REF-3.08% stabilized after one month, which is a much faster reaction than seen in literature for other types of sulfate deteriorations like DEF or external sulfate attack, that often go on over multiple years [28,45–47].

The resonance frequency test is a measure for the internal damage in the mortar sample. If microcracks were formed, they would manifest as irregularities in their frequency curves, but this was not the case for these mortars. Even though significant swelling was attained for REF-3.08%, it was nevertheless not severe enough to cause internal fissuration.

The mass of the mortars kept steadily increasing each week, because of ingress of the water in which they were kept. The mortars made with the reference FRA gained more mass, because of their irregular shape which captures more air into the mixture than a round aggregate [30,48]. For the reference FRA specifically, a high air content in mixes with this material was already observed [49]. Industrially fabricated FRA are rounder by nature than laboratory crushed FRA [50], explaining why their results lie between those of the natural aggregates and the reference FRA.

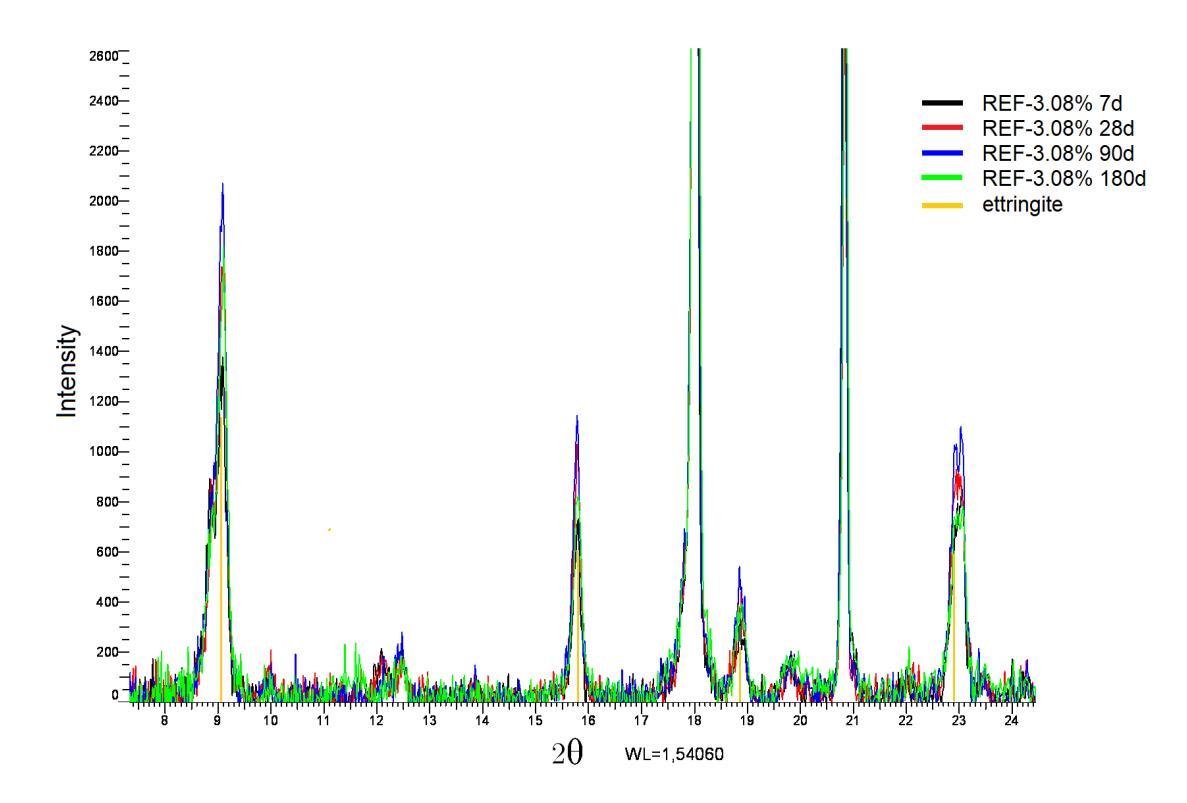
Figure 4. XRD analysis of "REF-3.08%" at 7, 28, 90, and 180 days.

An XRD analysis on "REF-3.08%" (Figure 4) at different moments shows how ettringite peaks become more intense with age, corresponding well to the observed swelling results. The biggest growth for the ettringite peaks is between 7, 28, and 90 days, after which the intensity stabilizes and even decreases slightly at 180 days.

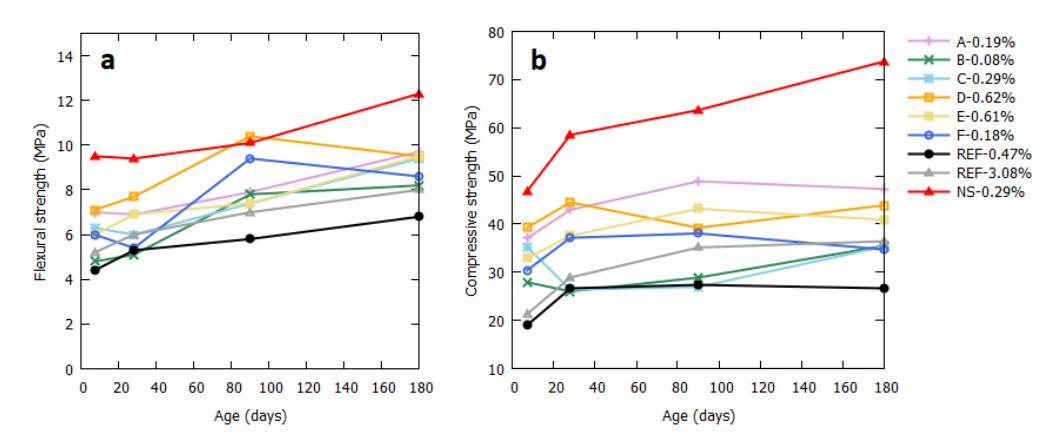
Figure 5. Flexural (a) and compressive (b) strength of the mortar samples after 7, 28, 90, and 180 days.

Figure 5 shows the flexural and compressive strength of the mortar samples after 7, 28, 90, and 180 days. As expected, the mortar with natural aggregates has a better mechanical performance than those with the reference FRA. The heavily contaminated sample REF-3.08% showed a higher flexural and compressive strength than REF-0.47%, even though it underwent significant swelling. The samples with the industrial FRA performed between the natural aggregates and the reference FRA, confirming their higher quality compared to a pure crushed concrete. This could again be due to the irregular shape of the REF aggregates: the higher air content in these mixes affected their mechanical resistance.
