Morpho-sedimentary dynamics associated to dam removal. The Pierre Glissotte dam (central France)

Louis Gilet, Frédéric Gob, Clément Virmoux, E Gautier, Nathalie Thommeret, et al.. Morphosedimentary dynamics associated to dam removal. The Pierre Glissotte dam (central France). Science of the Total Environment, 2021, 784, pp.147079. 10.1016/j.scitotenv.2021.147079 . hal-03229949

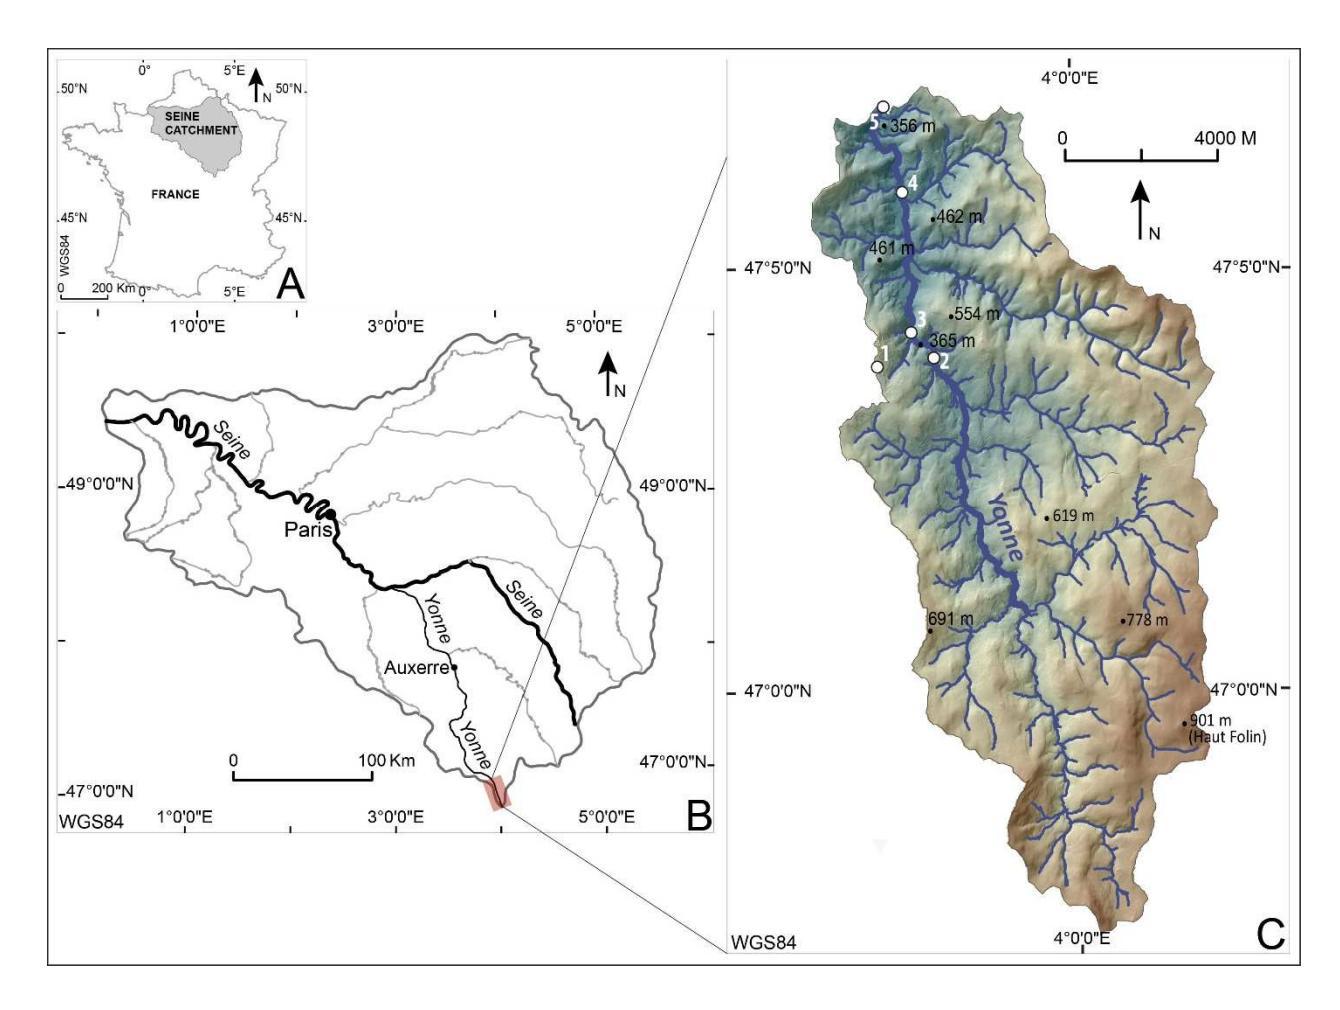
Fig. 1 Upper Yonne catchment and location of the Pierre Glissotte dam. Map C: 1. Château-Chinon city; 2. Moulin Blondelot dam; 3. Pierre Glissotte dam; 4. Corancy hydrometric station; 5. Tail of the Pannecière reservoir.

The Morvan massif is a Hercynian medium-elevation mountain range located in the southeastern part of the Seine catchment in central France, where the maximum altitude is 902 m (Fig. 1). The substratum is mainly granitic and gneissic rocks, and the climate is temperate oceanic with pluviometry influenced by the orography. Mean annual precipitation in the region is 900 mm. Combined with the impermeability of the substratum, this has led to the formation of a channel network with high drainage density. The landcover of the hillslopes in the upper Yonne catchment, where the Pierre Glissotte complex is located, is mainly meadows and forests (Fig. 2).

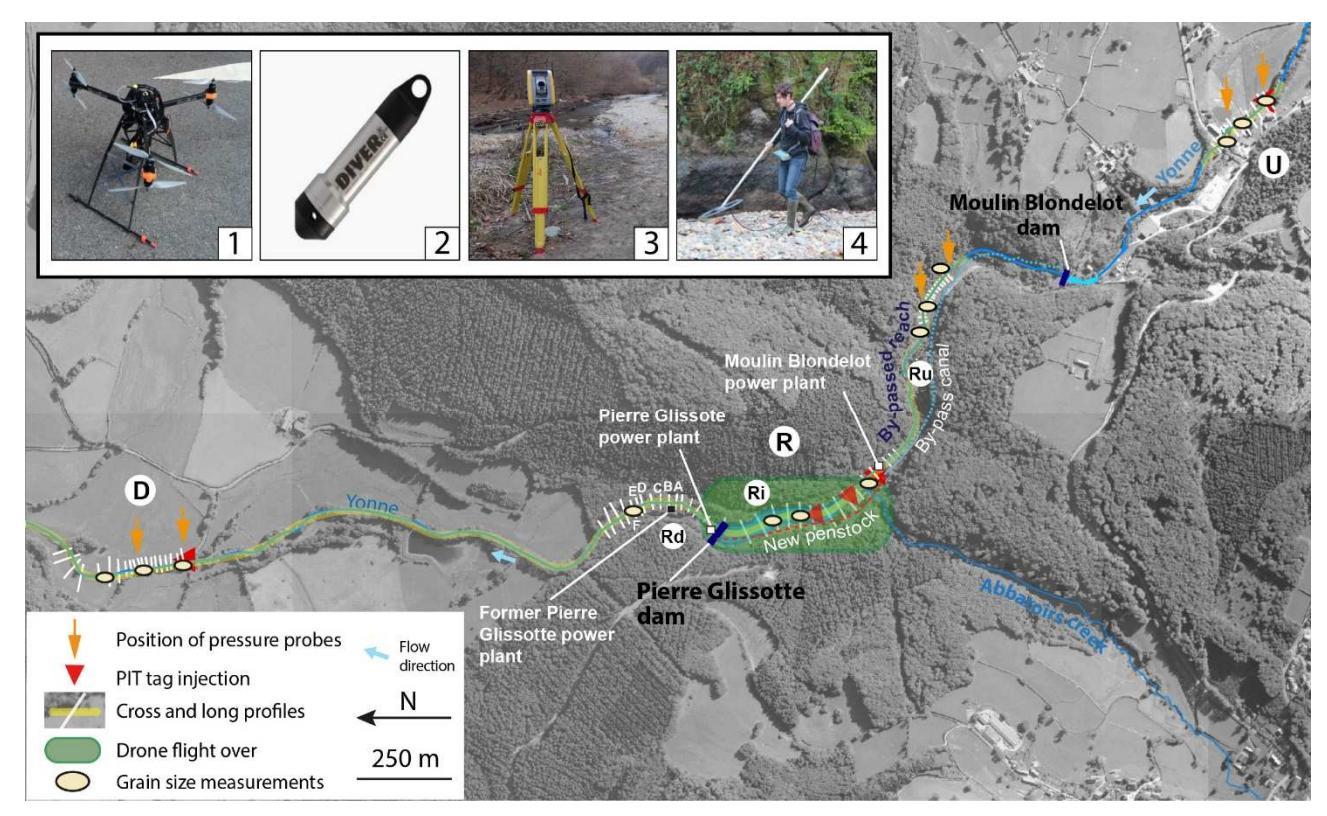
Fig. 2 Location of the study sites and overview of the methods and technologies. 1. Hexacopter
drone; 2. Diver pressure probe (water level); 3. Total station Trimble S6; 4. PIT tag detection
antenna. In Rd sub-reach, A, B, C, D, E, F correspond to the cross-sections of Figure 8.

176 In addition to the site of the former Pierre Glissotte dam reservoir (R), bedload transport was also monitored 177 at two control sites, upstream (U) and downstream (D), that were not influenced by the dismantling of the 178 structure (Fig. 2). These sites were also selected to represent the diversity of existing hydrological situations 179 in the study area (Table 1). Both were positioned outside the hydrological influence of the dams, upstream 180 and downstream of the study area (U is located 0.6 km upstream of the Moulin Blondelot dam and D is 181 located 1.3 km downstream of the Pierre Glissotte dam). The study of river reaches not affected by the 182 dismantling operation was expected to help inform our understanding of the specific functioning of a typical 183 transient site after the removal of a dam.

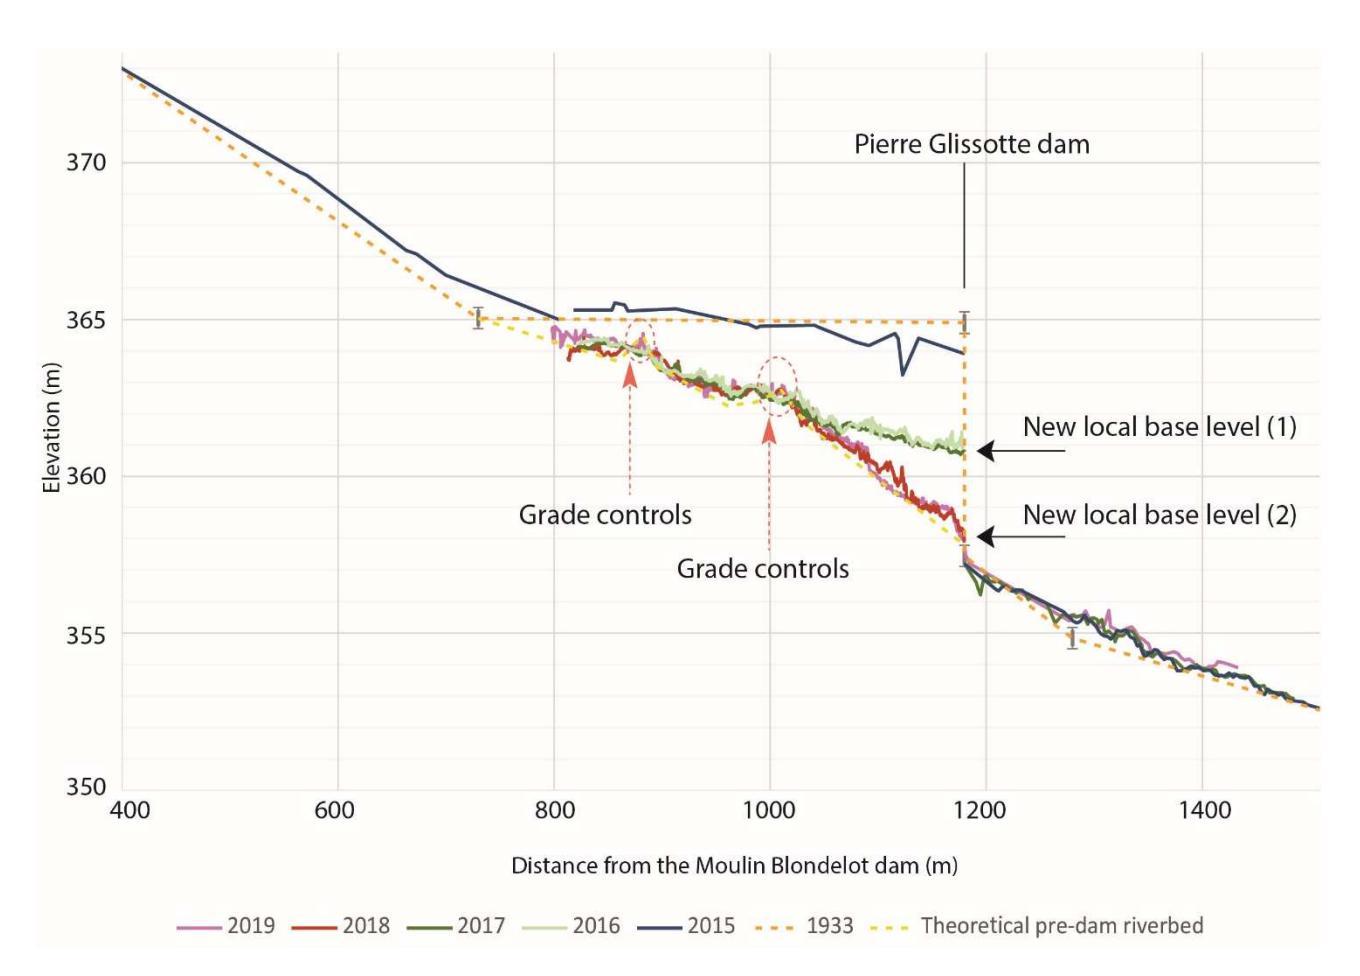
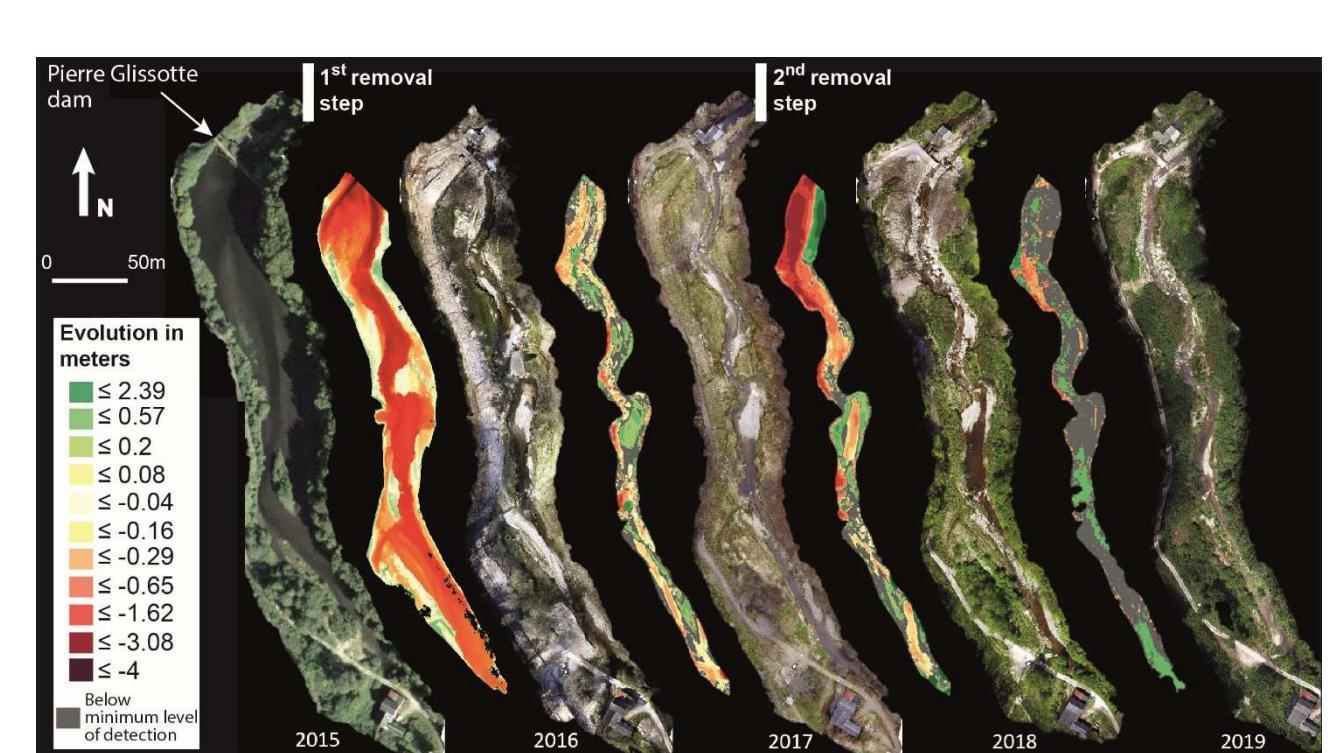
Fig. 3 Development of the new Yonne long profile around the Pierre Glissotte dam.

402 confidence interval (LoD_{95%}) of the DSMs of difference, described in section 4.2.2. The intervals of the

403 vertical evolution correspond to a manual classification.

351	6.5 and 19.5 m and the maximum bankfull height was over 4 m (median value: 2.1 m) (Figs. 3 and 4, and
352	supplementary material, Fig. S5). The formation of an average 16-m wide and 2.3-m deep channel resulted
353	in the remobilization of 26% of the volume of sediment contained in the reservoir, i.e. 11,039 m ³ of mainly
354	sandy material (Fig. 4, Table 4) (Gilet et al., 2018).

From summer 2016 on, we observed a weakening of the intensity of the erosive processes and the progressive stabilization of the new morphological and sedimentary conditions shaped in the reservoir (Figs. 357 3 and 4).

370 After the second stage of the removal (October 2017), significant vertical and lateral erosion occurred again 371 (Figs. 3 and 4). Seven months later, 4,180 m³ of gravel-sand sediment had been eroded and reinjected into 372 the river system (Table 4). A significant proportion of this release was the result of both river action and 373 mass movement that affected the banks. Figure 4 shows that erosion was particularly concentrated in a 374 stretch 170 m in length immediately upstream of the former dam. Nevertheless, small areas of significant erosion can also be seen in the middle of the former reservoir. Also, the important aggradation that can be 375 seen on Figure 4 near the dam (dark green area) is artificial. Sediments were excavated to form the new 376 377 channel passing through the hole in the dam and stocked against the right hillslope of the valley (also visible 378 in supplementary material, Figs. S2 and S5, photograph taken on November 16, 2017). A comparison 379 between the 2018 and 2019 profiles shows that the bed was not completely fixed (Fig. 3). Some sectors were incised and others were in a state of aggradation, even if the differences in altimetry were moderate (a few 380 381 tens of centimeters). These moderate changes were confirmed by the differential DSM between 2018 and 382 2019 (Fig. 4). The sediment volumes calculated from it were 597 m³ of eroded sediments for 603 m³ of 383 aggraded sediments (Table 4). These numbers suggest a slowdown of morphogenic activity but not the complete stabilization of the fluvial system. Eventually, 34% of the reservoir fill was eroded and exported 384 385 downstream of the dam (Table 4).

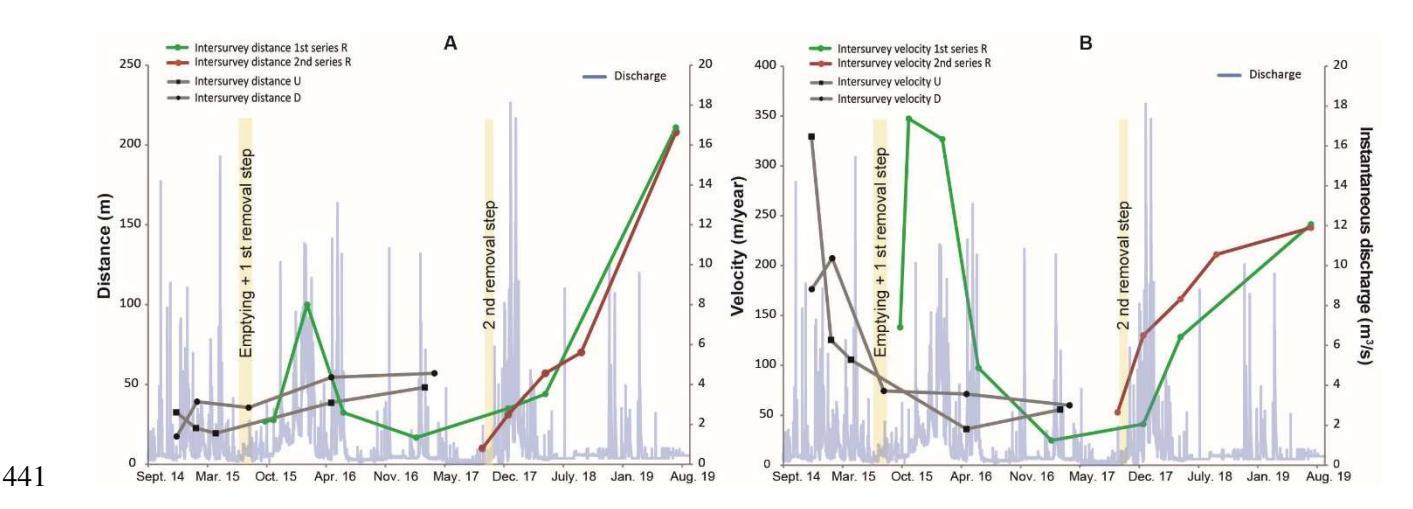
442 Fig. 5 Bedload displacements at Pierre Glissotte (R) and at the study sites undisturbed by the removal

443 (U, D). A. Mean inter-survey distance covered by the mobile tracers. B. Mean inter-survey velocity of

- 444 **the mobile tracers.** For each survey, the mean inter-survey distance (A) of the detected tracers corresponds
- to the mean distance traveled since the previous survey. For each survey, mean inter-survey velocity (B) is
- the ratio between the mean inter-survey distance and the time elapsed since the previous survey.
- 447

Figure 5 shows the movement of the tracers over time and with respect to the hydrology. For each survey, the mean inter-survey distance (Fig. 5A) of the detected tracers corresponds to the mean distance traveled since the previous survey (or to injection in the 1st survey). Mean inter-survey velocity (Fig. 5B) is the ratio between the mean inter-survey distance and the time elapsed since the previous survey.

The relative morphological stability observed from summer 2016 was accompanied by a major slowdown of the bedload transport (Fig. 5): the mean distance covered by the mobilized tracers between June 2016 and February 2017 was 17 m (25 m/year), despite the occurrence of multiple flood events during that time interval (Fig. 5).

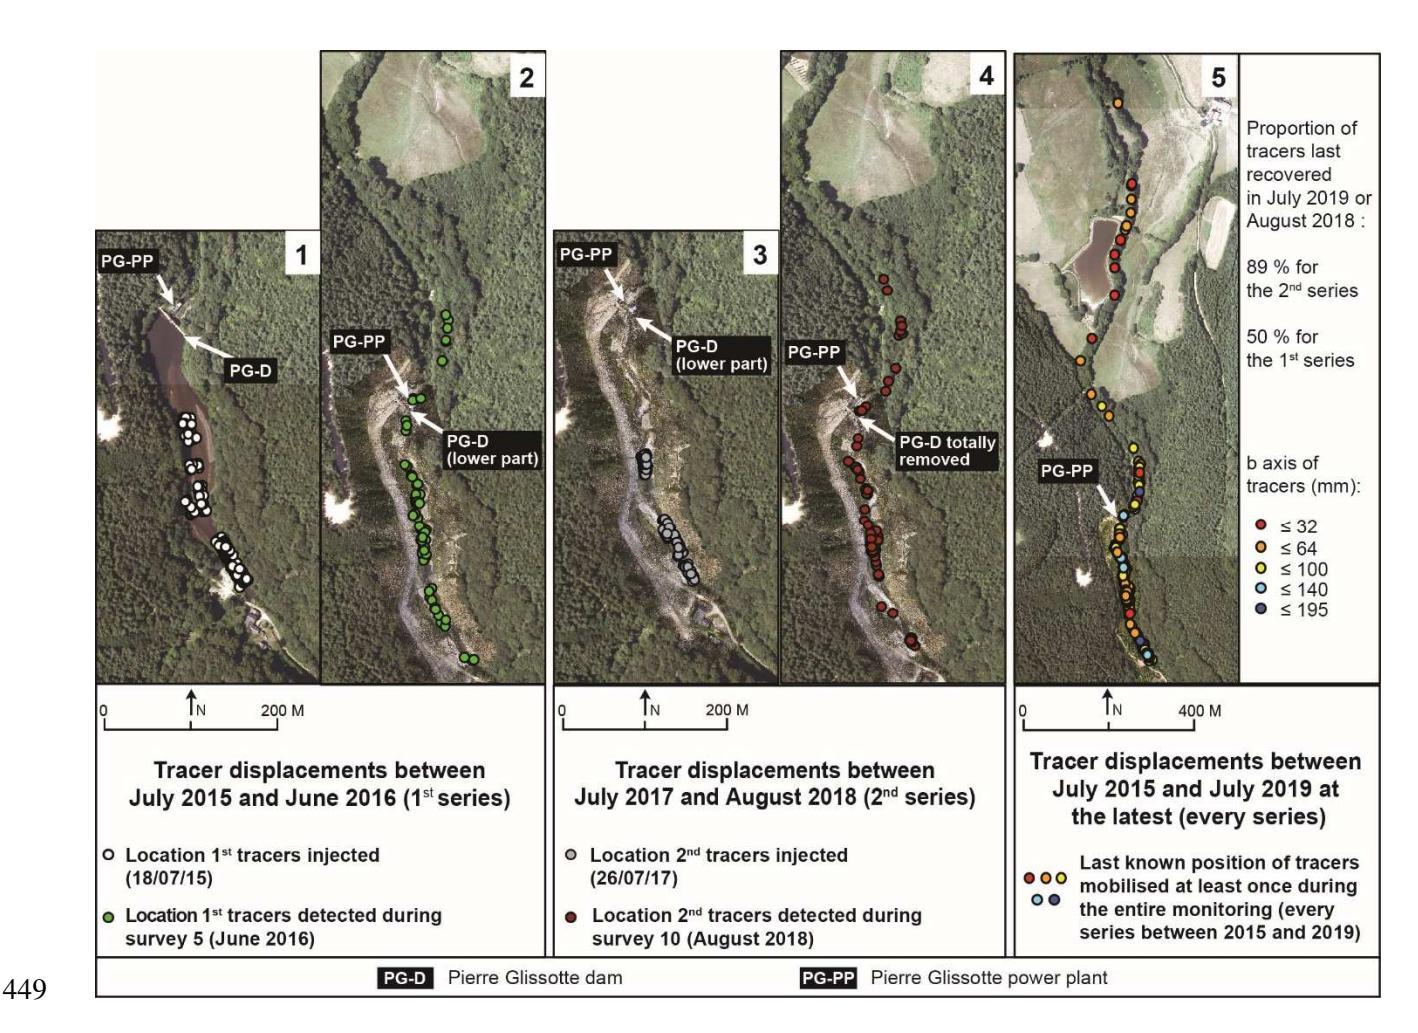
Fig. 6 Positions of RFID tracers at different phases of the Pierre Glissotte removal.

416 The remarkable morphogenic activity in the first nine months following the first removal phase is clearly 417 visible when the results of the bedload tracers at Pierre Glissotte are compared with those at the undisturbed 418 sites, U and D (Fig. 5A-B). The distance is shorter and the velocity recorded at the control sites in the same period is significantly weaker: e.g., the bedload velocity was 36 m/year at U, and 71 m/year at D, between 419 April 2015 (U) - August 2015 (D) and May 2016. Also, for comparable hydrological conditions during the 9 420 421 months following the first removal step, bedload displacements appear more important at Pierre Glissotte. 422 Between February and June 2016, a first decrease in the mobility of the Pierre Glissotte tracers was observed 423 but the mean displacement velocity was still high (Fig. 5B). In total, between the 1st injection and June 2016, the mean distance travelled by mobile tracers was 123 m (134 m/y) (Fig. 6, photographs 1-2). 424

Following the reactivation of bedload transport, the formation of the channel was accompanied by an increase in the particle size of the bed substrate, again in accordance with what has been observed in other cases of dam removal (Pearson et al., 2011; Major et al., 2012). A shift from fine (< 2 mm) or slightly coarse (< 8 mm) grain size to a gravel bed was, for instance, observed in the Souhegan River (Pearson et al., 2011) following the removal of Merrimack Dam. Though at the Merrimack Dam, a stage of refinement was initially observed over the 300-350 m stretch upstream of the dam. At Pierre Glissotte, all the coarse fractions present at the tail and in the reservoir were very quickly remobilized and travelled the entire lengthof the reservoir (400 m) in just a few months (Fig. 6, photographs 1-2).

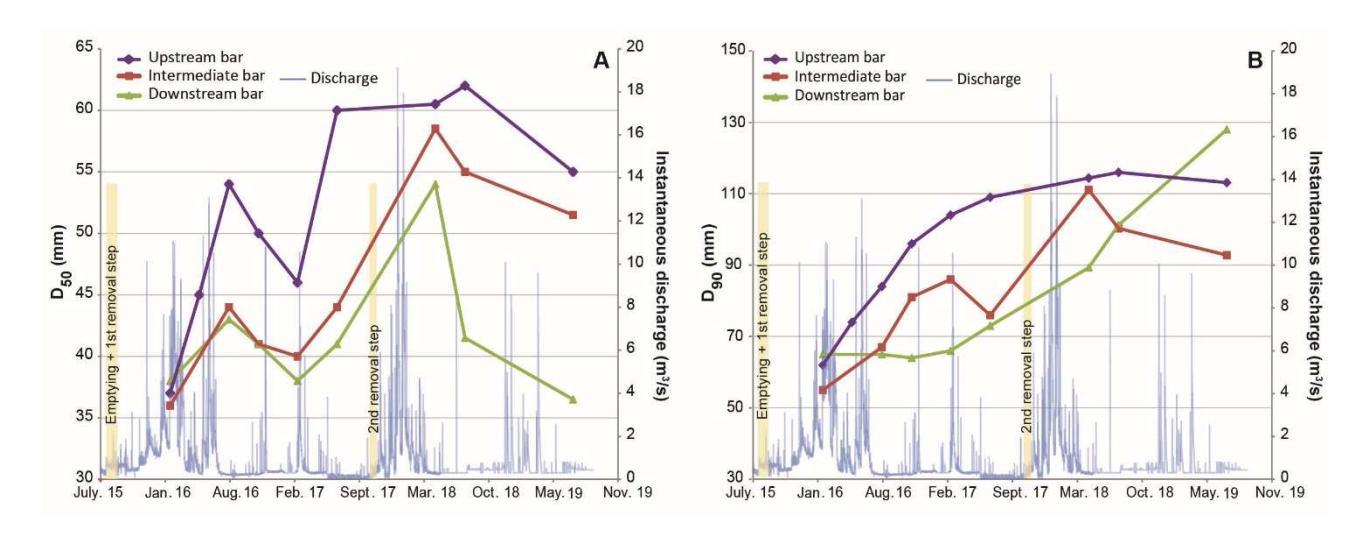
Fig. 7 Changes in grain size distribution of three gravel bars located in the former Pierre Glissotte
reservoir. A. Changes at D₅₀; B. Changes at D₉₀.

decrease in median diameter was particularly strong in the case of the downstream bar (Fig. 7A) when its D₉₀, which had changed very little after the first stage of work, increased very rapidly from September 2017 on (Fig. 7B). This downstream bar thus appeared to be becoming more heterogeneous, probably due to the departure of its intermediate size fraction.

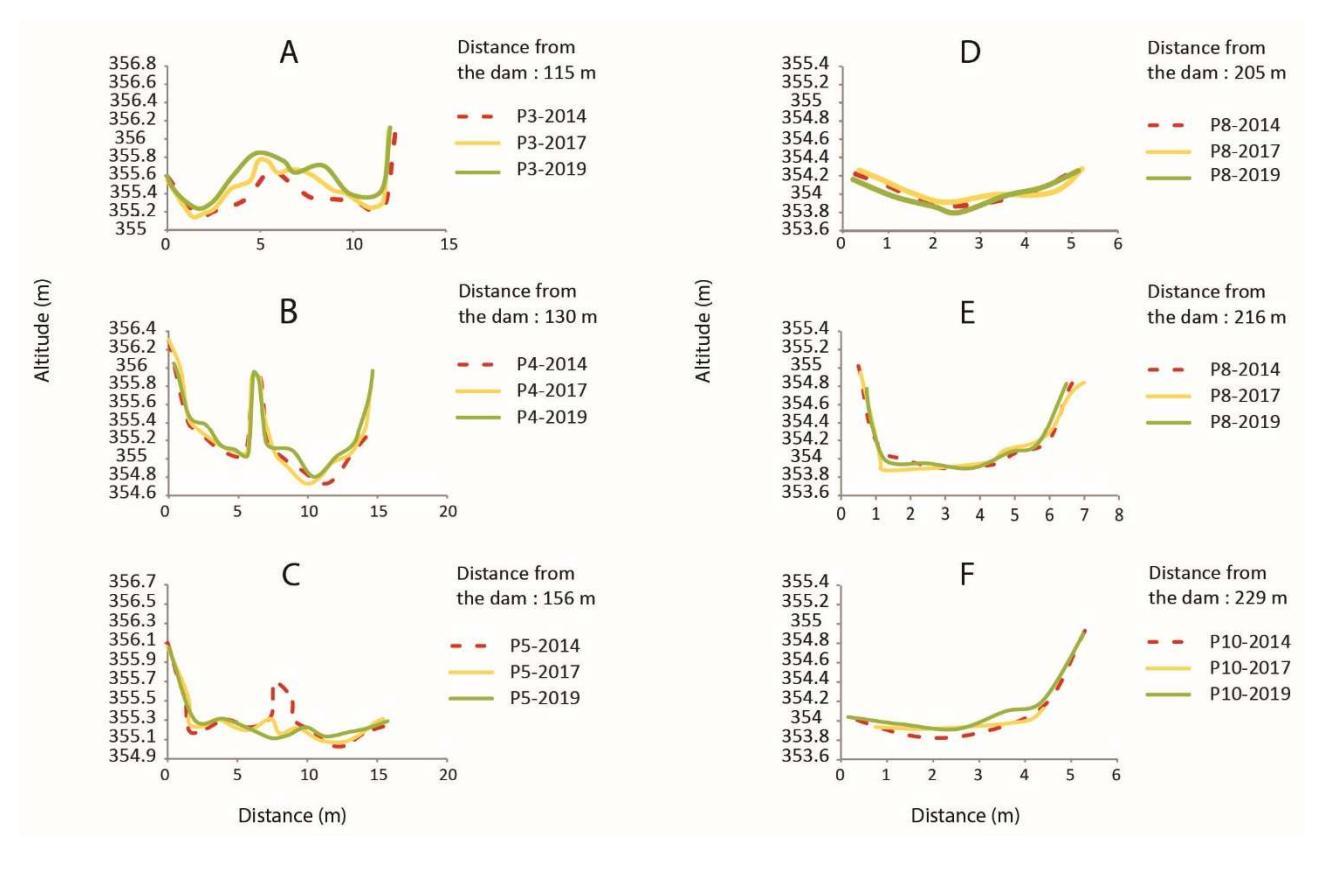
Fig. 8 Series of cross-sectional profiles downstream of the former Pierre Glissotte dam (Rd sub-reach)
 in 2014, 2017 and 2019.

A comparison of the long profile before the removal of the dam with those surveyed in 2017 (after the 1st stage) and in 2019 (after the 2nd stage), over a length of 315 m downstream from the dam, confirmed the absence of significant deposits and generalized bed elevation (Fig. 3). The vertical variations are rather positive, indicating the formation of small gravel deposits. However, in the last survey in 2019 they were still fairly limited (< 30 cm). These small bars, or rather gravel and pebble patches, were actually more present 521 between 2017 and 2019 than after the first stage of the restoration operation. Comparison of cross-sections 522 surveyed in 2014, 2017 and 2019 confirm our observations up to 2019 (Fig. 8, see also Fig. 2 for location). 523 The morphological changes consisted mainly in a few areas of limited aggradation (< 40 cm). These 524 aggraded sections were mainly either on median or mid-channel bars that already existed before the dam was removed (Fig. 8A), or near the banks (Fig. 8F). Also, like the long profile, some vertical adjustments appear 525 to have continued between 2017 and 2019 (Fig. 8A, 8C, 8F). Some changes are still complex to interpret as 526 cross-sections show both aggradation and bed degradation (Fig. 8C), changing dynamics (Fig. 8D) or an 527 528 almost unchanging situation (Fig. 8E). Considering the substrate, the comparison of two surface grain size campaigns carried out 160 m downstream of the former dam, in September 2018 and October 2019, tends to 529 530 underline the limited nature of the textural adjustments: the D_{50} only increased from 73.5 to 79.5 mm and the 531 D₉₀ decreased from 250 to 241 mm.

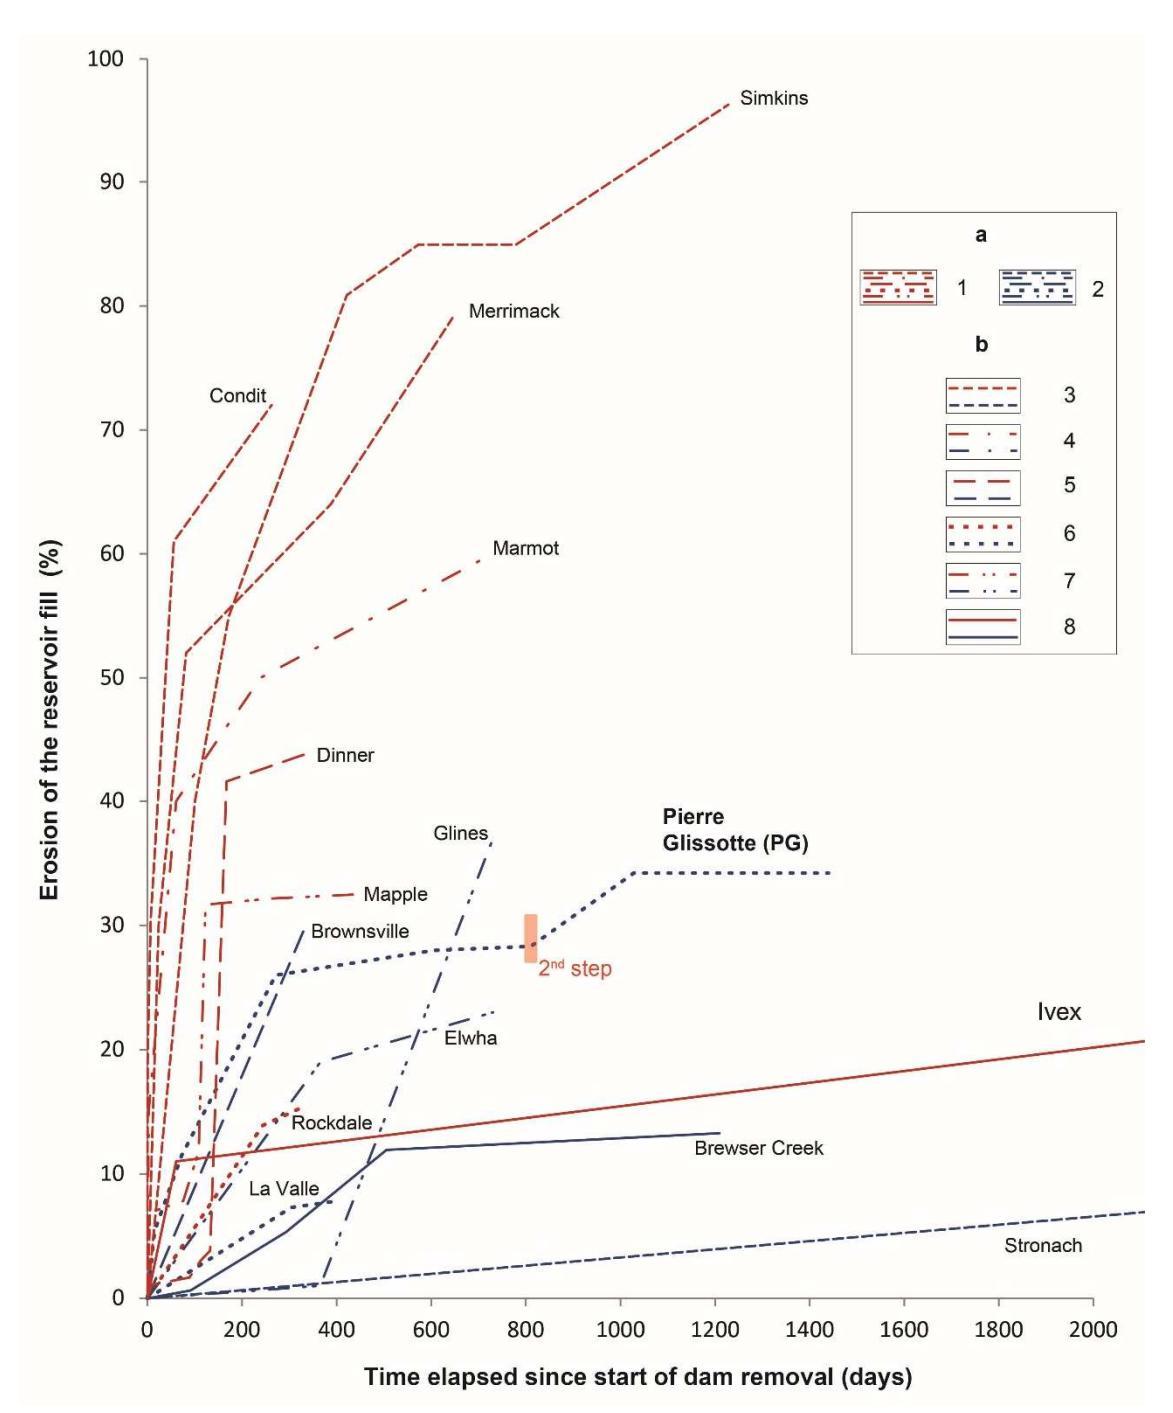
- Fig. 9 Comparison of the erosional velocity of reservoirs following removal projects (Sawaske et Freyberg, 2012; Lewis et Grant, 2015, modified). After: Doyle et al., 2003; Stewart, 2006;
 Evans, 2007; Straub, 2007; Burroughs et al., 2009; Walter & Tullos, 2010; Pearson et al., 2011;
 Major et al., 2012; Randle et al., 2015; Collins et al., 2017).

- a. Type of dam removal: 1. Rapid removal; 2. Staged removal; b. Main sedimentary composition of the
- reservoir; 3. Dominance of sands; 4. Non-cohesive mixed sediments (sands and coarse material); 5. Coarse
 material (> 2mm); 6. Mixed fine sediments (sand, mud); 7. Mixed sediments (mud, sands and coarse material); 8. Mud.

- 575
- 576 A closer look at the Pierre Glissotte situation shows that the very rapid erosion that occurs in the reservoir
- 577 directly after the lowering of the 3 upper meters of the dam is favored by the non-cohesive nature of the

The same cycle of intense adjustments followed by the slowing down of erosive activity was observed after the second step of the removal (Fig. 9), though the adjustments recorded were more limited and the active phase was shorter. This may be explained because the channel substrate was coarser but also because of the appearance of large boulders that play the role of local base level. These blocks are multi-decimetric to metric and, together with some bedrock outcrops, slowed down the vertical erosion. Indeed, other studies have shown that these hard areas (or other materials that are more cohesive and resistant than the previously
