Dynamics of Land Use And Its Impacts In Kintele Urban Municipality: Degradation And Land Loss Through Gullying (Republic Of Congo)

Idriss Auguste Williams Mbouka Milandou. Dynamics of Land Use And Its Impacts In Kintele Urban Municipality: Degradation And Land Loss Through Gullying (Republic Of Congo). International Journal of Scientific Engineering and Applied Science (IJSEAS), 2021, 7 (8), pp.223-240. hal-03348050

The degradation and loss of land through gullying in Kintélé is largely due to the dynamics of land use. This study shows that in 30 years (1989 - 2019), land degradation and loss only started in 2016. In 1989, the bare/occupied land class was almost non-existent, but in 2019, with the influx of people from Brazzaville, it increased to almost 3,000 ha. This anthropic pressure on land is aggravated by 15 ravines unevenly distributed in 12 districts of the commune. The total volume of the void left is 2,800,000 m3, equivalent to 4,480,000 tonnes of land destroyed and lost. In this context, human settlements and activities are affected. But like the "land use" factor, the sensitivity of the physical environment plays an important role, due to the fact that the soils are

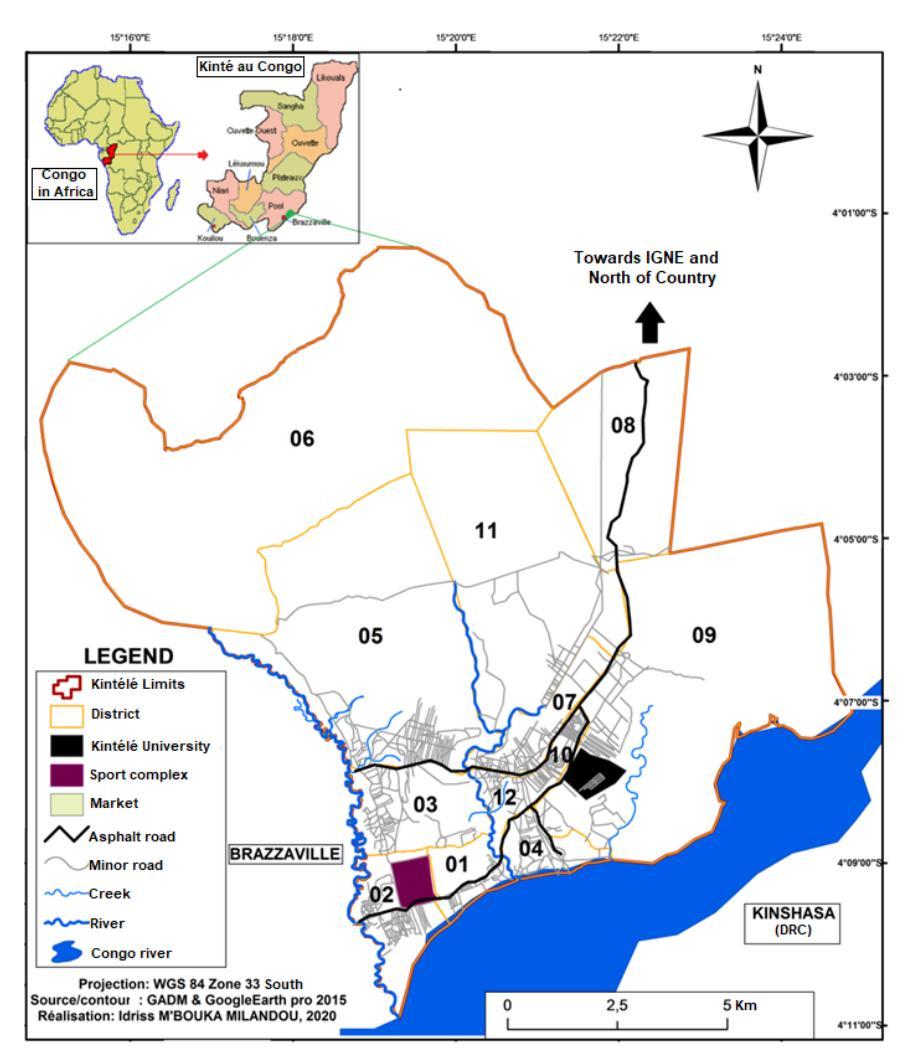
Figure 1: Situation and limits of the urban commune of Kintélé © I.A.W. M'BOUKA MILANDOU

Located in the Pool department, the town of Kintélé covers an area of approximately 154.60 km² (15,460 ha). It is bounded to the north and north-east by the administrative centre of Igné, to which it was attached as a village until 2016, before being erected as an urban commune in 2017 (Law No. 14-2017, of 16 March 2017), to the south by the Congo River, to the north-west by the sub-prefecture of Goma tsé-tsé and to the south-west by the department of Brazzaville (Figure 1).

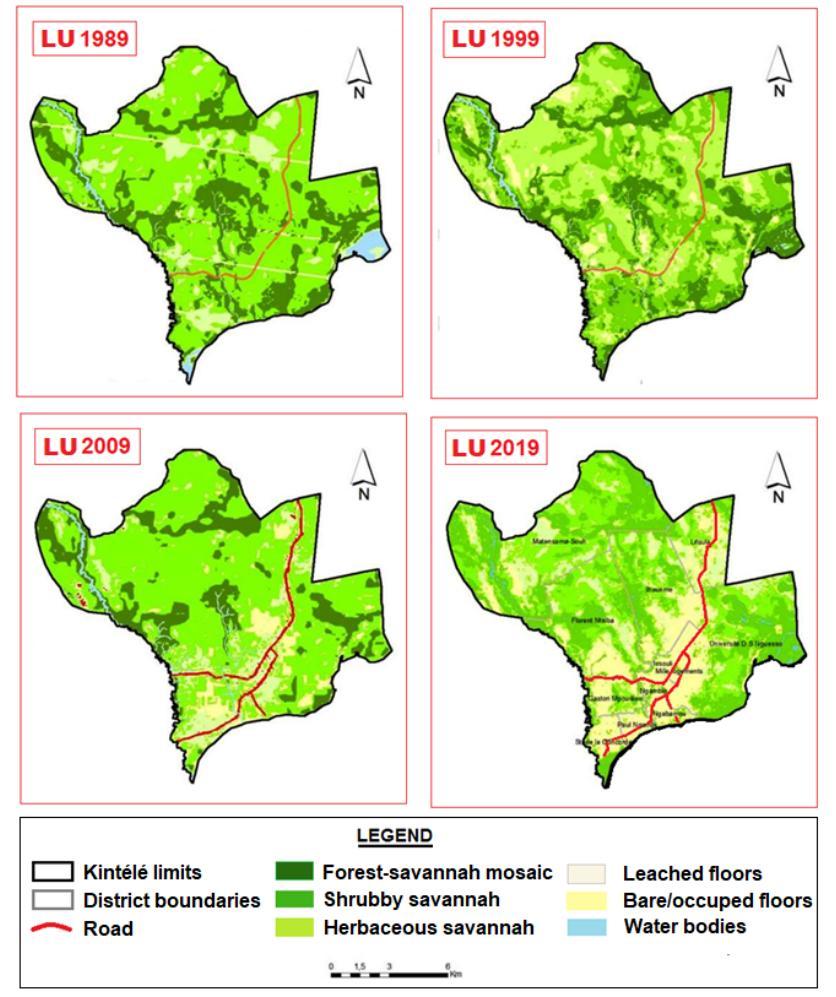
Figure 2: Diachronic evolution of land use at Kintélé from 1989 to 2019 © Idriss M'BOUKA MILANDOU

Figure 2 illustrates the diachronic land use in Kintélé from 1989, 1999, 2009 and 2019, i.e. 30 years. The maps clearly show the change in the site when it was a grouping of small villages from 1989 to 1999. From 2009 onwards, the landscape was quite different from previous years thanks to the development of several tourist places (hotels, bars, etc.) without, however, the locality being erected as an urban commune. But in 2019, two years after the creation of the urban commune, the landscape changed with the dynamics of land use by the populations from Brazzaville and elsewhere (Igné, etc.).

The analysis of the 2009 and 2019 LU maps shows a strong dynamic in the occupation of space (Figure 2). The visual comparison of the two classifications indicates significant changes. From a purely statistical point of view, we cannot conclude definitive results because the proportion of pixels masked by clouds and their shadows is too high. During this period a recovery of the FSM on nature was observed, with an increase of 1943.66 ha and a Rc of 70.81%. This reflects the abandonment of certain sites at risk of erosion by the authorities from 2017 onwards, when Kintélé was decreed an "urban commune" (Table 5, Figure 5). Those who acquired plots of land or estates abandoned them waiting to be exploited later. The SS disappeared and the HS regressed thanks to the many public building sites (sports complex, university, etc.) but also many private dwellings. The leached soils have again increased by 1090.28 ha, i.e. a Rc of 177.57%. They are coupled with the BOF, which also progressed by 2008, 73 ha, i.e. a Rc of 60.29%, thus explaining the strong urban growth, relative to the demographic growth of the commune.

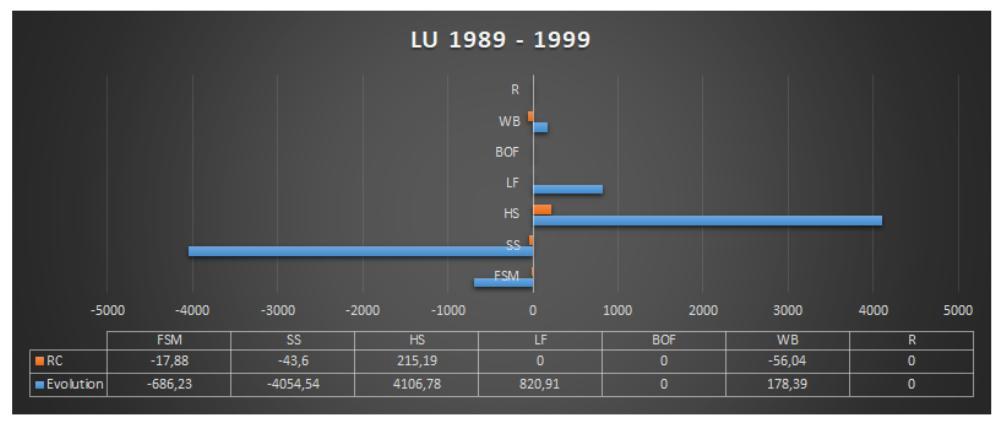
Figure 3: Overview of LU changes observed during the period 1989-1999 © I.A.W. M'BOUKA MILANDOU

The period from 1989 - 1999 (10 years), represents a period when Kintélé was still a village in the sub-prefecture of Igné. It comprised a group of small villages along the Congo River. In this respect, analysis of land use between 1989 and 1999 shows that the study area has nevertheless undergone a change in landscape. This observation comes first from direct observation of the 1989 and 1999 LU maps (Figure 2). A visual comparison of the two classifications shows some changes. From a purely statistical point of view, we cannot conclude definitive results because the proportion of pixels obscured by clouds and their shadows is too high (Table 2, Figure 3).

There is a loss of area (regression) is observed for the FSM class, since S is equal to -686.23 ha. This regression is proportional to the Rc, which also has a negative value, i.e. -17.88% also expressing a regression. This situation is the same for the SS class, where S is -4054.64 ha and Rc is -43.60%, as well as for the WB class, where -178.39 ha represents the regressive evolution value and Tc is equal to -56.04%. The regressive evolution of the FSM and SS classes can be explained by the pressure exerted at that time by the rural population on natural resources, in particular the plant cover for firewood, wood for the construction of huts and for the manufacture of charcoal. Agricultural activities based on cassava were not too developed. As for the class of WBs characterised by rivers, streams and springs, they have regressed due to the drying up of certain springs, according to the testimonies of the populations. On the other hand, the HS class has evolved from 4106.18 ha, i.e. a Rc of 215.19%. This explains the colonisation of the herbaceous savannah instead of the forest-savanna mosaic and shrubby

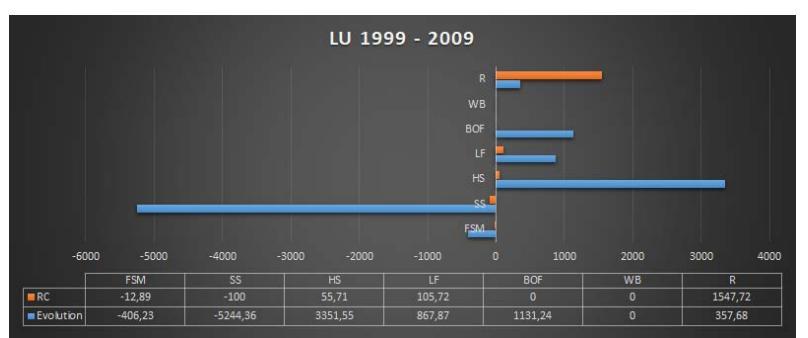
Figure 4: balance of LU changes observed during the period 1999-2009 © I.A.W. M'BOUKA MILANDOU

The analysis of land use between the years 1999 and 2009 shows that the study area has undergone a change in landscape. This finding is based primarily on direct observation of the 1999 and 2009 LU maps (Figure 2). A visual comparison of the two classifications shows some changes. From a purely statistical point of view, we cannot conclude definitive results because the proportion of pixels obscured by clouds and their shadows is too high (Table 3 and Figure 4).

But this period continues to mark the regression of the FSM, i.e. -406.48 ha and a Rc of -12.89%, followed by the SS which has practically disappeared and a regression Rc of -100%. This still explains the pressure exerted by the resident populations of the villages on the FSM and SS for the needs explained above. But during this period, it should be noted that several tourist sites were already beginning to emerge and these attracted many people for tourism but also for the purchase of estates and plots of land.... the aggressiveness on human resources was growing. But the herbaceous savannah continued to progress with 3351.55 ha in 10 years, occupying the spaces left by the FSM and the SS, with a Rc of 55.71%. The LF also progressed by 867.87 ha, i.e. a Rc of 105.7%. SNOs were noticed during this period, since, as announced above, the populations were already beginning to occupy the site. In 2009 this BOF class was 1131.24ha. As for the WBs, they remained stable from 1999 to 2009, with 139.93 ha occupied. Roads have increased by 357.68 ha or a Rc of 1547.79%. This reflects the development of roads and/or dirt tracks for access to tourist sites, in addition to the NR2 which already existed.

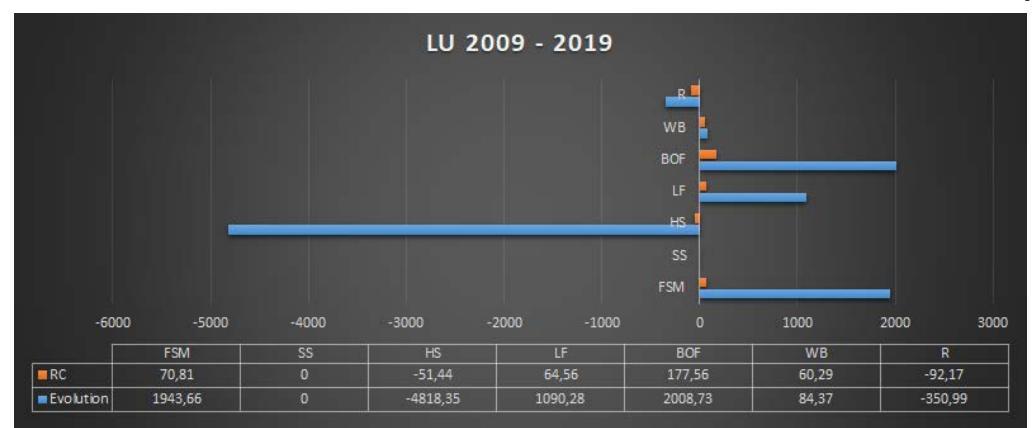
Figure 5: balance of LU changes observed during the 2009-2019 period © I.A.W. M'BOUKA MILANDOU

WBs decreased by 84.37 ha, or 60.29% of Rc. This situation reflects the disappearance of many rivers or their sedimentation. This phenomenon is due to the large amount of eroded land on the slopes and flanks that come to be deposited in the watercourses, with consequences that will be discussed below.

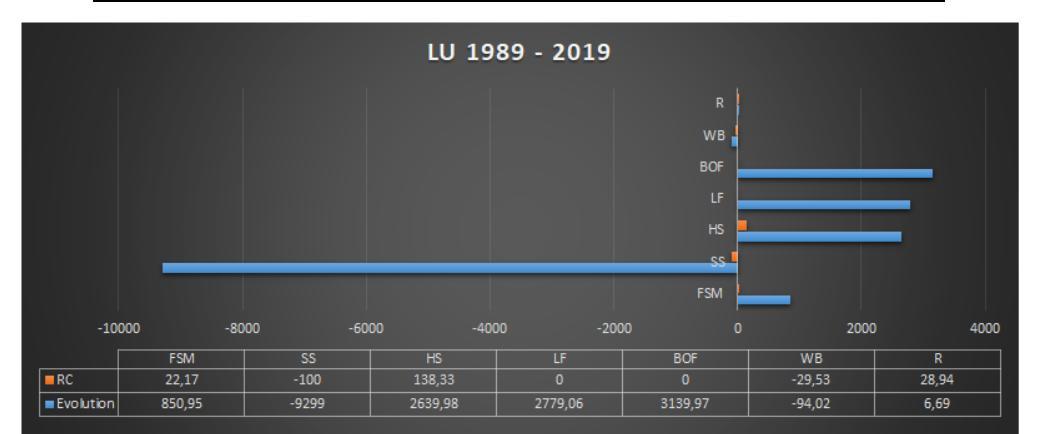
Figure 6: Summary assessment of LU changes observed during the period 1989-2019 © I.A.W. M'BOUKA MILANDOU

This synthesis shows the evolution and the rate of change in 30 years, from 1989 to 2019, in order to really analyse the progressions, stagnations and regressions of LU classes at Kintélé. Table 6 and Figure 6 show this trend.

The results show that in general, from 1989 to 2019, there has been more progress than regression and stagnation of LU classes. The FSM evolved from 850.95 ha, i.e. a Rc of 22.17%, thus showing a slight recovery of the forest-savanna mosaic despite the heavy occupation of the land in this commune, since if in 1989 the FSM area was 3837.43 ha, it evolved to 4688.38 ha.

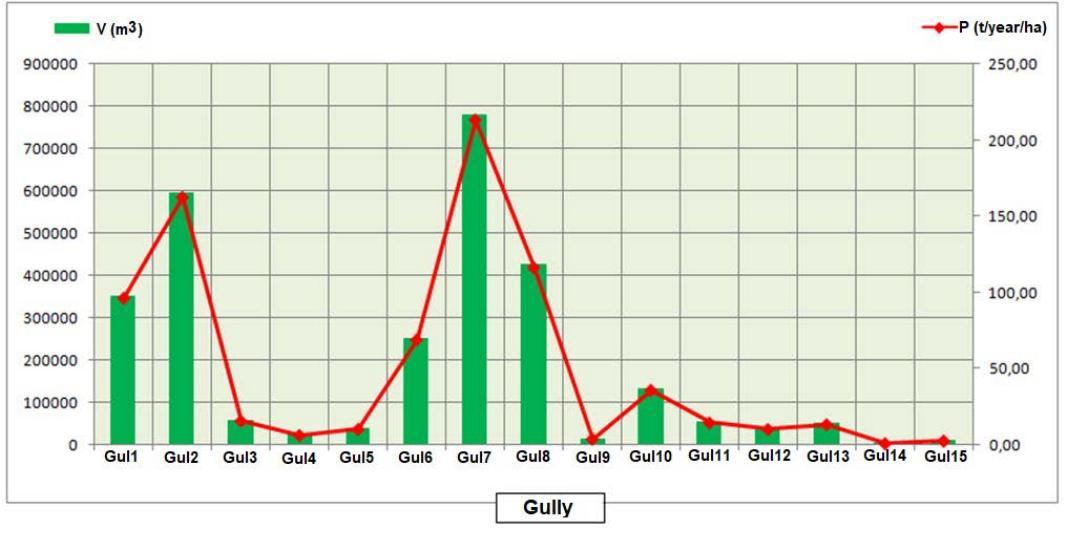
Figure 7: Volume of gully voids and amount of land destroyed and lost in tons/year/ha © Idriss M'BOUKA MILANDOU

Table 7, Figures 7 and 8 show the volumes of gullies and the loss of land, as well as the location of the different points of erosion.

The largest gullies are those with a void volume of more than 400,000 m³, namely Gul7, Gul2, Gul8, Gul1 and Gul6. They respectively have void volumes of 777,166 m³ for Gul7, equivalent to 212.92 tonnes/year/ha of land destroyed and lost, or a total of 1,243,465.74 tonnes since 2016; 591,961.165 m3 for Gul2, equivalent to almost 947,137.86 tonnes of land destroyed and lost since 2016, is equivalent to 162.18 tonnes/year/ha; 423,771.27 m³ for Gul8, for a destruction and loss of land of around 678,034.03 tonnes since 2016, or 116.10 tonnes/year/ha; 350,518.98 m³ of volume equivalent to 96 tonnes/year/ha since 2016, or a total of 560,830.37 tonnes; finally for Gul6, a volume of 250,943.905 m³ was recorded, for 401,510.25 tonnes of land destroyed and lost since 2016, or 68.75 tonnes/year/ha (Figure 7). Gully 10, which follows the first 5, has a volume of 130,459.77 m³ and has caused the destruction and loss of around 208,735.63 tonnes of land, i.e. 52,183.91 tonnes/year/ha (Table 7, Figure 7).

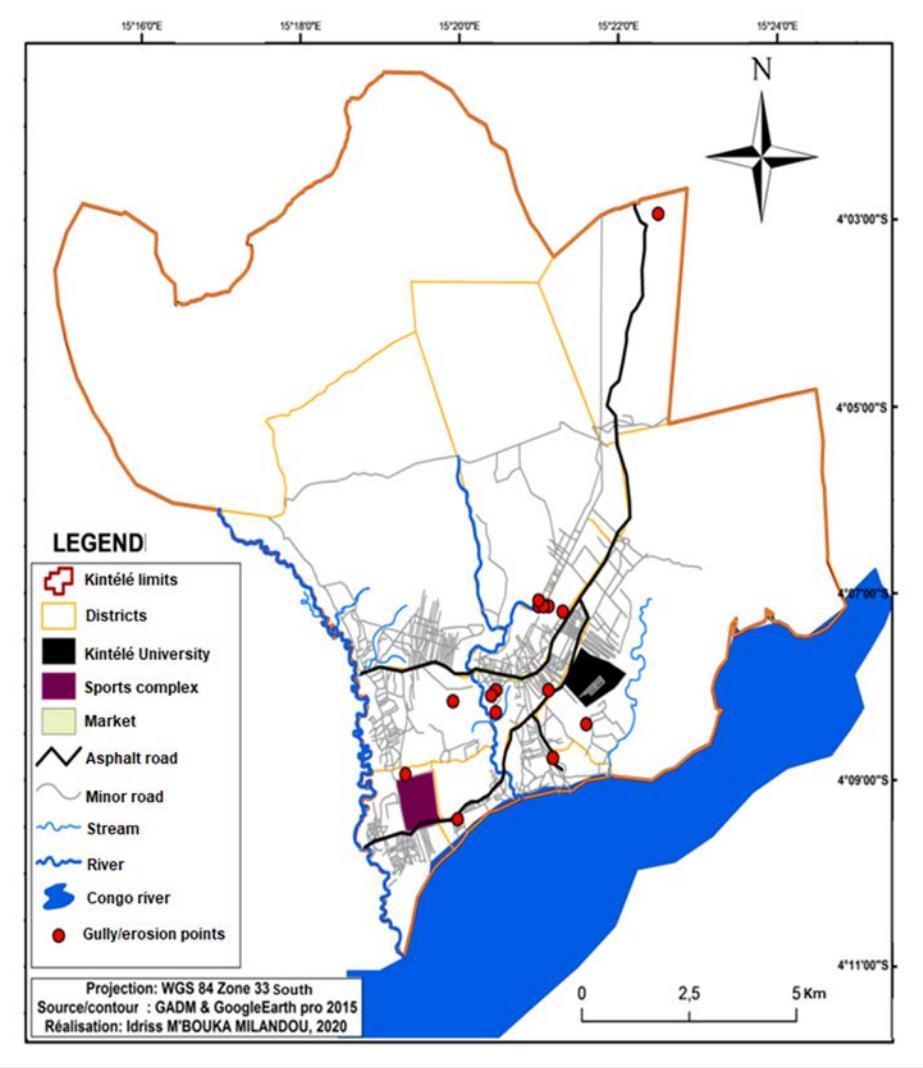
Figure 8: Current location of the different erosion points at Kintélé in 2019 © Idriss M'BOUKA MILANDOU

These ravines also affect the habitat, the urban road system and some plantations in 5 districts (Figure 8): Issouli, Stade de la Concorde, Gaston Mpouiloulou, Ngabamou and D.S. Nguesso University. This gully density seems to be related to the population in these neighbourhoods, since those with lower populations are also less affected.

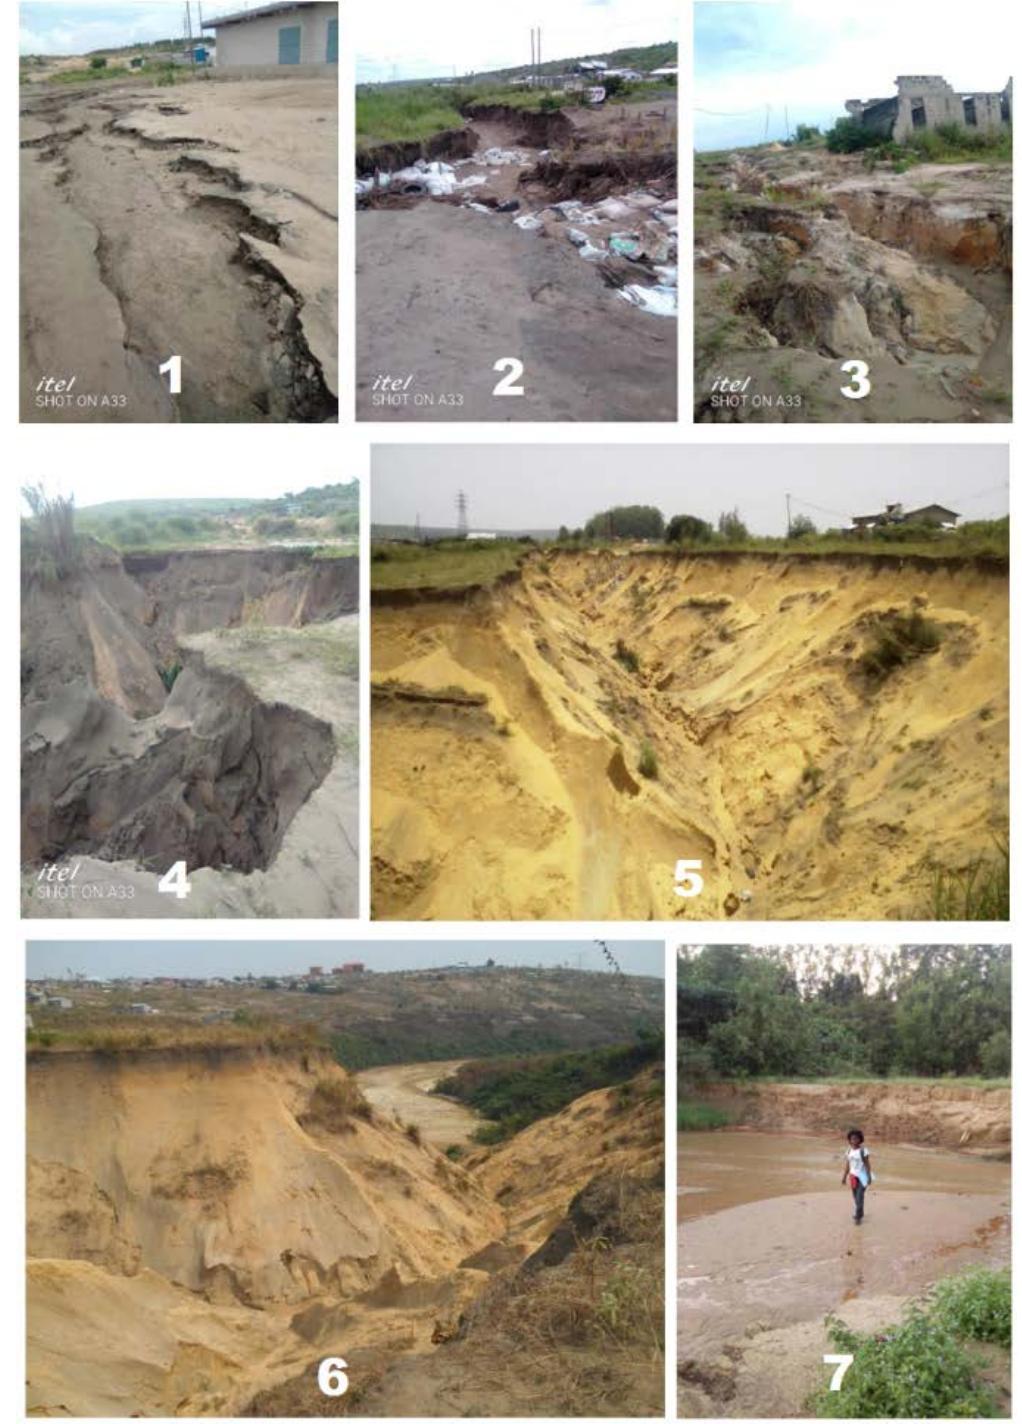
PLATE: FORMS OF DEGRADATION AND LOSS IN KINTELE LAND

Photo 1: gully scraping the soil from the plot to the alley, photos 2 and 3: gullies affecting the earthen avenues and endangering the habitat. It can be seen that in photo 2, there was an attempt to treat the shape with the bagged device filled with earth, but it was overflowed and dragged into the gully floor; photo 4: piriform gully; photo 5: giant V-shaped gully; photo 6: view of a giant gully and the alluvial plain showing the sedimentation of the river, in the 1000 housing estate; photo 7: sedimentation of a stream by the destroyed and eroded land upstream. © Idriss M'bouka Milandou, 2018-2019

Initially, these forms are piriform gullies that scour the soil (Photo 1), then, due to lack of treatment, they evolve into gullies (Photos 2 and 3). The gully evolves into a gully (Photo 4) which can be piriform, polylobate or not, when no treatment measures have been taken. Sometimes attempts at mitigation have been effective, but the quality of the treatment devices is either not effective or sometimes not maintained. This situation is at the root of the formation of the large ravines in Kintélé, according to testimonies from the living populations in the areas already affected.

These ravines are V-shaped (Photo 5), although some exceptions have been noted with a flat floor of less than 1 metre. However, this is due to the anthropisation of these ravines, transforming the floors into tracks or paths to access difficult places. The V-shaped gully shape is due to the dominance of the Batéké sands, which are loose rocks that cannot stabilise to facilitate the formation of a floor greater than or equal to 1 metre. The sandy nature of the rocks facilitates the transfer of sediment from the destroyed land.

The latter is deposited and accumulates in large quantities in the mostly drained shallows, thus we can observe the phenomenon of strong sedimentation that affects the watercourses of the municipality (Photo 6), with serious consequences on the environment, notably the reduction of the LU classes of the water bodies, by the clogging of springs and the sedimentation of rivers and streams (Photos 6 and 7).
