Investigation of the Interaction of Ultrasound with Plate Heat Exchanger

A study on ultrasonic wave propagation and interaction with plate heat exchanger

P. Dubey ^{a,b} et N.F. Declercq ^{a,b} ^a Georgia Tech-CNRS IRL2958, Georgia Tech Lorraine, 2 Rue Marconi, 57070 Metz, France ^b School of Mechanical Engineering. Georgia Institute of Technology, 30332 Atlanta, Georgia, USA

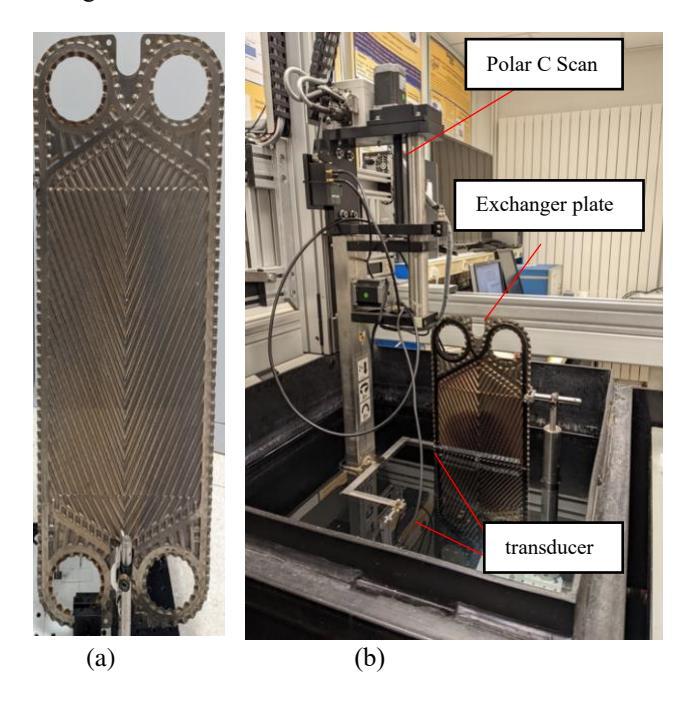
Figure 1 - (a) Image of a titane heat exchanger plate (b) Experimental setup for the linear ultrasound experiment showing the heat exchanger plate immersed in the water tank and emitter and receiver transducer to emit and acquire the signal, respectively.

Previous studies have reported using different mechanical and chemical mitigation methods for designing heat exchangers to reduce fouling in the plates [2]. A typical plate heat exchanger with a flow from the bottom left hole to the top right hole is as shown in Figure 1. Studies of crystallization fouling show that the scale formation pattern differs with increased CaSO4 concentration, wall temperature, and flow velocity [3]. Thus, designing plate patterns with taking into account all the above factors becomes much more complicated.

The pulser sends pulses with a frequency of 1 MHz frequency and an input voltage of 250 V. The Polar C Scanner carries out a 2D scanning of the plate. The acoustic pressure waves interact with the plate and are transmitted and/or reflected. The transmitted pulse is received by another transducer of the same centre frequency (1 MHz). The receiver transducer is placed on the opposite side of the heat exchanger plate, as shown in Figure 1(b).

Figure 1(b) shows an experimental setup for the experiment. The time of arrival of the transmitted signal for both samples is analysed. Also, the corresponding amplitude of the time domain peak is plotted. Furthermore, the spectrum of the received signal by transducer is compared to monitor any change in the regions with fouling and without fouling.

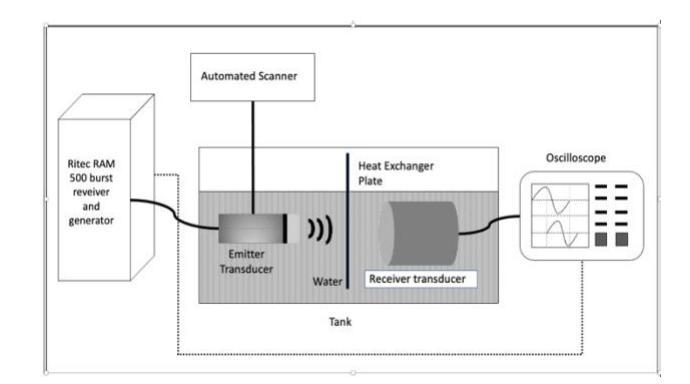
Figure 2 – Schematic for SHG through thickness setup with longitudnal waves to probe the heat exchanger plate.

Figure 2 shows the experimental setup of throughthickness investigation of longitudinal ultrasound waves using the SHG technique. A very high input voltage is provided to the transducer with the help of the RITEC system in order to visualize non-linear effect. For a 1 MHz sinusoidal input, the voltage obtained from RITEC is 760 pp Volts (with gated amplifier gain of 50) and 1980 p-p Volts (with gated amplifier gain of 100). The high voltage input is fed to the transducer from the RITEC.

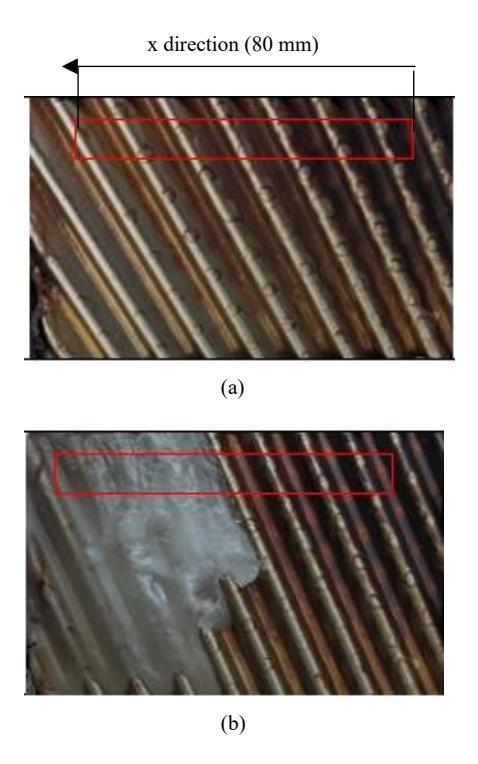
Figure 3 - (a) Sample 1 with no wax deposit on the heat exchanger plate. (b) Sample 2 with wax deposit on the heat exchanger plate. The highlighted area under investigation is 80mmx10mm with position x measured from right to left of the image shown by the arrow.

A heat exchanger plate made up of titan with a grove thickness of 4 mm is used for the experiments. A small area of 80mm x 10mm is considered for the investigation. The area under investigation is highlighted in red for the samples (fig 3(a) and fig 3(b)). Two samples are prepared to study the effect of the foulant. Sample 1 without a layer of foulant (fig 3 (a)) and sample 2 with a 4mm layer of foulant (paraffin wax) present in 50% of the area (position of wax starts approximately from x = 40 mm) (fig 3(b)). According to one of the promising pieces of literature, the use of paraffin wax to mimic an industrial deposit [20].

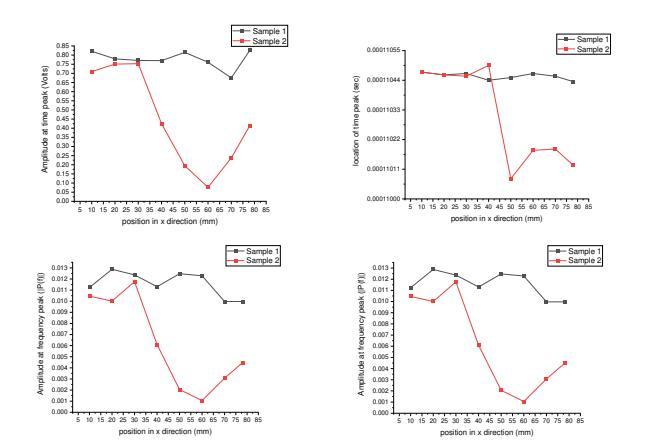
Figure 4 - (a) Time-domain plots showing the peak amplitude of the received signal (Top left) and (b) location of the time domain peak (Top right). Frequency domain plots showing (c) the amplitude of the frequency peak at 1MHz (Bottom left) and (d) the location of the corresponding peak (Bottom right) for sample 1 and sample 2.

As expected, the peak amplitude of the received timedomain signal changes with a layer of wax. The change in amplitude is more than 60% (Figure 4(a)). However, the location of the time peak does not vary significantly, and the deviation was found to be approximately 0.27% (Figure 4(b)).

The amplitude of the fundamental peak (1MHz) in the frequency spectrum shows a 27% decrease (Figure 4(c)). However, the location of the frequency peak was inconsistent in the region of wax deposition and deviated around 0.89 MHz to 0.91 MHz (Figure 4(d)). As predicted, the energy plot obtained depicts the reduction in the energy for sample 2 compared to sample 1.

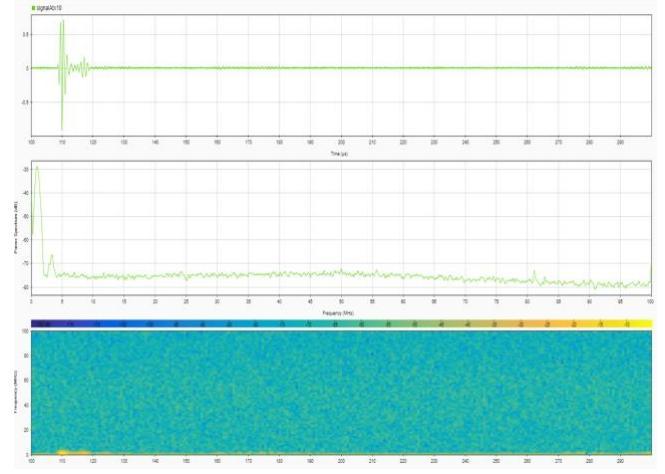
Figure 5 – Linear investigation plots showing the time signal, frequency spectrum and time-frequency plots for point at 10 mm (without wax region) for sample 2

To gain insight into the effect of ultrasound, the plots for the time signal, frequency spectrum, and time-frequency for sample 2 at point 10mm (without wax) and 70 mm (with wax) are plotted in Figure 5 and Figure 6, respectively and compared.

Figure 5 and Figure 6 show that a significant change is not visible in the frequency spectrum and on the time-frequency plots for different regions. In contrast, the non-linear investigation shows a significant change in the frequency spectrum for the two regions (Figure 7 and Figure 8). The plots show a significant change in the second harmonic and fourth harmonic with the presence of wax. An interesting

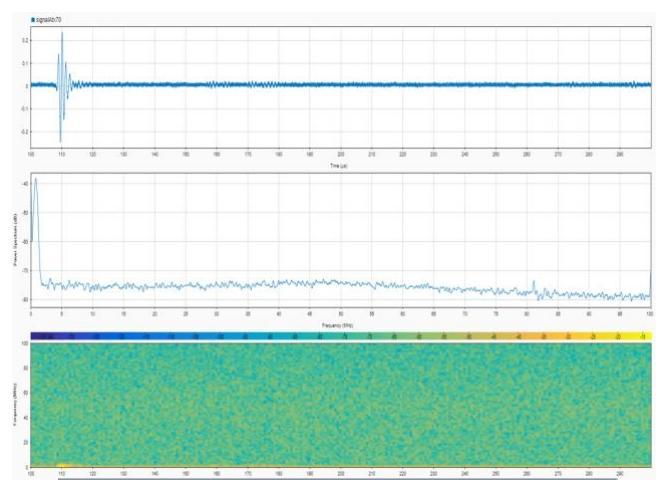
Figure 6 – plot shows the time signal, frequency spectrum, and time-frequency plots for point at 70 mm (withwax region) for sample 2.

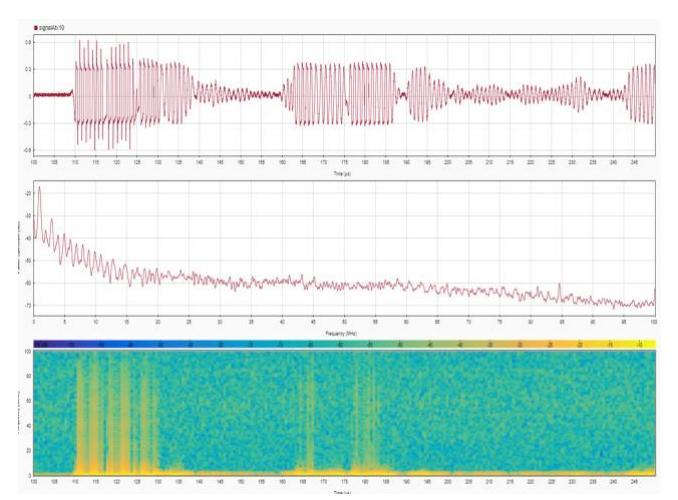
Figure 7 – Plots shows a non-linear investigation for an input voltage of 760 p-p Volts. From top to bottom: time signal, frequency spectrum, and time-frequency plots for the point at 10 mm (without wax region).

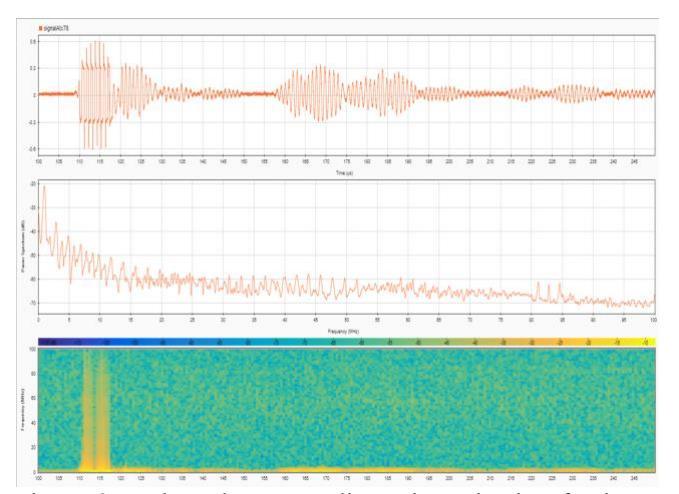
Figure 8 – Plots shows non-linear investigation for input voltage of 760 p-p Volts. From top to bottom : time signal, frequency spectrum and time frequency plot for point at 70 mm (without wax region)

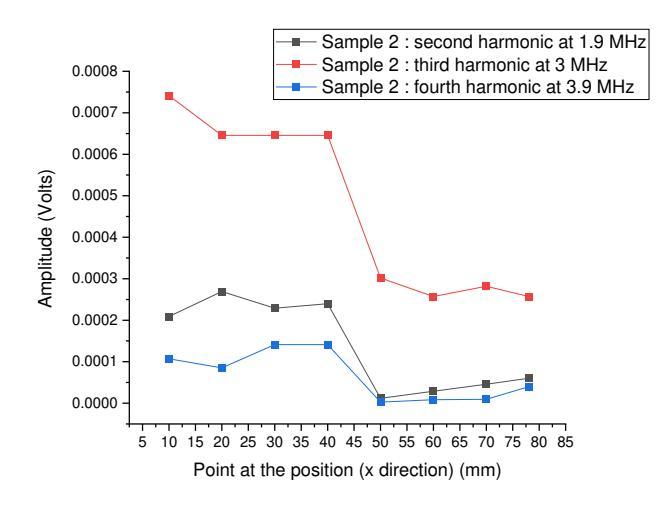
Figure 9 – Amplitude of second, third, and fourth harmonic with input a voltage of 760 p-p Volts showing a decrease in the amplitude with the presence of the layer.

phenomenon is observed relating to the sudden decrease in the second harmonic amplitude for the region with deposition (Figure 9).

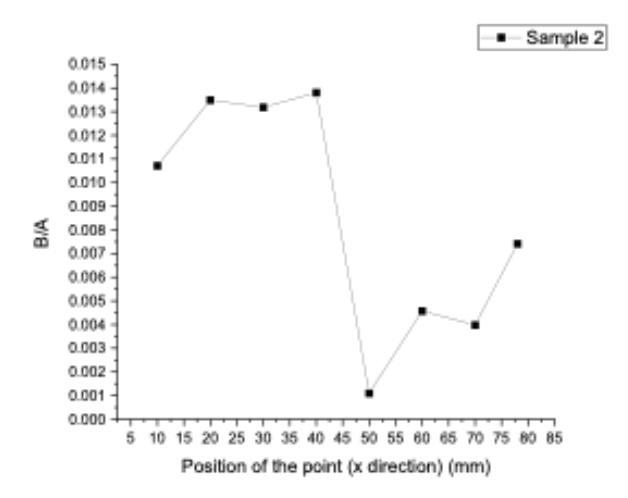
Figure 10 – Calculated B/A for different x positions of the sample 2 with an input voltage of 760 p-p Volts.

In addition, the SHG technique shows a significant decrease in the non-linearity parameter (B/A) due to the presence of wax in the plate (Figure 10). The decrease in B/A is estimated to be roughly 67.85% for the input voltage of 760 p-p. A similar calculation for higher input voltage (1980 p-p) seems consistent with the previous value and is estimated to be 69.23% (Figure 11).

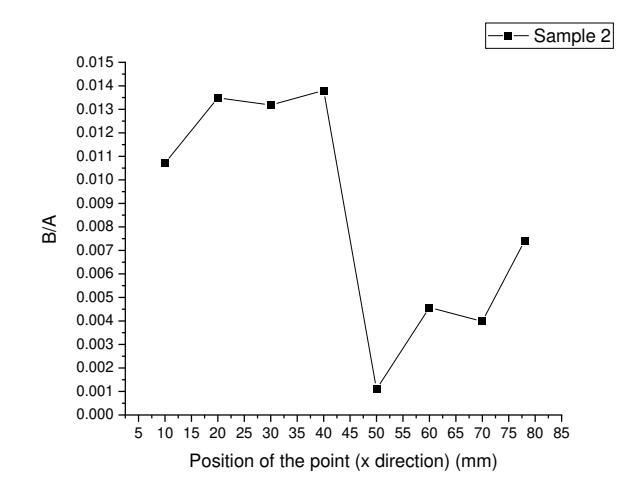
Figure 11 – Calculated B/A for different x positions of the sample 2 with an input voltage of 1980 p-p Volts.
