Monitoring electrically-active defects in silicafilled epoxy using light detection

E. Aubert¹, G. Teyssedre¹, C. Laurent¹ and S. Rowe²
¹Université de Toulouse, LAPLACE, CNRS, INPT, UPS 118, route de Narbonne, Toulouse, 31062, France
²Schneider Electric – Direction des recherches matériaux Rue Henry Tarze - 38050 Grenoble – France E-mail: <u>gilbert.teyssedre@laplace.univ-tlse.fr</u>

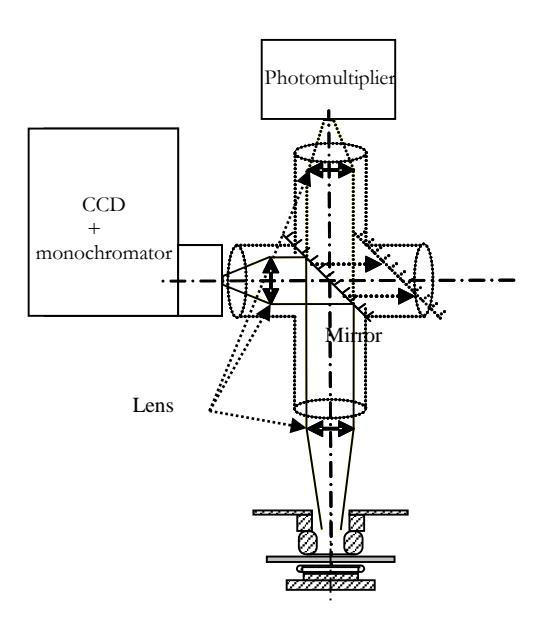
Fig. 2. Arrangement of the experimental set-up

Two brass electrodes are used to make measurements: the lower one is a massive electrode connected to the ground. The upper one is put to the HV; it has a ring shape to allow light detection, cf. Fig. 2. Finally, a mask is put on the ensemble to

Finally, spectral analyses of the light are made with the same CCD, introducing in front of it a grating monochromator. With the grating used (groove density of 133 per mm), the region 285-1000nm is resolved into about 1800 points. As shown in Fig. 2, a mirror installed on a translational guide allows deviating light towards the CCD when such experiments are carried out.

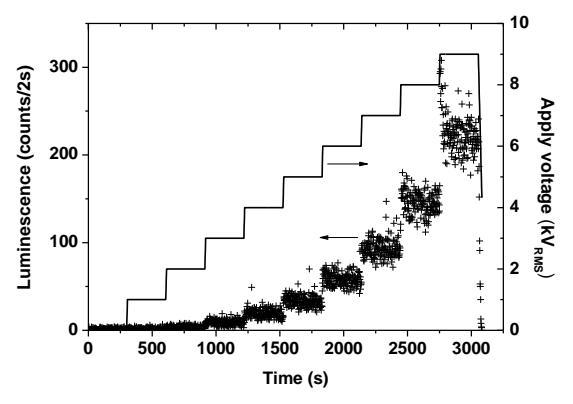
Fig. 3. Example of EL rough data recorded in air. The voltage was increased in steps of 1 kV lasting for 5min, and the PM signal was recorded continuously with a dwelling time of 2s.

Fig. 3, shows a typical measurement of light during increase of the voltage by 1kV steps. Each point represents a number of photons collected during 2 seconds (and converted in a number of pulses – or counts – by the signal conditioning channel). The signal is relatively stable at each voltage level. In what follows, averaged values of the signal at each voltage step will be presented.

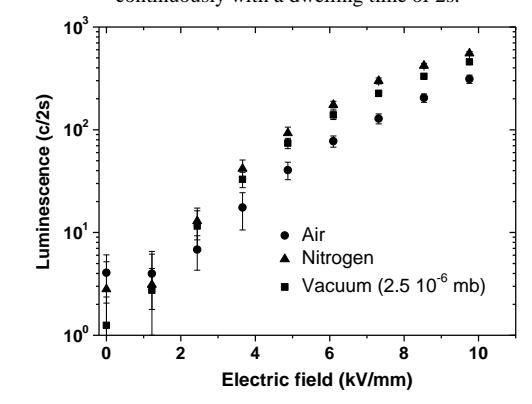
Fig. 4. EL-field characteristics of an unfilled epoxy in different atmosphere.

Through a systematic analysis of the emission for a population of samples, being filled or not, we have evaluated the impact of the atmosphere on the shape of the EL-field characteristic and on the EL level. Fig. 4, shows an example of results obtained for the same sample, in air, nitrogen and vacuum $(2.5 \times 10^{-6} \text{ mb})$. Some differences in the level of light being detected could be observed, depending on the atmosphere; however, there was no systematic trend on the effect of such or such atmosphere when characteristics were smooth. In the example the signal is lower for air and higher for nitrogen. In fact, differences could be observed only when instabilities appear on the characteristics.

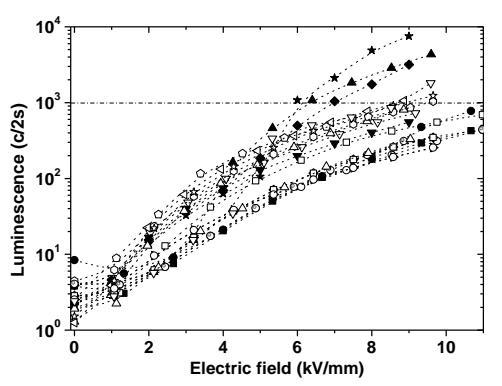
Fig. 5. Superposition of EL-field characteristics for various samples and with either air, vacuum or nitrogen as atmosphere. Solid symbols: silica-filled materials; open symbols: un-filled samples.

A second aspect which was treated is the statistic variation in the form of the characteristic with samples of different roughness (due to different mould being used) and with either silica-filled samples or pure epoxy samples. Fig. 5, shows a panel of characteristics obtained for various samples and atmosphere. The signal being measured span over large

intervals: roughly a sample-to-sample variation of x40 can be obtained at the extreme. It can also be observed that the variation factor is larger for high field than for lower ones.

Looking in details at these characteristics, it has been observed that some instabilities appear during the increase of the voltage, in the form of a step in the signal above a voltage ranging from 4 to 8kV, depending on samples. Such steps are responsible for the strong signal observed in some samples (>1000c/2s at 8kV/mm).

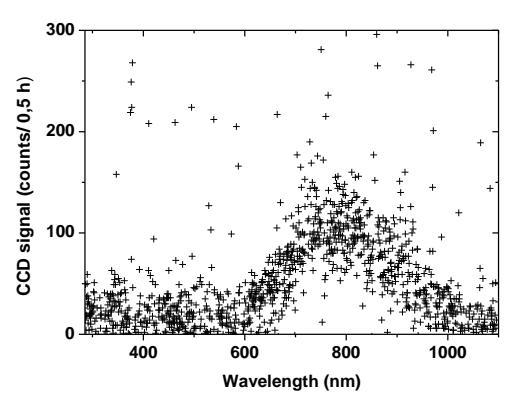
(a) Sample of typology 1. Integration time = 30 min; Voltage = 9 kV

Fig. 6. Examples of EL spectra obtained on samples having characteristics of different typology.

Several wavelength-resolved spectra have been recorded at different voltages and with different samples. Due to the low signal being measured, the time necessary to get an exploitable signal could be long (of the order of 1 hour). Also, for the same reasons, spectra could be recorded only in the high field range of the characteristics. We have observed that different spectra are obtained depending on the typology of the characteristic of the sample under test. To characteristics of typology 1 correspond broad non-structured spectra in the red domain, Fig. 6.a (the spectrum peaks at about 780nm). In case of typology 2, the emission appears in the same wavelength range; however clear structures appear in the spectrum, cf. Fig. 6.b.

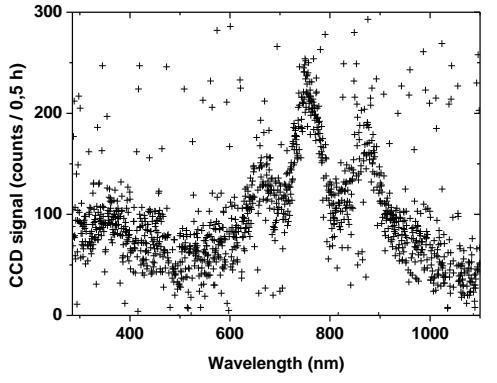
(b) Sample of typology 2; Integration time = 30 min; Voltage = 7 kV

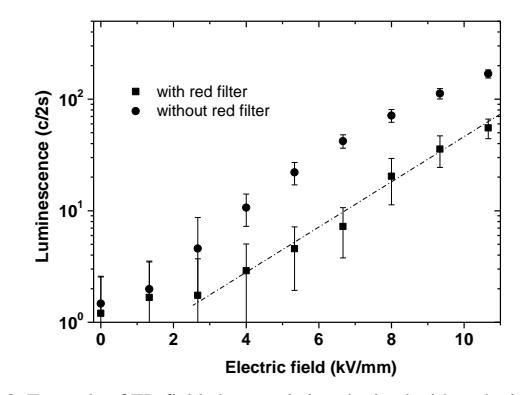
Fig. 8. Example of EL-field characteristics obtained with and without red filter on a filled sample.

One way to discard light related to SP emission consists in inserting an optical filter that cuts emission at wavelengths above 600nm. Fig. 8 compares the characteristics obtained with and without filter. The fact that the field dependence of the 2 characteristics are not proportional implies that the spectrum is field-dependent and hence that possibly several emission processes contribute to the emission. As regards potential emissions in pure epoxy, it has been shown that the longer wavelength emission detected is related to oxidation of the hardener of the epoxy [4], which peaks at 580nm. Clearly, such emission would be in the short wavelength tail of the SP emission and the two processes are difficult to separate using a red-censoring filter. Nevertheless, the shape of the characteristic indicates that the relative amplitude of the emission under 600nm increases with the field.

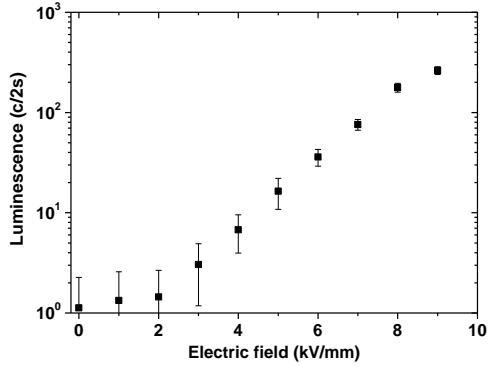
Fig. 9. EL-field characteristic of a filled sample metallized with ITO.

The best solution to avoid SP emission consists in using an electrode material that radiates out of the wavelength range of interest, which is the case of indium tin oxide (ITO) since its SP emission is in the far-IR. Another advantage of ITO is its transparency in the visible range, which is not the case of gold; the drawback being that the deposition technique is somewhat more complex. Fig. 10 shows an example of characteristic obtained with 220 nm -thick ITO electrodes. The shape of the characteristic is approximately linear and conforms more to that obtained with red-sensoring the signal of gold-metallized samples. Most importantly, the spectrum obtained with ITO electrodes is clearly different from that obtained with gold, cf. Fig. 9. The peak is shifted to about 570nm, consistently with that obtained during thermal oxidation of the resin [4] and also with cathodoluminescence measurements (results not shown here), being strong supports that this emission is really characteristic of the material. Work is in progress to develop measurements with ITO electrodes.

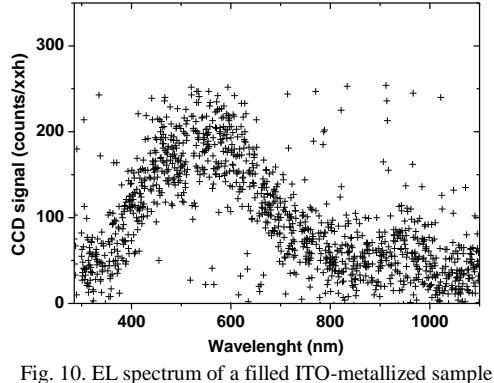
Fig. 10. EL spectrum of a filled 11O-metallized samp Integration time = 30 min ; under 12 kV
