Comparing methods to detect the formation of damage in composite materials

Comparing Methods to Detect the Formation of Damage in Composite Materials

Composite. Cross-ply laminate, Thermography, DIC, Damage

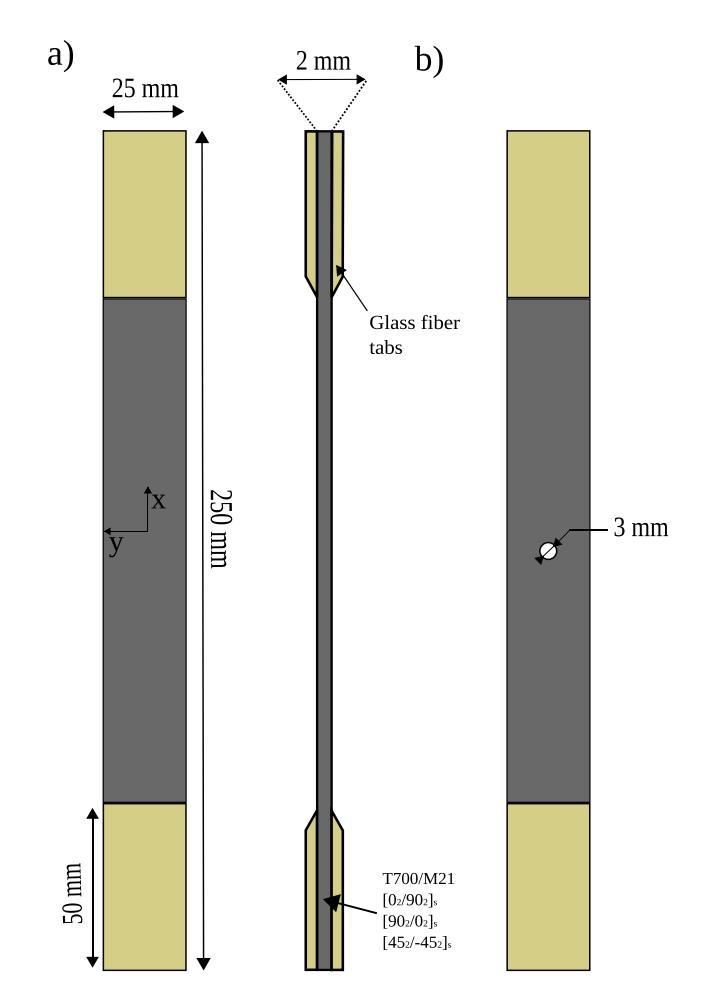
Fig. 1 Dimensions of the samples of the first series (a) and the second series (b). The only difference is the presence of the hole in the center of the ROI

Each test was performed with an angle of 0° , 45° and 90° between the direction of traction and the fibers of the surface plies. The dimensions of the samples are shown in Fig. 1. The samples were prepared with 50mm long

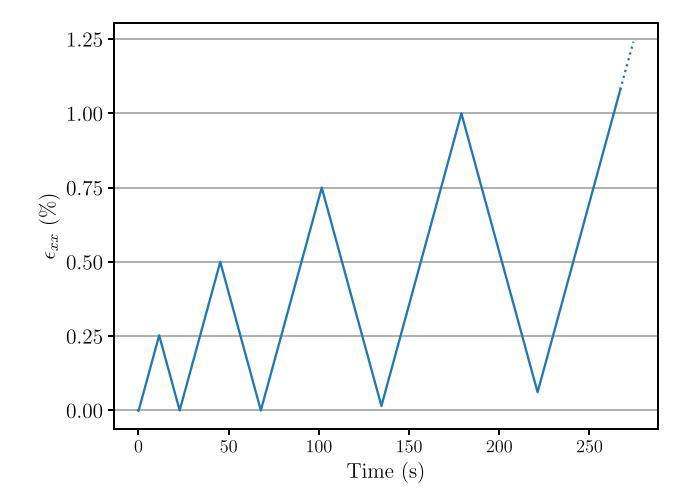
Fig. 2 Example of longitudinal strain applied to a sample: the strain increases by steps of 0.25% and the sample is unloaded until the force is 10N (strain is not necessarily 0% at the end of a cycle)

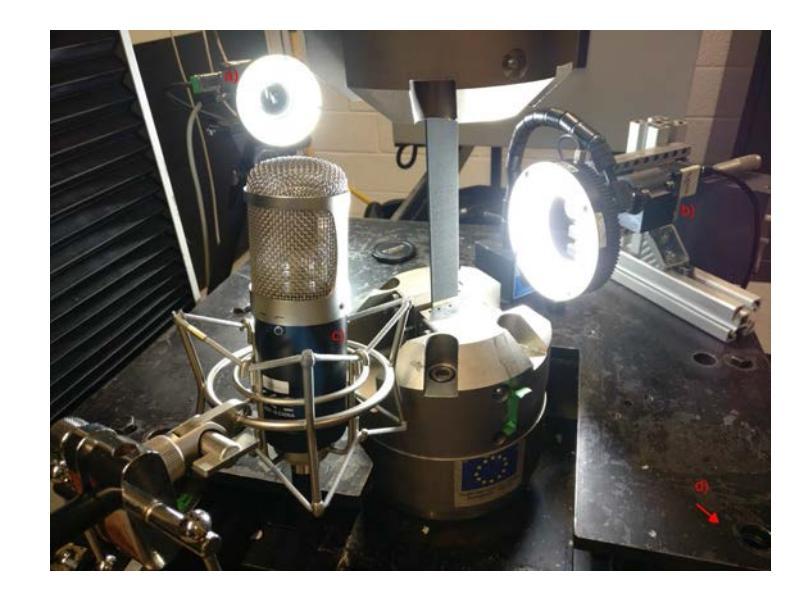
Fig. 3 Picture of the setup with the main camera (**a**), the side camera (**b**) and the microphone (**c**). The IR camera is out of the image (**d**)

The test is performed on an Instron 5882 tensile machine equipped with a class 0.2 load cell rated for 50 kN. A picture of the setup can be seen in Fig. 3. The machine is controlled using CRAPPY, a Python module designed specifically to control setups involving multiple sensors and actuators. The

In all of the tests, an infrared camera monitors one face of the sample, a high-resolution camera monitors the other face of the sample and a third camera monitors the side of the sample with a macro lens. The side of the sample was polished prior to the test to give a clear view of the plies.

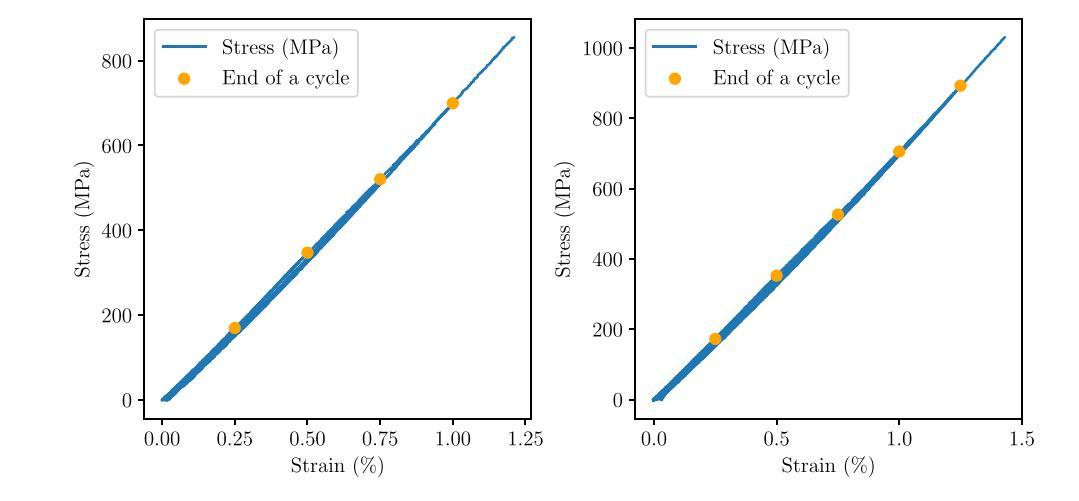
Fig. 4 Stress-strain curve of a test on a $[0_2,90_2]_s$ (left) and a $[90_2,0_2]_s$ (right) plain sample

The $[0_2,90_2]_s$ and $[90_2,0_2]_s$ samples show very similar behaviors. This is expected as in both cases, half of the fibers are vertical (in the direction of traction) and the other half are horizontal, only the order of the plies is different. In these tests, the stress-strain curve showed a nearly elastic behavior as shown in Fig. 4. This is despite the clearly visible damage of the horizontal plies. The only major difference in the macroscopic behavior is the ultimate strain as the $[90_2,0]_s$ sample breakage occurred at 1.45% which is higher than the $[0_2,90_2]_s$ at 1.22%. The former therefore performed one additional unloading/loading cycle at 1.25% strain. The moduli are close for these two orientations, with 68.6 GPa for the $[0_2,90_2]_s$ and 69.2 GPa for the $[90_2,0_2]_s$ sample.

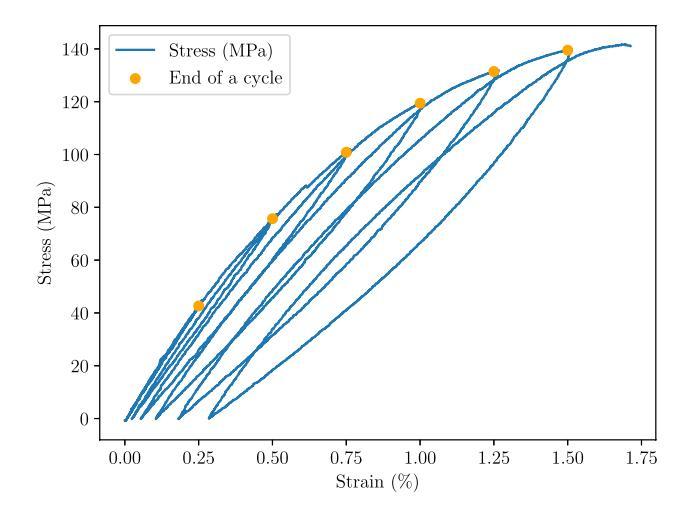
Fig.5 Stress-strain curve of a +/-45 sample on the third series of tests

The samples at 45° showed a significantly different behavior. At the macroscopic scale, damage is clearly present as shown on the stress-strain curve in Fig. 5. The stiffness of the sample is decreasing after each cycle, which is expected for this layup. For every orientation, the samples showed behaviors similar to those in [33].

is also the main damage mechanism, but instead of an opening, the cracks are the result of in-plane shear. As a consequence, the cracks appear progressively and do not open instantaneously like in the tensile mode. DIC shows that the amplitude of the displacement of each side of the crack grows when loading, but also diminishes during unloading. This means that the sides of the shear crack slide on each other during loading and unloading, possibly explaining the energy dissipation observed on the stressstrain curve on Fig. 5.

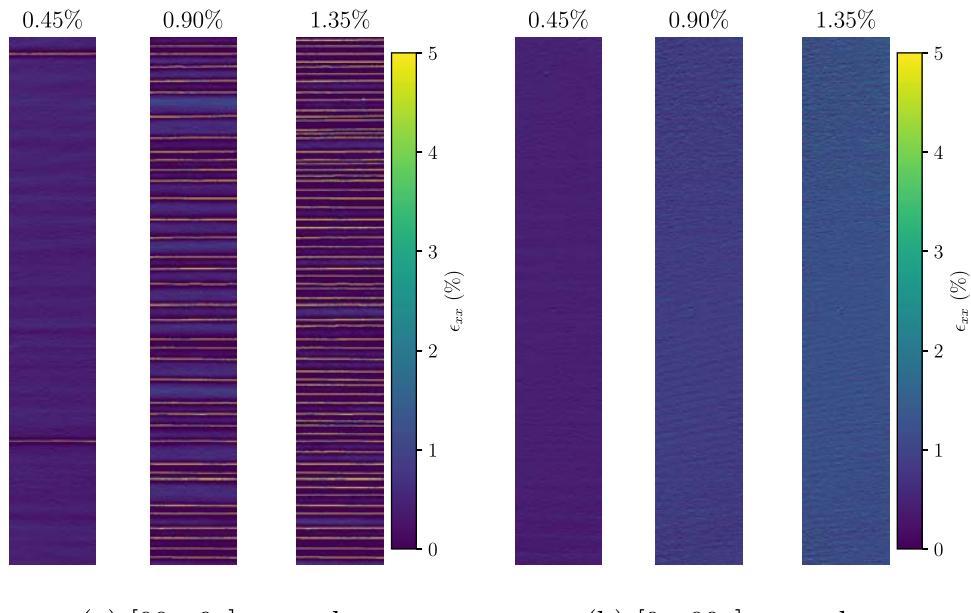
(a) $[90_2, 0_2]_s$ sample

Fig. 6 Strain field on the face of the plain samples at different levels of macroscopic longitudinal strain

Even though the macroscopic behavior is almost perfectly elastic in these configurations, numerous events suggest that the samples were actually subject to damage. DIC detects major events on the $[90_2,0_2]_s$ samples, suggesting an alteration of the 90° layer. The (Fig. 6a) shows the strain along the traction axis revealing some of these events on the $[90_2,0_2]_s$ sample. The lines on (Fig. 6b) are actually discontinuities but the DIC algorithm reveals them as strain spikes because of the regularization. For comparison, (Fig. 6c) shows the strain fields on the $[0_2,90_2]_s$ sample where no events are

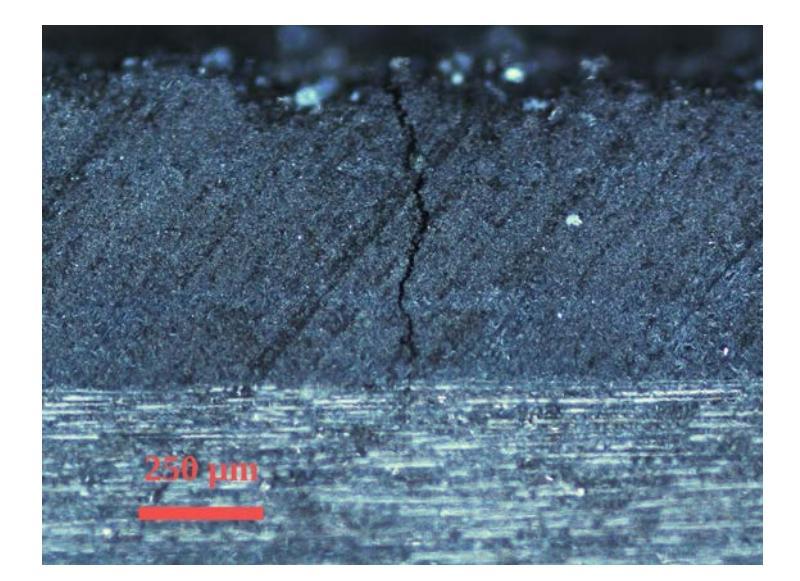
Fig. 7 Micrography of the side of a $[90_2,0_2]_s$ sample after testing showing a crack in the 90° surface layer

easily visible. The sudden discontinuity parallel to the fibers and forming instantly on the $[90_2, 0_2]_s$ sample appears to be transverse matrix cracking. To confirm this, micrographies of the sample were performed and the presence of cracks like the ones shown on Fig. 7 at the locations of these events confirmed this hypothesis.

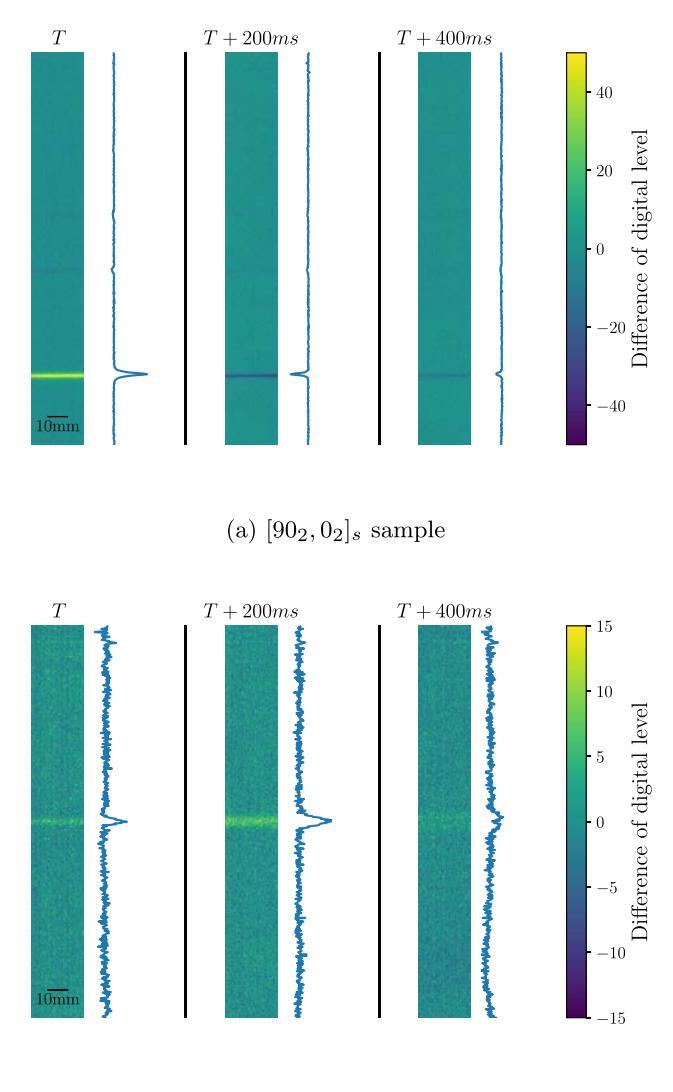
(b) $[0_2, 90_2]_s$ sample

Fig. 8 Signature of a transverse matrix crack on IR thermography

Thermography detects many events on the $[90_2,0_2]_s$ sample, they are likely caused by the heat released by the formation of the same type of cracks. These events show a sudden increase of temperature along a line over the width of the sample followed by a dissipation period of a few frames. Figure 8a shows the IR signature of these events. The $[0_2,90_2]_s$ samples show the same pattern (see Fig. 8b)

of the sample but the heat signature is still detectable thanks to the diffusion through the top layer. The signatures of a crack for both orientations are shown on Fig. 8. They are constituted of a localized IR emission increase in a single frame, followed by a return to the average temperature in 3 to 5 frames, inducing a negative spike on the differences of images. On the $[0_2,90_2]_s$ samples, the phenomenon is less clear as it is affected by the dissipation through the top layer.

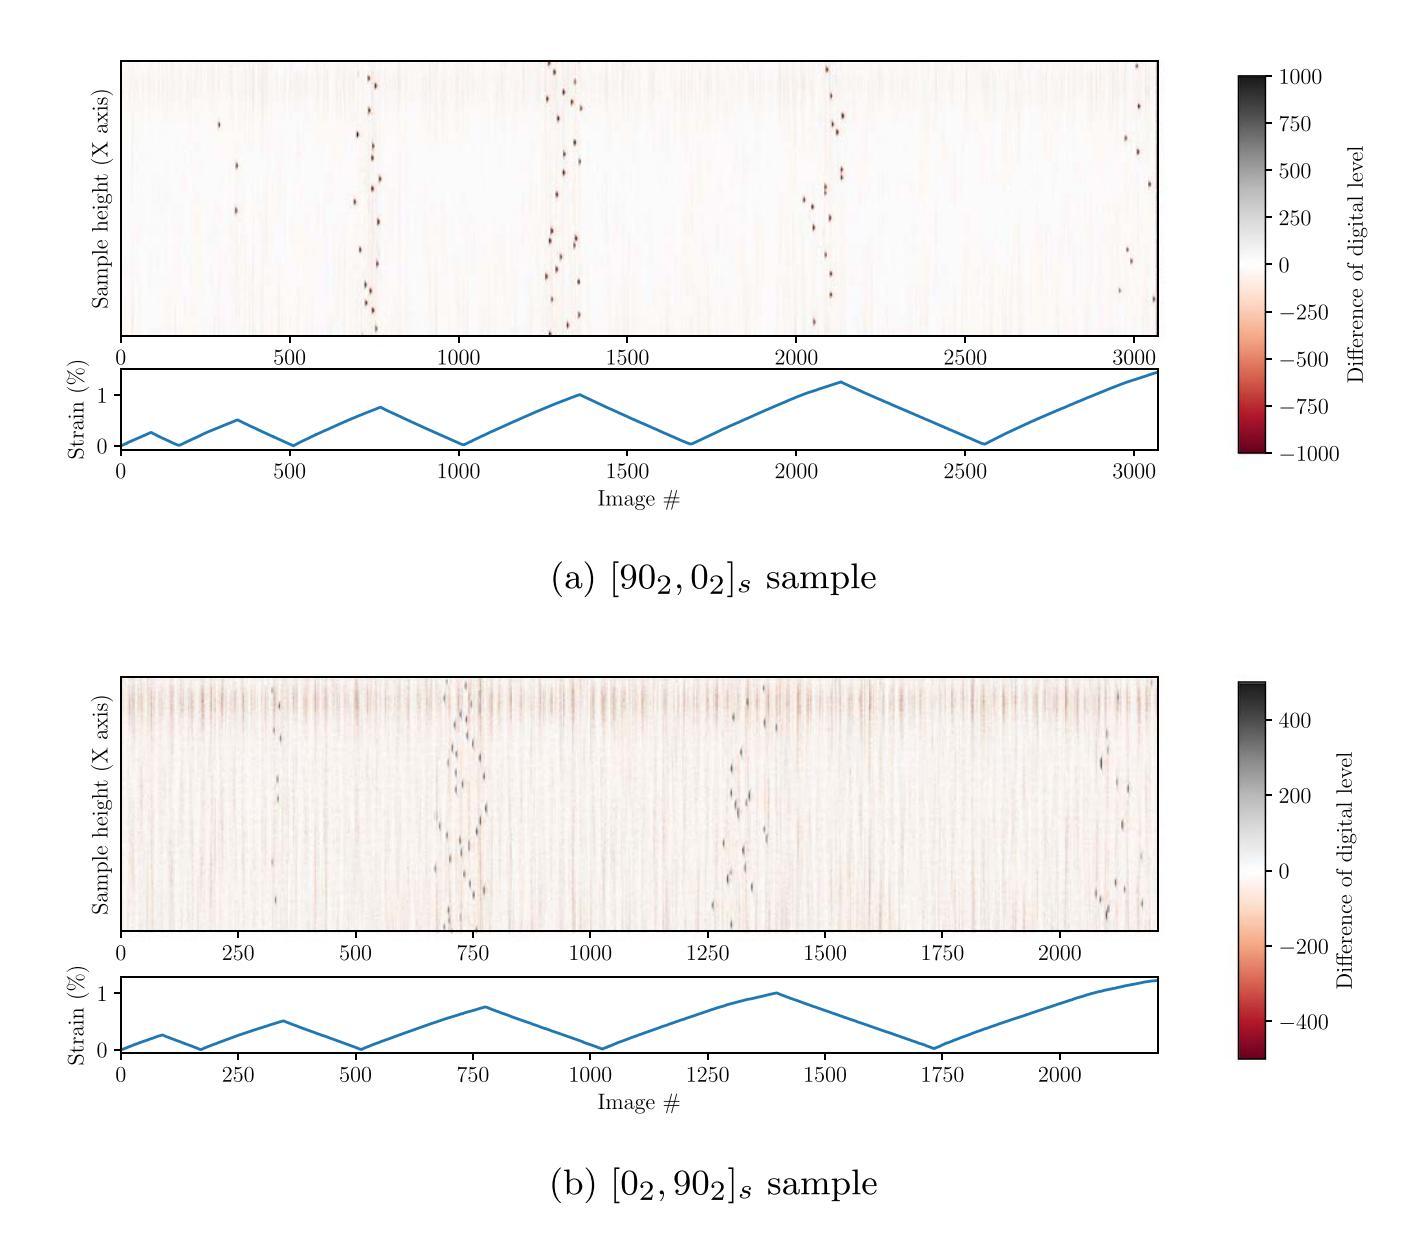
Fig. 9 History of the difference of digital levels from the IR camera summed over the width of the sample for both orientations

In order to follow the evolution of the crack density, an algorithm was developed to detect and count the cracking occurrences on the IR and visible images and compute the number of cracks per mm. The method used to process the IR images consists in a detection of local increases of the emission of the sample. The goal is not to quantify the amount of energy dissipated directly, or measure the temperature of the sample but simply detecting and locating the occurrence of such spikes of emission. The formation of a crack results in a temporary increase of the emission. Because the cracks propagate through the entire width in a single frame, a method taking advantage of this was developed to detect and count the cracks reliably. This is done by making the pixel-wise difference between two successive images, and summing them along the width of the sample, resulting in a 1D array. This method helps reducing both noise and the amount of data to process. When a crack occurs, a positive spike in this 1D array can be detected at the appearance of the crack followed by a negative spike that progressively flattens and spreads out as the heat dissipates. Figure 8a and b show the signature of the cracks on 0° and 90° samples and the graph of the sum used to perform the detection. Projecting this 1D diagram over time constitutes a 2D image on which the instant and localization of each event can be visualized simply as shown in Fig. 9. The events can be easily recognized by the short bright line followed by a dark gradient. On 0° samples, since the cracks do not form

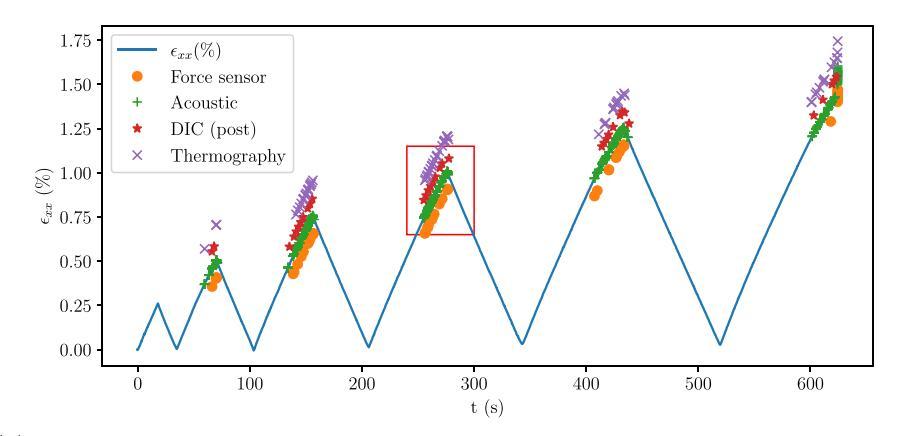
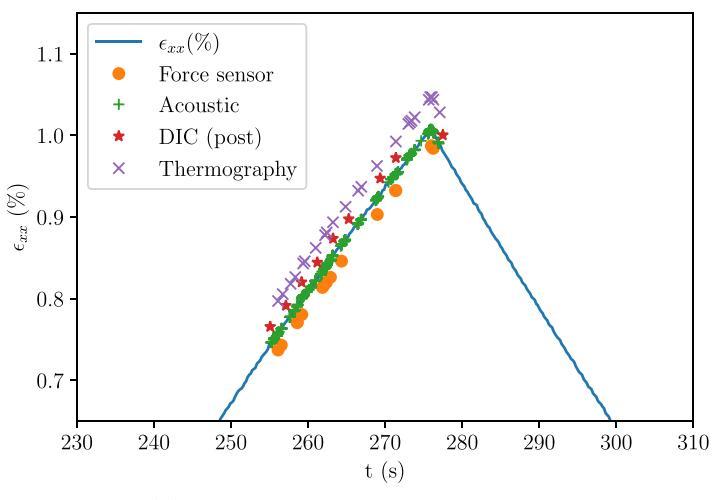
(b) Zoom on the red region of figure a

Fig. 10 Graph showing the evolution of the strain and markers on detected events for each measurement method. The markers were offset vertically to improve readability

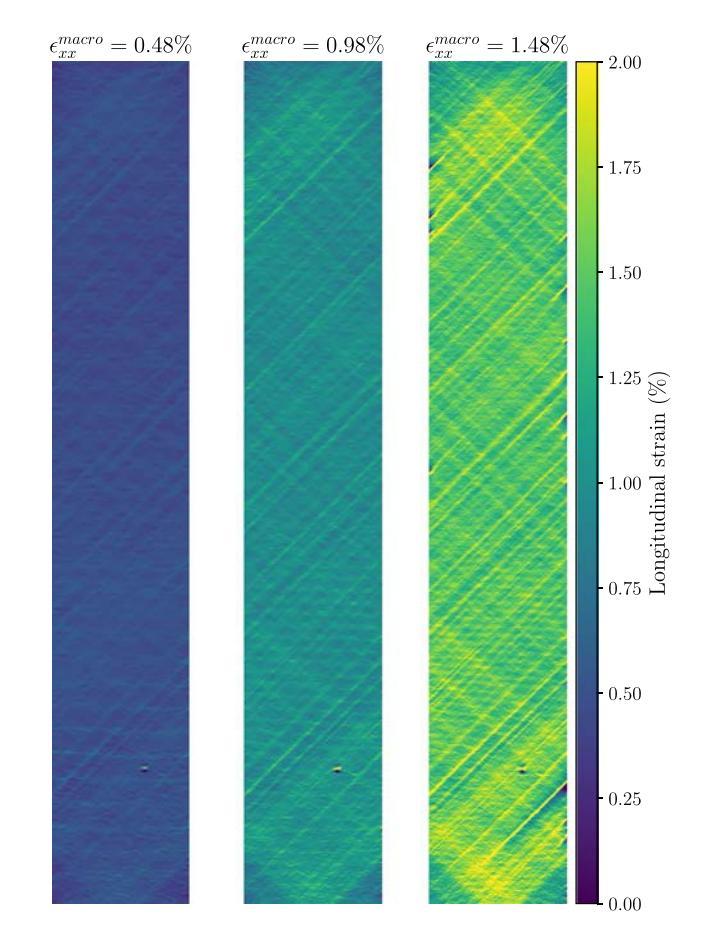
Fig. 11 Longitudinal strain field extracted from DIC on $[45_2, -45_2]_s$ layups during load at different levels of global strain

Strain fields show localizations on lines in the direction of the fibers. They form irregularly spaced lines of higher strain in the directions of the fibers of both the face and the inner plies as shown on Fig. 11. These shear bands decrease in amplitude during the unloading but they are still present between the cycles when the force has returned to 0N. This means that they have an elastic and a permanent component. This form of permanent alteration appears progressively, therefore they are not accompanied with a sudden release of heat. This is why they can not be observed using IR thermography. The strain fields also show bands perpendicular to the fiber of the surface. These bands are caused by the same phenomenon occurring on the inner layers and showing through the surface plies.

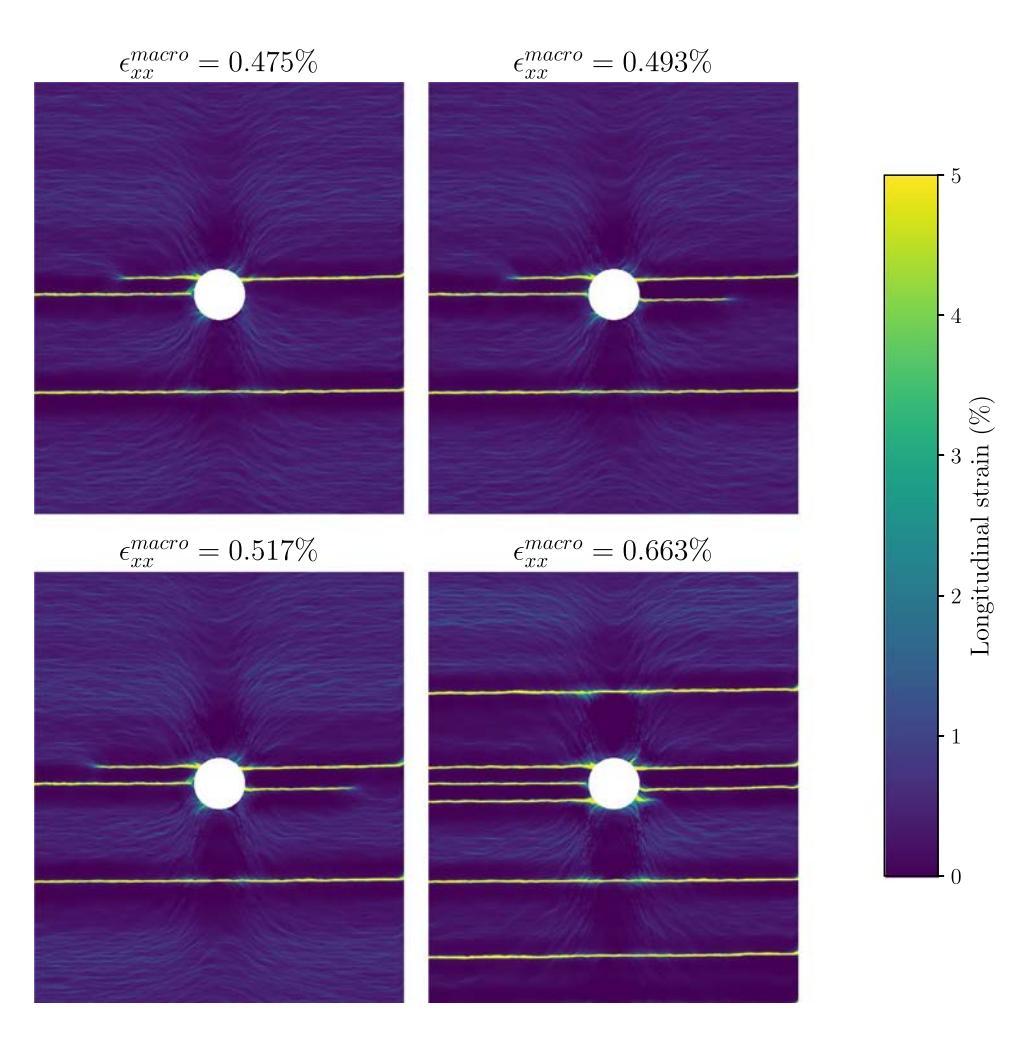
Fig. 13 Longitudinal strain on the $[90_2,0_2]_s$ sample, showing cracks growing from the hole towards the edge of the sample

In the uniform sections of the sample, these tests showed all the behaviors observed previously. Transverse matrix cracking in particular is omnipresent, as described in Section "Observations on $[0_2,90_2]_s$ and $[90_2,0_2]_s$ ". However, the area near the hole showed new behaviors: slow transverse cracking can be observed on the 90° plies of the samples at 0° and 90°. Instead of an instantaneous propagation through the entire sample like in the previous tests, some cracks showed a slow progression starting from the hole and growing towards the edge of the sample as shown

in Fig. 13. This can be explained by the non uniform strain state that is not favorable to an instantaneous propagation.

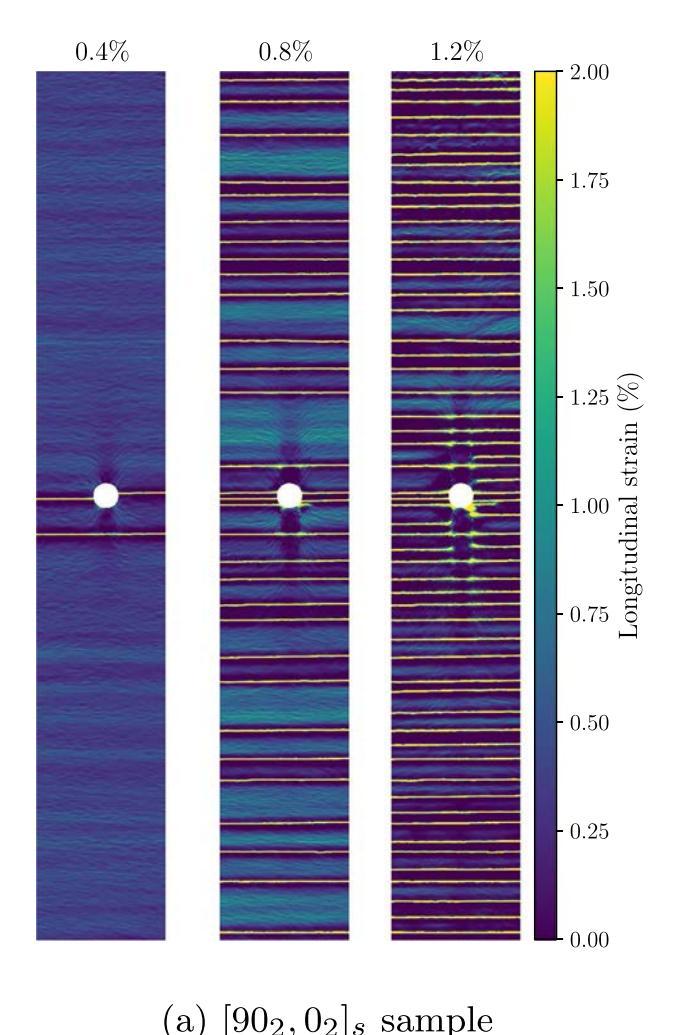
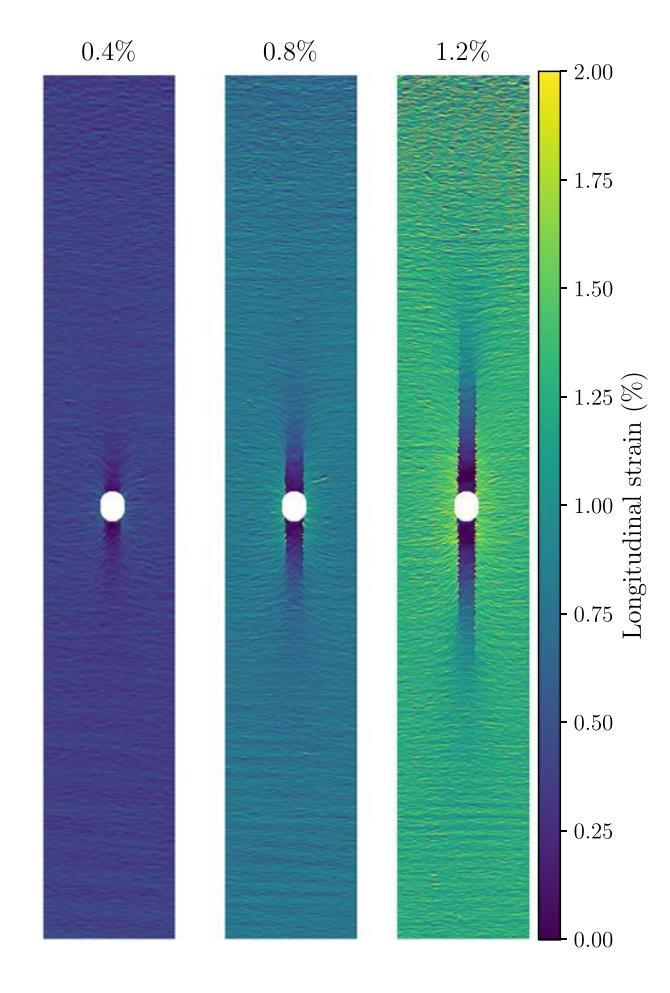
(b) $[0_2, 90_2]_s$ sample

Fig. 14 Strain field on the face of the samples with a hole

On the 0° plies, a shear crack can be observed growing from the side of the hole in the direction of the fibers. The Fig. 14 shows the strain field of these samples at different levels of strain during loading on which this behavior can be observed. This shear crack also occurs on the 0° plies of the 90° sample, but is less clear as it is seen through the 90° layer. Figure 15 shows the shear strain to illustrate the progression of the shear crack.

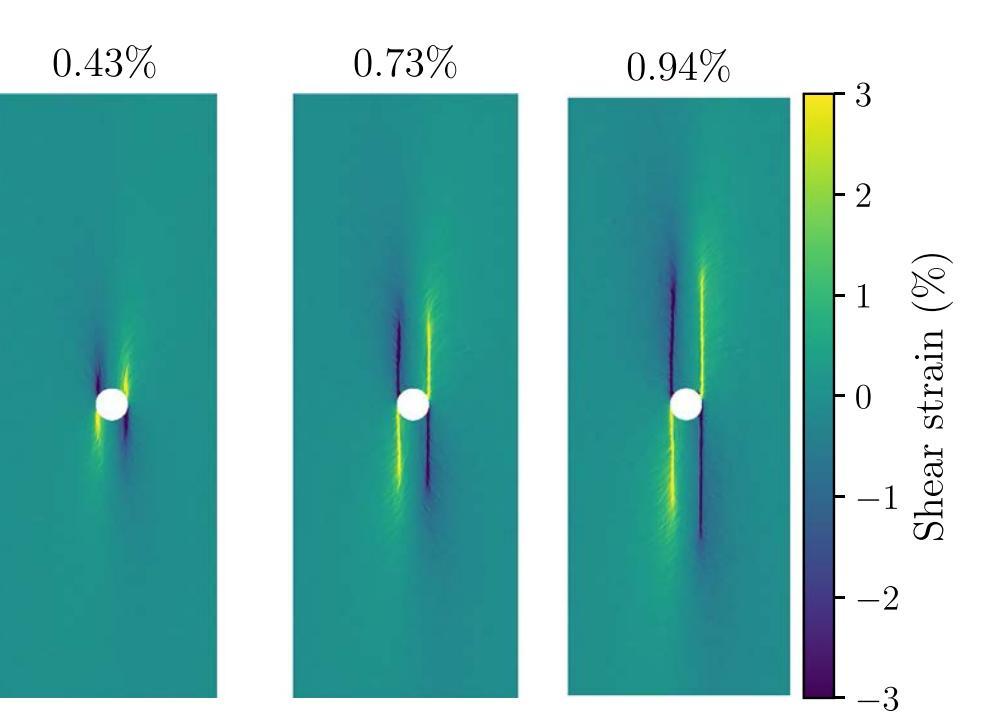
Fig.16 Longitudinal strain field on the $[45_2, -45_2]_s$ sample with a hole

is illustrated in Fig. 16. The region around the hole being subject to a higher strain, the rupture occurred in the center of all of the samples. The uniform regions of the sample showed a behavior similar to the previous tests with lines of shear strain on the direction of the fibers of both plies. The lines decrease in amplitude when unloading but the strain localization on the lines intersecting with the hole are still visible. This can be observed on the strain fields of the sample after unloading.

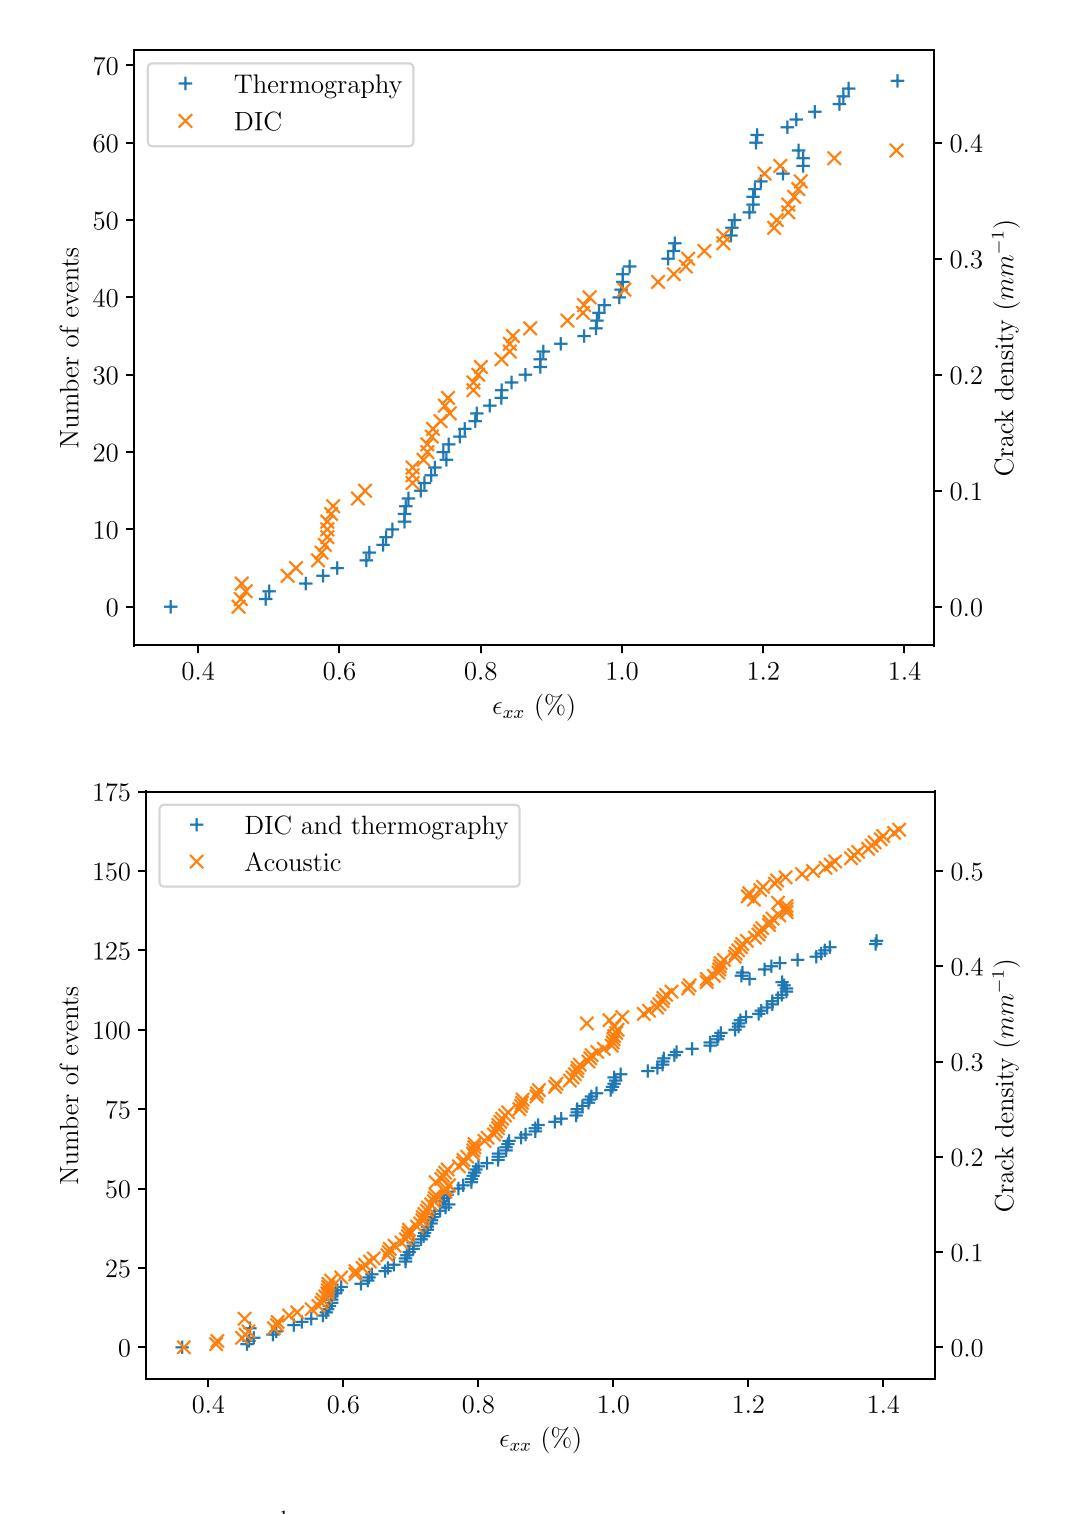
Fig. 18 Number of cracks detected by the microphone and by either DIC or thermography

Since the events detected with DIC and thermography all appear to be matrix cracking, they are all expected to be detected by acoustic measurements. The Fig. 18 shows the cumulated events of both thermography and DIC on two different faces versus the events detected by the microphone.

This figure shows that the number of events detected by the acoustic measurements is almost equal to the number of events detected by both DIC and thermography at strain levels below 0.8%. Beyond this level, this method appears to detect other events that could not be observed on either thermography or DIC. These events are probably an other type of damage. The classification of the events based on their spectral signature as in [42] could probably provide more information on the type of events, but the acquisition frequency of the microphone of 192kHz is not high enough to perform this kind of study.

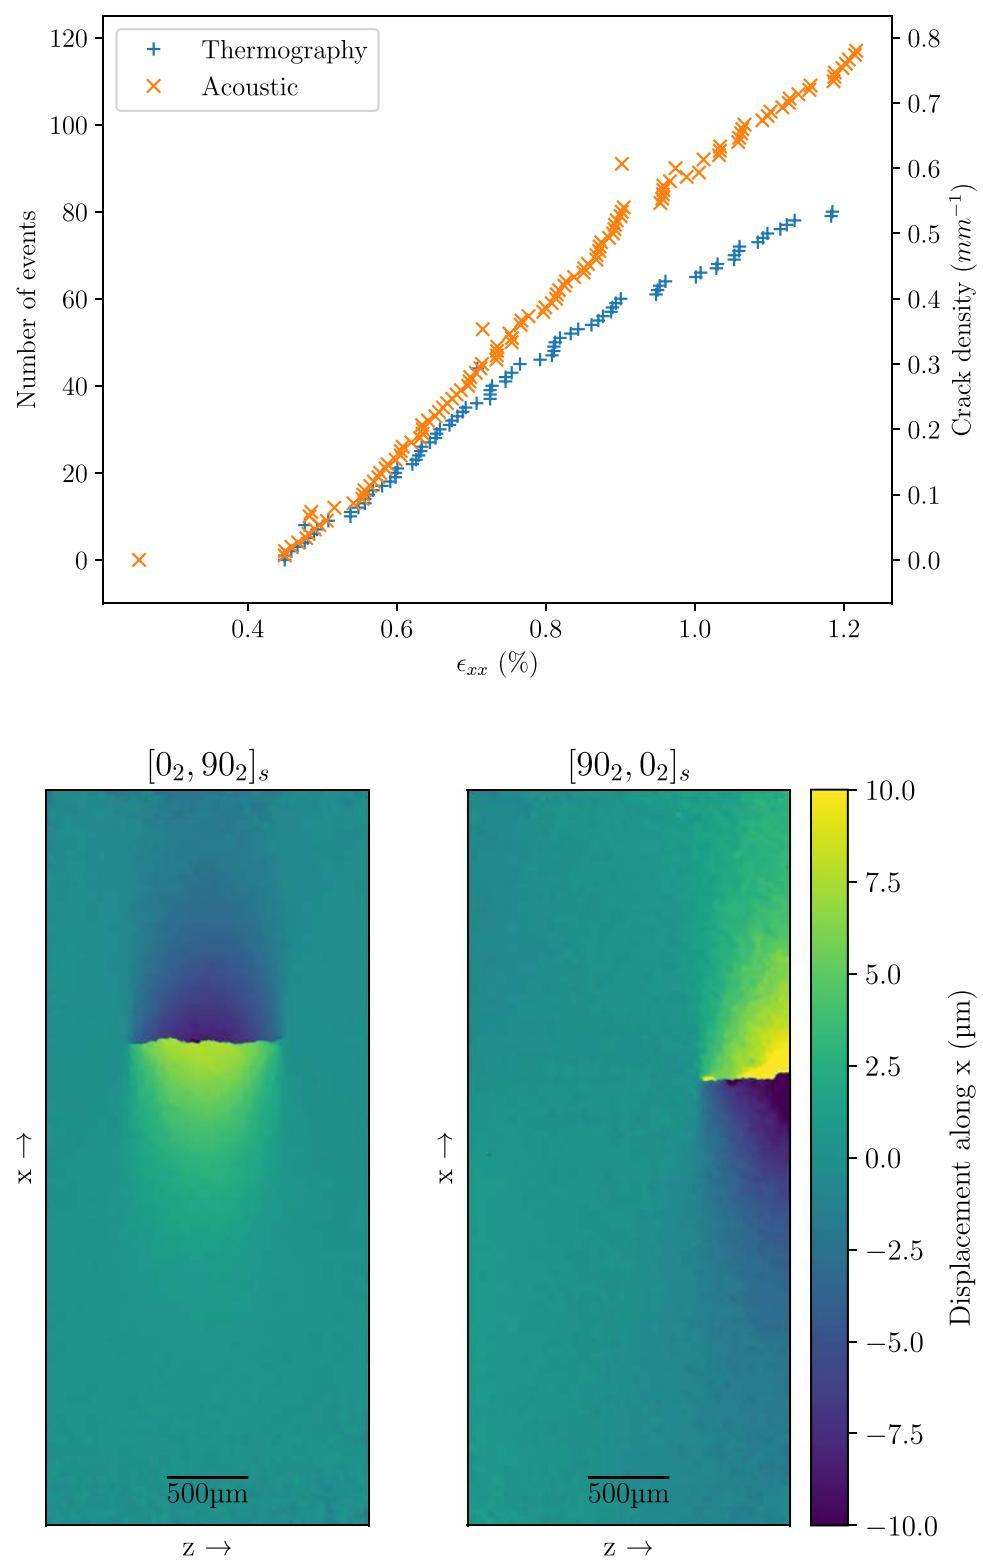
Fig. 20 Displacement field caused on the side of the sample by a transverse matrix crack in the 90 ply°

On 0° samples, the cracks appear in a similar way and propagate through all the thickness of the 90° plies as illustrated on Fig. 20. Previous observations (notably thermography) showed that the crack also propagates instantly through the entire width of the sample. The crack causes relaxation of the material on both sides of the crack, but the ply being constrained by the 0° plies on the side, the

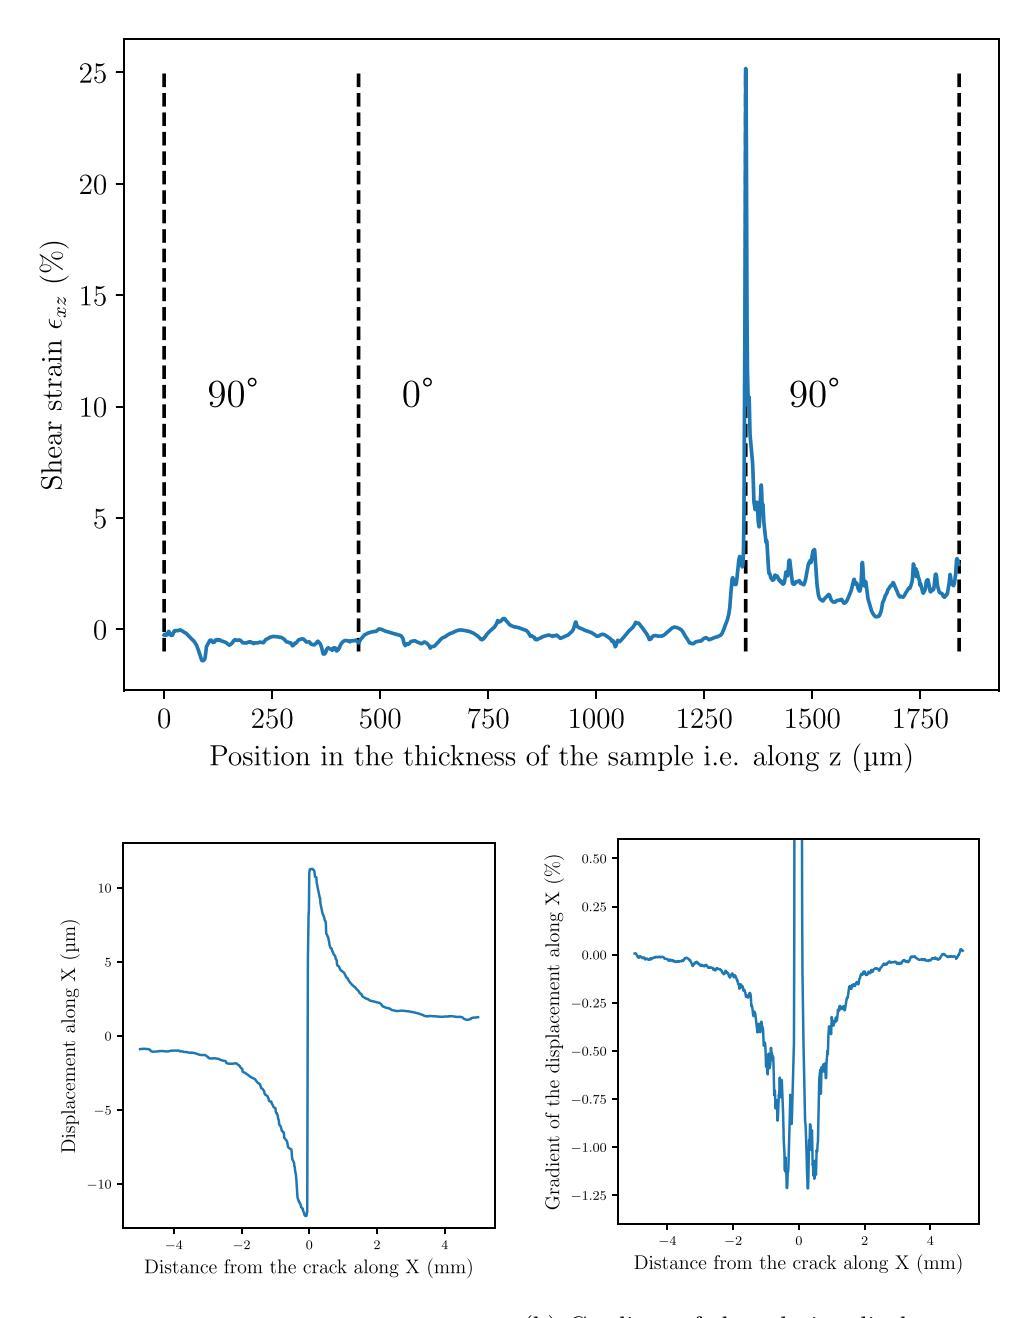
Fig. 22 Plots illustrating the impact of the formation of a transverse matrix crack on the surface of a 90° sample

(a) Relative displacement along X over a (b) Gradient of the relative displacement line normal to the crack along X averaged over the width of the sample

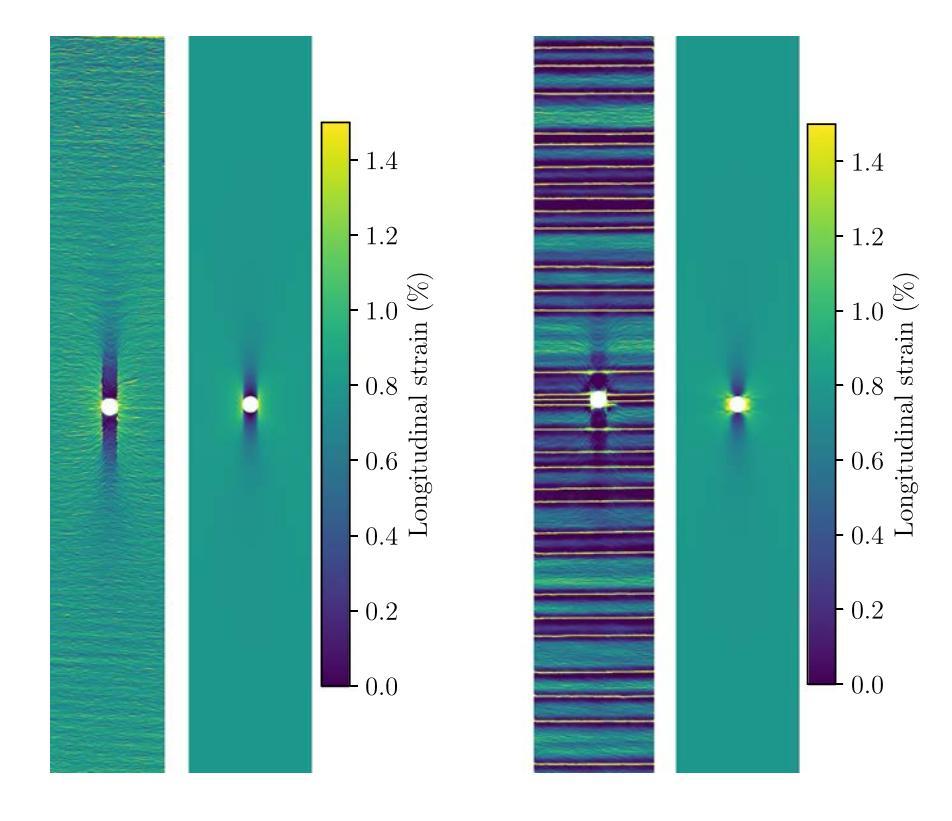
(a) Measured field (left) and simulated (b) Measured field (left) and simulated field (right) on $[0_2, 90_2]_s$ field (right) on $[90_2, 0_2]_s$

The simulated strain fields show patterns very similar to the ones observed on the measured fields around the holes for every orientation. On the 45° samples, the strain localization induced by the hole is similar between the simulations and the measurements as illustrated on Fig. 23. However, the strain in the uniform sections differs significantly because of the heterogeneity of the material. This illustrates clearly why the question of a representative volume is critical when using uniform models on composite materials.

In the case of the 0[°] sample, the shear cracks in the direction of the fibers and tangent to the hole are present, even though the amplitude is smaller. As shown on the Fig. 24a, the simulated and measured fields are very similar even though the amplitude of the phenomena induced by the hole are underestimated.

The shear cracks tangent to the hole are also present on the 90° samples, just as observed on the experimental fields. However in this orientation, the two fields are completely different as shown in (Fig. 24b). This is almost entirely due to the numerous transverse matrix cracks that occur in the surface layer. Also, on the 45° scenario, the shear cracks and heterogeneities in the shear modulus that cause the strain localisations on lines in the direction of the fibers are totally **Fig. 23** ϵ_{xx} on the $[45_2, -45_2]_s$ sample, at 0.8 (%) global strain
