# The building materials of the Rocca della Verruca fortress (Tuscany-Italy)

#### Abstract

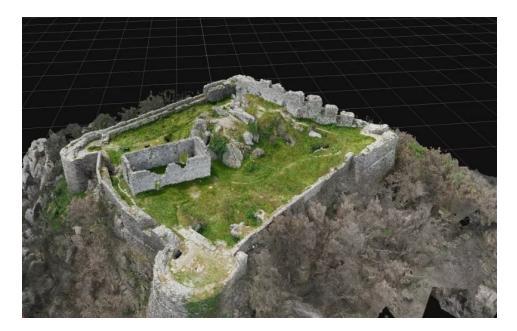
Fig. 2-Fortress mesh with texture, only photogrammetry (photo by Giovanni Pancani)

At present, the plan is quadrilateral with two round corner towers on the east side, the result of 16<sup>th</sup> century renovations, and two sharp-edged bastions on the west side (Fig. 2).

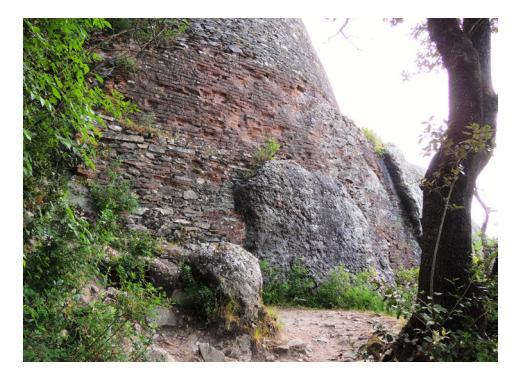
Fig. 3- The northeast round bastion which clings directly to the conglomeratic rock of the mountain peak (photo by Fabio Fratini, 2022)

clings directly to the conglomeratic rock of the mountain peak (Fig. 3).

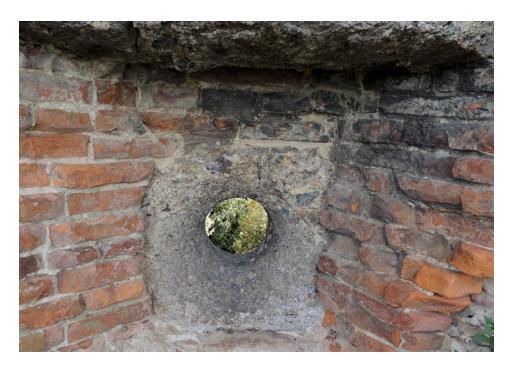
Fig. 4- A fire mouth with the hole and lintel made of Verrucano conglomerate (photo by Fabio Fratini, 2022)

In particular, the meta-conglomerate was used in the fire mouths (for the hole and as lintel and threshold) (Fig. 4), in the gateway (in large regularly hewn ashlars and in the trilithic lintel) (Fig. 5), in the first construction phase of the gabled building (in large regularly hewn ashlars and in the lintels of the openings). It was also used sporadically in the perimeter walls in small blocks. Indeed, these walls, as well as the donjon, were predominantly made of small, roughly hewn ashlars of grey to green - purple quartzite from the other geological formations present in the area surrounding the peak (Fig. 6). Quartzite, in small, regularly hewn ashlars, was also used in the second construction phase of the gabled building. Also, in quartzite (in the light green variety) is the threshold of the gateway to the fortress in which the trace of a hinge is visible (Fig. 7).

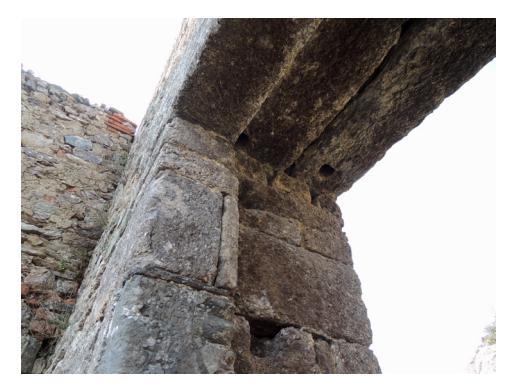
Fig. 5- The trilithic lintel of the gateway made of Verrucano conglomerate (photo by Fabio Fratini, 2022)

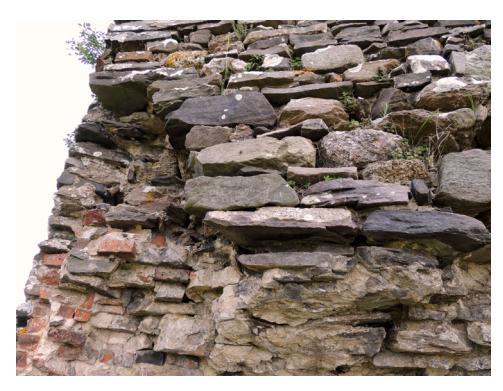
Fig. 6- The small, roughly hewn ashlars of grey to green-purple quartzite constituting most part of the perimeter walls (photo by Fabio Fratini, 2022)

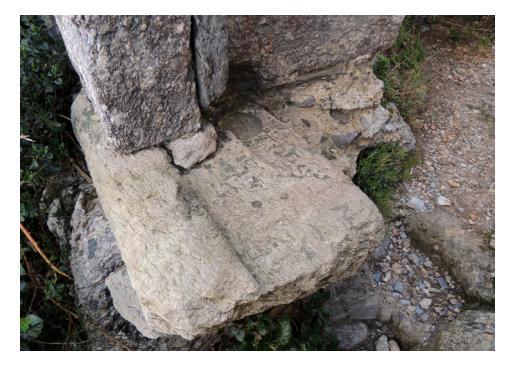
Fig. 7- The threshold of the gateway to the fortress made of a light green variety quartzite with the trace of a hinge (photo by Fabio Fratini, 2022)

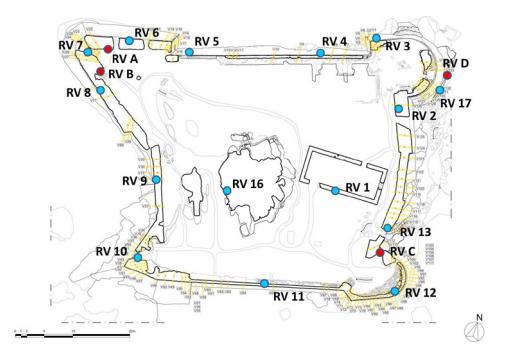
Fig. 8- Localisation of the samples: in blue, the bedding mortars; in red, the bricks (graphic elaboration by Silvia Rescic)

Bricks and bedding mortar were sampled according to the different construction phases. Their position is reported in Fig. 8. The following investigations were carried out:

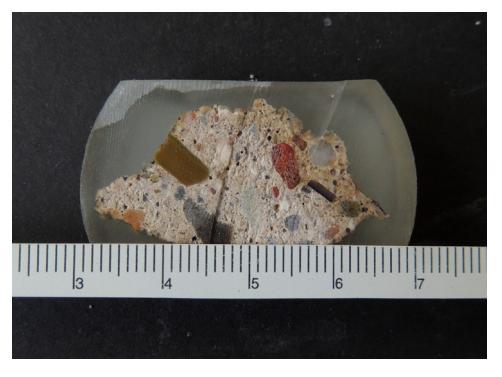
Fig. 9- Cross section of a bedding mortar of the earliest building phases, with a fairly coarse-grained aggregate (photo by Silvia Rescic)

The mineralogical-petrographic study of the bedding mortars shows that all of them were made with an air hardening lime binder without the addition of hydraulic additives. From the manufacturing point of view, it also appears that this lime was adequately purified from under burnt limestone fragments as evidenced by their absence in the mixtures. Compositionally, the aggregate does not show differences and consists of crystal clasts of quartz and calcite, lithic fragments of quartzite, quartz-micaschists, and micritic limestones. There are, however, differences in terms of the mixing recipe among the different construction phases. The earliest mortars (first phase of the gabled building [sample RV1], core of the jamb of the gateway [sample RV 13]) show a mixture with little amount of binder and a fairly coarse-grained aggregate (> 2 mm) (Fig. 9).

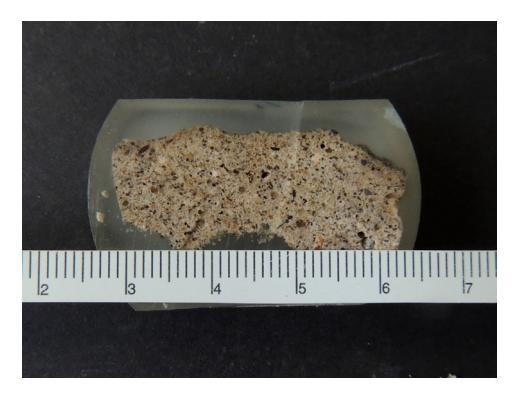
Fig. 10- Cross section representative of the bedding mortar of the north, west, south, and east sides walls characterized by a fine-grained unimodal aggregate (photo by Silvia Rescic)

The mortars of the north, west, south, and east sides walls and of the sharp-edged bastions of the west side have a fine-grained unimodal aggregate (100-300 $\mu$ m) and a relatively abundant binder (with a binder/aggregate ratio of 1/2-1/3) (Fig. 10). The mortars of the 16<sup>th</sup> century circular bastions on the east side show an aggregate with a medium unimodal grain size (400-500 $\mu$ m) and an abundant binder (binder/aggregate ratio of 1/2) (Fig. 11).

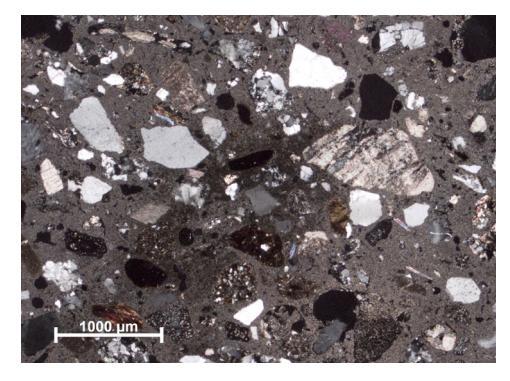
Fig. 11- Brick with a quite abundant framework of fine grain size and random presence of argillaceous rock fragments; image at the optical microscope in thin section, crossed polarized light (photo by Silvia Rescic)

The bricks show mixtures of homogeneous appearance with a quite abundant framework of fine grain size (50-200  $\mu$ m) and a scarce presence of argillaceous rock fragments (Fig. 12). As for the groundmass, some bricks show a not birefringent aspect while others are birefringent, indicating in this case a lower firing temperature but still starting from the same raw materials which are the clayey sediments of the alluvial plain at the base of the mountain.

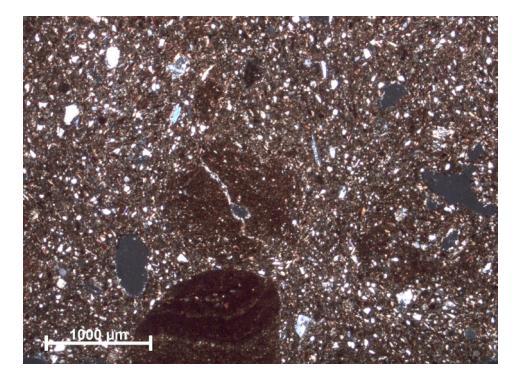
Fig. 12- Bedding mortar of the 16th century circular bastions with a medium grained unimodal aggregate (image at the optical microscope in thin section, crossed polarized light) (photo by Silvia Rescic)
