Effect of As-Built and Ground Surfaces on the Fatigue Properties of AlSi10Mg Alloy Produced by Additive Manufacturing

Article

Abstract: The present work concerns the influence of surface (machined, as-built) on the fatigue resistance of AlSi10Mg produced by a powder-bed laser process. The competition between defects and surface roughness is assessed by using Kitagawa-type diagrams. Samples are printed along three directions: 0° , 45° and 90° . After axial fatigue tests with a load ratio of R = -1, all the fracture surfaces are carefully analysed. The initiation sites can be (i) a defect, (ii) the surface roughness, (iii) the surface ripple. The results indicate that ground surfaces lead to the same fatigue life as as-built surfaces. It is also shown that T6 treatment improves the fatigue results with 'isolated defect size analysis' neither roughness parameter for an as-built surface. Therefore, microstructure, residual stresses or multiple initiation should be further analysed to understand the results.

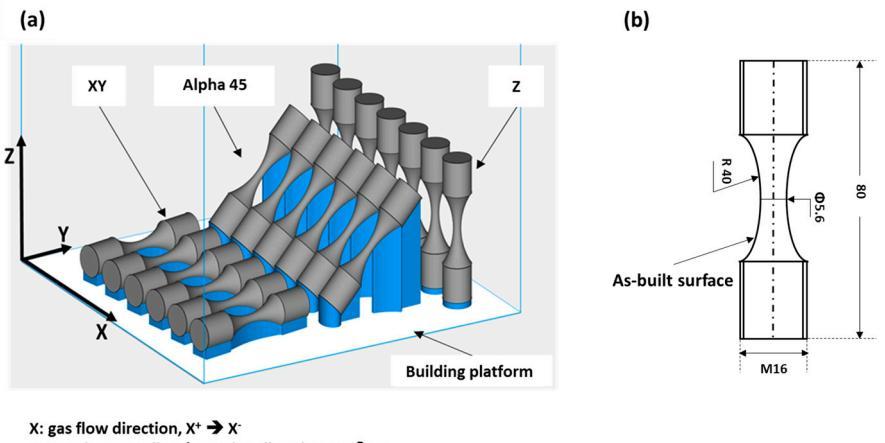
Y: powder spreading / scraping direction, Y⁺ → Y Z: building direction

Specimens were fabricated on an EOS M90 machine (at Liebherr group, Toulouse, France) using a pre-alloyed powder with an average particle size of 30 µm. The powder has a chemical composition in accordance with the DIN EN 1706:2010 standard. Samples were produced in three directions with respect to the building platform and the powder spreading or scraping direction according to Figure 1a, namely XY for bars produced on the plan of the platform, alpha45 for those built along a 45° inclined direction and Z in the case where the building direction is perpendicular to the platform. The layering was performed by means of a scraper. Bars were built on a platform heated at 200 °C and a stress relaxation treatment was performed during 2 h at 300 °C under air environment. Fatigue specimens were machined according to the drawing in Figure 1b. In Figure 2a, one can note that XY and alpha45 specimens were produced with construction supports that needed to be removed before testing. In this study, these supports were manually removed using pliers in the first step, followed by a grinding wheel. This manual process is not calibrated on a machine and could be strongly dependent on the operator. There is no specific procedure to check symmetry or quantity of removed material. The way it

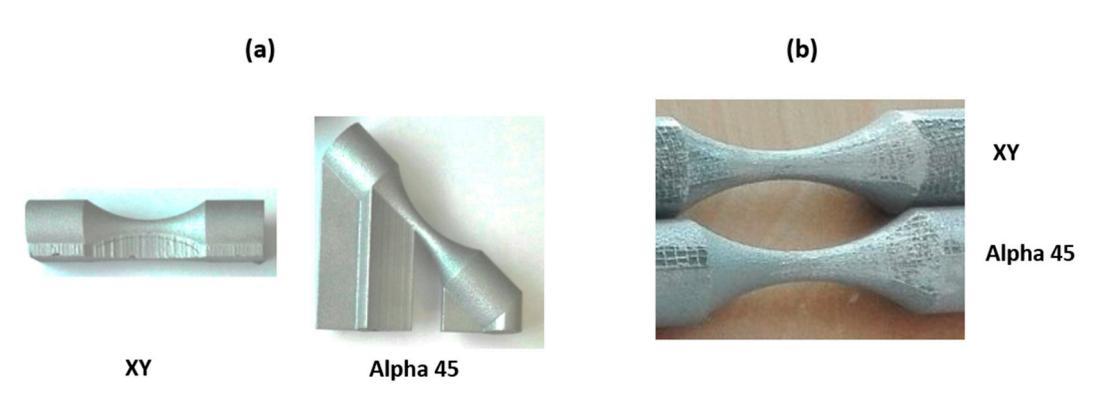
Figure 2. (a) Raw sample extracted from the platform, (b) fatigue sample after support removal and before thread machining.

was conducted in this study is representative of the way it is conducted in some industrial contexts. The fatigue test specimens, as presented on Figure 2b, have a partially as-built (AB) gauge length surface, with a raw surface and a ground area. The specimen was completed by the machining of the threads. Before any further words, it must be reminded that the fabrication of the bars is controlled by many parameters, and particularly by those related to the laser beam (power, speed and hatch distance) and by the layer thickness. The value of process parameters used for the fabrication are given in Table 1. Two passes (set 1 and set 2) of the laser were made to achieve the contours. Consequently, when one considers a cross section in the gauge length according to Figure 3, different areas can be distinguished according to the building strategy. Energy density (E_v) was calculated using the following equation:

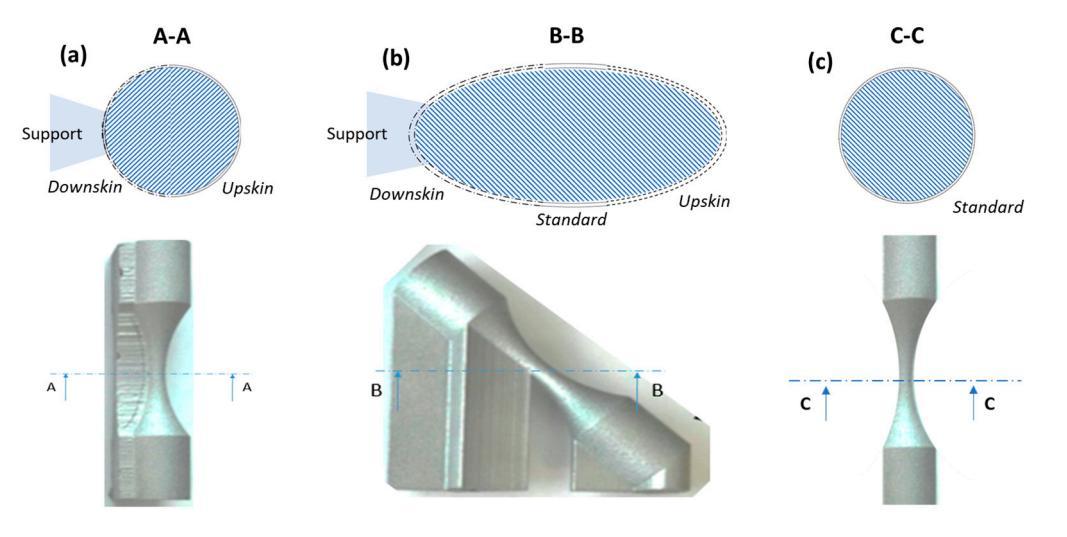
Figure 3. Contour scanning strategy, (a) XY sample, (b) Alpha45 sample, (c) Z sample.

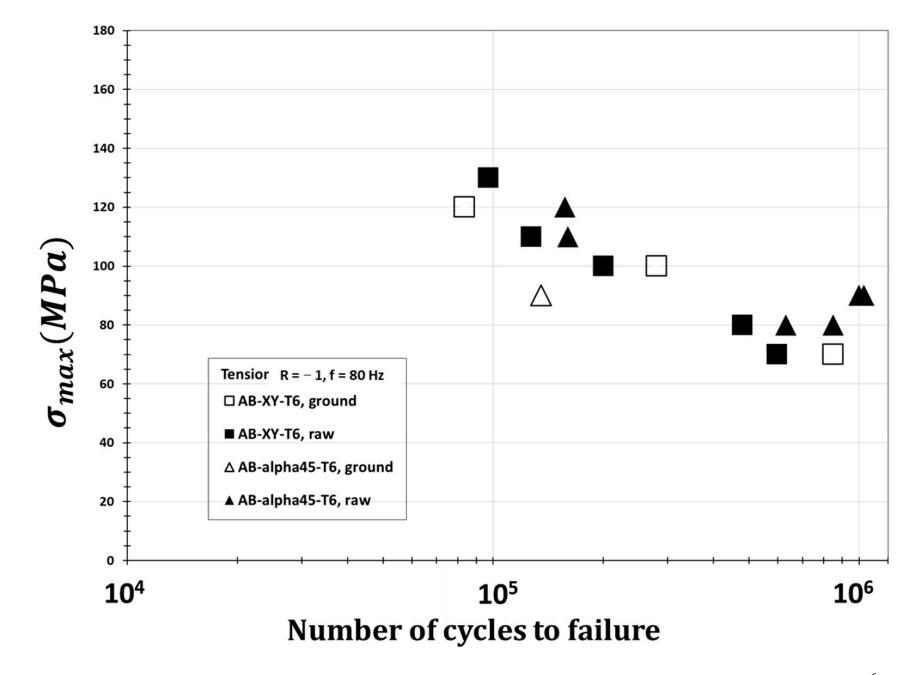
The influence of support grinding on the fatigue resistance of T6 material is quantified in Figure 4. In that purpose, specimens with alpha45 and XY orientations were tested. Open symbols correspond to specimens that failed from an initiation site located in the ground area, while filled symbols are associated with an initiation from the as-built surface. Three of the eight fractured XY specimens (square symbols) exhibited a failure in the grinding areas, while this type of failure origin was observed only once among the seven alpha45 specimens tested (diamond symbols). One can furthermore notice in Figure 4 that open symbols, representing the failures from ground areas, are almost in the same scatter band as full symbols denoting failure initiated on as-built surfaces. Therefore, it can be concluded that the manual process used to remove the construction supports does not

Figure 4. Influence of support grinding on fatigue life (AB: As-built surface); 10⁶: run-out samples.

seem to influence the fatigue strength drastically. Additional information on the fracture surface will be presented to support this first conclusion on the effect of ground surfaces.

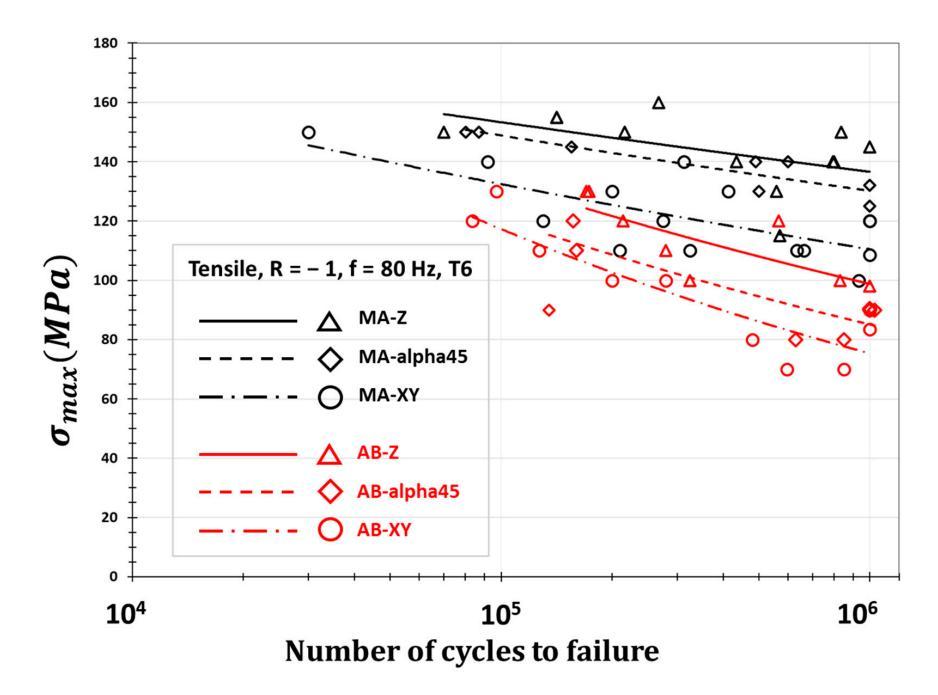
On the basis of the S-N curves presented in Figure 5, the respective influence of as-built surfaces and building direction are quantified for both T6 and non-T6 materials. The results are compared with those obtained on machined specimens in a previous study [14]. For T6 material, one can observe a marked decay in fatigue strength due to the as-built surface. In addition, a certain anisotropy due to the building direction, and similarly, the one observed in machined samples, can be noticed in specimens with as-built surfaces, according to the following ranking: Z > alpha45 > XY. This is consistent with a sketch proposed in [14] that correlates the fatigue behaviour to the grain size, all other parameters being kept equal.

Figure 5. Influence of as-built surfaces and building direction; T6 heat treated material (AB: As-Built; MA: machined [14]); 10⁶: run-out samples.

exhibit a strong anisotropy. By comparing T6 and non-T6 results in Figures 5 and 6, one can see that the fatigue strength of non-T6 material is lower than the T6 heat-treated one. This confirms that, even in presence of an as-built surface, the improvement of material matrix, induced by a T6 peak-hardening heat treatment, leads to a significant improvement of the fatigue strength. However, given the limited data and the scatter, this analysis needs to be supported by additional observations. In the same way, it is important to analyse carefully the fractured surfaces to identify the nature of the fatigue initiation site.

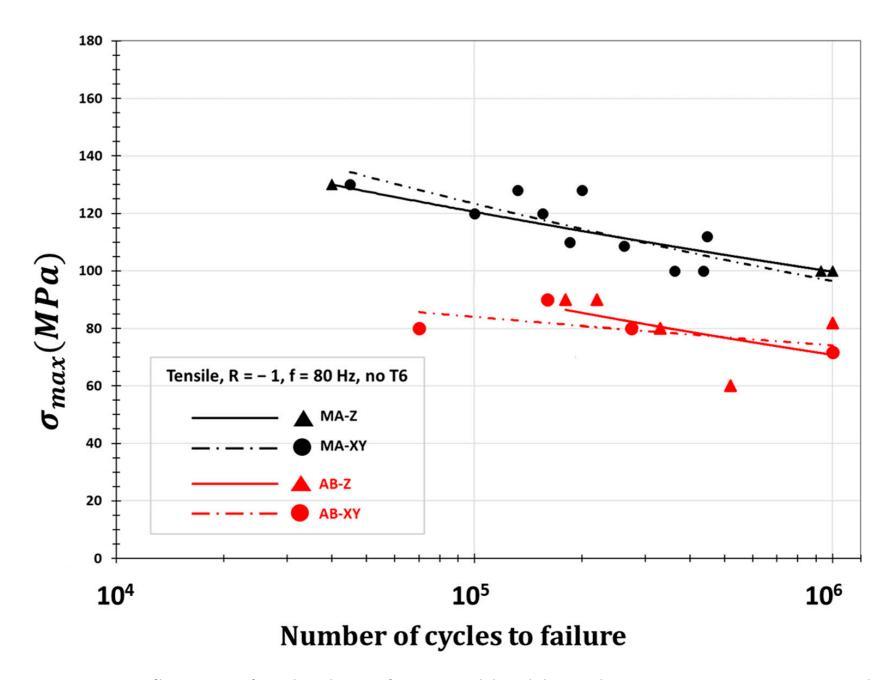
The S-N results for non-T6 material are provided in Figure 6. Only two directions are compared here. Despite to the limited number of specimens tested, it seems that there is no significant influence of the building direction. A similar observation was made on machined specimen in a previous study [14]. Therefore, it comes out that, even in the presence of an as-built surface, the fatigue behaviour of the non-T6 material does not

Figure 6. Influence of as-built surfaces and building direction, non-T6 material, comparison with machined [14]; 10⁶: run-out samples.

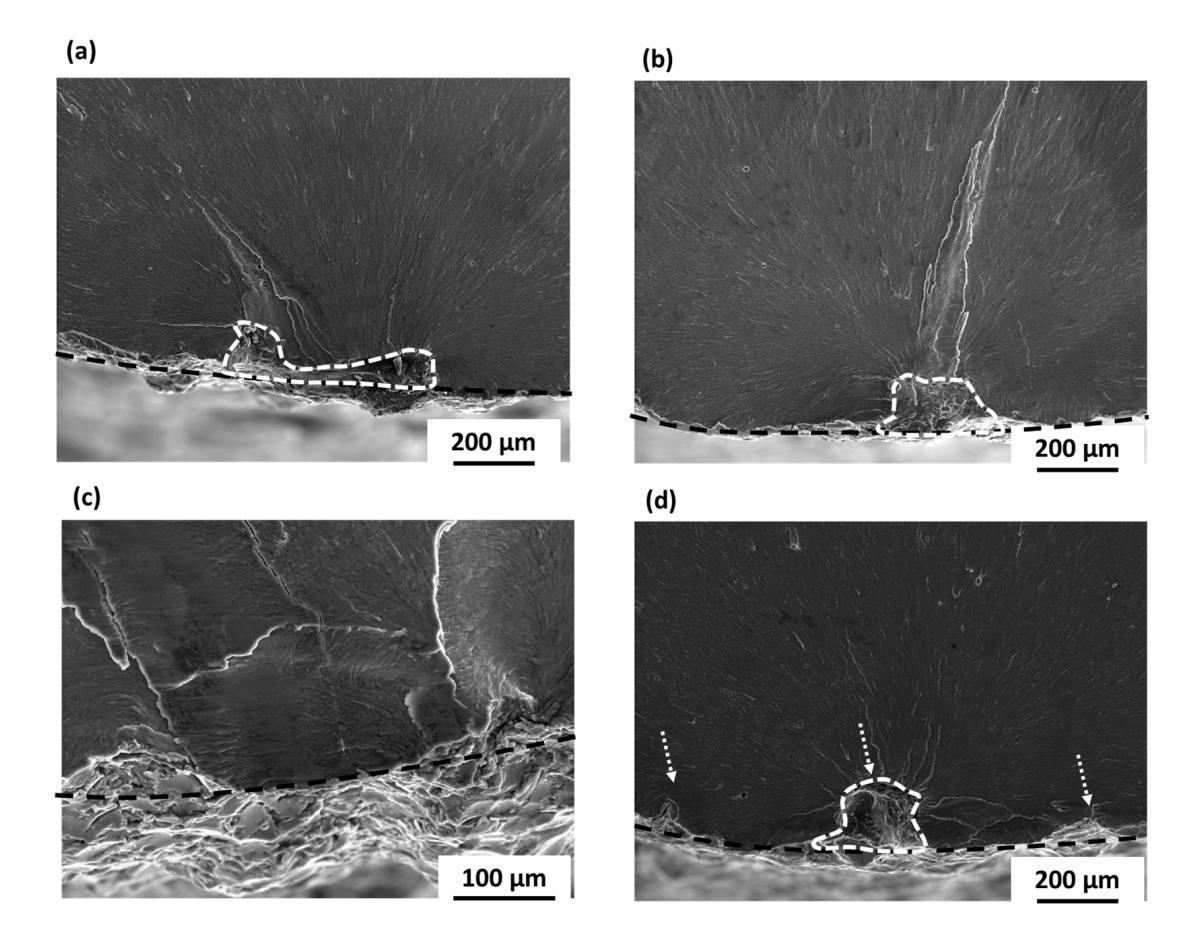
SEM fracture surface observations of non-T6 and T6 material are presented in Figures 7 and 8 which show the fatigue initiation sites. The nominal contours of each specimen, that means the circle that circumscribed the ripples, are indicated by black broken lines. If the initiation related to the presence of porosity, lack-of-fusion or even isolated defect is generally well characterised in machined samples [14,22,25–33], it seems difficult to clearly identify such initiation sites in of the case of such rough surfaces. In Figure 7a,b, and Figure 8b,d, the convergence of river lines makes it possible to surround an area that can be used as the initiation site. In Figure 7c, the crack seems to initiate from a surface at the scale of a particle, while in Figure 7d, one can clearly identify three initiation on a surface ripple. Therefore, the next step in the fracture surface analysis consists of the quantification of the initiation site size, when considered as defect.

Figure 7. SEM observations (**a**) *Z* sample, as-built surface roughness and lack-of-fusion-type defect, $\sigma_{max} = 80$ MPa, Nf = 330,000 cycles, (**b**) *Z* sample, lack-of-fusion-type defect, 90 MPa, 180,000 cycles, (**c**) XY sample, as-built surface roughness, 80 MPa, 275,000 cycles and (**d**) alpha45, sub-surface surface defect, 90 MPa, 90,000 cycles.

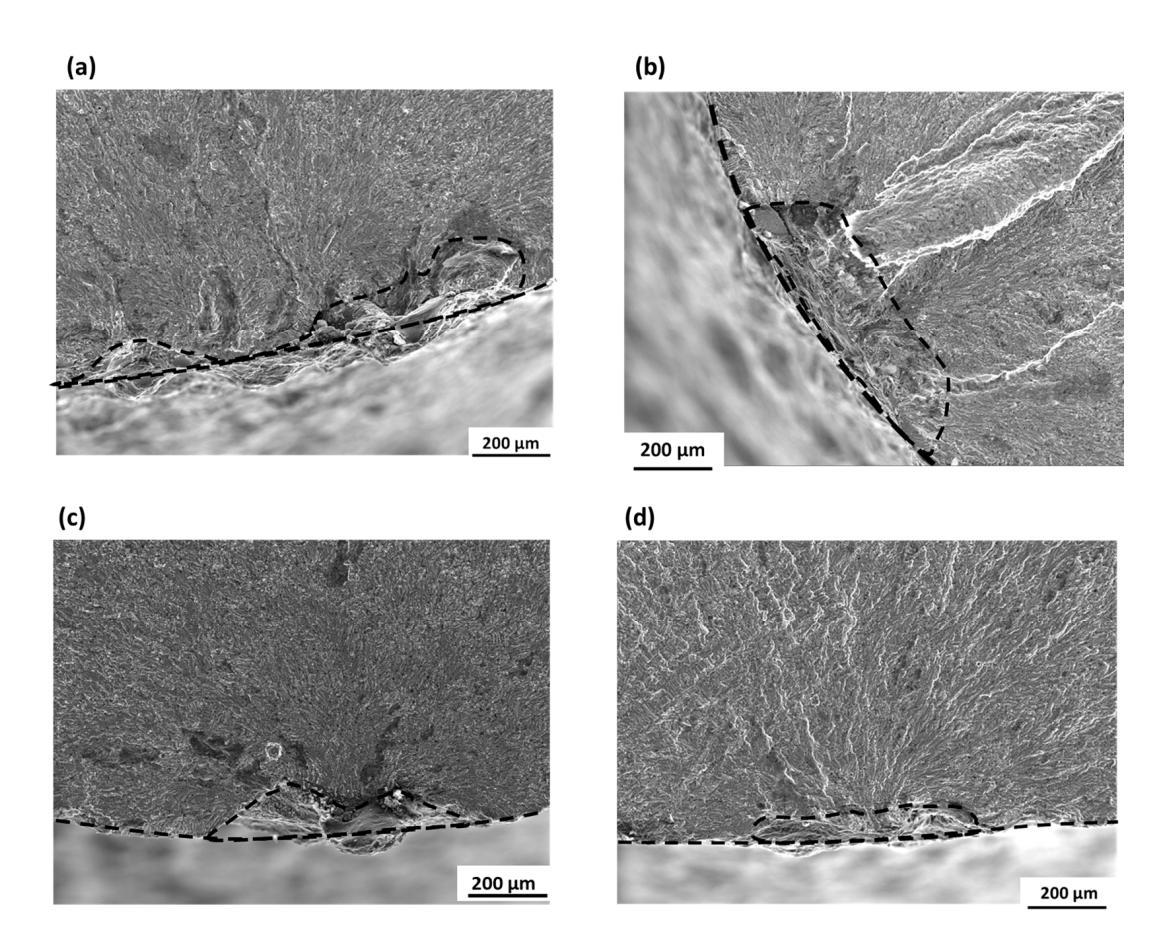
Figure 8. SEM observations of initiation sites (**a**) *Z* sample, surface ripple and lack-of-fusion-type defect, 100 MPa, 800,000 cycles, (**b**) *Z* sample, lack-of-fusion-type defect, 110 MPa, 300,000 cycles, (**c**) XY sample, surface ripple, 90,MPa, 135,000 cycles and (**d**) alpha45, lack-of fusion-type defect, 100 MPa, 1 million cycles.

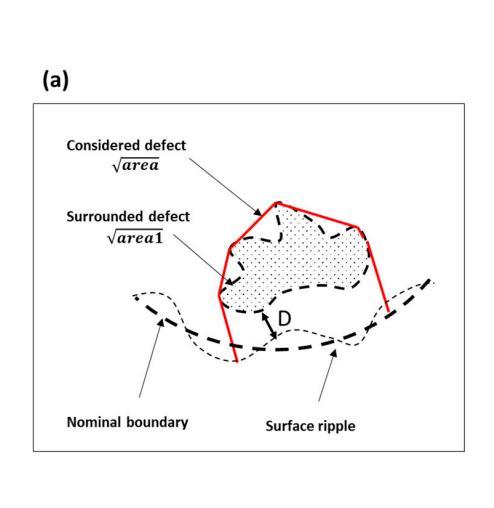
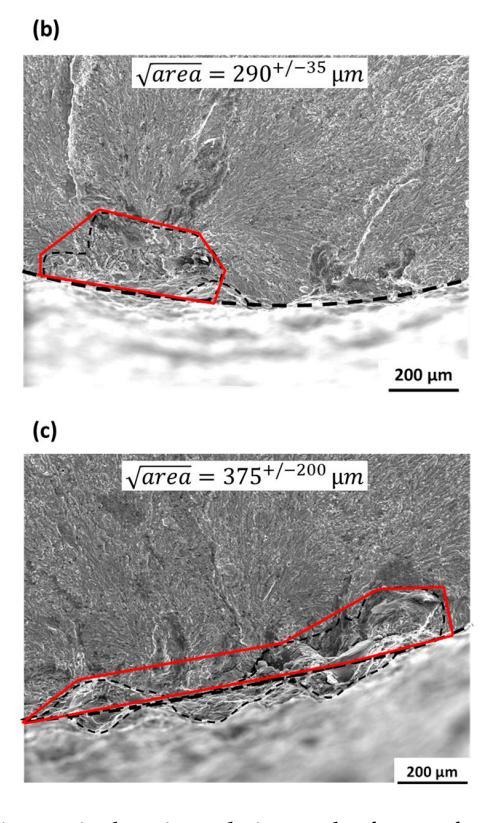
The characteristic defect size is quantified from its contour by using the \sqrt{area} parameter as defined by Murakami and Endo [34]. This parameter corresponds to the square root of the surface resulting from the defect projection onto a plane perpendicular to the loading direction. This criterion was extended by Iben Houria et al. [29], who included the defect concavity and the ligament between the defect and the free surface. This definition of the defect size is extended to the case of surface ripple, as presented in Figure 9a, that is an example of a sub-surface defect, with a size equal to $\sqrt{area1}$. When $\sqrt{area1}$ is smaller than the ligament length *D*, the considered \sqrt{area} size encompasses the convexity, the ligament and the surface ripple. The defect size is assessed from fracture surface observations using this approach and quantification examples are given in Figure 9b,c. The error mentioned in Figure 9b comes from the ripple position. In Figure 9c, the error comes from the consideration or not of the ripple outside the nominal contour.

Figure 9. (a) Estimation of the defect size depending on its location relative to the free surface, (b,c) quantification of defect size on fracture surfaces of AB-Z-T6, (b) 110 MPa, 300,000 cycles and (c) 100 MPa, 800,000 cycles.

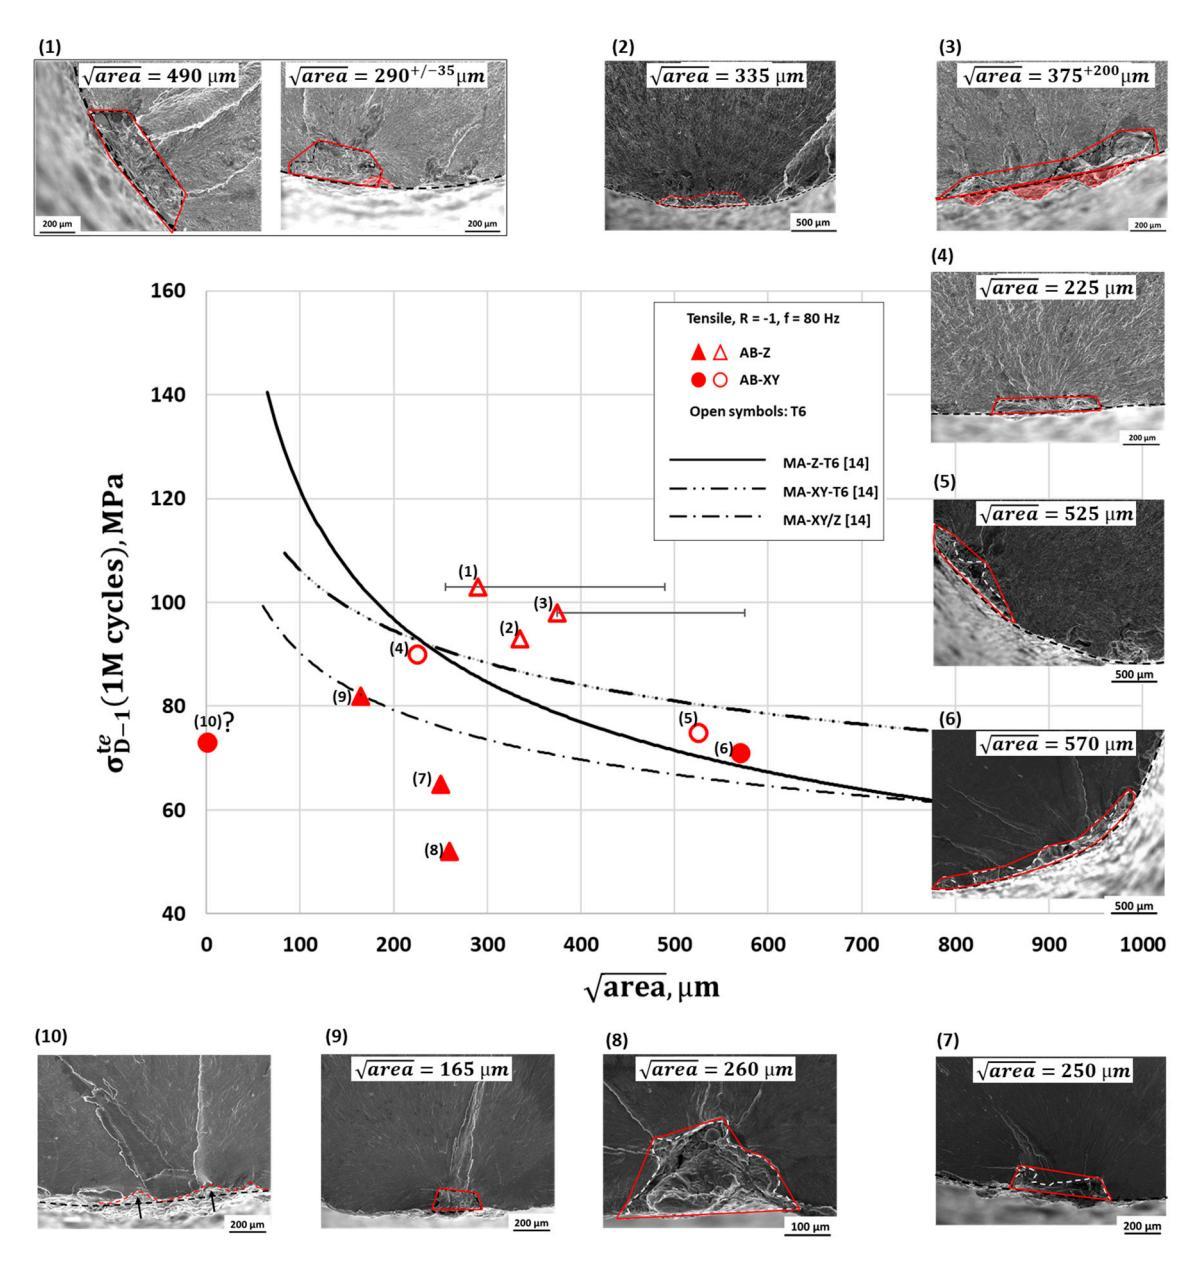
Once the defect size is assessed for each failure, the Kitagawa diagram can be plotted (Figure 10) with the fatigue limit as a function of the defect size. The curves are given for machined samples extracted from a previous study on the same material [14]. Experimental points correspond to fatigue limit obtained, according to Equation (2). One has to notice that this Kitagawa diagram contains less experimental points than the S-N curves as only XY and Z specimen are considered here.

Figure 10. Kitagawa-type diagram showing the impact of defect size of the fatigue limit for as-built material and two building directions, XY and *Z*, in comparison with machined [14].

The experimental points are labeled from 1 to 5 for T6 material and 6 to 10 for non-T6. A large scatter is noticed for the case of the non-T6 material, with a defect size around 250 μ m. Two Z specimens exhibit highly different fatigue limits, while for two other specimens the results are in agreement with those obtained on machined surfaces, even though point number 10 is difficult to place on the graph because of the uncertainty in the surrounding of the defect. Regarding the fracture surface, one can observe that fatigue cracks initiate on surface particles, even in the presence of ripples.

In the case of the T6 material, the results obtained with XY samples match with the tendency curve established for machined samples, while Z-specimens exhibit quite surprising results in that sense that their fatigue strength is superior to the one of machined samples. These unexpected results could be explained by a probable refining of sub-surface grain resulting from the production with extremely low energy density, as presented in Table 1. In fact, this extremely low energy implies higher solidification rates, and thus finer grains that contribute to improve the fatigue strength. The possible contribution of residual stresses should also be considered. Therefore, even if the analysis is enriched by the quantitative assessment of the defect size, in the case of as-built surfaces, one can consider that the sole \sqrt{area} parameter is not sufficient to uncouple the influence of defects from the other parameters such as the building direction or the T6 heat treatment. The local microstructure, the multiple initiation sites and the residual stresses are probably additional important parameters that need to be taken into account in a more comprehensive approach. As explained in a previous section, the roughness is measured for each as-built sample. A possible correlation between the values of the fatigue limit with the roughness parameter R_v has been investigated without success, probably due to the fact that R_v varies from 60 to 90 µm, which is quite a small range.

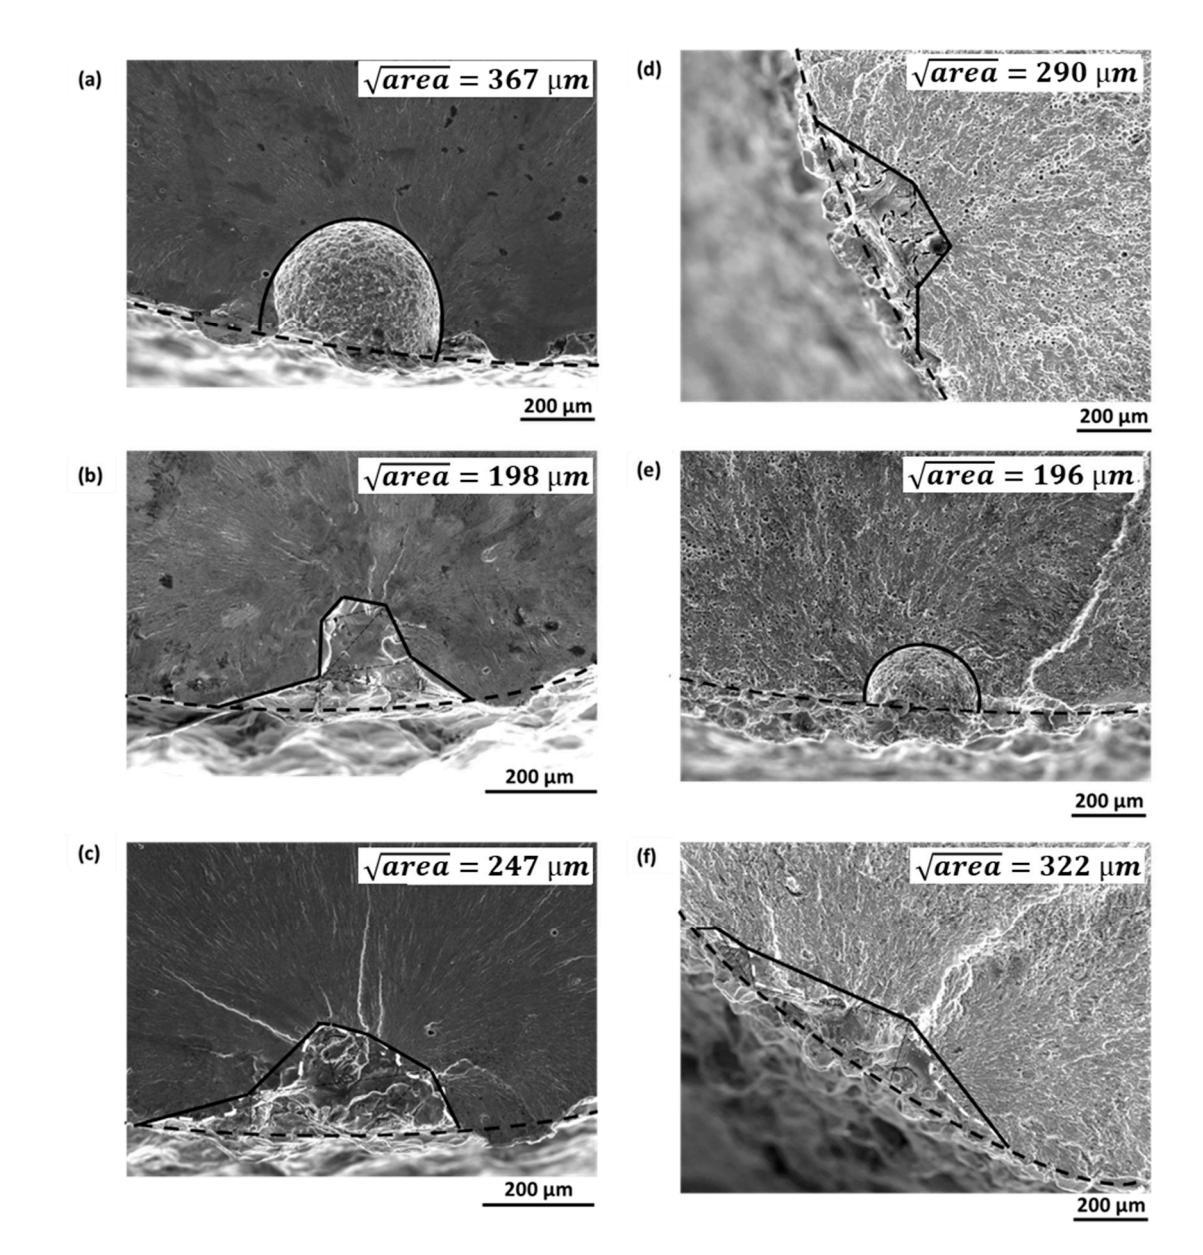
presented in Figure 11. One can notice that contrary to the artificial defects in Figure 11a,e, with quite a regular or homogeneous shape, natural defects are more tortuous.

Figure 11. Data presented on Table 4. SEM observations of initiation sites for AB-Z (**a**–**c**) and AB-Z-T6 (**d**–**f**) specimen. For non-T6 cases: (**a**) direct rupture at 30 MPa after 800,000 cycles, (**b**,**c**) fatigue limit at 1 million cycles of 60 and 53 MPa, respectively. For T6 cases: fatigue limits at 1 million cycles of 37 MPa, 59MPa and 71 MPa, respectively, for (**d**–**f**).

As listed in Table 4, fatigue tests of both T6 and non T6 materials reveal failures on ALM process-inherited defects, despite the presence of artificial defects with at least the same size or even larger. On the one hand, for T6 specimens, a case of failure initiating on a natural defect of 290 μ m in size is noticed despite the presence of an artificial defect of 370 μ m. On the other hand, the non-T6 specimens exhibit a case of failure on a natural defect in presence of an artificial defect of the same size. This confirms that the \sqrt{area} parameter has to be used with extreme care when analysing the data obtained in the presence of as-built surface roughness. Fracture surfaces of as-built broken specimens are

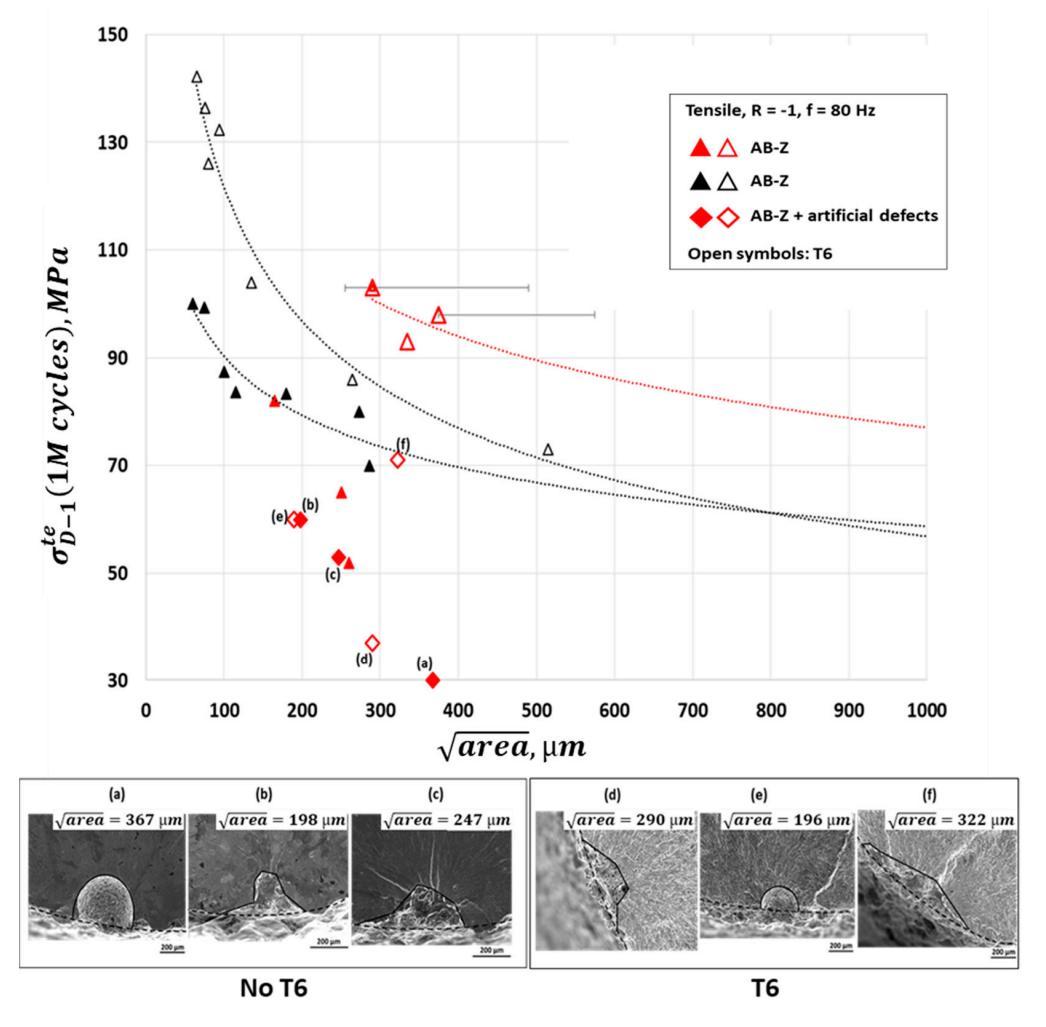
Figure 12 is restricted to the analysis of Z specimens. The results of machined samples correspond to a previous study [14], supporting the use of the \sqrt{area} parameter to analyse the effect of a single defect and to quantify the effect of a microstructure modification due to T6 heat treatment when the surface is regular. For as-built samples, the fatigue strength is particularly low when the specimen contains an artificial defect; one can also remark on some extremely low points for the T6 material. As previously mentioned, the vertical placement of points is certainly inaccurate due to the overestimation of the load-bearing section, but with only 3% underestimation. For the horizontal placement, the meaning of the error bar has been previously explained by the quantification of defects in presence of the surface ripples.

Figure 12. Kitagawa-type diagram showing the impact of defect size and morphology on the fatigue limit of as-built surfaces compared with machined samples in the Z building direction.

Let us now analyse the points labelled with (a) to (f). Specimens (a), (b) and (c) are not heat-treated, contrary to (d), (e) and (f) samples. Fracture surface analysis make it possible to confidentially quantify the defect size for all specimens. For specimen (d), for example, failure is due to the presence of a 290 μ m defect inherited from the process, regardless of the prior introduction of an artificial 370 μ m defect with a spherical shape. Similarly, for specimen (b), in the presence of both artificial and process-inherited defects with the same size, the fracture surface analysis indicates a failure initiating from a natural defect. This confirms that the \sqrt{area} size parameter is not the first order parameter controlling the fatigue limit of as-built surfaces. However, the failure of specimen (a) compared with (d) probably illustrates a competition between defect size and type, with or without prior T6 heat treatment.
