Ultrasonic elastography for the prevention of breast implant rupture: Detection of an increase with stiffness over implantation time

Ultrasonic elastography for the prevention of breast implant rupture: detection of an increase with stiffness over implantation time

Keywords: breast implants, Acoustic Radiation Force Impulse, ultrasound elasticity imaging

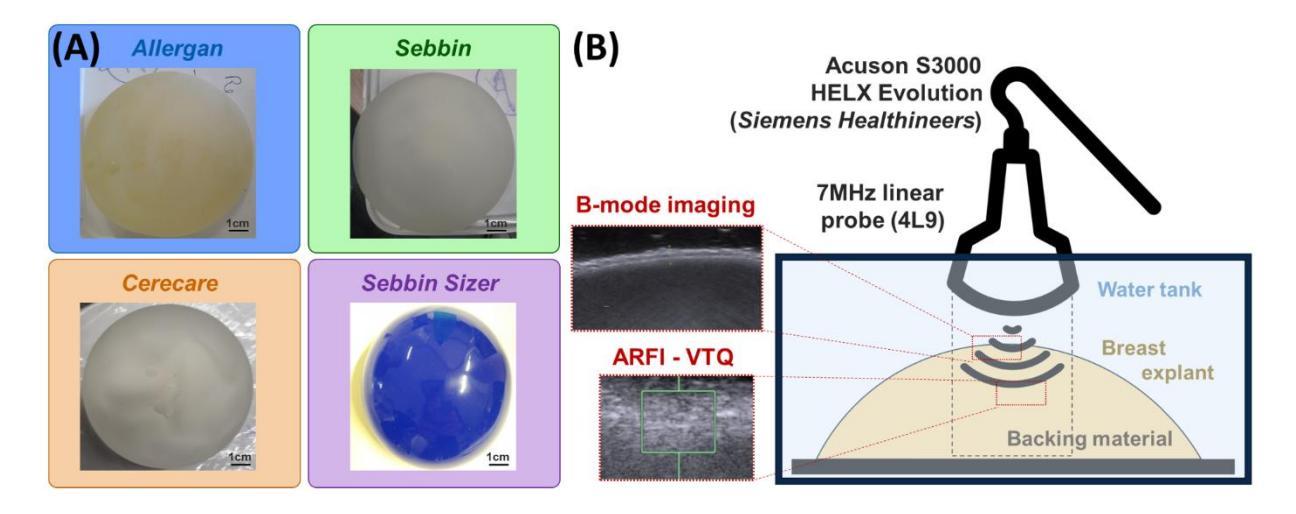
Fig. 1. The samples were scanned using a clinical ultrasound system (*Acuson S3000 HELX Evolution, Siemens Healthineers, Erlangen, Germany*) with a 4L9 linear array transducer centered at 7 MHz. The multi-layer membrane of each explant was observed, and their thicknesses measured using B-mode imaging. Based on the generation of shear waves by focused ultrasound in the organ and then the detection of their propagation velocity by ultrasound imaging, ARFI (Acoustic Radiation Force Impulse) imaging methods (Nightingale et al., 2002, 2001; Palmeri et al., 2008) allows to extract non-invasively the mechanical properties. The gel stiffness was then quantified using Virtual Touch Quantification (VTQ), a shear wave elastography method based on ARFI imaging. Shear wave

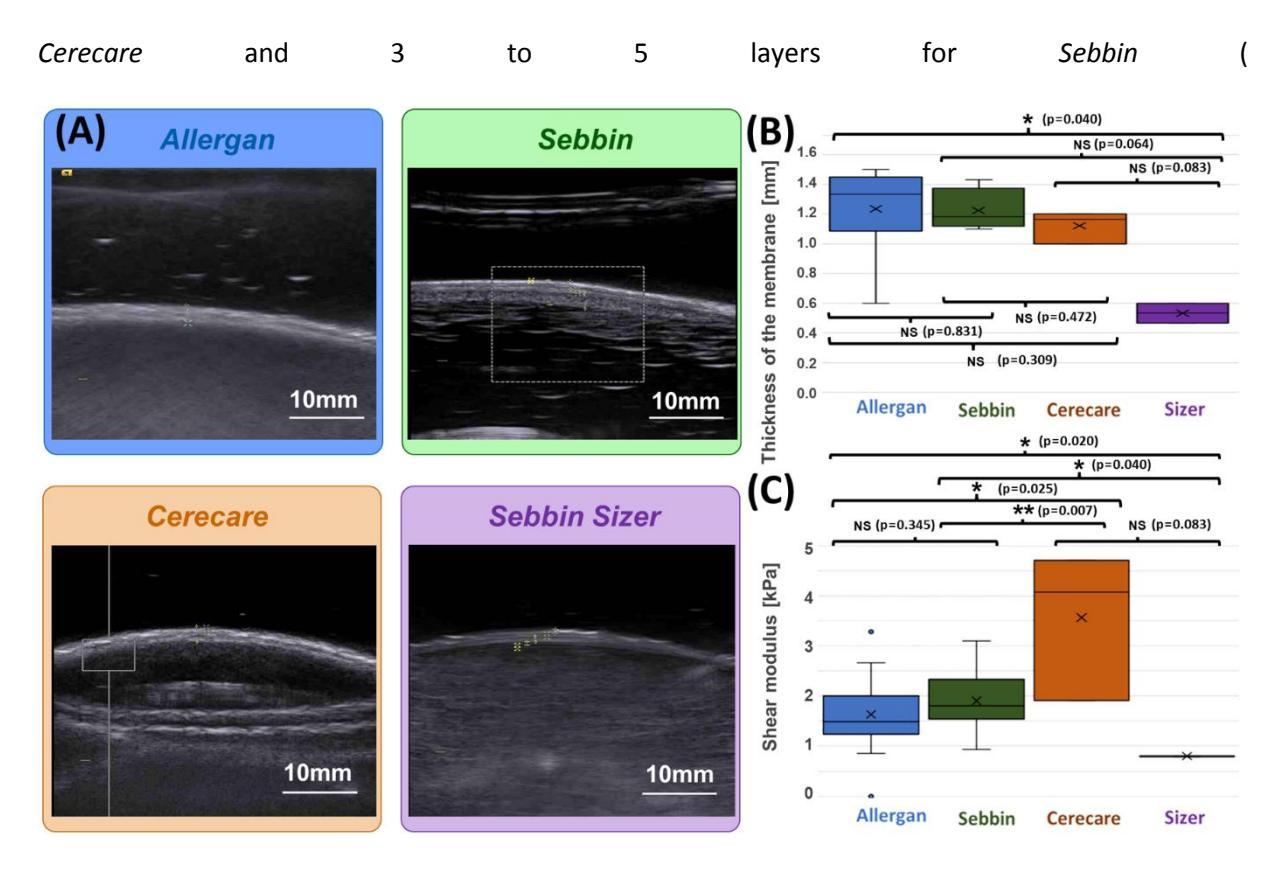
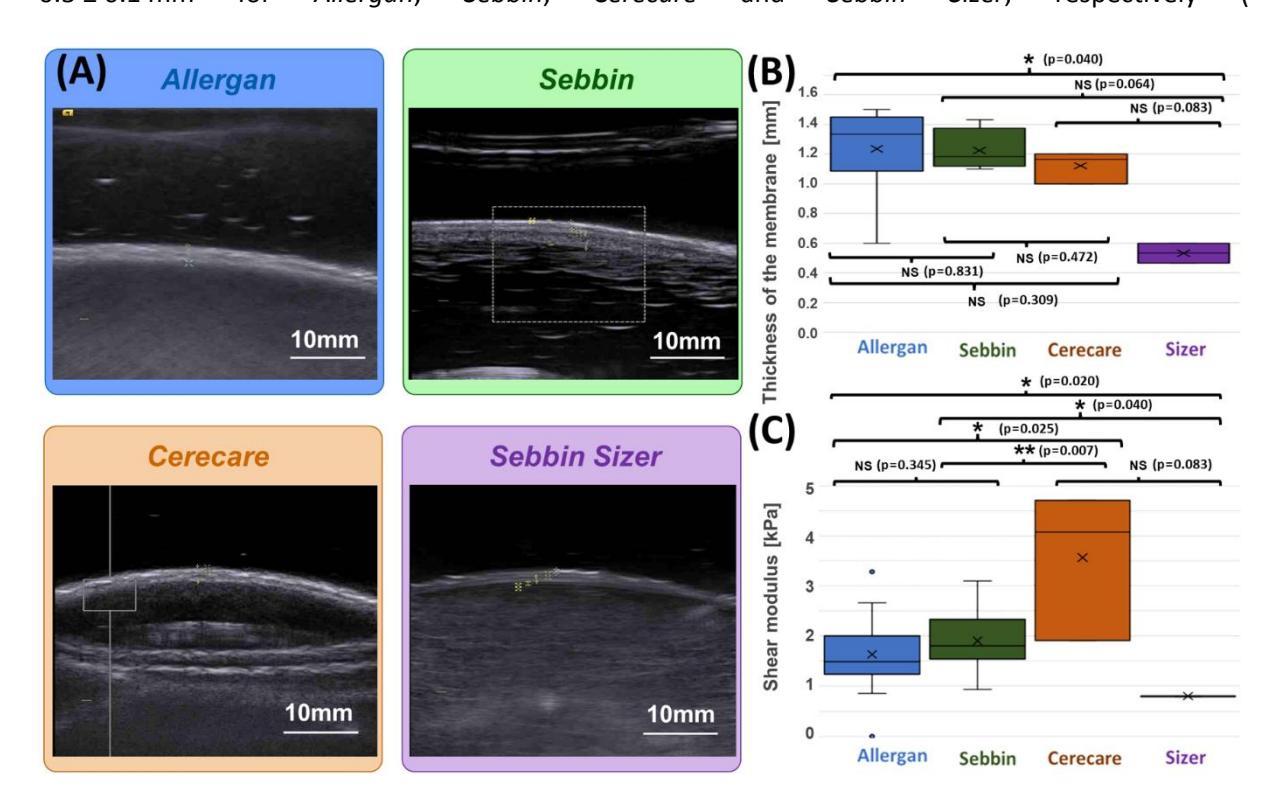
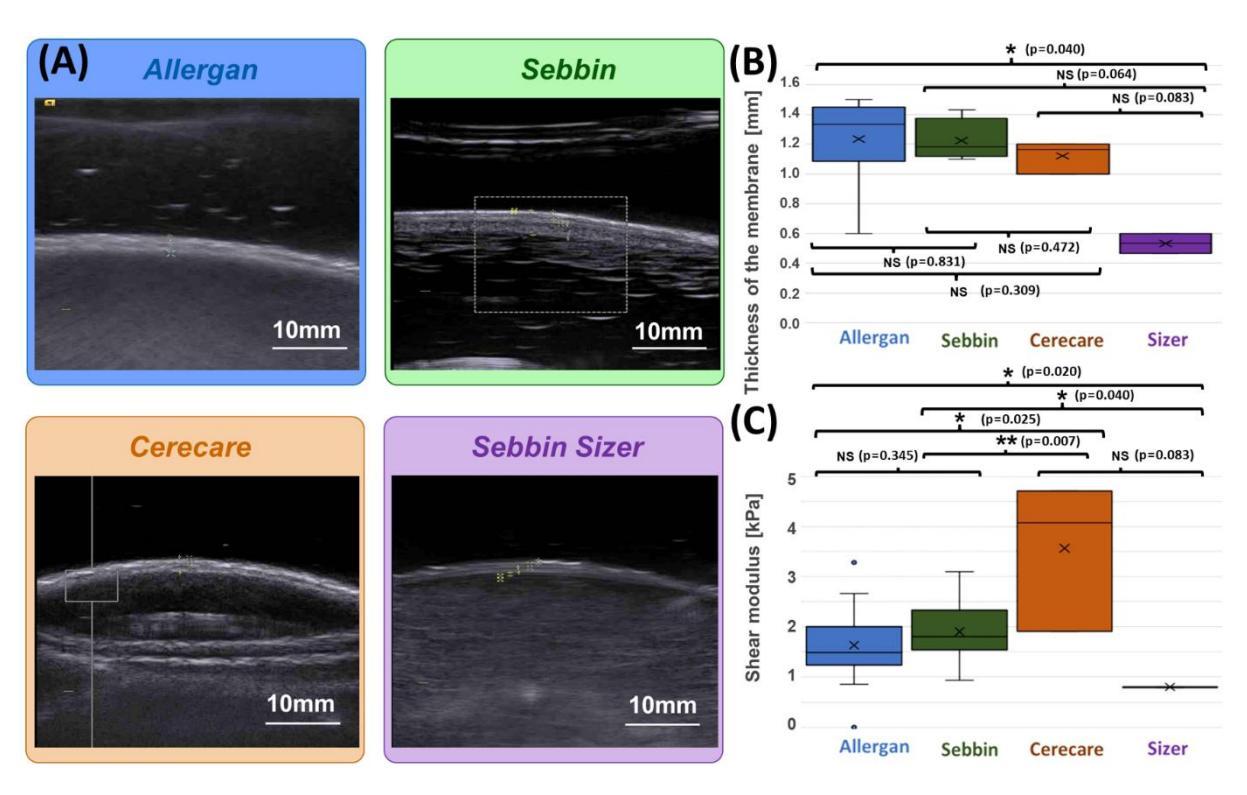
Fig. **3**(A)). The membranes had a thickness of 1.2 ± 0.2 mm, 1.2 ± 0.1 mm, 1.1 ± 0.1 mm and 0.5 ± 0.1 mm for *Allergan*, *Sebbin*, *Cerecare* and *Sebbin Sizer*, respectively (

Fig. **3**(B)). While the thicknesses were similar for the three categories of explants intended for long-term implantation, the thickness of the *Sebbin Sizer* for short-term implantation was lower.

Fig. **3**(C)). Thus, while Allergan and Sebbin have similar stiffness $(1.79 \pm 0.71 \text{ kPa} \text{ and} 1.90 \pm 0.67 \text{ kPa}$, respectively), Cerecare implants appear stiffer $(3.57 \pm 1.47 \text{ kPa})$. The Sebbin Sizer implants have the lower stiffness $(0.80 \pm 0.01 \text{ kPa})$. We can assume that the manufacturing processes of the Sebbin and Sebbin Sizer have an influence on the gel stiffness, as the latter are not intended for long-term resistance. Unlike the Sebbin Sizer, the values on Cerecare show large standard deviation.

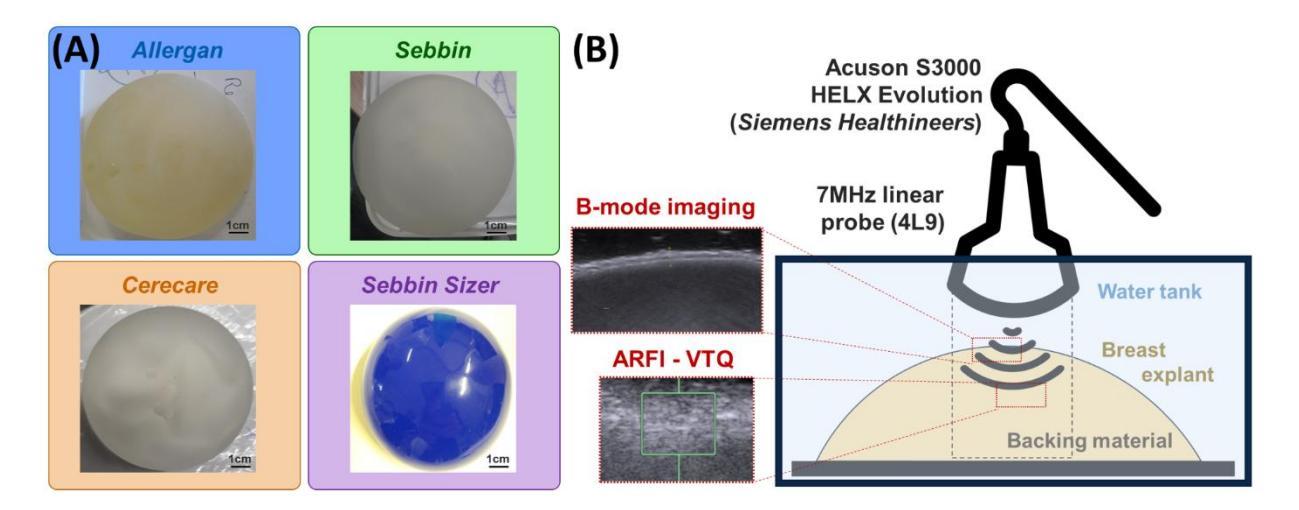
Fig. 1. (A) Example of explants from the 4 manufacturers. (B) Illustration of the experimental configuration. The explants were immersed in water. The membrane thickness was measured using B-mode imaging and the gel stiffness quantified by ARFI VTQ elastography.

The explants were immersed in water to facilitate ultrasound transmission, as illustrated in

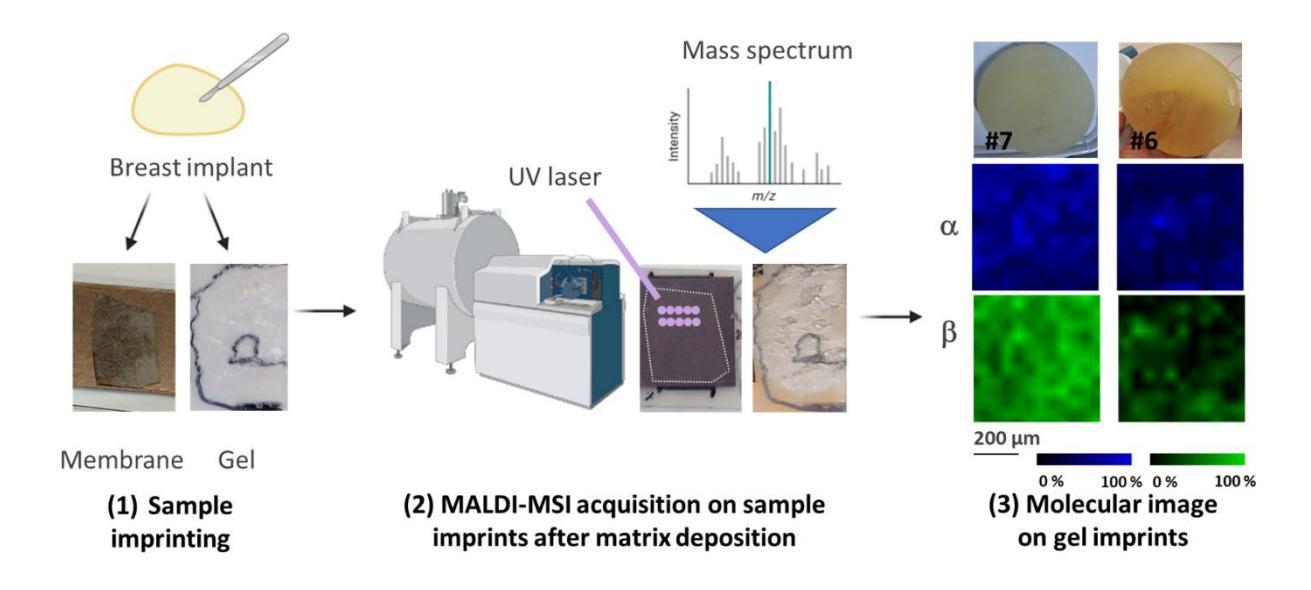
Fig. 2. MALDI-MSI workflow for the molecular analysis of membrane and gel from breast implants. (1) Membrane and gel were separated and directly deposited on an ITO-coated glass slide (gel) or imprinted on a copper tape covering the slide (membrane). (2) MALDI ionization matrix was applied before shooting the samples with a laser to obtain molecular images from membrane and gel. Molecules were identified by data base interrogation. (3) MALDI-MSI performed on the gel from *Allergan* textured samples #6 and #7 indicate presence of 3-ketocholesterol (α) and 7-ketocholesterol (β).

After the ultrasound tests, two *Allergan* explants (#6 and #7) were used for matrix assisted laser desorption/ionization mass spectrometry imaging (MALDI-MSI) analysis (Fig. 2). The aim is to determine: (1) whether organic compounds from the surrounding biological breast tissues were likely to be found in the gel of the explants after having crossed the membrane; (2) whether they would be able to provide hypotheses as to the modification of the mechanical properties of the inner gel.

The gels were deposited on an indium tin oxide (ITO) glass slide. As membranes would not stick to the glass slide, a conductive copper tape was used to make imprints of the membrane's surfaces. Then, the samples were covered with α -cyano-4-hydroxycinnamic acid (HCCA) matrix (10 mg/mL in 70% acetonitrile, 0.2% trifluoroacetic acid) using a M5 spotter (HTX). MALDI-MSI acquisitions were

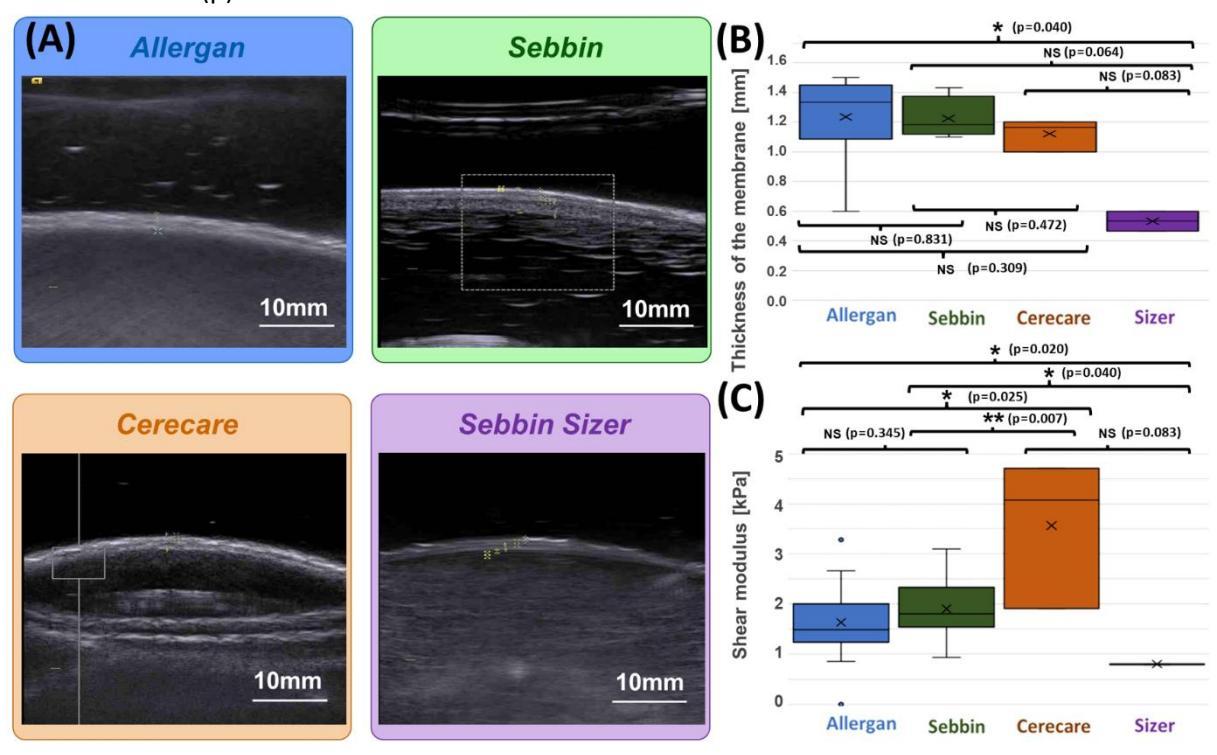
Fig. 3. (A) Examples of B-mode images for the measurement of membrane thickness of implants from each of the four types of implants. mages are presented at the same scale. Membrane thicknesses (B) and then shear moduli measured by ARFI method (C) are compared without dissociation as a function of prosthesis age or implantation time. (*NS: p-value > 0.05, *: p-value < 0.05, *: p-value < 0.01, ***: p-value < 0.001*)

The different layers of the membrane appeared on B-mode imaging with 2 layers for Allergan and

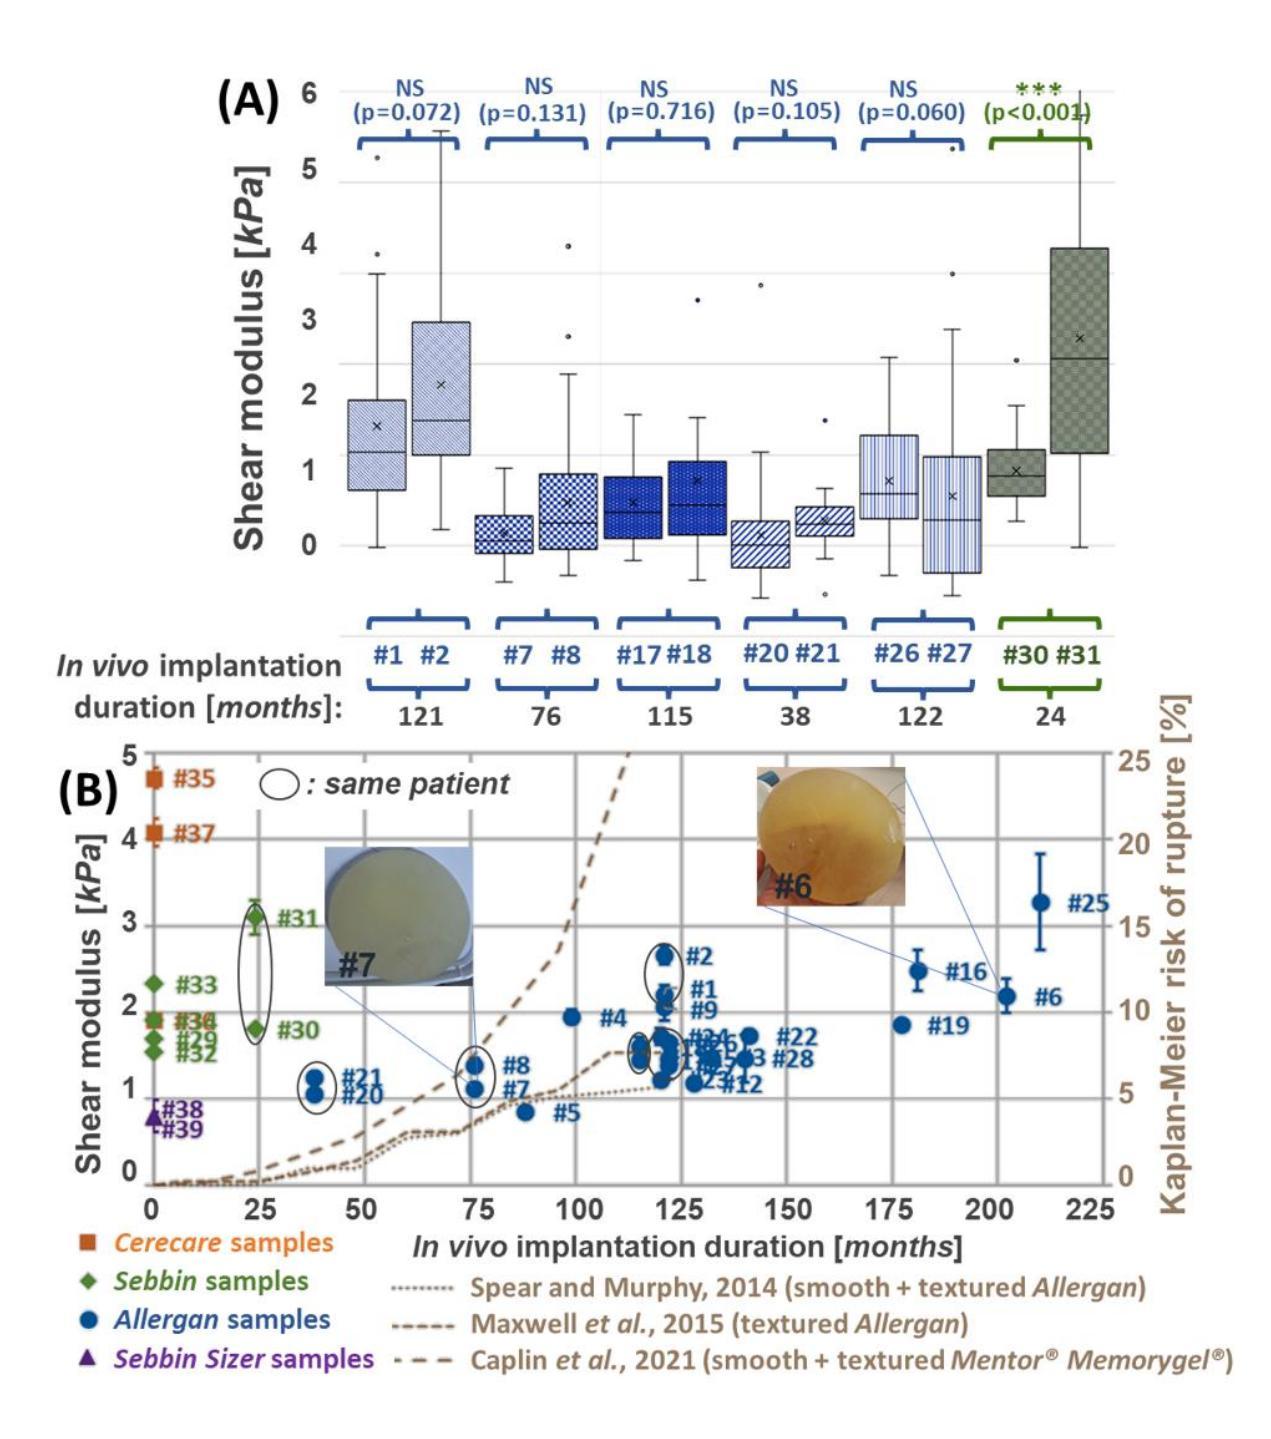
Fig. 4. (A) Paired comparison of stiffness values by ARFI measurements of explants from the same patients. Explant shear modulus is presented as a function of implantation duration for *Allergan* textured in blue and *Sebbin / Cerecare / Sebbin Sizer* smooth implants in green, orange and purple, respectively, collected in this study (B) (primary axis). A clear correlation between implantation time and implant stiffness appeared significantly (PCC = 0.67, r_s = 0.5). The evolution of the shear modulus is compared to that of the rupture risk (Kaplan-Meier risk rate (Kaplan and Meier, 1958)) reported in the literature (brown, secondary axis) (Caplin et al., 2021; Maxwell et al., 2015; Spear and Murphy, 2014). (*NS: p-value > 0.05, *: p-value < 0.05, **: p-value < 0.01, ***: p-value < 0.001*)

For *Allergan*, we had 5 pairs of explants, extracted from the same patient two by two. A pair-wise comparison of the stiffness of these explants shows similar values (Fig. 4(A)). This is not the case for the only pair of *Sebbin*. For *Sebbin* a real significant difference appears between the two implants. Fig. 4(B) shows in blue the *ex vivo* analysis of the stiffness of the silicone gel of the 24 *Allergan* explants (textured) over their implantation duration.

The mechanical properties of all the explants tested showed a significant increase of stiffness in time after about 8 years of implantation and this increase is correlated with the implantation duration (PCC = 0.67, r_s = 0.5). An explant carried for 210 months is 3 times stiffer than for 38 months. This quasi-linear behavior in two parts has an inflection point around 8 years of implantation (PCC of 0.72 and 0.85 for <7 and >9 years, respectively). The evolution of the shear modulus is compared to that of the rupture risk (Kaplan and Meier, 1958) reported in the literature (Caplin et al., 2021; Maxwell et al., 2015; Spear and Murphy, 2014). Although only a few prospective systematic analyses have been conducted (Bodin et al., 2015), a similar trend is observed.

First differences appeared by visual observation of the general external aspect of the explants, the oldest ones often presenting an accentuated yellowish aspect, suggesting exchanges with the biological tissue (Fig. 4(B)).
