Infrared thermographic evaluation of fatigue behavior of concrete

Minh-Phong Luong

Minh-Phong Luong. Infrared thermographic evaluation of fatigue behavior of concrete. 14th International Conference on Structural Mechanics in Reactor Technologies (SMiRT 14), 1997, Lyon, France. pp.155-161. hal-00116460

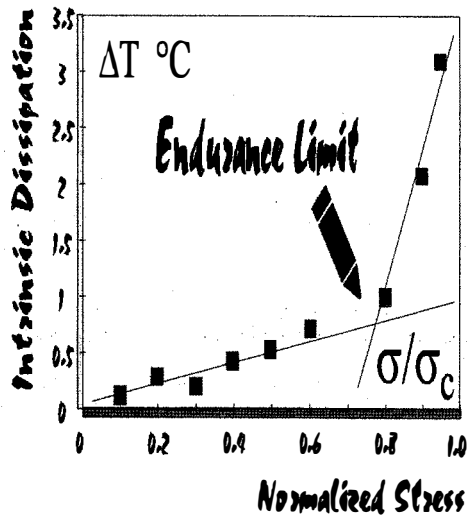
Fig. 2 Graphical determination of the fatigue limit of a concrete specimen.

Experimental results are summarized in Figure 2 which illustrates how the fatigue limit is determined using a graphical procedure. The threshold of critical thermal dissipation is roughly the same for different chosen number of load cycles. It roughly corresponds to the value deduced from standard procedures. These experiments have shown that the infrared thermographic technique can provide the fatigue limit of concrete within a few hours instead of several months when using for instance the standard staircase method.

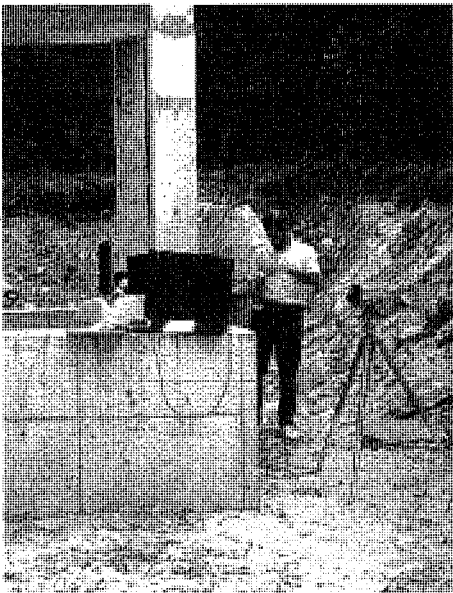
Fig. 3 Experimental concrete structure under a seismic type loading.

The damaged areas are located and highlighted by heat patterns. These results support and validate the assumptions to be taken into consideration in numerical procedures for stability assessment of concrete structures. The phenomenological behavior in consideration is therefore the standard of reference, allowing the use of the methods and results of continuum mechanics for analyzing and modeling their engineering performance. Information about the location and significance of structural defects as a basis for maintenance decisions, including the extreme case of removal from service, can be obtained through inspection and nondestructive evaluation. The proposed infrared thermographic procedure involves careful

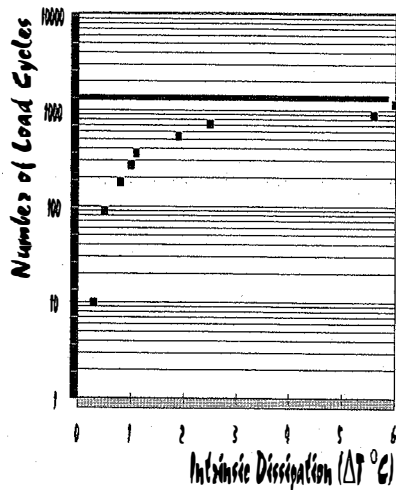
Fig. 4 Fatigue lifetime evaluation of a column base of the reinforced concrete structure subjected to seismic type loading.

examination of areas where defects are most likely to occur. The critical areas can be identified by analyzing the structure and the service histories of similar structures in similar environments. The application of infrared scanning to inspection of concrete structure relies on the fact that the energy is dissipated during the process of accumulative damage when internal cracks or flaws develop. Figure 3 describes an experimental reinforced building frame, intended for earthquake resistance studies. The most severe likely earthquake can be survived if the members are sufficiently ductile to absorb and dissipate seismic energy by inelastic deformations with little decrease in strength. Under seismic loading, simulated by a rotating mass exciter placed on the top of the building, plastic hinges form progressively at the column bases where heat dissipation can be observed by infrared thermography. Fig. 4 shows the progressive evolution of heat dissipation at a column base before crack line becomes visible.
