Infrared thermographic evaluation of fatigue behavior of concrete

Minh-Phong Luong. Infrared thermographic evaluation of fatigue behavior of concrete. 14th International Conference on Structural Mechanics in Reactor Technologies (SMiRT 14), 1997, Lyon, France. pp.155-161. hal-00116460

Luong M.P.

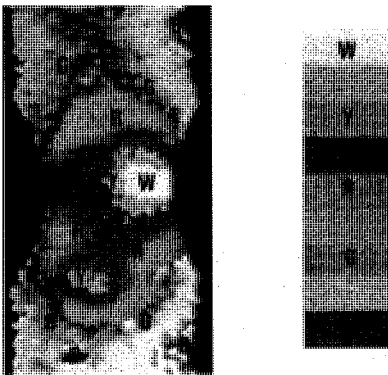
Fig. 1 Infrared thermography of a concrete specimen under vibratory compressive excitation: weakness zones are readily detected by heat patterns after 7,000 load cycles (0.2 °C for each color hue).

- a) With a vibratory excitation between 25 and 50 percent of the nominal uniaxial compression $\sigma_N = F/S_0$, the heat dissipation, detected for 2,000 load cycles, is small, even at the hottest location.
- b) When $0.50 \leq \sigma/\sigma_N \leq 0.75$, stress concentrations around cracks or defects are readily detected at the 1,000th load cycle.
- c) For $0.63 \leq \sigma/\sigma_N \leq 0.88$, cracking occurs increasingly in the reduced section part of the specimen.

Infrared thermography readily depicts intrinsic dissipation localization announcing quite different mechanisms of damage preceding concrete failure. The different phases of heat dissipation, operating during an unstable failure, are readily described by heat patterns. When defects or weakness zones are present on the specimen, infrared observations evidence the progressive mechanism of defect coalescence (Figure 1). The rate of heat generation at the hottest location is used to detect the threshold of the failure process if compared with the traditional stress-strain curve.
