Minh-Phong Luong. Infrared thermographic evaluation of fatigue behavior of concrete. 14th International Conference on Structural Mechanics in Reactor Technologies (SMiRT 14), 1997, Lyon, France. pp.155-161. hal-00116460

Infrared thermographic evaluation of fatigue behavior of concrete

Luong M.P.

LMS - Ecole Polytechnique, France

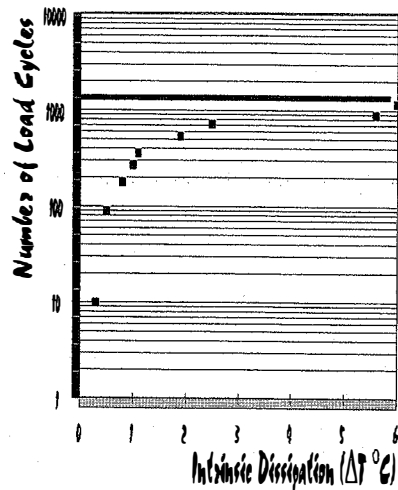
Fig. 4 Fatigue lifetime evaluation of a column base of the reinforced concrete structure subjected to seismic type loading.

examination of areas where defects are most likely to occur. The critical areas can be identified by analyzing the structure and the service histories of similar structures in similar environments. The application of infrared scanning to inspection of concrete structure relies on the fact that the energy is dissipated during the process of accumulative damage when internal cracks or flaws develop. Figure 3 describes an experimental reinforced building frame, intended for earthquake resistance studies. The most severe likely earthquake can be survived if the members are sufficiently ductile to absorb and dissipate seismic energy by inelastic deformations with little decrease in strength. Under seismic loading, simulated by a rotating mass exciter placed on the top of the building, plastic hinges form progressively at the column bases where heat dissipation can be observed by infrared thermography. Fig. 4 shows the progressive evolution of heat dissipation at a column base before crack line becomes visible.
