Natural and anthropogenic hazards in karst areas of Albania

M. Parise, P. Qiriazzi, S. Sala

M. Parise, P. Qiriazzi, S. Sala. Natural and anthropogenic hazards in karst areas of Albania. *Natural Hazards and Earth System Sciences*, 2004, 4 (4), pp.569-581. hal-00299185

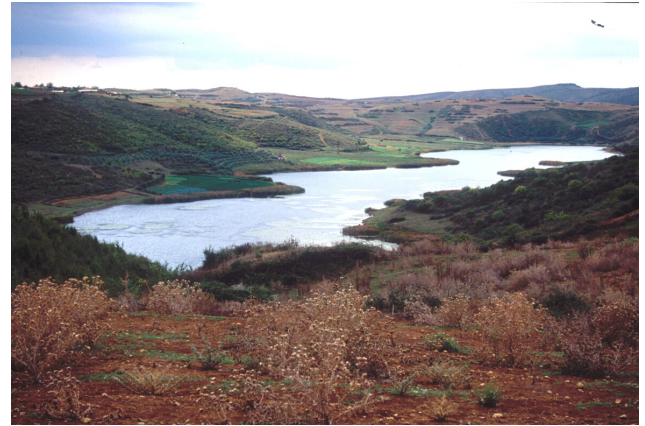
Fig. 2. View of lake Deges the largest among the about 80 karst lakes in the Dumre district.

formation is related to the presence of thick deposits of residual clays and *terre rosse* (Fig. 2). Messinian evaporites are present in the Kavaja area, west of Tirana, producing a quite different landscape. The evaporites crop out along a narrow, NW-SE elongated, strip at the contact with Pliocene sands and clays. In this case, several caves are present in the evaporitic rocks, mostly with sub-horizontal development (Bassi et al., 1999; Qiriazzi et al., 2004).

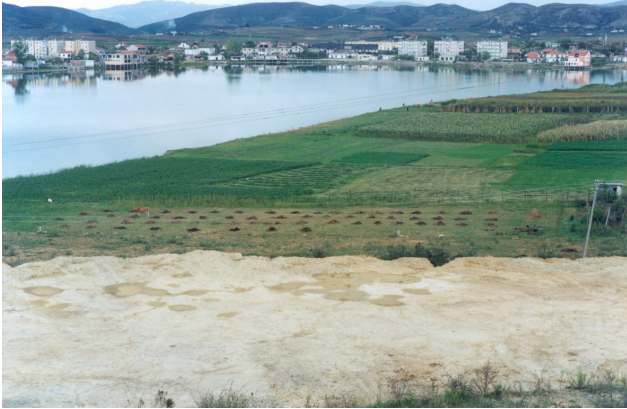
Fig. 4. Partial view of the Belsh lake, in the Dumre district. The water was once used as drinkable water, but later development of the town of Belsh (at the lake margin), and intensive use of herbicides and pesticides for agricultural practice in the surrounding areas, resulted in heavy pollution, and degradation in the quality of water.

Pollution is furtherly indicated by loss of many fish species which once populated the lakes. Specially for the lakes located nearby villages, such as the case for Belsh Lake (Fig. 4), at the homonymous village, the level of pollution seems to be particularly bad, due to discharge of liquid waste, likely including chemicals, in the lake. Unfortunately, no data are available to control the type and amount of polluting substances, and, to our knowledge, no monitoring of the quality of water has started.

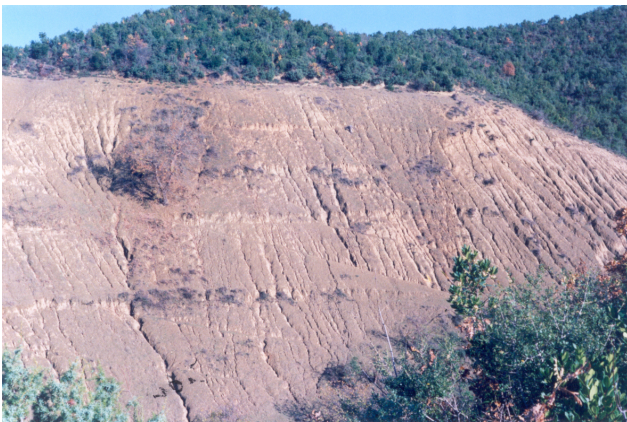
Fig. 6. Slope in the Gramsh area, south of Elbasan: the slope in flysch deposits, originally covered by vegetation, was used for agriculture practice, with the farm tractors working along the steepest slope gradient. This resulted in development of rills and gullies, which in turn forced the farmers to abandon the slope.

be coupled with the topography of the region, and with land-use practices as well. The latter, in particular, may be responsible for increasing of the erosion, especially when farmers cultivate steep slopes using machinery which open the way to development of linear erosion, through the formation of rills and gullies (Fig. 6).

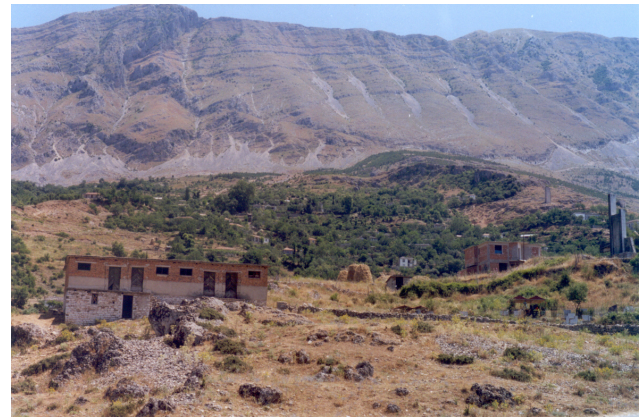
Fig. 7. Tectonic contact between flysch and conglomerates (in the foreground) and limestones which form the backbone of *Mali i Gjere* (in the background), near Gjirokastr. Until 40 years ago, the limestone mountains were covered by thick forests. Wood cutting and wildfires were extremely diffuse in the area in the last tens of years, and the lack of tree cover promoted intense erosion, with great production of debris which fed the talus cones visible at the footslopes.

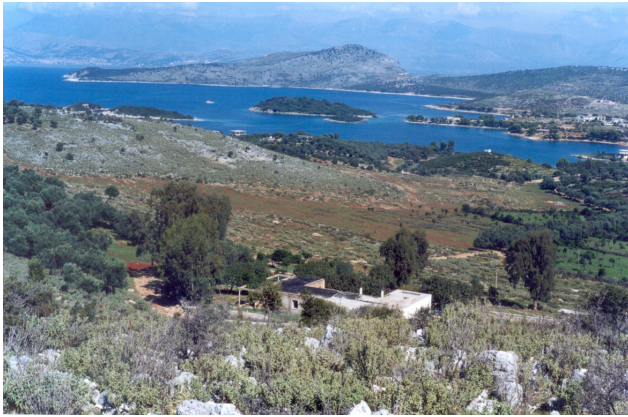
Fig. 8. View of the albanian coast south of Saranda: this stretch of the Adriatic Sea is polluted due to wastewater from the Ksamil village (visible in the photo) and from the military buildings shown in the foreground.

Even as regards groundwater pollution, the political and social changes occurred in Albania did not change much the situation during the transitory period: on the contrary, since subterranean water was used without any restriction, and industrial remnants discharged underground, the quality of water in karst areas strongly degraded. A further problem, on which up today very few data are available, is represented by sea water intrusion in coastal karst areas, due to excessive pumping from wells. Sea water intrusion is a very serious problem along many coasts of the Mediterranean, and has been intensively studied, for example, in the Apulian karst of southern Italy (Cotecchia et al., 1983; Delle Rose et al., 2003). Located exactly in front of Apulia, at the other end of the Adriatic Sea, Albania too has long stretches of coast where carbonate rocks crop out, and wide coastal plains characterized by marsh and palustrine lands, as in Apulia (Delle Rose and Parise, 2002). All of these areas, in consequence of the increasing population moving toward the coast, because of the attempt to launch tourist exploitation of the sites, are likely to be involved in the next years by sea water intrusion problems, if the exploitation of groundwater resources is not performed adequately (Selenica, 1998). In addition to sea water intrusion problems, events of pollution have been registered at many sites, due to mismanagement of the environment (Fig. 8).

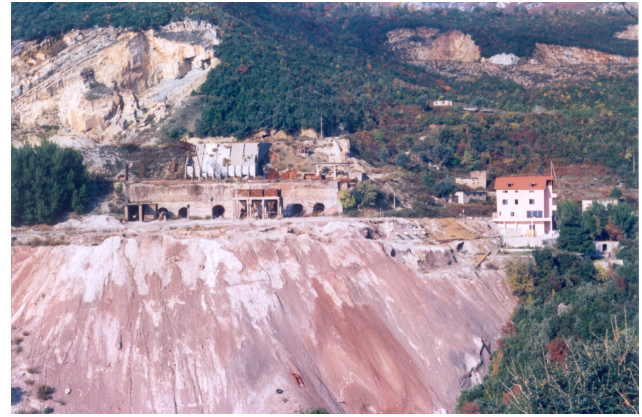
Fig. 9. Quarry facilities which were active during the Communist period for lime production from limestones of Burdigalian age. The quarry is located close to the village of Linxe, in the Dajt province, just east from Tirana. Wastes from the activity were discharged in the Tirana river, running just below, and some of its main tributaries.

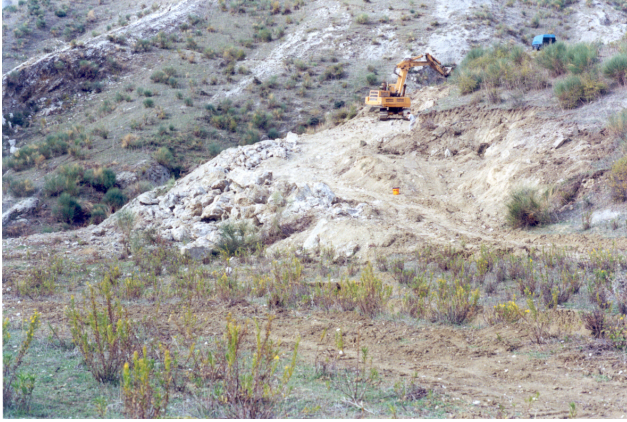
Fig. 10. Gypsum and alabaster mining areas near the village of Mëngaj (Kavaje district). Messinian evaporites have been the object of intensive extraction, without considering the presence of several karst caves, some of which have been destroyed by the mining activity. Protests from environmentalists and scientists eventually resulted in stopping the activities, thus saving at least a karst cave located few tens of meters apart from where the caterpillar is (north-western corner of the photo).

Evaporite rocks are object of quarrying, too: few years ago, in the area of Mengaj, a small village close to the town of Kavaja, where Messinian evaporites extensively crop out, works to extract gypsum started. Several dolines were soon canceled, until the front of excavation reached the entrance of a cave (Fig. 10). Even though the intention was to proceed quarrying, with no concern for the cave, which was going to be destroyed, in this case the protest arised from environmentalists, local inhabitants and researchers was successful in stopping the activity. This was, however, a very unique example. Many other caves in evaporite rocks had been lost, at Mengaj, in the Dumre district, and at other sites.

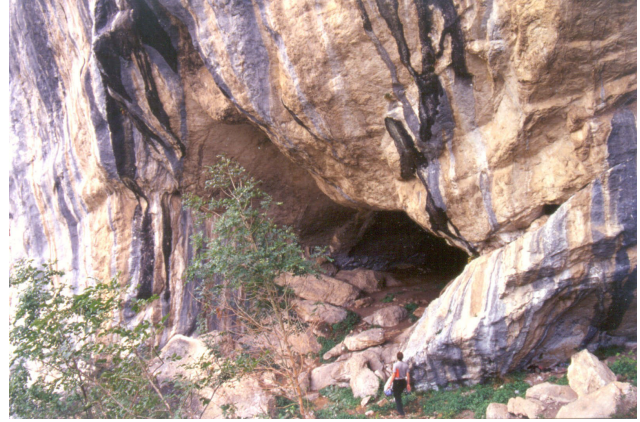
Fig. 11. Entrance of the cave *Shpella ë zeze*, important site for karst, paleontological and archaeological researches.
