Site investigation and modelling at “La Maina” landslide (Carnian Alps, Italy)

Abstract. The Sauris reservoir is a hydroelectric basin closed downstream by a 136 m high, double arc concrete dam. The dam is firmly anchored to a consistent rock (Dolomia dello Schlern), but the Lower Triassic clayey formations, cropping out especially in the lower part of the slopes, have made the whole catchment basin increasingly prone to landslides. In recent years, the “La Maina landslide” has opened up several joints over a surface of about 100 000 m², displacing about 1 500 000 m³ of material. Particular attention is now being given to the evolution of the instability area, as the reservoir is located at the foot of the landslide. Under the commission of the Regional Authority for Civil Protection a numerical modelling simulation in a pseudo-time condition of the slope was developed, in order to understand the risk for transport infrastructures, for some houses and for the reservoir and to take urgent measures to stabilize the slope. A monitoring system consisting of four inclinometers, three wire extensometers and ten GPS bench-mark pillars was immediately set up to check on surface and deep d

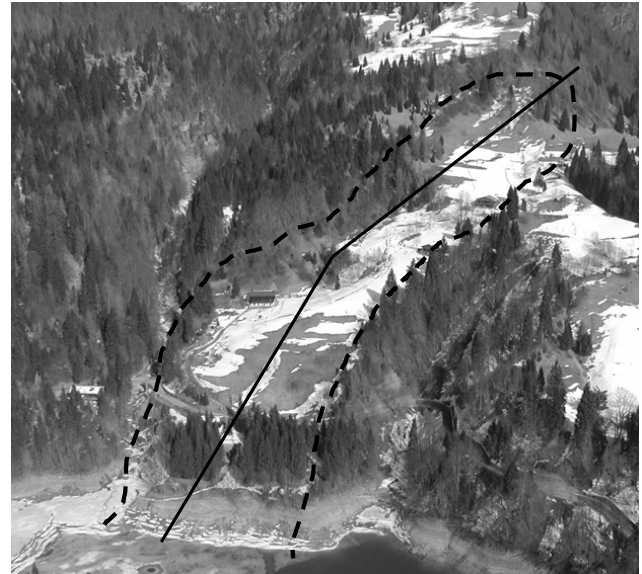
Fig. 2. The “La Maina” landslide. Modelling cross section is highlighted.

The “La Maina” landslide (Fig. 2) is located some kilometers uphill from the dam, bordered by Poch stream on the right hand side, just before the Sauris villages. The phenomenon involves both the Quaternary terrains and Werfen Formation which were mobilised after a period of high intensity rainfall occurred in October 2002. The landslide represents a risk for some houses located in the unstable area and on its foot as well as for the underlying provincial road (unique road from Sauris to Ampezzo) and for the lake whose basin might be involved if a collapse occurs.

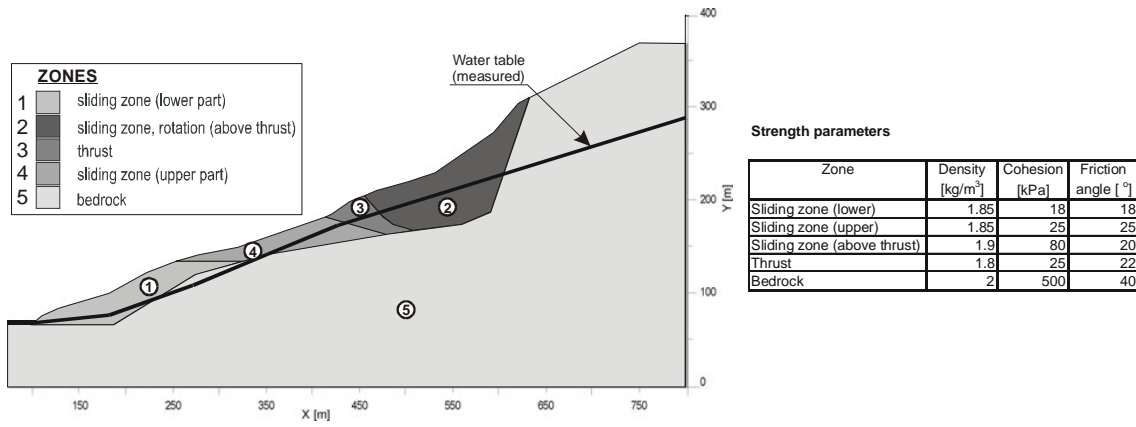
Fig. 4. Division of the slope into geotechnical zones.

- slope is divided into proper geotechnical zones (Fig. 4);
- values of geotechnical parameters are defined for each zone (see Fig. 4);
- failure process is intuitively estimated (“predicted”).

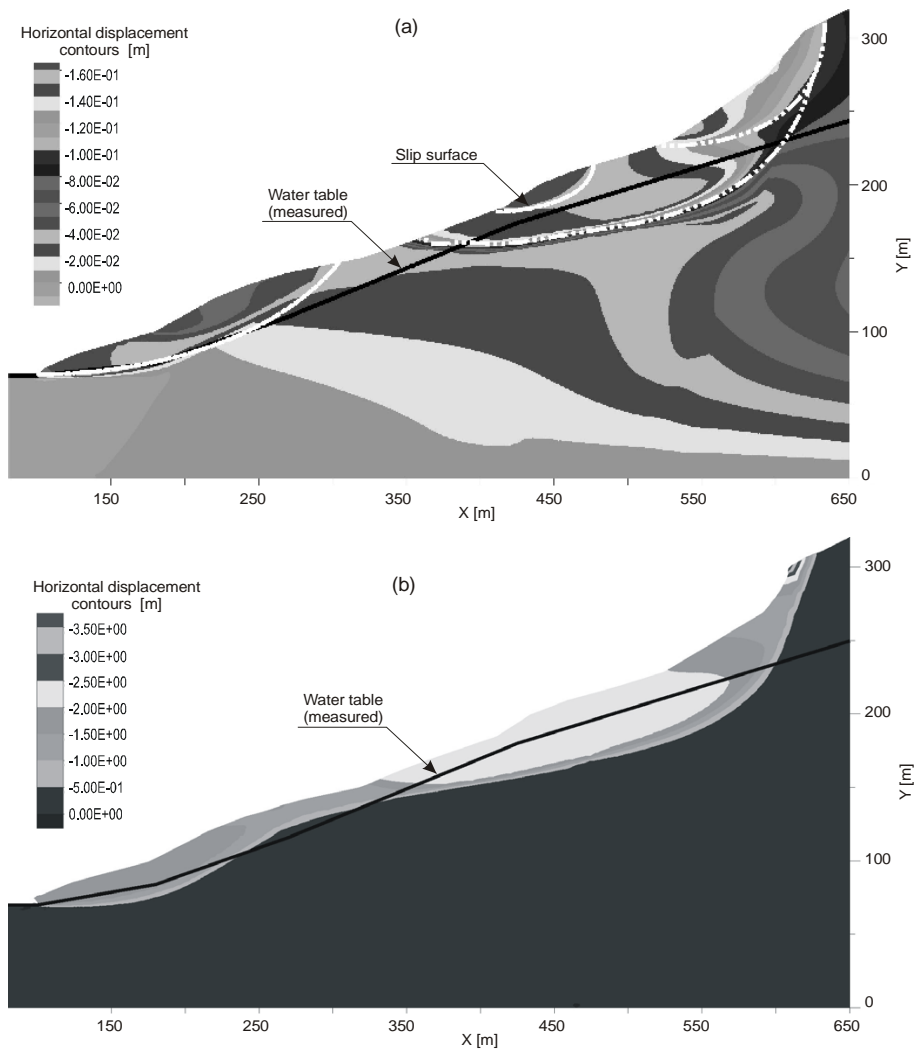
Fig. 5. Horizontal displacement of the slope, (a) actual conditions, (b) water table position lifted at 6 m compared with actual level.

last (third) stage water table was increased at 6 m in comparison to the actual position. The main results are presented in Figs. 5 and 6.

Figure 5 shows the distribution of actual and possible (predicted) horizontal displacement. It could be seen that presently measured water level does not trigger ultimate

slope failure. Maximum displacement is equal to about 16 cm; moreover, calculation system reaches equilibrium. Slip surfaces obtained numerically are in approximate agreement with those from measurements and visual observations. On the contrary, increasing of the water table in the third stage triggers great displacements. Although the system is also equilibrated, displacements are very large and such slope could be considered as definitively failed.

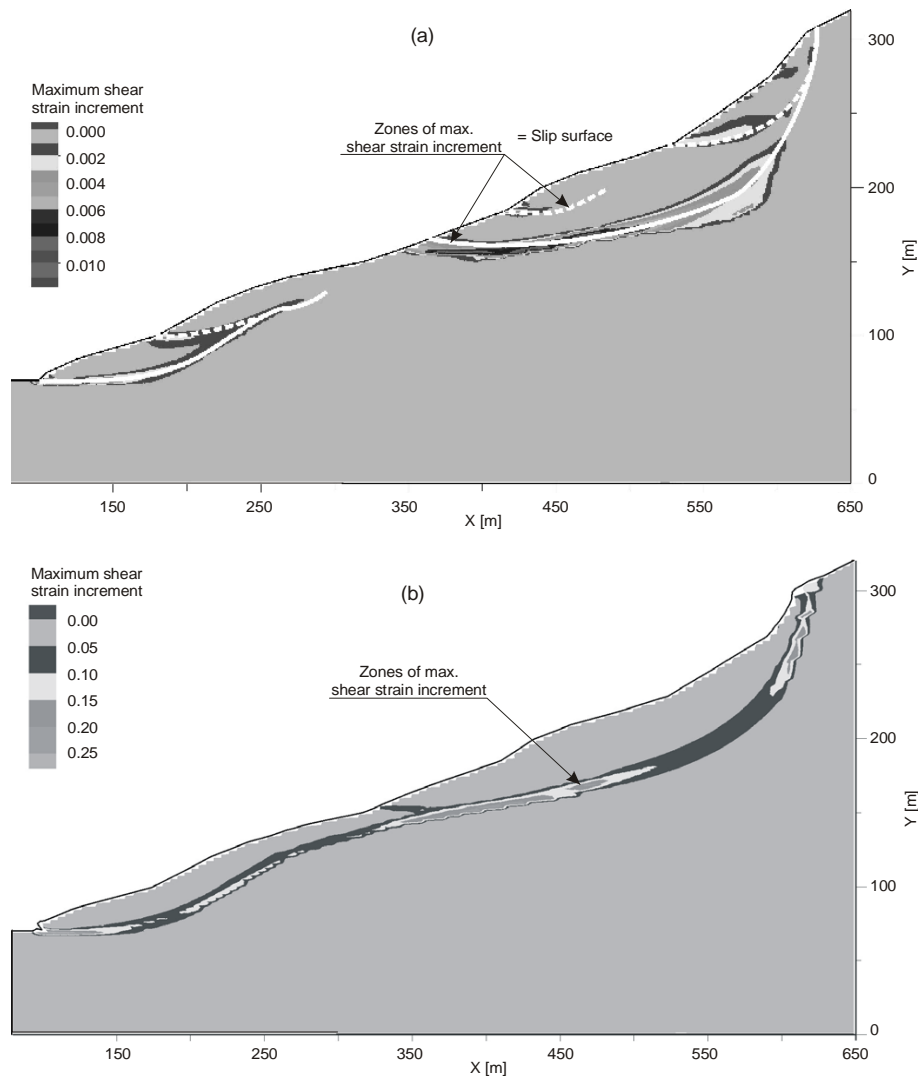
Fig. 6. Maximum shear strain increment, (a) actual conditions, (b) water table position lifted at 6 m compared with actual level.

Figure 6 presents the distribution of the important index *SSI* (maximum shear strength increment), indicating the zones, in which most intensive shear (slip) occurs. In other words, this index determines position of the slip surface. Thus, it has great “informative” value. It could be seen that in the (b) case, slip surface is continuous, running from the slope top to the bottom, whereas in actual (a) case the surface is fragmented. It is also worth of mentioning that in the later case the *SSI* magnitude is 25 times greater than in the former one. This means that large landslide probably does not exist at present, but if the water table would increase, creation of such process would be highly probable.

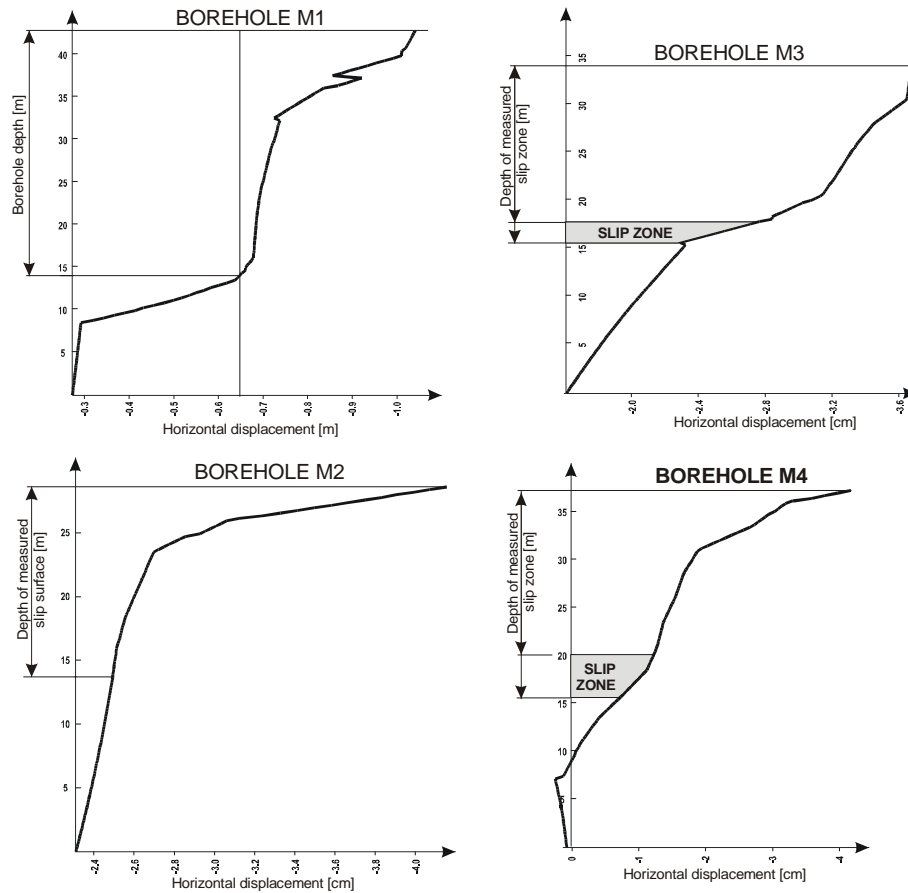
Fig. 7. Comparison of the calculated horizontal displacement curves with the location of the slip zones in inclinometer boreholes.

Other information provided by the model are that in the actual conditions two landslide bodies are present and that the upper one moves faster and with greater magnitude than the lower one. In these conditions the upper body creates an overpressure that increases the instability of the lower body. The reliability of the results was checked by their comparison with the “signs” of the process occurring in nature. One of them is the comparison of failure surface location in the inclinometer holes with the depths calculated. The results are shown in Fig. 7. The shape of calculated horizontal displacement curves and location of measured slip zones is drawn for boreholes. The qualitative agreement could be seen in M3 and M4 boreholes. The depth of calculated slip surface in M1 borehole is greater than the depth of the borehole. Thus, comparison is impossible in this case. The agreement of measured and calculated slip surfaces is not evident in M2 borehole. It proves the appropriateness of the assumptions and modelling procedures, at least on the approximate level and thus the reliability of the results.

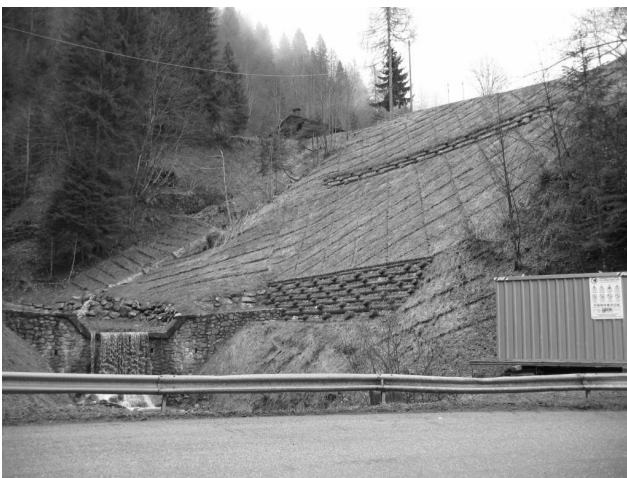
Fig. 8. Lower part of the “La Maina” landslide after the consolidation.

The high risk caused by “La Maina” landslide forced a type of investigation that could provide reliable results in short time. The monitoring system was important both to evaluate the hazard of the landslide and to collect data for the model. The survey and modelling allowed to recognize that at present there are two distinct landslide’s bodies. Since an increasing of the water table seems to be unreasonable with the data collected, a sudden failure of the slope is not expected. The good agreement between the model and the geological and morphological evidences outlined the proper mitigation measures. The urgent consolidation was focused on the lower part of the landslide where the elements at risk are located. Using naturalistic engineering the Corpo Forestale dello Stato has installed a system of superficial drainage and has consolidated the slope in order to avoid the erosion by the Poch stream (Fig. 8). For the upper body of the landslide a complex drainage system is planned for the future.
