# Slope stability assessment of weathered clay by using field data and computer modelling: a case study from Budapest

P. Görög and Á. Török

**Abstract.** A future development site of a housing estate, an abandoned-brick yard with clayey slopes was studied in details to assess slope stability and to calculate the factor of safety. The Oligocene clay, the former raw material, is divided into two different geotechnical units in the clay pit. The lower one consists of grey impermeable clays while the upper unit is characterised by yellowish weathered clay having a limited permeability. At some localities the topmost weathered clay layers are covered by loess, and slope debris. Parts of the former pit were also used as a landfill site. The slope stability analyses were performed based on borehole information and laboratory analyses in order to provide necessary engineering geological data for further site development and urban planning. Two geotechnical codes Plaxis and Geo4 were used to model the slope failures and assess the slope stability. The aim of using two different approaches was to compare them since Plaxis uses finite elements modelling while Geo4 uses conventional calculat

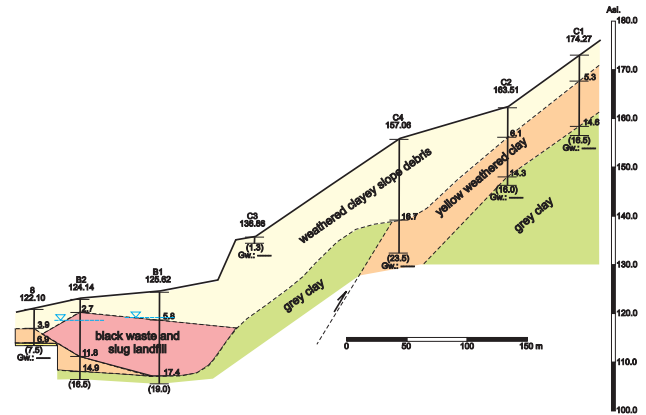
**Fig. 2.** The geological profile of the slope used in model calculation showing the location of drillings (borehole data from Paál, 1998).

the upper layer includes both, the yellow weathered clay and clayey slope debris having very similar physical properties. The third layer, the waste landfill was only inserted in the lower slope and toe of slope part, where it is located below the slope debris. This model is in accordance with the borehole data and our field observation, that landfill is only found in a depression at the lower part of the slope (Fig. 2). The input parameters of the model were obtained from laboratory tests. The weakest measured values were used (Table 1) to have a realistic model, and to calculate the factor of safety. The stability of the clayey slope and the toe area in front of the slope were also analysed. Another aim of our analyses was to demonstrate the effect of the site development on the slope stability by using a 300 kN/m<sup>2</sup> distributed load at the top of the slope. These model conditions represent the situation when houses are built upslope.

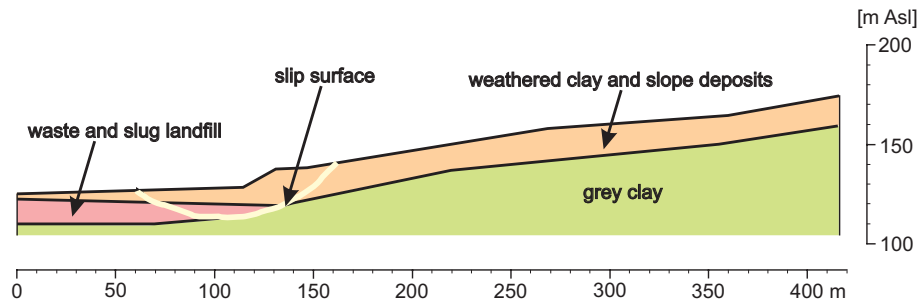
Fig. 3. The calculated circular slip surface by using Geo4 (factor of safety:  $n=1.7$ ).

Stability of the natural slope was analysed in the first set of models. Geo4 software needs an initial slip surface as an input and the software optimise it. Namely, it searches the location of the slip surface when the safety factor is the smallest. It can both work with circle and polygonal slip surfaces. The slope can be divided into two parts since the upper part is best modelled with a two-layer model while at the lower part waste and slag landfill occurs, and thus a three-layer model was applied. At first, the weakest point of the slope was determined, where the factor of safety has a minimum value. It was found to be at the foot of the slope deposit. The circular slip surface penetrates into the waste and slag landfill when Geo4 software calculations were applied (Fig. 3). In this case the calculated factor of safety is  $n=1.7$ . For comparison, the same geological structure was used for finite element model calculations. The analyses with the Plaxis almost gave the same slip surface (Fig. 4) and the calculated factor of safety

Two geotechnical software having different model approaches were compared. The results for circular slip surface models when Plaxis (FEM calculations) and Geo4 (conventional Bishop's method calculations) were used are very similar, the factors of safety were 1.6 and 1.7, respectively. Minor differences are related to the different approaches of the two software calculations. For polygonal slip surfaces Geo4 is the only software, which can be applied since the slip surface can be manually adjusted, while by using Plaxis it is not possible. The global factor of safety for polygonal slip surface was 2.0, due to the fact that slip surface were longer and it also reached the upper slope where larger friction was documented. The weakest point of the slope was found within the waste and slag landfill, which is overlain by weathered clayey slope debris. Landslides are often triggered by high pore pressure usually due to infiltrating meteoric water and clayey–slope-debris covered springs. The slip surface for circular model is located within the landfill while for polygonal model it is longer and located at the boundary

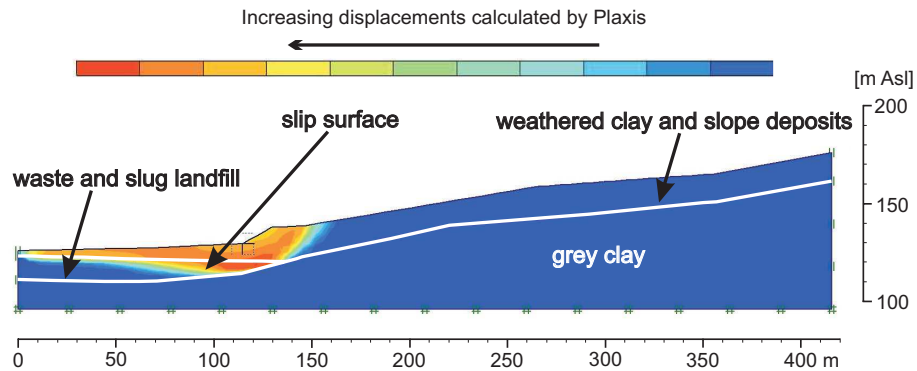
Fig. 4. Displacement distribution of the slope with surface load calculated by Plaxis (factor of safety:  $n=1.6$ ).

is slightly less ( $n=1.6$ ). Nevertheless, it is necessary to note that the Plaxis works with combined factor of safety. Consequently a factor of safety  $n=1.6$  calculated with Plaxis is equal to a factor of safety of  $n=1.7$ – $1.8$  calculated with conventional method.

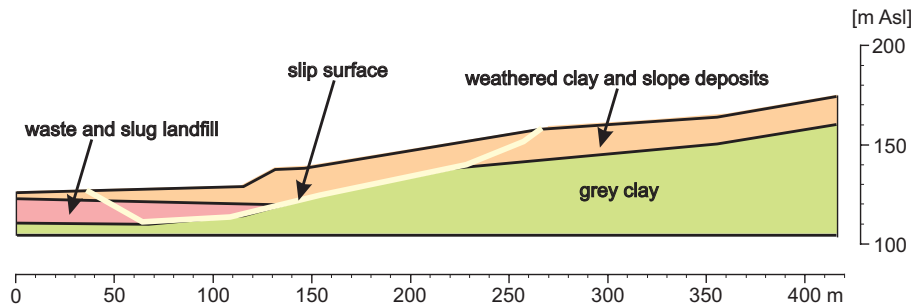
**Fig. 5.** The calculated polygonal slip surface by using Geo4 (factor of safety:  $n=2.0$ ).

The supposed sliding mass was divided into  $n$  vertical slices according to Sarma (1973). It gave a polygonal slip surface which was also modelled by Geo4. A factor of global safety was also calculated with Geo4, since the global factor of safety of the slope cannot be analysed with Plaxis. It is related to the fact that in the finite elements modelling such as Plaxis the location of the slip surface can not be manually adjusted. The lower part of polygonal slip surface coincides with the circular slip surface while the upper part of it follows the boundary zone between the impermeable grey clay and the overlying weathered clay and slope debris (Fig. 5). The factor of safety with this polygonal slip surface is  $n=2.0$ .

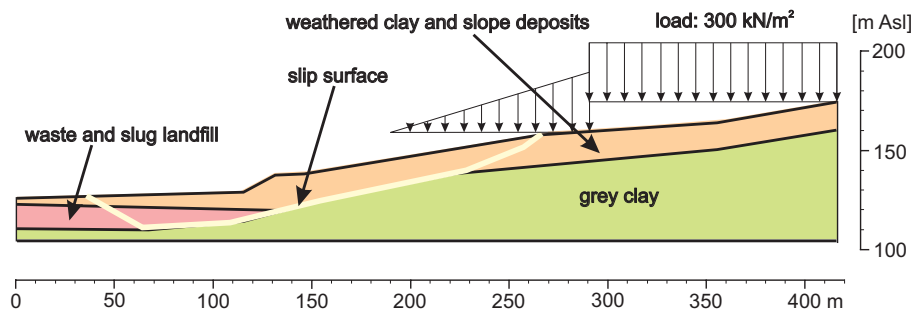
**Fig. 6.** The calculated polygonal slip surface for building load by using Geo4 (factor of safety:  $n=1.6$ ).

and seeps via the yellow weathered clay down to the boundary to grey clay. In this boundary zone, where the slip surface is located, the water significantly reduces the physical parameters of both clays, by increasing pore water pressure and decreasing friction angle and cohesion. Former experiences have also shown that in similar clays (Okamoto et al., 2004), such as the yellow weathered clay, the increasing water-content radically decreases the angle of friction contributing to slope failures. According to model calculations the loads from house constructions on the upper slope have no significant influence on the safety factor when circular slip surface model is used. To the contrary it reduces the global safety of the slope to  $n=1.6$ , when the polygonal slip surface model is applied (Fig. 6).
