Using geophysics on a terminal moraine damming a glacial lake: the Flatbre debris flow case, Western Norway

Abstract. A debris flow occurred on 8 May 2004, in Fjærland, Western Norway, due to a Glacial Lake Outburst Flood and a natural terminal moraine failure. The site was investigated in 2004 and 2005, using pre- and post-flow aerial photos, airborne laser scanning, and extensive field work investigations, resulting in a good understanding of the mechanics of the debris flow, with quantification of the entrainment and determination of the final volume involved. However, though the moraine had a clear weak point, with lower elevation and erosion due to overflowing in the melting season, the sudden rupture of the moraine still needs to be explained. As moraines often contain an ice core, a possible cause could be the melting of the ice, inducing a progressive weakening of the structure. Geophysical investigations were therefore carried out in September 2006, including seismic refraction, GPR and resistivity. All methods worked well, but none revealed the presence of ice, though the depth to bedrock was determined. On the contrary, the moraine appeared to be highly saturated in wat

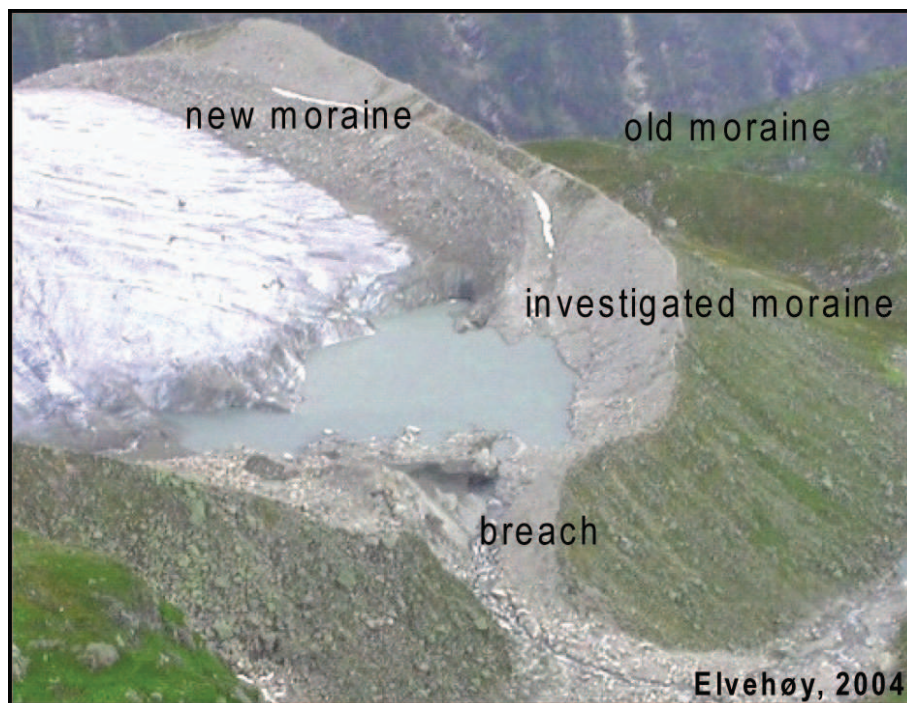
Fig. 2. Aerial photography of the moraine site after the 2004 GLOF.

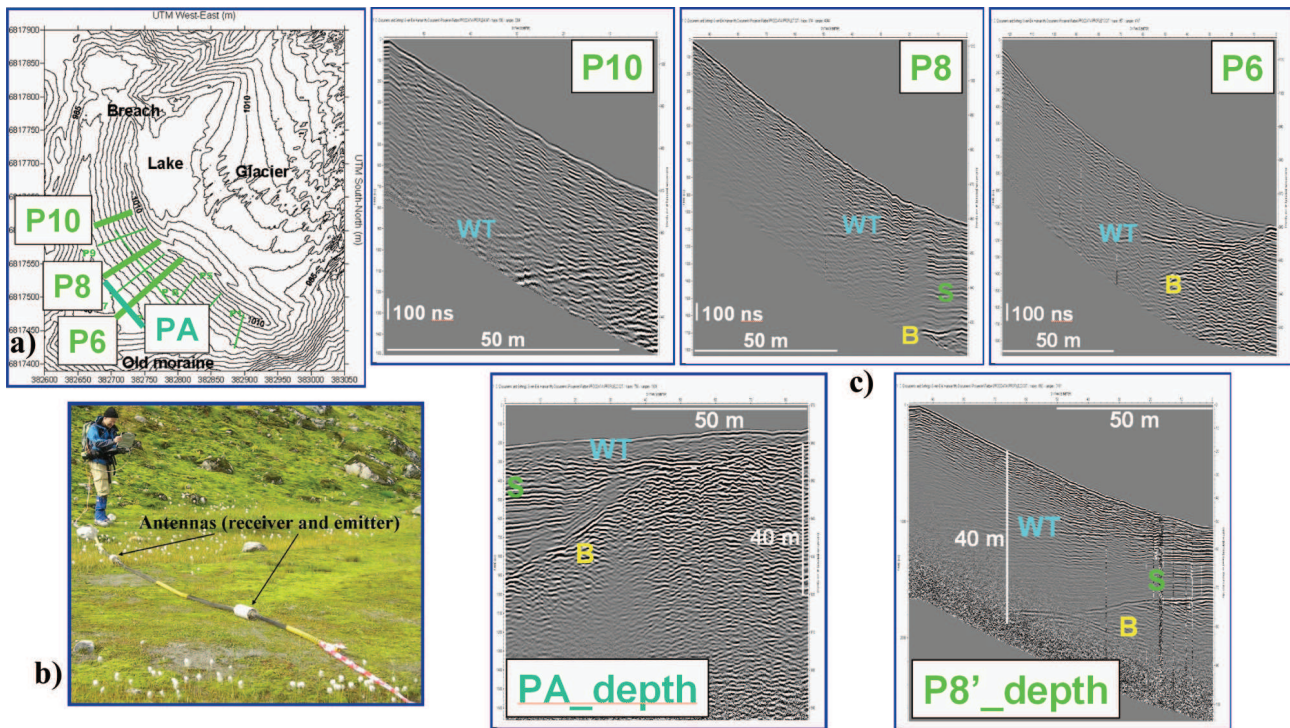
Fig. 5. GPR. (a) Location of the profiles. (b) 50 MHz acquisition system with both emitting and receiving antennas on the same rod and pulled by an operator (c) Examples of processed profiles, the upper ones being in time, and the lower ones obtained after depth conversion. Water-table like reflectors (WT), bedrock (B) and lake-deposit sediments (S) are identified.

We had both standard non-shielded antennas (25 and 50 MHz) and a new rough-terrain 50 MHz antenna of Malå (Fig. 5b). We quickly found out that the latter was the perfect tool to use on the moraine due to numerous and often large boulders covering it and preventing the use of the long antennas. The acquisition was so efficient compared to the standard antennas that all profiles in Fig. 5a were more or less acquired within a day.

The data were processed using ReflexW. Though the structure inside the moraine is quite heterogeneous, with different grain sizes from rather fine sand to large boulders, the GPR results showed several interesting features with clear reflectors down to 30–40 m in depth (Fig. 5c). Some are associated with water-table like features (strong and near horizontal reflectors, see P6). Others are typical layered structures (in PA and P8) believed to be lake deposits in an older lake trapped by the older moraine. In addition, bedrock is clearly reached in several profiles. Strong diffractions at dipping bedrock can be seen along Profile PA at the foot of the moraine, thus giv-

ing the possibility to estimate velocities at several depths in order to properly convert from time to depth (bottom profiles in Fig. 5c). A velocity in the main moraine and a different one in the lake deposits were then used.

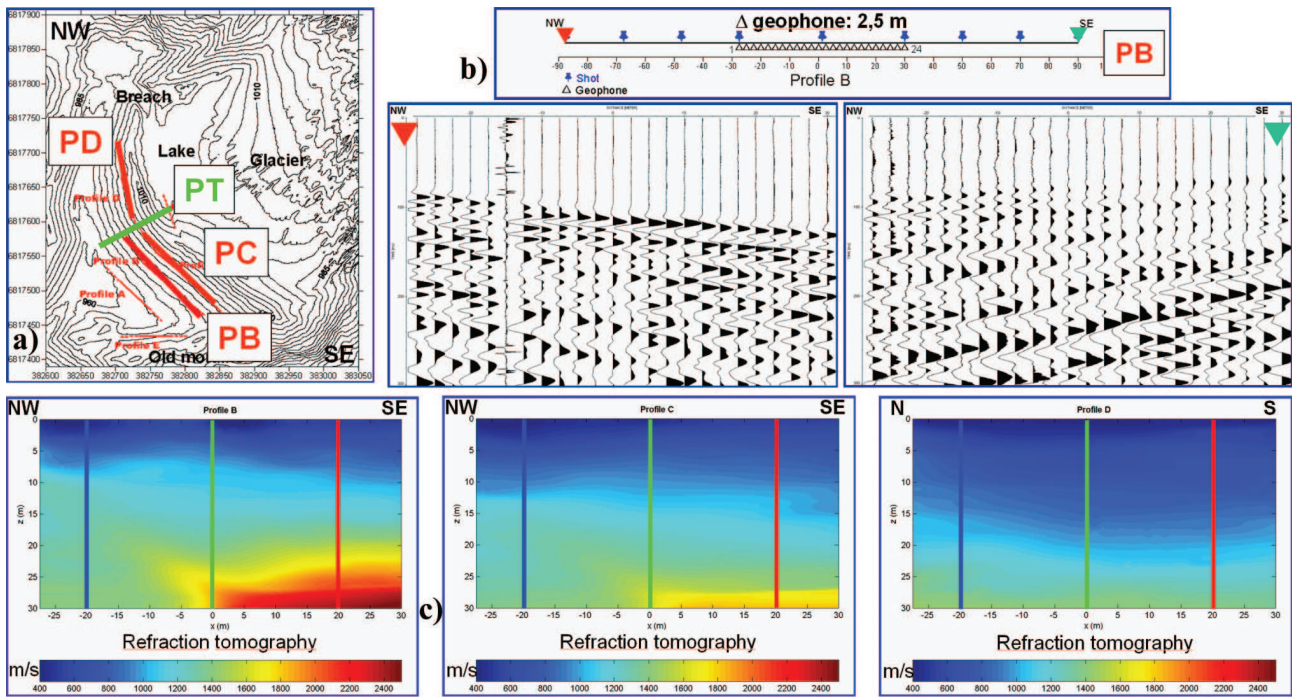
Fig. 6. Seismic refraction data. (a) Location of the profiles. (b) Example of 2 shots for one of the profile (PB). (c) Refraction tomography results for 3 profiles.

comparison with a seismic gun (Betsy gun). The use of the latter was difficult, slowing down significantly the acquisition without giving better results. Five standard refraction profiles were acquired, three on the main moraine, one on the old one and one at the foot of the moraine, all along the corresponding moraine axis, the sampling between geophones being 2.5 m (Fig. 6a). In addition, a line across the main moraine was acquired with denser shots and with the 24 geo-

The seismic refraction data were of very good quality and hammer blows were sufficient for offsets up to 80 m from the receiving line extremities (Fig. 6b). The data were

systematically of better quality above the wetter zone identified by both resistivity and GPR, while showing weaker first-arrivals away from that zone, either towards the breach or on the South-East side. We used the wavefront-based tomography approach of ReflexW to produce tomograms, as in Fig. 6c and Fig. 7b. No ice-velocity is found within the moraine, in agreement with resistivity. Within the moraine, the velocity increases with a rather linear gradient (compaction and/or capillarity-induced water content) up to water-like velocities, followed by a transition zone believed to correspond to the highly water-saturated sediment package, before reaching the bedrock (Fig. 7c). The good quality of the data, also shown in Fig. 7d, was unexpected and a denser acquisition in lines, receivers and shots, would have permitted a 3-D tomography.

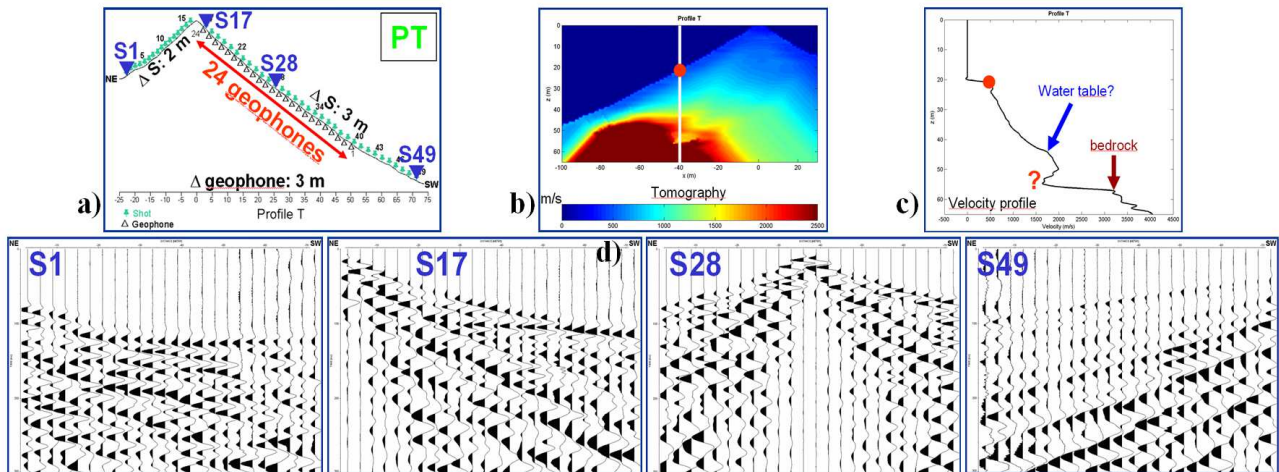
Fig. 7. Seismic refraction data (2). (a) Geometry of the transverse profile (see location in Fig. 6a) with 24 fixed geophones and 49 hammer-blow positions. (b) Final tomography result. (c) Vertical velocity profile at the lateral position given in (b). (d) Examples of shot recordings.

phones located on the distal side every 3 m (PT in Fig. 6a with a cross-section given in Fig. 7a; one day was needed for that profile only).
