Experimental characterization of the self-healing of cracks in an ultra high performance cementitious material

Sébastien Granger, Ahmed Loukili, Gilles Pijaudier-Cabot, Gilles Chanvillard

Experimental characterization of the self-healing of cracks in an ultra high performance cementitious material: Mechanical tests and acoustic emission analysis

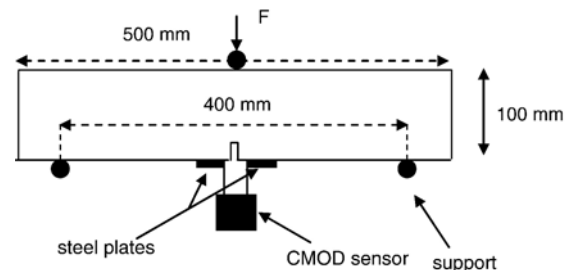
Fig. 1. Three points bending tests configuration.

The specimens are loaded under three points bending. The tests are notch opening controlled with a constant rate of $0.05 \mu\text{m/s}$. The crack mouth opening displacement (CMOD) is measured (Fig. 1), with a sensor placed between two steel plates stuck on each side of the notch on the bottom face of the specimen. The aim of this preliminary phase is to get a controlled cracking of the specimen. The objective of the study is to quantify the mechanical behaviour of healed concrete specimens, so, it was decided to aim a single residual crack width of approximately $10 \mu\text{m}$, which permits to get a fast self-healing. It is worth noting that the influence of the crack width [4,12] on the phenomenon is not investigated here. Pre-cracking is performed in the post peak regime: after having reached the peak load (comprised between 3 and 4 kN), unloading is performed when the applied force reaches 2 kN, which

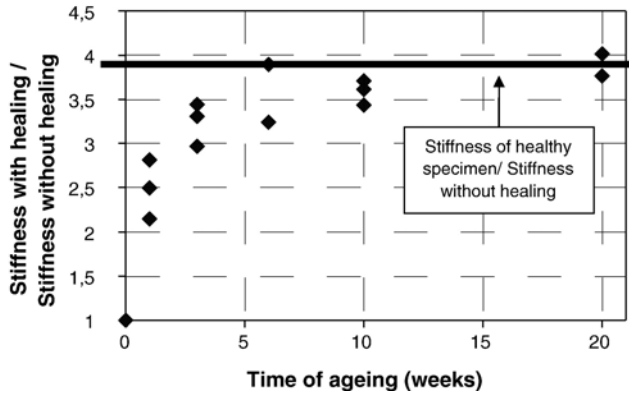
Fig. 7. Evolution of the ratio between the reloading stiffness with healing (in water) and the reloading stiffness without healing, as a function of time of ageing — comparison with the average stiffness of healthy specimens.

Fig. 7 shows the evolution of the ratio between the reloading stiffness with healing, and the reloading stiffness without healing, as a function of the ageing time. Stiffness is calculated by a linear regression for load ranges from 0.4 kN to 0.8 kN. It is noticeable that there is a fast recovery by self-healing, and this stiffness tends to those of healthy specimen, which is represented on the graph by the straight line. These results can be explained by the fact that new products are formed in the crack, especially, if we consider the low water/cement ratio, new C-S-H. These crystals make a bridge between the two faces of the crack and progressively fill it. The stiffness of these crystals is certainly close to those of primary C-S-H (formed by normal hydration) and when the crack is fully filled, the global stiffness of the specimens can reach the initial one, before damage.

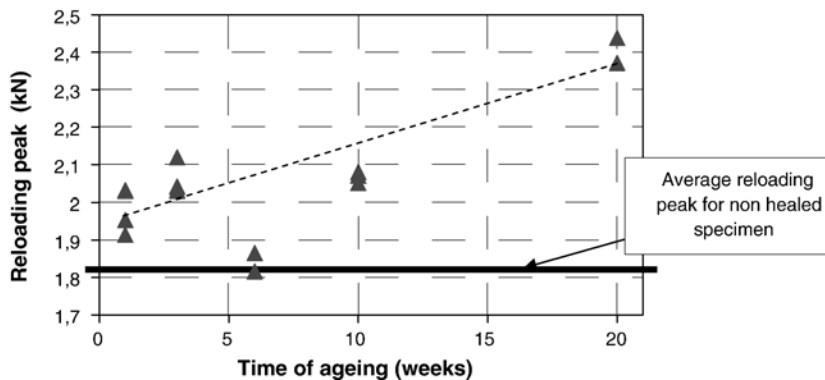
Fig. 8. Evolution of the reloading peak for healed specimens (storage in water) with the time of ageing — comparison with the average reloading peak of non-healed specimen.

Concerning the flexural resistance, Fig. 8 represents the evolution (with the ageing time) of the peak load upon reloading for healed specimens. It shows that self-healing provides a slight improvement of the resistance, compared with the resistance of non-healed specimens. Nevertheless, the initial flexural resistance is not reached and this could be explained by the fact that crystals formed in the crack bridge it but can not form the complex microstructure which provides the strength of the material initially, especially all the links between C-S-H. We may wonder what could be the evolution of the mechanical behaviour for longer ageing periods. It is probable that constrained crystal growth in between the crack surfaces and within the FPZ may not provide the same strength as for the initial hydration of the material.

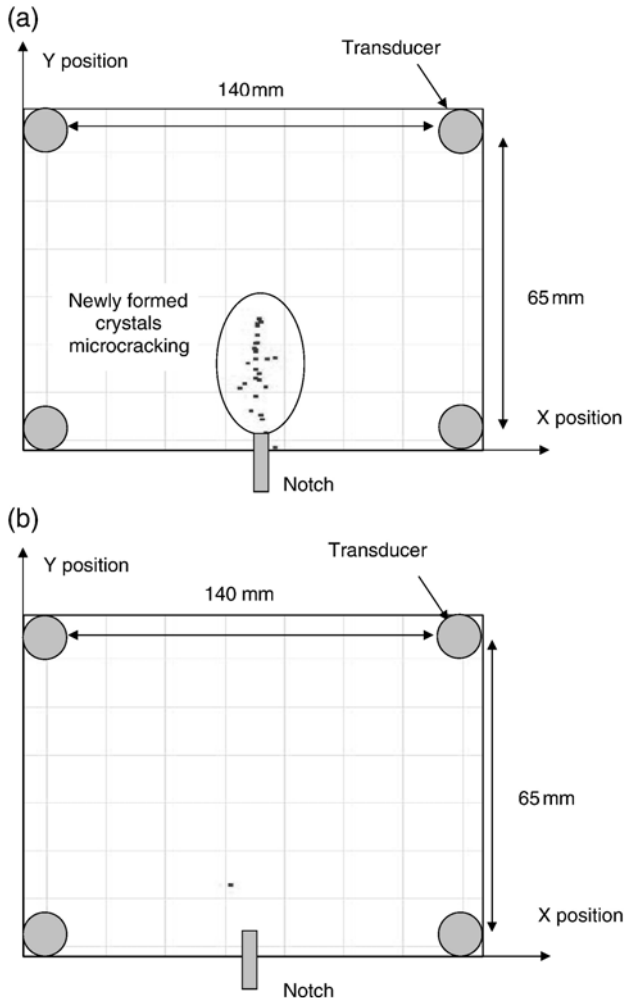
Fig. 12. Microcracking maps, during the reloading phase (until 18 μm — pre-peak regime) of specimens aged for 10 weeks; (a) ageing in water, (b) ageing in air.

Fig. 12 presents the maps for a specimen aged in water and for a specimen aged in air, both during 10 weeks. It is noticeable that acoustic activity appears for the healed specimen in the region of the initial crack, while nearly nothing is detected for a non-healed specimen. In view of the mechanical results which exhibit stiffness and strength recovery, one can say that in the first case, there is a damage of the newly formed crystals in the crack, and in the second case, there is only the re-opening of the existing crack, with very little acoustic activity (some due to friction probably). Note that for non-healed specimens, performing the same AE localisation analysis without removing the less energetic events would still provide little acoustic activity, less than that observed for healed specimens.

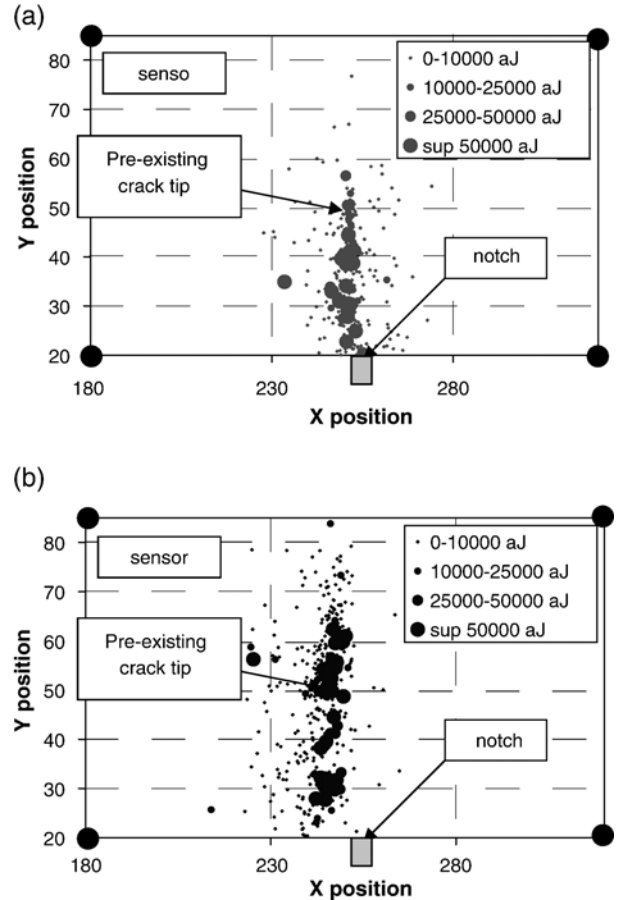
Fig. 13. Energy location maps at 90% of the peak load in the post peak regime; (a) healed specimen, (b) non-healed specimen.

We may now consider the comparison during the reloading phase, not at the same CMOD, but at the same load level. Results at 90% of the peak load, in the post peak regime are analysed. Fig. 13 represents the location maps in terms of energy. Points representing the microcracks are plotted according to their acoustic energy in aJ (the analysis is carried out after having removed less energetic events): the bigger the point, the larger the energy. If we now sum these energies for events located below and above the pre-existing crack tip (which is for

height of 50 mm from the bottom face of the specimen), we can notice that 97% of the acoustic energy dissipated until 90% of the peak load is located in the pre-existing FPZ, for the specimen which has been stored in water, although it is 48% for a non-healed specimen. This acoustic energy dissipated in the crack for a healed specimen should be due mainly to microcracking of newly formed crystals inside the initial crack. Friction would provide some acoustic activity, but probably not the stiffness and strength recovery that was observed on the mechanical response at the same time. For the non-healed specimen, the acoustic activity is due to further propagation of existing microcracks (note that the specimen is again in the post peak regime).
