PARTIAL DISCHARGE MEASUREMENTS ON GLASS-MICA-EPOXY SAMPLES FOR ELECTRICAL INSULATION DURING ACCELERATED THERMO-OXIDATIVE AGING.

P. Schlupp¹, V. Boucher^{1,2}, P. Rain², A. Petit³

¹ Electricité de France (EDF) – R&D, France

ABSTRACT

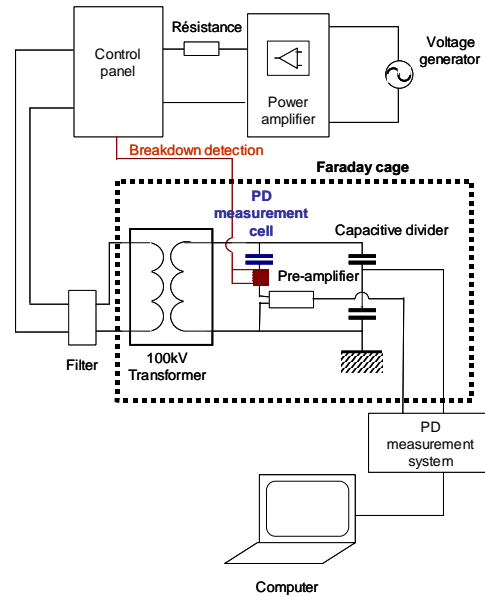
Figure 6: PD measurement electrical circuit diagram

In order to minimize interferences, several electronic devices have been used (figure 6): a voltage generator associated to a power amplifier instead of an autotransformer directly connected to the grid, an adjustable resistance, a filter and a capacitive divider. Furthermore, the high voltage part of the circuit is located in a Faraday cage.

The PD measurer is an ICM system from Power Diagnostix. For each voltage level, the recording duration is 100 s. Between each voltage level the recording is stopped for 20 s in order to adjust the next voltage level. The “dead time” after each PD is adjusted to 15 μs . The apparatus is calibrated with a calibrator of 10 pC. In order to reject the background noise, the lower detection limit is adjusted to 2% of the maximum scale. In order to avoid damages to the PD electronics in the case of sample breakdown, a current loop detector is placed between the sample and the PD preamplifier. The purpose is to cut off the generator if a breakdown current is detected.

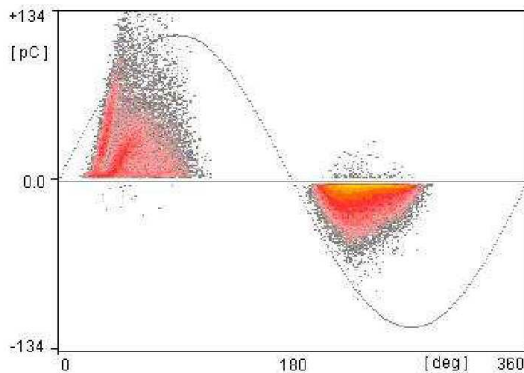
Figure 7: PD pattern at 8 kV (PIDV) for a new Ref-F sample

For the new Ref-F sample, many PDs are present from PDIV on (figure 7). Nevertheless, the triangular shape of the positive half-period and the asymmetry between the two half-periods suggests that those PDs aren't coming from the sample but probably from a bubble trapped between the sample and the electrode. So, for this sample, it was not possible to estimate the maximum void size by the mean of the PDIV measurement.

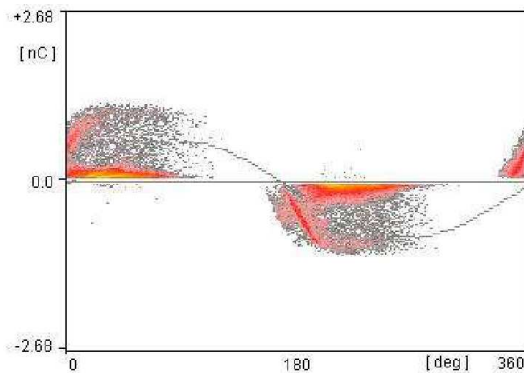
Figure 8: PD pattern at 15 kV for an aged Ref-F sample (805 h, 155°C, 2.3 bar O₂)

For the aged Ref-F sample, only one “rabbit ear” can be seen on this pattern (figure 8). That seems to mean that there is a predominant single void in the sample. This is confirmed by the visual inspection of the sample, as only one delamination of 60 µm thick has been observed at the edge of the sample, delamination that goes deep inside the sample (figure 11). Using equation 1 and the Paschen law, the calculation leads to

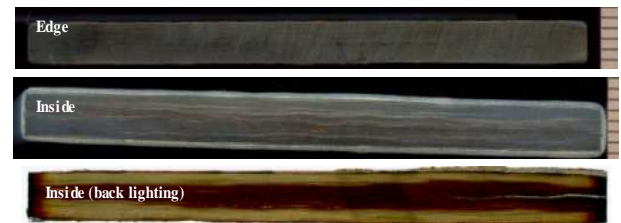
For the aged Ref-F sample, a single large delamination can be seen inside the sample (figure 11). But it is impossible to know if this delamination has been created during the cutting or if it is the result of the propagation of an existing crack. In any case, it is probably the result of an initial defect. It is also interesting to note that only one delamination of 60 μm thick is present at the edge of the sample (zoom in figure 12), but this delamination goes deep inside the sample.

Figure 11: Scan of an aged Ref-F sample (805 h, 155°C, 2.3 bar O₂)

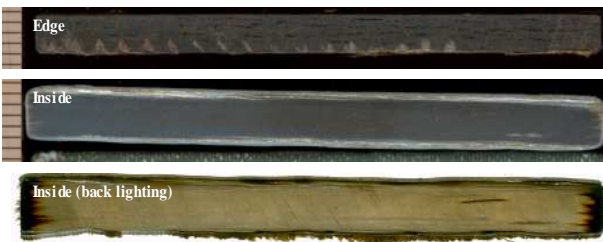
For the aged Class-H sample (figure 15 and zoom in figure 16), and contrary to the aged Ref-F sample, the edges present many voids, voids that doesn't go deep inside the sample. The largest voids are about 100 µm thick. Nevertheless, some local defects are also present inside the sample.

Figure 15 : Scan of an aged Class-H sample (740 h, 180°C, 2.3 bar O₂)

For the aged Class-H sample the calculation gives a void size smaller (60 μm) than the largest void size observed (100 μm) at the edges of the sample. This is not surprising since, contrary to the aged Ref-F sample, the voids at the edges don't go deep inside the sample (figure 15). Nevertheless, some local defects are also present inside the sample which may explain this PDIV.
