Characterization of {111} planar defects induced in silicon by hydrogen plasma treatments

A microstructural characterization by transmission electron microscopy of the {111} planar defects induced in Si by treatment in hydrogen plasma is discussed. The {111} defects are analyzed by conventional transmission electron microscopy (TEM) and high-resolution transmission electron microscopy (HRTEM). A quantitative image processing by the geometrical phase method is applied to the experimental high-resolution image of an edge-on oriented {111} defect, in order to measure the local displacements and the strain field around it. Using these data, a structural model of the defect is derived. The validity of the structural model is checked by high-resolution image simulation and comparison with the experimental images.

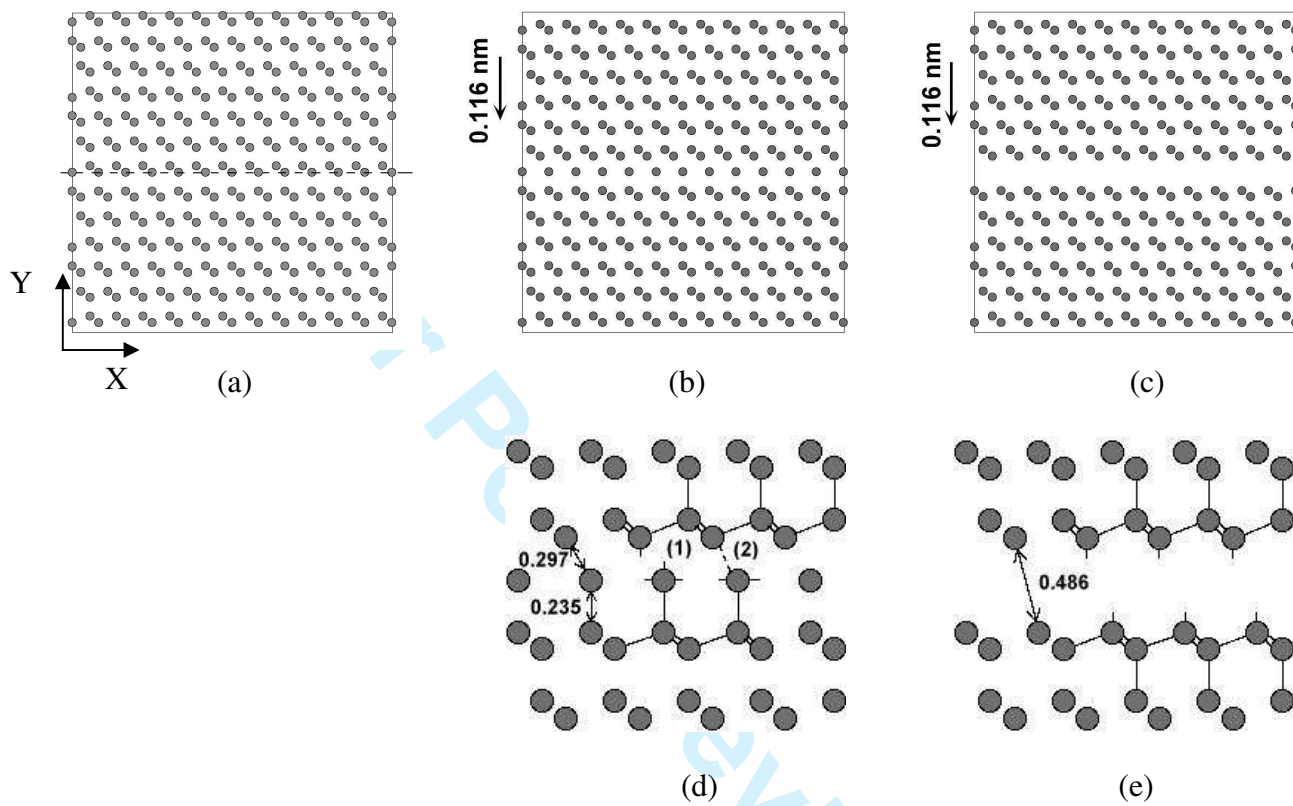
Figure 6.

11
12
13
14 **Figure 6.** Possible structural models of the {111} defect based on the displacement values obtained by
15 the GPM analysis. (a) Undistorted Si structure projected along [110]; the horizontal line marks the
16 interface between the bottom fixed part of the crystal and the upper part to which the displacement
17 vector is applied; (b) structural model *A* of the {111} defect where one Si layer has been removed; (c)
18 structural model *B* of the {111} defect where two Si layers have been removed; (d) and (e) enlarged
19 view of the atomic arrangement close to the defect plane for models *A* and *B*, respectively; interatomic
20 distances in nm are indicated.
21
22
23
24
25
26
27
28
29
30
31
32

47 We used the Crystal Kit software for the structural modelling of the defect. Starting from the
48 undistorted Si crystal structure projected along [110] (figure 6a), the 0.116 nm rigid body displacement
49 has been applied to the upper part of the matrix with respect to the fixed bottom part. Two structural
50 models (*A* and *B*) can be derived using the same displacement value. In one case, only one layer of Si
51 atoms adjacent to the interface has been removed (model *A* in figure 6b), while in the second case both
52 Si layers close to the interface have been removed (model *B* in figure 6c). In both cases, we consider
53
54
55
56
57
58
59
60

35 The structural model in figure 6c corresponds to the H₂* defect model described in literature [26],
36 where the Si-Si chemical bonds were cut and the hydrogen atoms saturate the resulting dangling bonds.
37 Indeed, in the case of model *B*, where two rows of Si atoms are removed, the defect can be chemically
38 stabilized by saturating with H the dangling bonds of the two rows of Si atoms adjacent to the defect
39 plane. Consequently, the planar defect could be described as a collection of H₂* defects lined up on a
40 {111} plane.
41
42
43
44
45
46
47
48

49 Model *B* seems to be favoured from the chemical and energetic point of view against model *A*.
50 An enlarged structural model of the atoms arrangement close to the defect plane for the two models *A*
51 and *B* is shown in figure 6d and e, respectively, where the real distances (not the projected ones)
52 between the Si atoms are specified in nm. The chemical bonds are also figured for the atoms limiting
53 the defect. We mention that these models do not take into consideration any atomic relaxation around
54
55
56
57
58
59
60

1
2 the defect. In the case of model *A*, one sees that the shortest distance between the Si atoms bordering
3 the defect is 0.297 nm instead of 0.235 nm as in a perfect structure. Consequently, there are two
4 possibilities of saturating the dangling bonds:
5
6
7

8
9 i. The Si atoms delimiting the defect remain unbound and the dangling bonds, one for each Si
10 atom limiting the defect from the upper crystal and three for each Si atom limiting the defect from the
11 bottom crystal, are saturated with H atoms (marked with (1) on figure 6d);
12
13

14
15 ii. The formation of a stretched bond between the Si atoms delimiting the defect and saturation
16 with H atoms of the two remaining dangling bonds belonging to the Si atoms limiting the defect from
17 the bottom crystal (marked with (2) on figure 6d).
18
19
20
21
22

23 The two variants of the model *A* need either an increased number of H atoms for the saturation
24 of the dangling bonds, or the formation of a stretched chemical bond, which is energy costly. Model *B*
25 (enlargement in figure 6e) seems much more plausible, since it only involves Si-Si bonds cutting and
26 saturation of the resulting dangling bonds with H atoms, one for each Si atom neighbouring the defect.
27
28 The defect could be physically formed by removing the Si atoms from the structure as a result of the
29 etching effect of the H-plasma on the Si wafer.
30
31
32
33
34
35
36
37
38
39
