10ème Congrès Français d'Acoustique

Evaluation of Acoustic Parameters of Churches

Janko Vodopija¹, Sinisa Fajt², Miljenko Krhen²

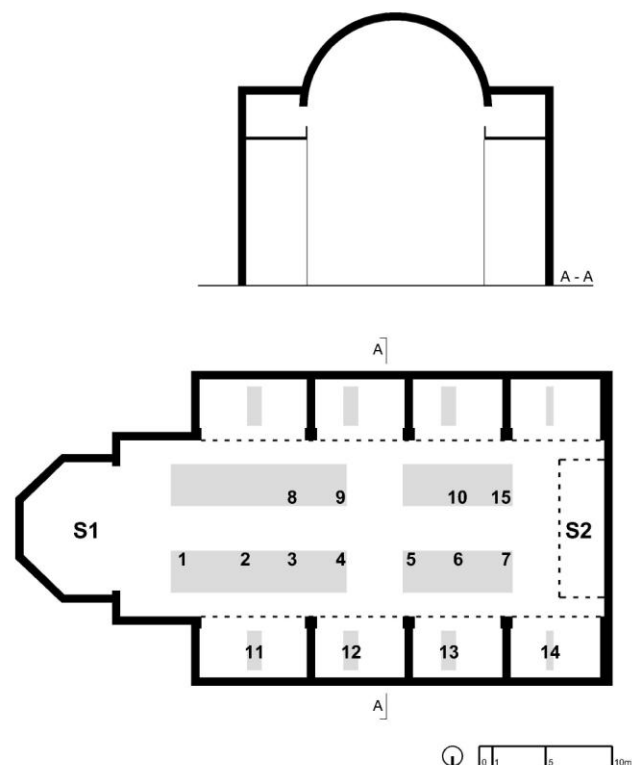
Figure 1: The plan and a section of the Basilica of the Sacred Heart of Jesus

Figure 1 shows the plan and the A-A section of the basilica. Shaded gray areas represent main listening areas where thick wooden pews are situated. S1 and S2 represent source positions, one at the altar and the other situated in front of the organ to simulate the listening conditions for music. It is

important to notice that the altar position S1 is elevated 60 cm above the main listening area level, while S2 and the organ are situated at the balcony above the doors at the height of approximately 11 m. The numbers in shaded areas represent the positions where the measurements were taken, both objective and subjective. Altogether there are 15 positions, 4 in lateral chapels and 11 in the main nave, 4 of these 11 were positioned symmetrically on the other side to ensure control measuring points [1]. Complete architectural parameters are given in Table 1.

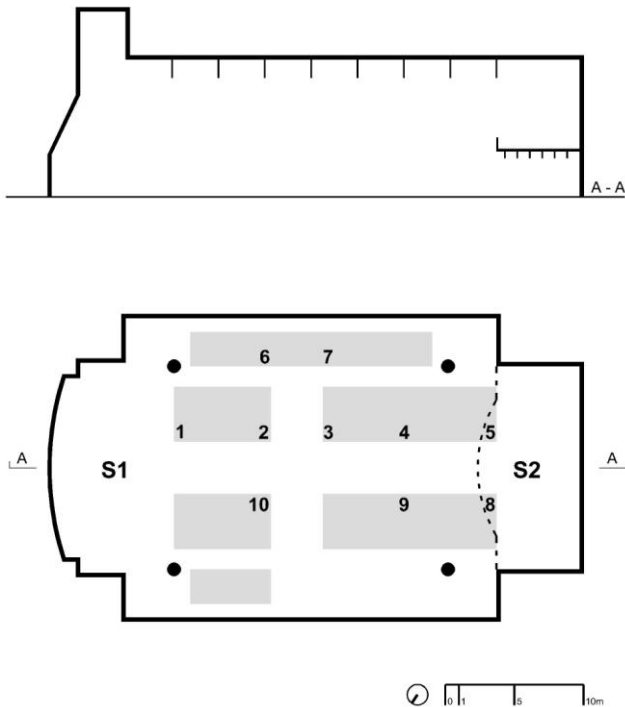
Figure 2: The plan and a section of the church of the Immaculate Heart of Mary

In Figure 2 we present the plan and A-A section of the church of the Immaculate Heart of Mary. It is quite obvious

that the ceiling plan is completely different in comparison to the previously described church. The height is twice as low, and what is more important is that the ceiling is flat and coffered, made of concrete. Only recently the central part of the ceiling has been slightly modified by inserting wooden plates with light reflectors into coffers. The floor is made of polished stone plates, similarly to the previous church, while the whole structure is made of concrete with sharp edges and almost no diffusive elements at all. Side walls are covered in flat wooden plates up to the height of 2,5 m. Wooden pews, wooden plates at the ceiling and the recently built organ represent the only absorbing and diffusing elements. The architectural parameters are given in Table 2.

Shaded areas represent main listening areas with wooden pews, and numbers refer to the measuring point similarly as in the previous church. Two source positions, S1 and S2, were used, one at the altar and the other in front of the organ at the back western wall. The S1 position was approximately 70cm above the main floor level, and the S2 position is about 5m above the floor level.

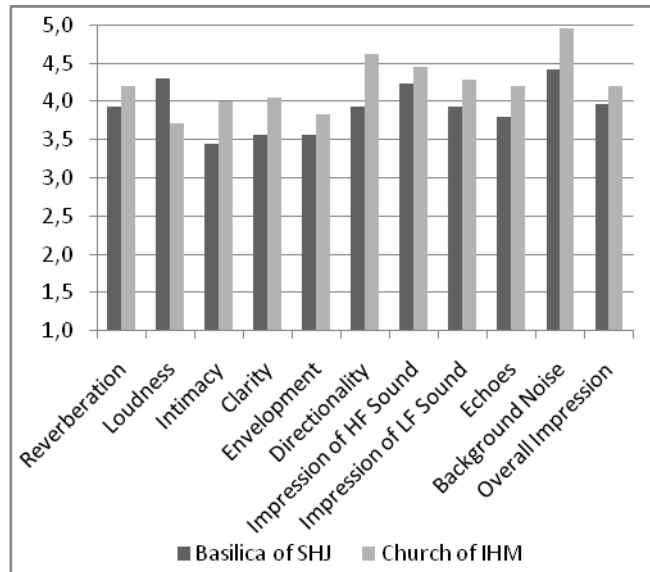
Figure 3: Comparative subjective scores of acoustic parameters

Figure 3 shows subjective scores of evaluated subjective parameters for the examined churches. The values of all parameters except Loudness are higher for the Church of IHM than the Basilica of SHJ.

The subjective impression of loudness is stronger in the Basilica because of the larger volume and consequently longer reverberation time values. The exact subjective scores and their standard deviation values are presented in Table 3. Intimacy, Clarity and Directionality were evaluated substantially higher in the Church of IHM.

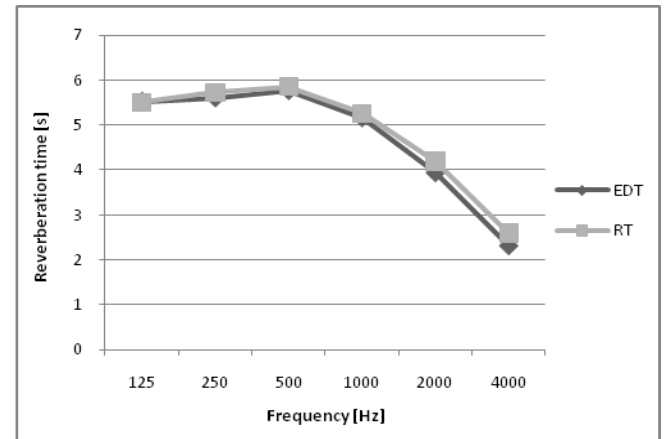
Figure 4: Average Octave Band Reverberation time of the Basilica of the Sacred Heart of Jesus

Both EDT and RT follow the same pattern and we can see that values are a little bit lower at the frequencies of 125 and 250 Hz which is due to low-frequency absorption effect of wooden structures (pews, altars, confession booths). Generally the reverberation frequency function follows the expected curvature, with values getting lower at high frequencies due to the sound absorption in the air. Exact RT and EDT values and their standard deviation are given in Table 4.

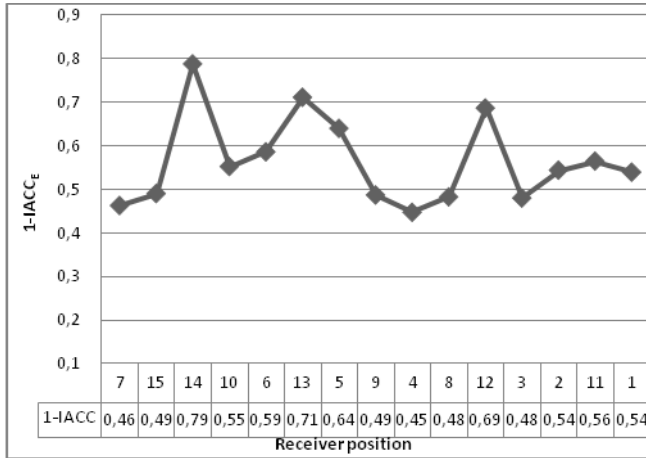
Binaural quality index was measured when the source was S2. The parameter IACC_E was measured at all receiver positions. It is presented in the form 1-IACC_E and is averaged over three octave bands (500 Hz, 1000 Hz, 2000 Hz). The results are given graphically in Figure 7. The receiver positions are sorted in the same way as before to

show that the $1-IACC_E$ has almost no dependence on source-receiver distance. The values inside the nave are very similar with average value 0,52 while the position in the lateral chapels have significantly higher values averaging 0,69.

Figure 7: $1-IACC_E$ vs. Source S2 – receiver distance

The positions in lateral chapels are closer to the side walls and are also surrounded by front and back wall of the chapel, which all contribute to a higher difference in the sound coming to the left and the right ear, thus resulting in higher and better IACC values.

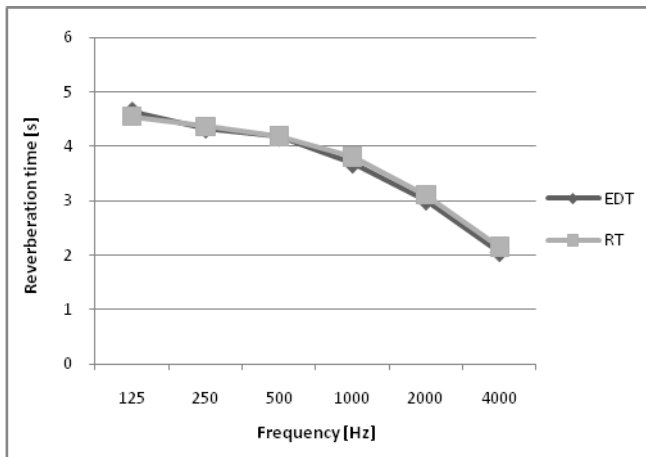
Figure 8: Average Octave Band Reverberation time of the church of the Immaculate Heart of Mary

Figure 8 shows EDT and RT as a function of frequency. Both parameters follow the same pattern, with highest values at 125 Hz and then decreasing as the central octave frequencies get higher. The balanced absorption at low frequencies results in better Bass Ratio $BR = 1,12$ than in the previously examined basilica where $BR = 1,01$.

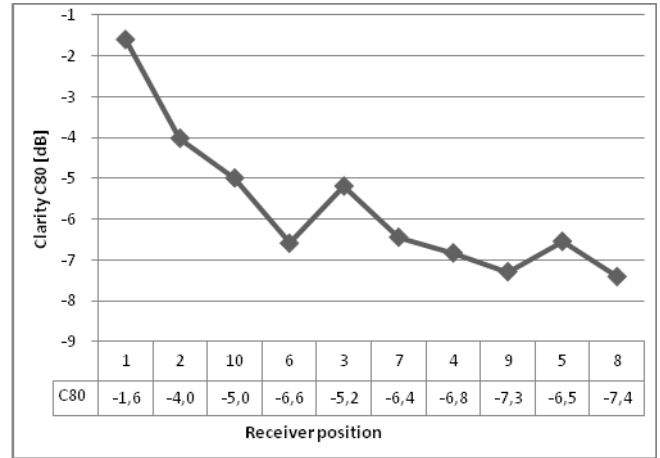
Figure 9: C80 vs. Source S1 – receiver position distance

C80 follows the expected pattern for the simple hall plan as is the case in this church, decreasing with the distance from the source S1 and shows no specific fluctuations. Quite in contrast, in Figure 10 we see C80 when the source is at the organ position S2.

In Table 7 are given exact values of EDT and RT and their respective standard deviation. Figure 9 shows C80 values as a function of receiver positions sorted from the closest to the farthest from the source, in this case S1 at the altar position.

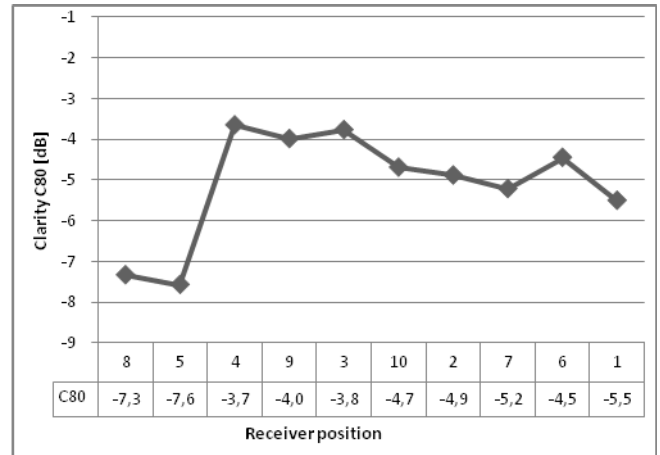
Figure 10: C80 vs. Source S1 – receiver position distance

The closest positions, 8 and 5, have the lowest C80 of all the positions in the church and the difference is significant. The reason for this unusual and unexpected behavior is that these two positions are only geometrically closest to the source when looking at the church plan. But they are in fact under the balcony and they have no direct line of sight with the source S2 or the organ. When carefully observing the church plan in Figure 2, one can see the dashed line that shows the position of the balcony. The height of the balcony is approximately 3m, so in fact we have the lower part of the balcony as the ceiling plan, coffered in concrete, above those two positions. This specific situation explains such low values of C80. The values decrease with the distance from the source. The complete measurement results are presented in Table 8. Comparing the values from Tables 8 and 9 we can see there is no significant difference in regard to the source positions S1 and S2, although the clarity values are a little higher for S2, which can be explained in the same manner as for the previous church.

The source that is situated closer to the half of the church height or the imaginary central line of floor-ceiling distance contributes to a better and more equal distribution of reflections from the ceiling and the floor which eventually results in better clarity. Definition D50 and Center Time TS are very similar in both cases.

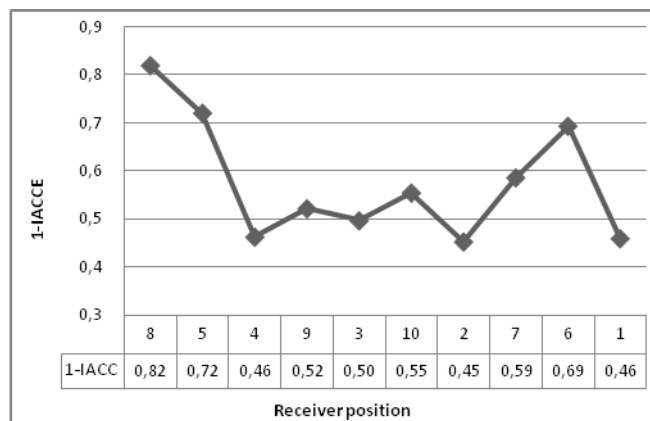
Figure 11: 1-IACC_E vs. receiver positions

Figure 11 shows 1-IACC_E values in the church. The positions that are closer to the side walls have higher values than the central positions. Again, there is interesting behavior at the positions 5 and 8 that have the highest values overall. These positions are also very close to a reflecting surface, the low coffered ceiling at the height of 3m, and that gives the explanation for high 1-IACC. Furthermore these positions generally receive only the reflected sound. The average 1-IACC_E in the church is 0,58.
