# 10ème Congrès Français d'Acoustique

## Evaluation of Acoustic Parameters of Churches

Janko Vodopija<sup>1</sup>, Sinisa Fajt<sup>2</sup>, Miljenko Krhen<sup>2</sup>

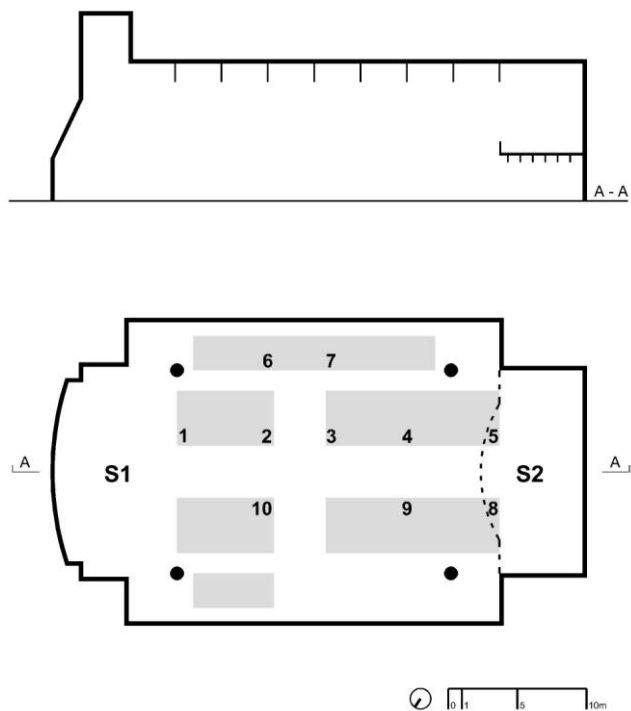
Figure 2: The plan and a section of the church of the Immaculate Heart of Mary

In Figure 2 we present the plan and A-A section of the church of the Immaculate Heart of Mary. It is quite obvious

that the ceiling plan is completely different in comparison to the previously described church. The height is twice as low, and what is more important is that the ceiling is flat and coffered, made of concrete. Only recently the central part of the ceiling has been slightly modified by inserting wooden plates with light reflectors into coffers. The floor is made of polished stone plates, similarly to the previous church, while the whole structure is made of concrete with sharp edges and almost no diffusive elements at all. Side walls are covered in flat wooden plates up to the height of 2,5 m. Wooden pews, wooden plates at the ceiling and the recently built organ represent the only absorbing and diffusing elements. The architectural parameters are given in Table 2.

Shaded areas represent main listening areas with wooden pews, and numbers refer to the measuring point similarly as in the previous church. Two source positions, S1 and S2, were used, one at the altar and the other in front of the organ at the back western wall. The S1 position was approximately 70cm above the main floor level, and the S2 position is about 5m above the floor level.

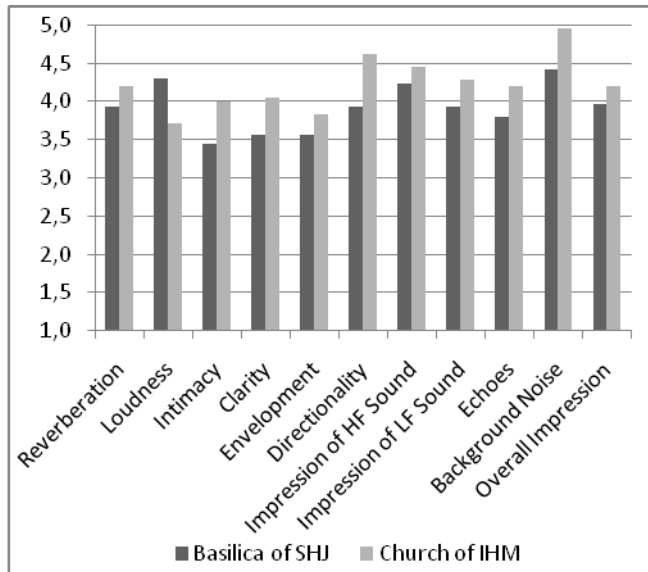
Figure 3: Comparative subjective scores of acoustic parameters

Figure 3 shows subjective scores of evaluated subjective parameters for the examined churches. The values of all parameters except Loudness are higher for the Church of IHM than the Basilica of SHJ.

The subjective impression of loudness is stronger in the Basilica because of the larger volume and consequently longer reverberation time values. The exact subjective scores and their standard deviation values are presented in Table 3. Intimacy, Clarity and Directionality were evaluated substantially higher in the Church of IHM.

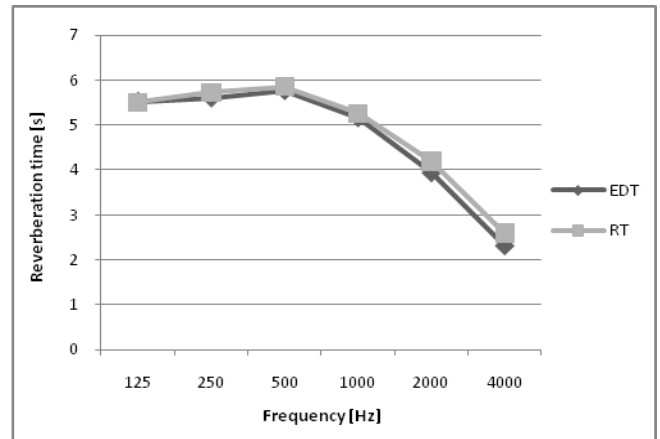
Figure 4: Average Octave Band Reverberation time of the Basilica of the Sacred Heart of Jesus

Both EDT and RT follow the same pattern and we can see that values are a little bit lower at the frequencies of 125 and 250 Hz which is due to low-frequency absorption effect of wooden structures (pews, altars, confession booths). Generally the reverberation frequency function follows the expected curvature, with values getting lower at high frequencies due to the sound absorption in the air. Exact RT and EDT values and their standard deviation are given in Table 4.

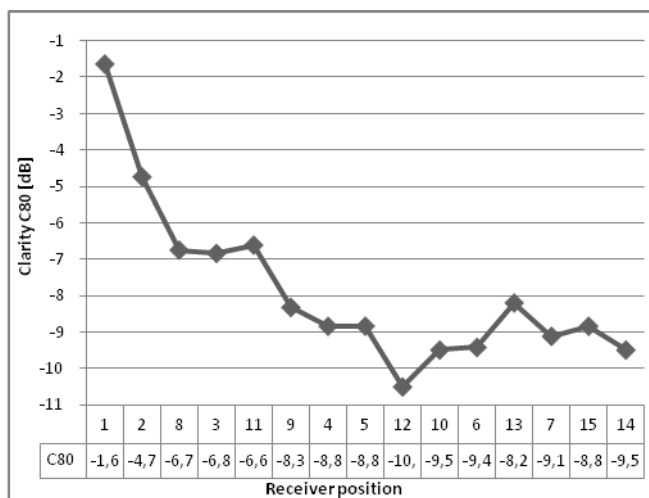
Figure 5: C80 vs. Source S1 – receiver position distance

The next examined parameter is clarity C80, presented graphically in Figures 5 and 6. The numbers on the X axis represent the receiver position number and they are sorted starting from the closest position to the farthest position from the sources S1 (the altar position) and S2 (the organ position).

In Figure 5 are the measured C80 values when the source was situated at the altar (S1). The C80 decreases with the distance from the source. The height of S1 is approximately 2m above the main listening area floor. In this case the sound reflecting from the ceiling has to travel longer to reach the listeners, thus resulting in an averagely lower C80 = -7,8 dB, compared to S2 (the organ position) when the average C80 = -5,9 dB.

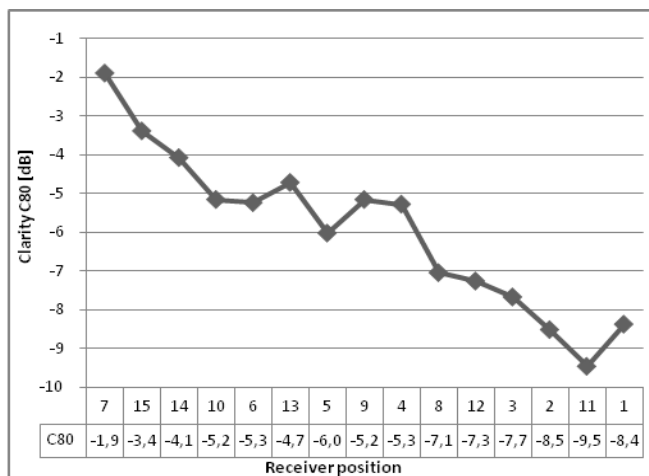
Figure 6: C80 vs. source S2 – receiver position distance

Figure 6 shows the second case when the sound source was in front of the organ. Again, the clarity decreases with distance, but the overall values are higher when compared to the values when the source is at the altar. The central positions in the nave show almost no difference in clarity compared to the positions in the lateral chapels, as the two closer lateral chapels have a higher C80 than the farther two and the source-receiver distance seems to be the leading factor influencing the clarity. The source S2 at the organ position is situated at the height of approximately 11 meters above the floor (8m height of the balcony + stairs + 1,5m height of the speaker stand), so it is just a little closer to the ceiling than to the floor. Still, we can say that this sound

source is well centered with regard to floor-ceiling distance and by looking at the values of parameters at different positions we can observe more uniformity and smaller differences in values of adjacent receiver positions than in the first case. Objective parameters Definition D50 and Center Time TS were also measured and their values correlate to a large extent with the pattern of C80, so they are not presented in graphical form.

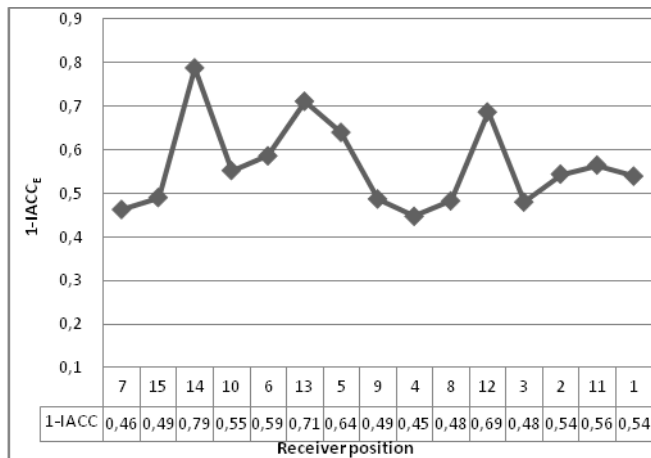
Figure 7:  $1-IACC_E$  vs. Source S2 – receiver distance

Binaural quality index was measured when the source was S2. The parameter IACC<sub>E</sub> was measured at all receiver positions. It is presented in the form 1-IACC<sub>E</sub> and is averaged over three octave bands (500 Hz, 1000 Hz, 2000 Hz). The results are given graphically in Figure 7. The receiver positions are sorted in the same way as before to

show that the  $1-IACC_E$  has almost no dependence on source-receiver distance. The values inside the nave are very similar with average value 0,52 while the position in the lateral chapels have significantly higher values averaging 0,69.

The positions in lateral chapels are closer to the side walls and are also surrounded by front and back wall of the chapel, which all contribute to a higher difference in the sound coming to the left and the right ear, thus resulting in higher and better IACC values.

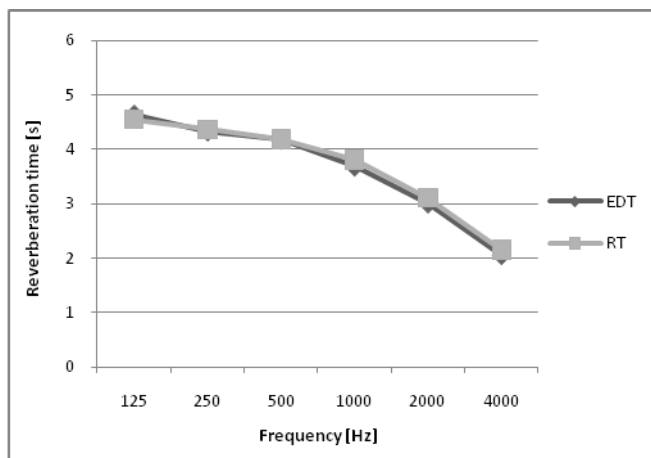
Figure 8: Average Octave Band Reverberation time of the church of the Immaculate Heart of Mary

Figure 8 shows EDT and RT as a function of frequency. Both parameters follow the same pattern, with highest values at 125 Hz and then decreasing as the central octave frequencies get higher. The balanced absorption at low frequencies results in better Bass Ratio  $BR = 1,12$  than in the previously examined basilica where  $BR = 1,01$ .

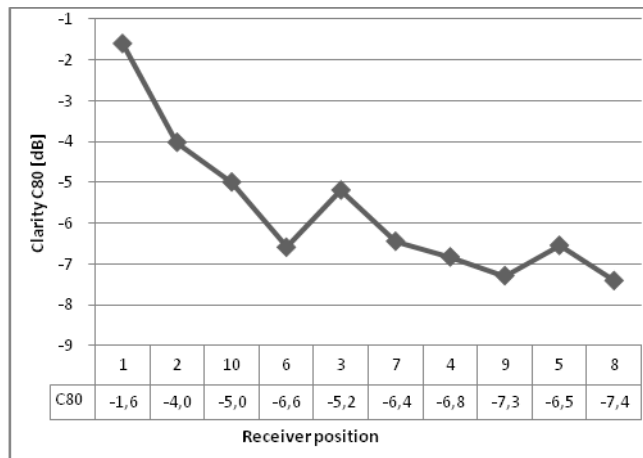
Figure 9: C80 vs. Source S1 – receiver position distance

In Table 7 are given exact values of EDT and RT and their respective standard deviation. Figure 9 shows C80 values as a function of receiver positions sorted from the closest to the farthest from the source, in this case S1 at the altar position.

C80 follows the expected pattern for the simple hall plan as is the case in this church, decreasing with the distance from the source S1 and shows no specific fluctuations. Quite in contrast, in Figure 10 we see C80 when the source is at the organ position S2.

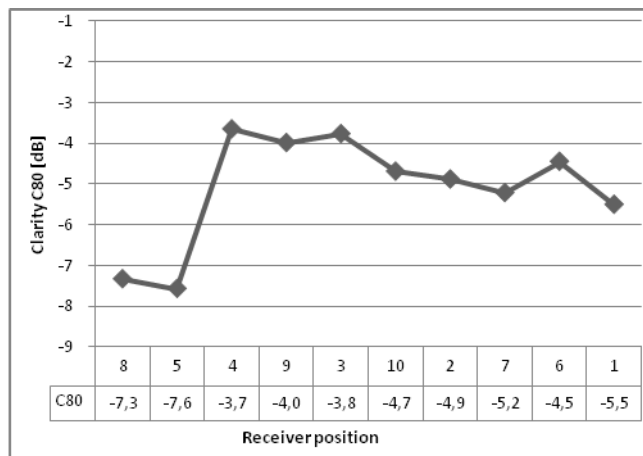
Figure 10: C80 vs. Source S2 – receiver position distance

The closest positions, 8 and 5, have the lowest C80 of all the positions in the church and the difference is significant. The reason for this unusual and unexpected behavior is that these two positions are only geometrically closest to the source when looking at the church plan. But they are in fact under the balcony and they have no direct line of sight with the source S2 or the organ. When carefully observing the church plan in Figure 2, one can see the dashed line that shows the position of the balcony. The height of the balcony is approximately 3m, so in fact we have the lower part of the balcony as the ceiling plan, coffered in concrete, above those two positions. This specific situation explains such low values of C80. The values decrease with the distance from the source. The complete measurement results are presented in Table 8. Comparing the values from Tables 8 and 9 we can see there is no significant difference in regard to the source positions S1 and S2, although the clarity values are a little higher for S2, which can be explained in the same manner as for the previous church.

The source that is situated closer to the half of the church height or the imaginary central line of floor-ceiling distance contributes to a better and more equal distribution of reflections from the ceiling and the floor which eventually results in better clarity. Definition D50 and Center Time TS are very similar in both cases.

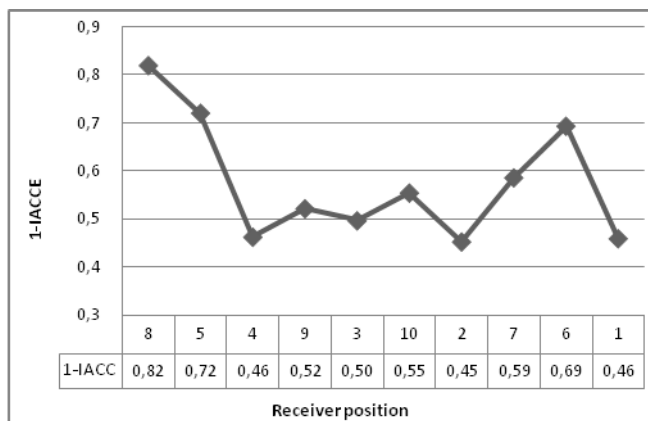
Figure 11: 1-IACC<sub>E</sub> vs. receiver positions

Figure 11 shows 1-IACC<sub>E</sub> values in the church. The positions that are closer to the side walls have higher values than the central positions. Again, there is interesting behavior at the positions 5 and 8 that have the highest values overall. These positions are also very close to a reflecting surface, the low coffered ceiling at the height of 3m, and that gives the explanation for high 1-IACC. Furthermore these positions generally receive only the reflected sound. The average 1-IACC<sub>E</sub> in the church is 0,58.
