# 10ème Congrès Français d'Acoustique

## Evaluation of Acoustic Parameters of Churches

The purpose of this paper is to give an evaluation of subjective and objective acoustic parameters in two architecturally different churches in Zagreb, Croatia. These churches have completely different architectural parameters due to different style, shape and volume. The influence of high vaulted ceiling in one church is compared to the lower flat ceiling of the other. The influence of large high ceiling lateral chapels to both binaural and monaural parameters is examined. Subjective parameters such as Intimacy, Clarity, Reverberation, Spatial and Overall Impression are compared to measured objective parameters. A comparison of obtained values of objective parameters has been made in order to examine the influence of different sound source positions.

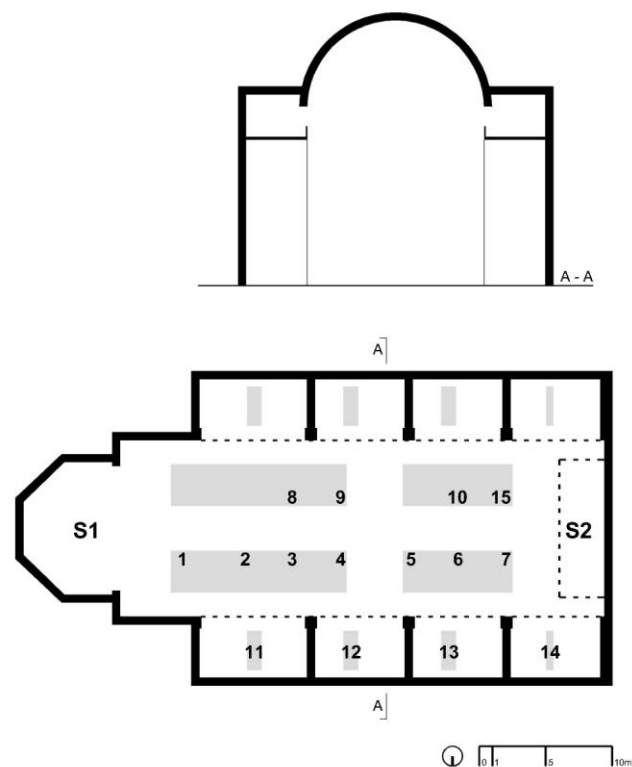
Figure 1: The plan and a section of the Basilica of the Sacred Heart of Jesus

Figure 1 shows the plan and the A-A section of the basilica. Shaded gray areas represent main listening areas where thick wooden pews are situated. S1 and S2 represent source positions, one at the altar and the other situated in front of the organ to simulate the listening conditions for music. It is

important to notice that the altar position S1 is elevated 60 cm above the main listening area level, while S2 and the organ are situated at the balcony above the doors at the height of approximately 11 m. The numbers in shaded areas represent the positions where the measurements were taken, both objective and subjective. Altogether there are 15 positions, 4 in lateral chapels and 11 in the main nave, 4 of these 11 were positioned symmetrically on the other side to ensure control measuring points [1]. Complete architectural parameters are given in Table 1.

The first lateral chapel is longer than the following three and its length is 8,1 m, surface 37,3 m<sup>2</sup> and volume 410 m<sup>3</sup>. The connecting area to the nave of this largest chapel is 89 m<sup>2</sup>, while this area for the other chapel equals 74,3 m<sup>2</sup>. These measures are given because coupling effects between lateral chapels and the nave will also be examined. The ceiling is vaulted and its highest point reaches 20m. Though the church is built in neobaroque style it does not have rich ornamentation and most diffusive surfaces result from lateral altars, confession booths and pews, all made of wood. The floor is made of polished stone plates which are highly reflective. Side walls and ceiling are finished in plaster, and each chapel has a central thick glass window covering 9,2 m<sup>2</sup>.

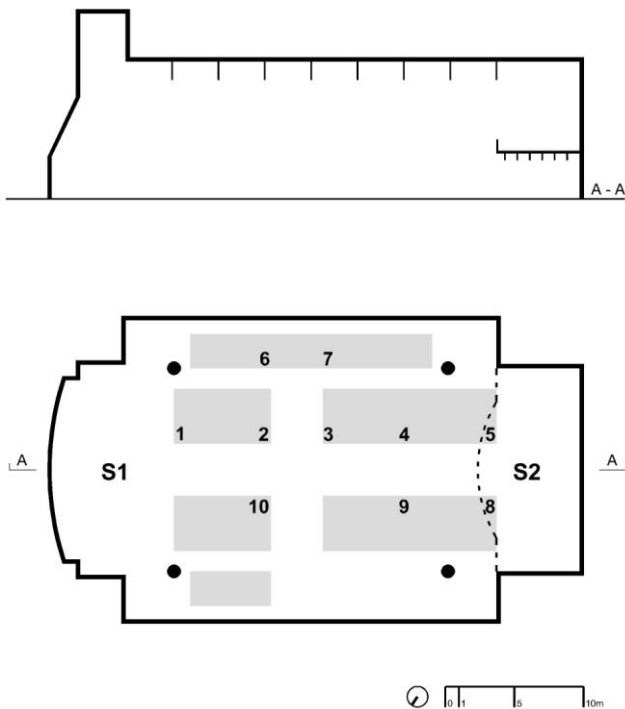
Figure 2: The plan and a section of the church of the Immaculate Heart of Mary

In Figure 2 we present the plan and A-A section of the church of the Immaculate Heart of Mary. It is quite obvious

that the ceiling plan is completely different in comparison to the previously described church. The height is twice as low, and what is more important is that the ceiling is flat and coffered, made of concrete. Only recently the central part of the ceiling has been slightly modified by inserting wooden plates with light reflectors into coffers. The floor is made of polished stone plates, similarly to the previous church, while the whole structure is made of concrete with sharp edges and almost no diffusive elements at all. Side walls are covered in flat wooden plates up to the height of 2,5 m. Wooden pews, wooden plates at the ceiling and the recently built organ represent the only absorbing and diffusing elements. The architectural parameters are given in Table 2.

Shaded areas represent main listening areas with wooden pews, and numbers refer to the measuring point similarly as in the previous church. Two source positions, S1 and S2, were used, one at the altar and the other in front of the organ at the back western wall. The S1 position was approximately 70cm above the main floor level, and the S2 position is about 5m above the floor level.

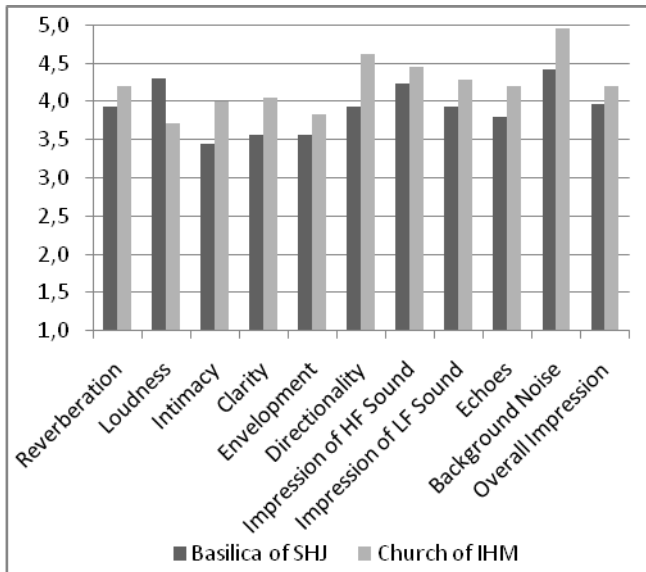
Figure 3: Comparative subjective scores of acoustic parameters

Figure 3 shows subjective scores of evaluated subjective parameters for the examined churches. The values of all parameters except Loudness are higher for the Church of IHM than the Basilica of SHJ.

The subjective impression of loudness is stronger in the Basilica because of the larger volume and consequently longer reverberation time values. The exact subjective scores and their standard deviation values are presented in Table 3. Intimacy, Clarity and Directionality were evaluated substantially higher in the Church of IHM.

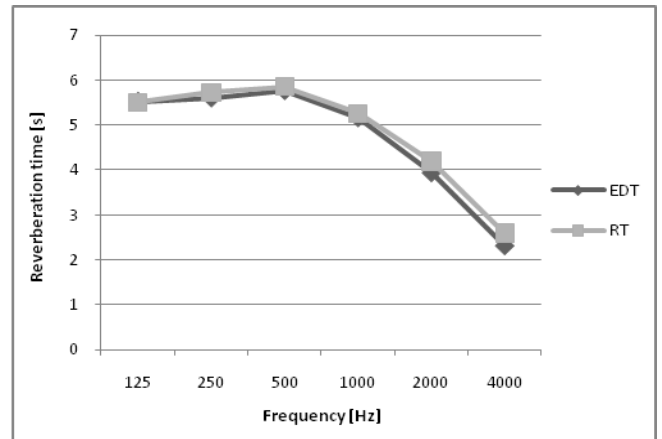
Figure 4: Average Octave Band Reverberation time of the Basilica of the Sacred Heart of Jesus

Both EDT and RT follow the same pattern and we can see that values are a little bit lower at the frequencies of 125 and 250 Hz which is due to low-frequency absorption effect of wooden structures (pews, altars, confession booths). Generally the reverberation frequency function follows the expected curvature, with values getting lower at high frequencies due to the sound absorption in the air. Exact RT and EDT values and their standard deviation are given in Table 4.

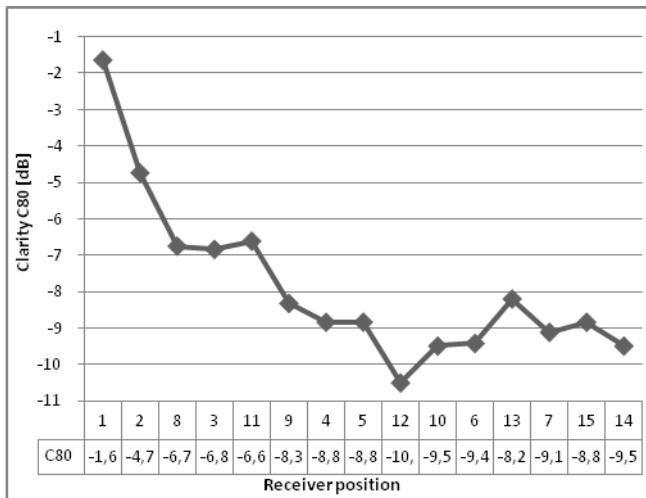
Figure 5: C80 vs. Source S1 – receiver position distance

In Figure 5 are the measured C80 values when the source was situated at the altar (S1). The C80 decreases with the distance from the source. The height of S1 is approximately 2m above the main listening area floor. In this case the sound reflecting from the ceiling has to travel longer to reach the listeners, thus resulting in an averagely lower C80 = -7,8 dB, compared to S2 (the organ position) when the average C80 = -5,9 dB.

The next examined parameter is clarity C80, presented graphically in Figures 5 and 6. The numbers on the X axis represent the receiver position number and they are sorted starting from the closest position to the farthest position from the sources S1 (the altar position) and S2 (the organ position).

Complete measurement results of objective parameters from the altar position (S1) are given in Table 5. In the second case, with the source at the organ position (S2), we have obtained the parameter values presented in Table 6.

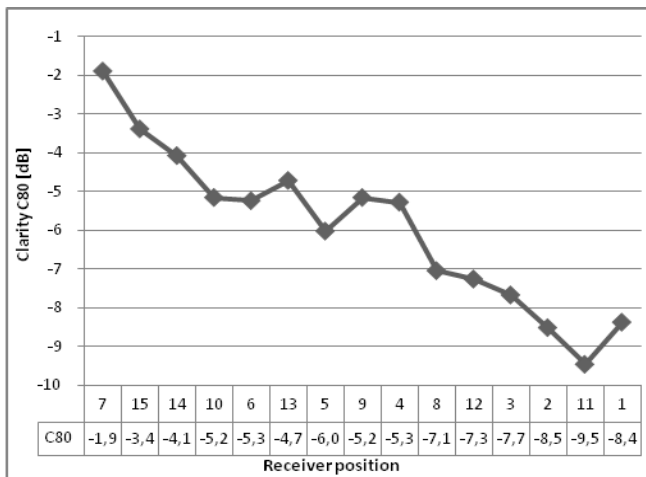
Figure 6: C80 vs. source S2 – receiver position distance

Figure 6 shows the second case when the sound source was in front of the organ. Again, the clarity decreases with distance, but the overall values are higher when compared to the values when the source is at the altar. The central positions in the nave show almost no difference in clarity compared to the positions in the lateral chapels, as the two closer lateral chapels have a higher C80 than the farther two and the source-receiver distance seems to be the leading factor influencing the clarity. The source S2 at the organ position is situated at the height of approximately 11 meters above the floor (8m height of the balcony + stairs + 1,5m height of the speaker stand), so it is just a little closer to the ceiling than to the floor. Still, we can say that this sound

source is well centered with regard to floor-ceiling distance and by looking at the values of parameters at different positions we can observe more uniformity and smaller differences in values of adjacent receiver positions than in the first case. Objective parameters Definition D50 and Center Time TS were also measured and their values correlate to a large extent with the pattern of C80, so they are not presented in graphical form.

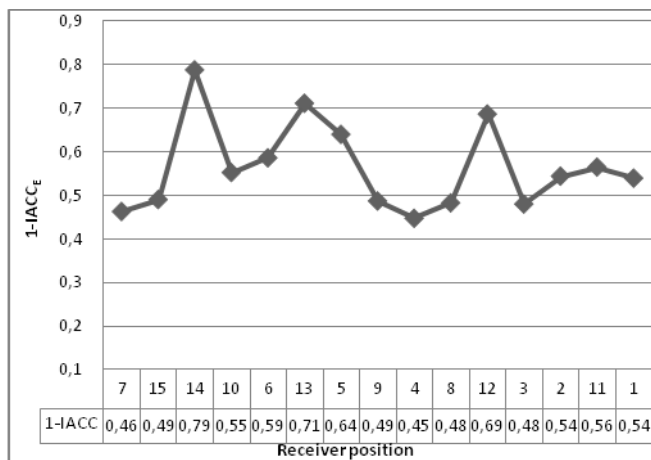
Binaural quality index was measured when the source was S2. The parameter IACC<sub>E</sub> was measured at all receiver positions. It is presented in the form 1-IACC<sub>E</sub> and is averaged over three octave bands (500 Hz, 1000 Hz, 2000 Hz). The results are given graphically in Figure 7. The receiver positions are sorted in the same way as before to

show that the  $1-IACC_E$  has almost no dependence on source-receiver distance. The values inside the nave are very similar with average value 0,52 while the position in the lateral chapels have significantly higher values averaging 0,69.

Figure 7:  $1-IACC_E$  vs. Source S2 – receiver distance

The positions in lateral chapels are closer to the side walls and are also surrounded by front and back wall of the chapel, which all contribute to a higher difference in the sound coming to the left and the right ear, thus resulting in higher and better IACC values.

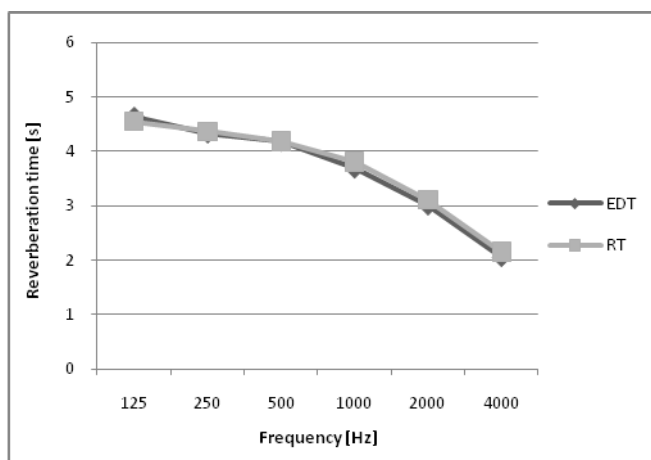
Figure 8: Average Octave Band Reverberation time of the church of the Immaculate Heart of Mary

Figure 8 shows EDT and RT as a function of frequency. Both parameters follow the same pattern, with highest values at 125 Hz and then decreasing as the central octave frequencies get higher. The balanced absorption at low frequencies results in better Bass Ratio  $BR = 1,12$  than in the previously examined basilica where  $BR = 1,01$ .

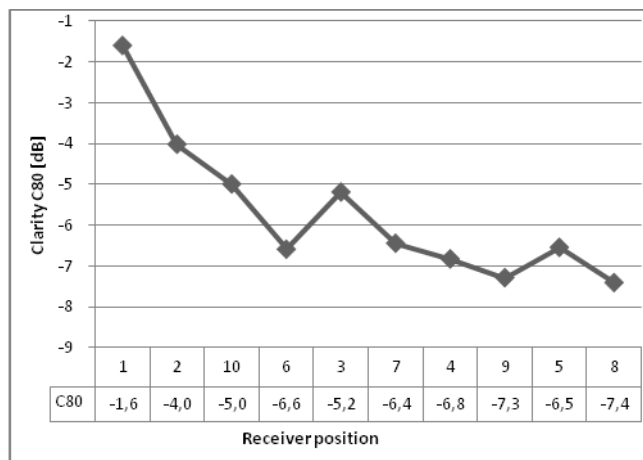
Figure 9: C80 vs. Source S1 – receiver position distance

C80 follows the expected pattern for the simple hall plan as is the case in this church, decreasing with the distance from the source S1 and shows no specific fluctuations. Quite in contrast, in Figure 10 we see C80 when the source is at the organ position S2.

In Table 7 are given exact values of EDT and RT and their respective standard deviation. Figure 9 shows C80 values as a function of receiver positions sorted from the closest to the farthest from the source, in this case S1 at the altar position.

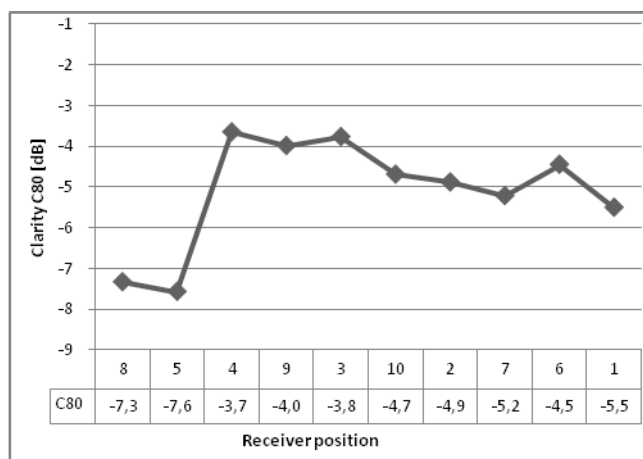
Figure 10: C80 vs. Source S2 – receiver position distance

The closest positions, 8 and 5, have the lowest C80 of all the positions in the church and the difference is significant. The reason for this unusual and unexpected behavior is that these two positions are only geometrically closest to the source when looking at the church plan. But they are in fact under the balcony and they have no direct line of sight with the source S2 or the organ. When carefully observing the church plan in Figure 2, one can see the dashed line that shows the position of the balcony. The height of the balcony is approximately 3m, so in fact we have the lower part of the balcony as the ceiling plan, coffered in concrete, above those two positions. This specific situation explains such low values of C80. The values decrease with the distance from the source. The complete measurement results are presented in Table 8. Comparing the values from Tables 8 and 9 we can see there is no significant difference in regard to the source positions S1 and S2, although the clarity values are a little higher for S2, which can be explained in the same manner as for the previous church.

The source that is situated closer to the half of the church height or the imaginary central line of floor-ceiling distance contributes to a better and more equal distribution of reflections from the ceiling and the floor which eventually results in better clarity. Definition D50 and Center Time TS are very similar in both cases.

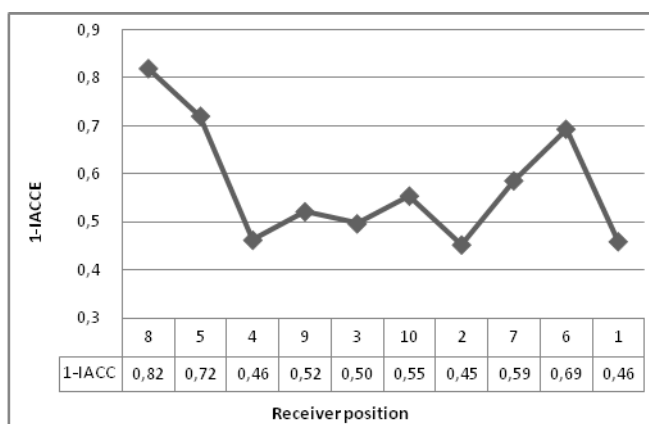
Figure 11: 1-IACC<sub>E</sub> vs. receiver positions

Figure 11 shows 1-IACC<sub>E</sub> values in the church. The positions that are closer to the side walls have higher values than the central positions. Again, there is interesting behavior at the positions 5 and 8 that have the highest values overall. These positions are also very close to a reflecting surface, the low coffered ceiling at the height of 3m, and that gives the explanation for high 1-IACC. Furthermore these positions generally receive only the reflected sound. The average 1-IACC<sub>E</sub> in the church is 0,58.
