## **Maintenance procedures and definition of limit states for exterior wood coatings**

Gerhard Gröll, Michael Truskaller, Laurence Podgorski, Susanne Bollmus, Florian Tscherne

Gerhard Gröll, Michael Truskaller, Laurence Podgorski, Susanne Bollmus, Florian Tscherne. Maintenance procedures and definition of limit states for exterior wood coatings. *European Journal of Wood and Wood Products*, 2010, 69 (3), pp.443-450. <10.1007/s00107-010-0469-z>. <hal-00615332>

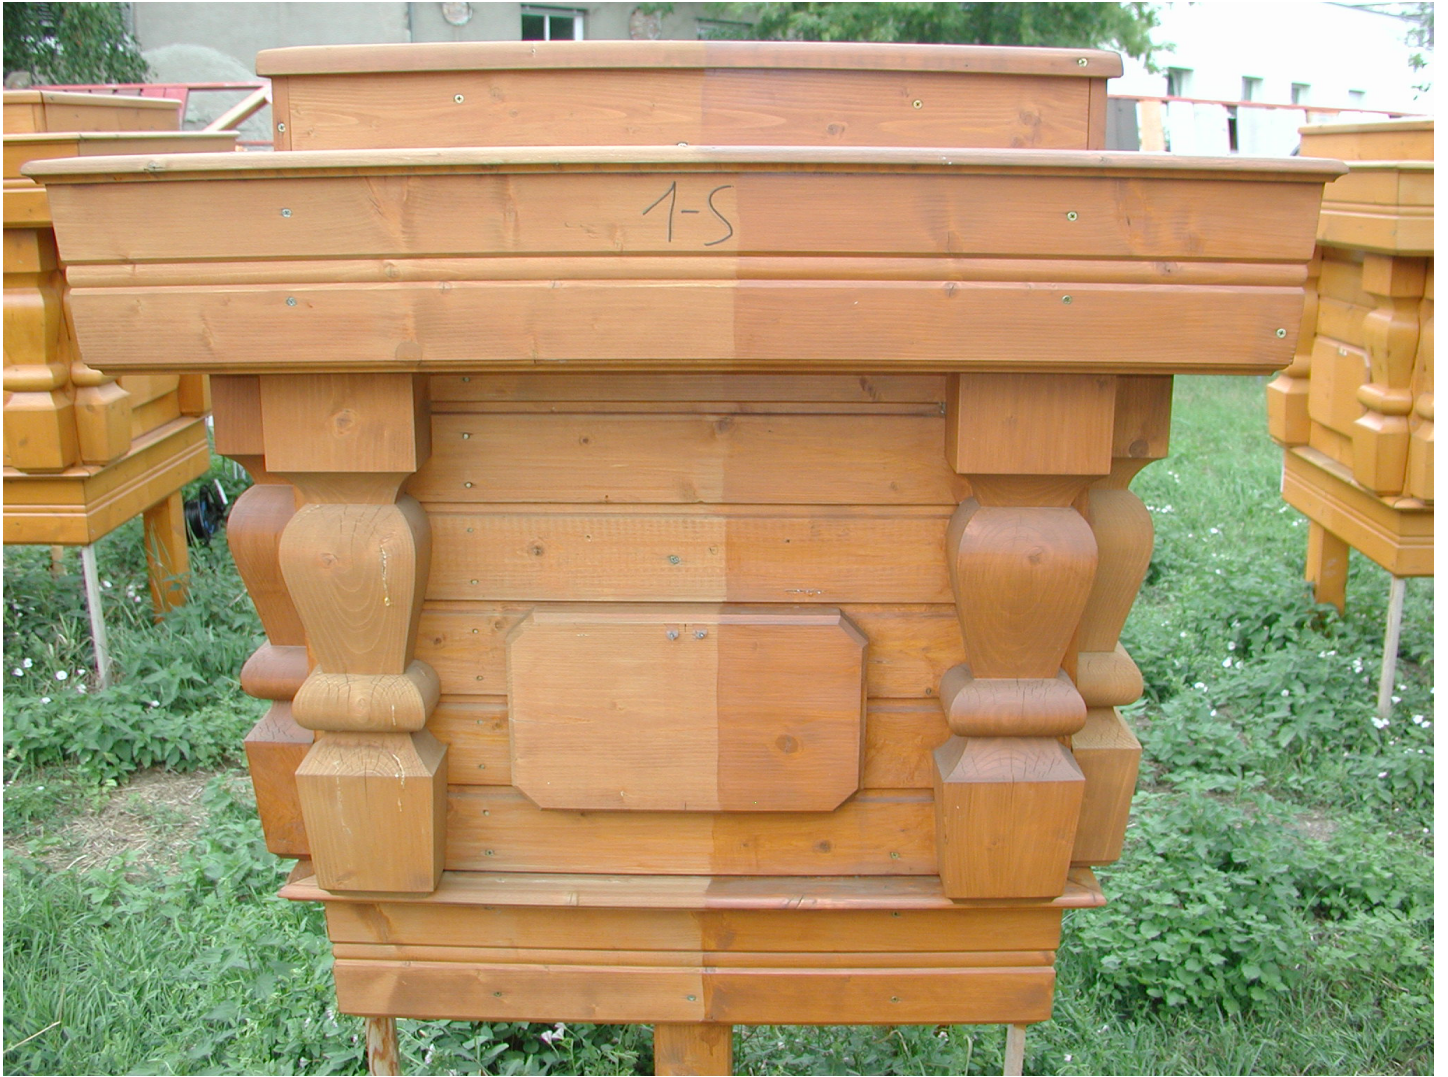
Figure\_1

**Figure 1: Front view of balcony construction, side exposed to south; left side: original coating; right side: maintenance coating (applied after 18 months of exposure)**

After 18 months of natural weathering one half of each side (east, south, west) of the balcony parts was maintained by preparing the surfaces with light sanding, cleaning using a brush with bristles of brass and brush application of a coating material in one layer. For each construction a coating product suitable for the original coating system was used for maintenance. In most cases identical products were used for original and maintenance coating of the parts (Table 1). After 24 months of natural weathering the surfaces of the balcony parts were assessed visually and defects were recorded comparing the surfaces with and without maintenance coating. The development of coating defects after this period of weathering was sufficient to identify if maintenance was done at the proper time or if this action was too early or too late for the individual coating systems.

For coating systems 5 and 6 the original coating showed minor defects such as small cracks and discolorations around them while on the maintained surfaces no defects were visible, also in the regions around knots and patches in the wood. The coating systems 11 and 12 comprised severe defects on the original surface and somewhat less pronounced defects on the part with the maintenance coating.

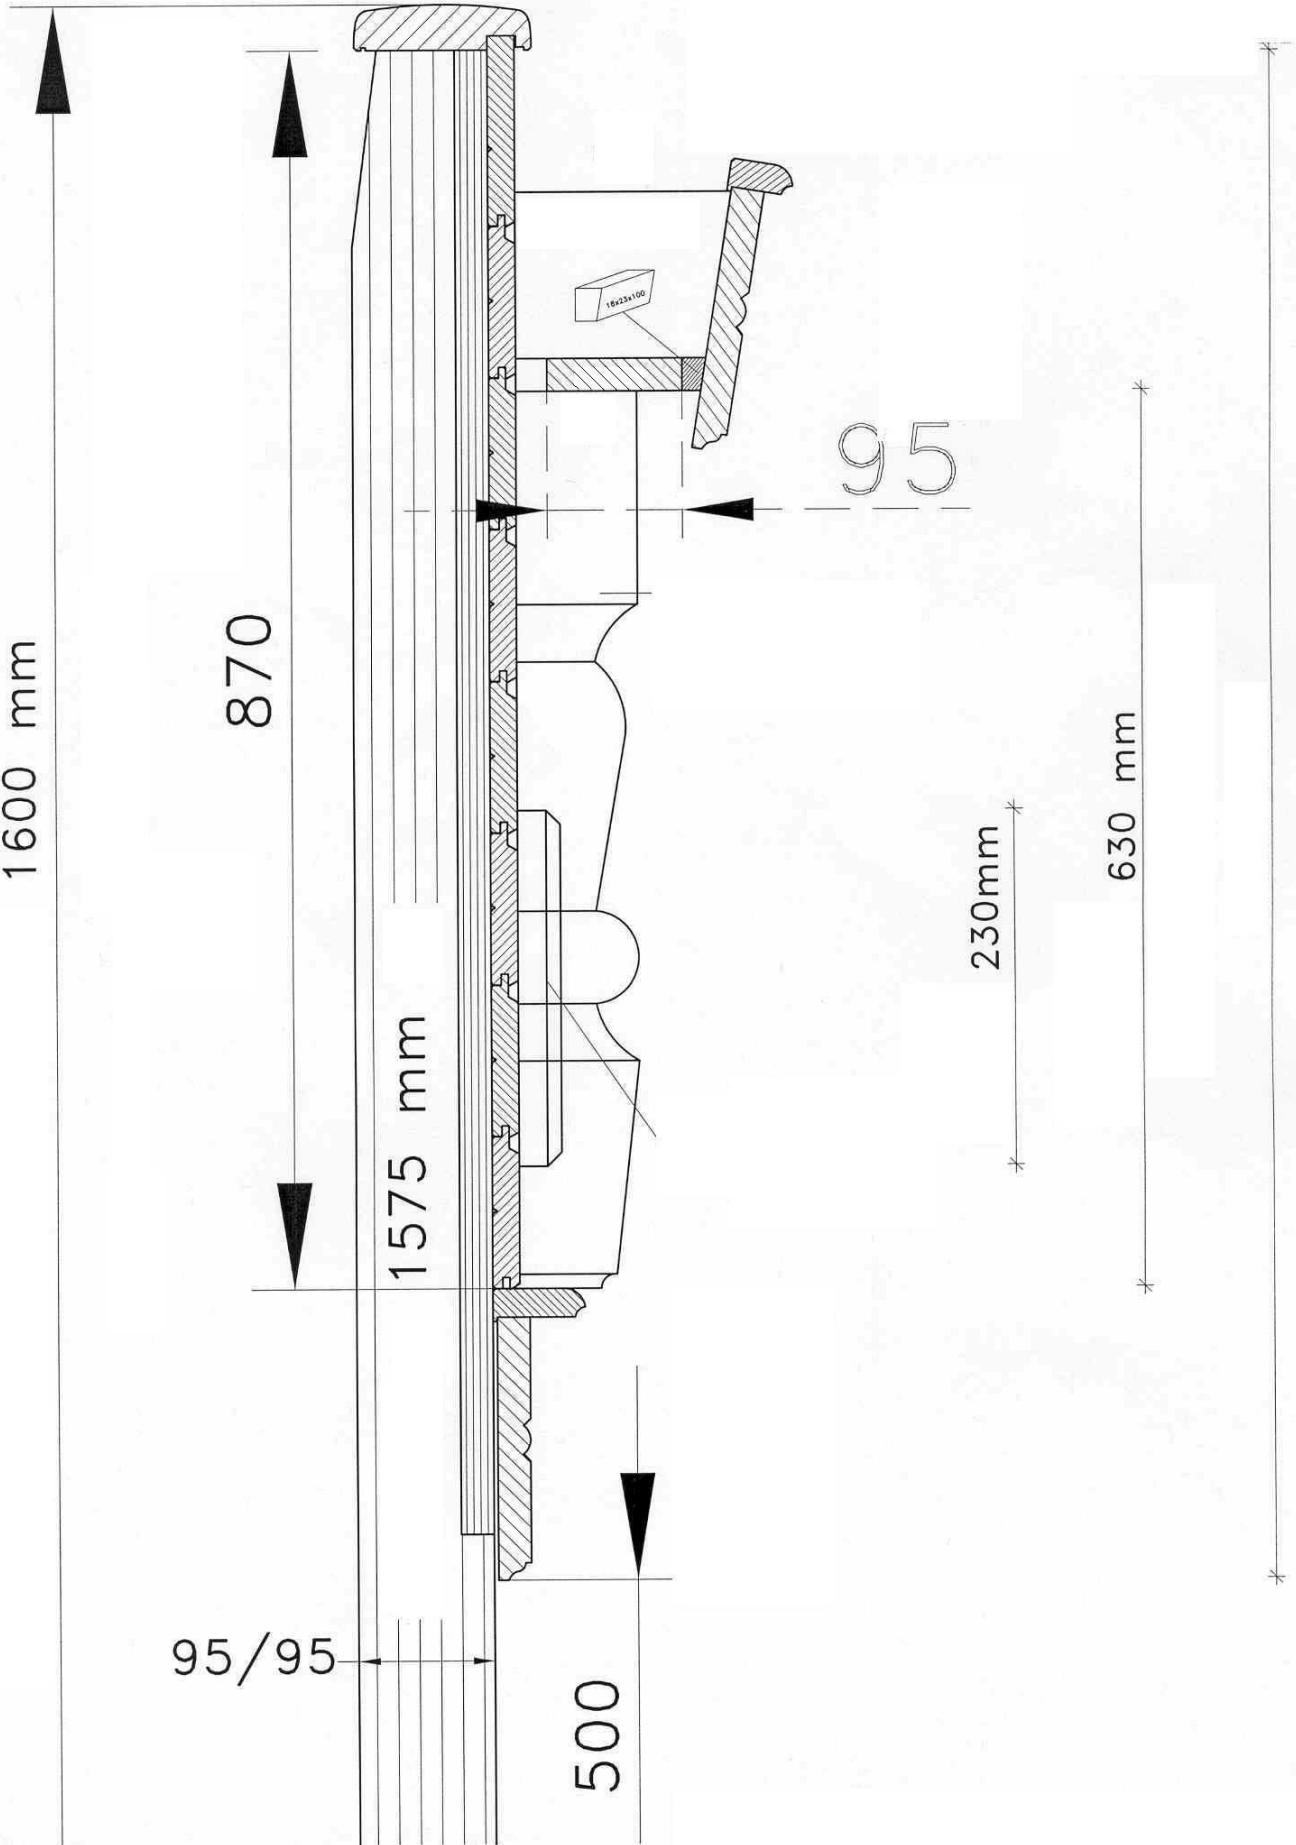
**Figure 2: Design of the balcony constructions (vertical section)**

Fifteen balcony constructions made of Norway spruce wood (*Picea abies*) with the same design were coated with different coating systems and exposed to natural weathering at Holzforschung Austria in Vienna starting at 20.11.2003. One more balcony construction was left uncoated. The shape of the constructions was triple-sided with the sides facing east, south and west and they comprised no floorings (Fig. 1 and 2). The parts represented typical balcony constructions as widely used in Austria and southern Germany. On the top sides of the hand rails a few patches as commonly used to repair wood defects before coating application were placed into the wood. These constructions were chosen to reflect practical situations rather than standard testing procedures with ideal wood panels and thereby gather experience that is relevant in practice. The 15 coating systems were selected to represent the variety of products available on the market with regard to coating film thickness and transparency. They were applied either with brush, dipping or flow coating technique by industry partners and professional painters with suitable experience. The dry film thickness of the coatings was measured on samples taken from the finished constructions using microscopic measurements on cross sections according to EN ISO 2808, procedure 6A. A characterisation of the coating systems is shown in Table 1.
