Maintenance procedures and definition of limit states for exterior wood coatings

Gerhard Gröll, Michael Truskaller, Laurence Podgorski, Susanne Bollmus,
Florian Tscherne

Gerhard Gröll, Michael Truskaller, Laurence Podgorski, Susanne Bollmus, Florian Tscherne. Maintenance procedures and definition of limit states for exterior wood coatings. *European Journal of Wood and Wood Products*, 2010, 69 (3), pp.443-450. 10.1007/s00107-010-0469-z . hal-00615332

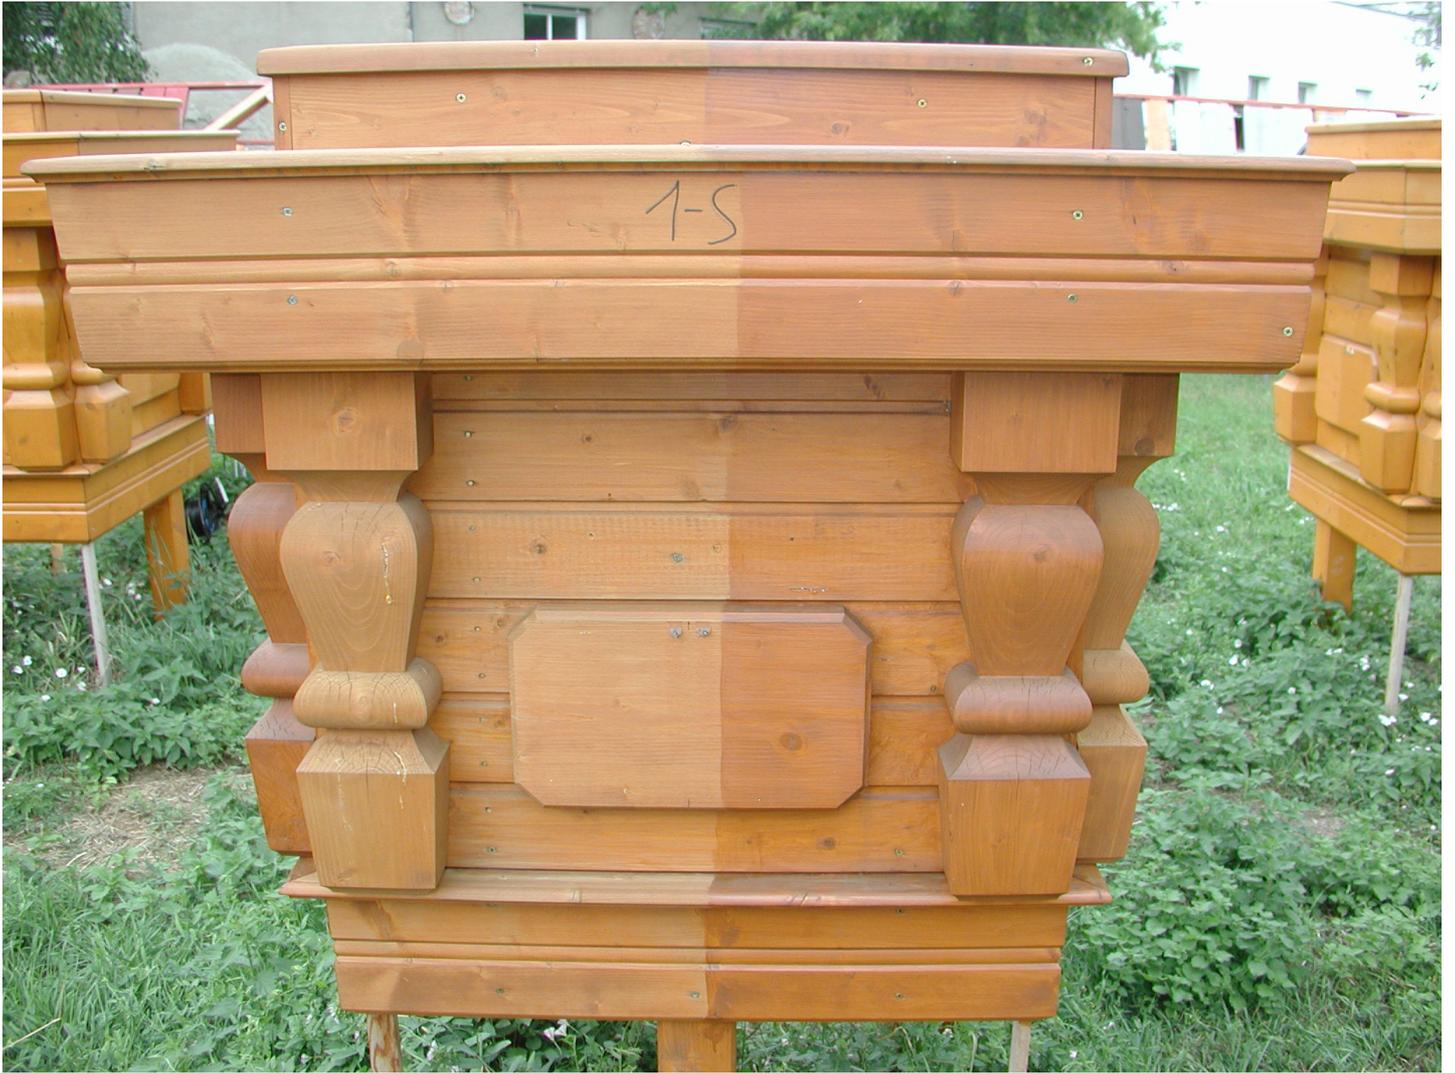
Figure_1

Figure 1: Front view of balcony construction, side exposed to south; left side: original coating; right side: maintenance coating (applied after 18 months of exposure)

After 18 months of natural weathering one half of each side (east, south, west) of the balcony parts was maintained by preparing the surfaces with light sanding, cleaning using a brush with bristles of brass and brush application of a coating material in one layer. For each construction a coating product suitable for the original coating system was used for maintenance. In most cases identical products were used for original and maintenance coating of the parts (Table 1). After 24 months of natural weathering the surfaces of the balcony parts were assessed visually and defects were recorded comparing the surfaces with and without maintenance coating. The development of coating defects after this period of weathering was sufficient to identify if maintenance was done at the proper time or if this action was too early or too late for the individual coating systems.

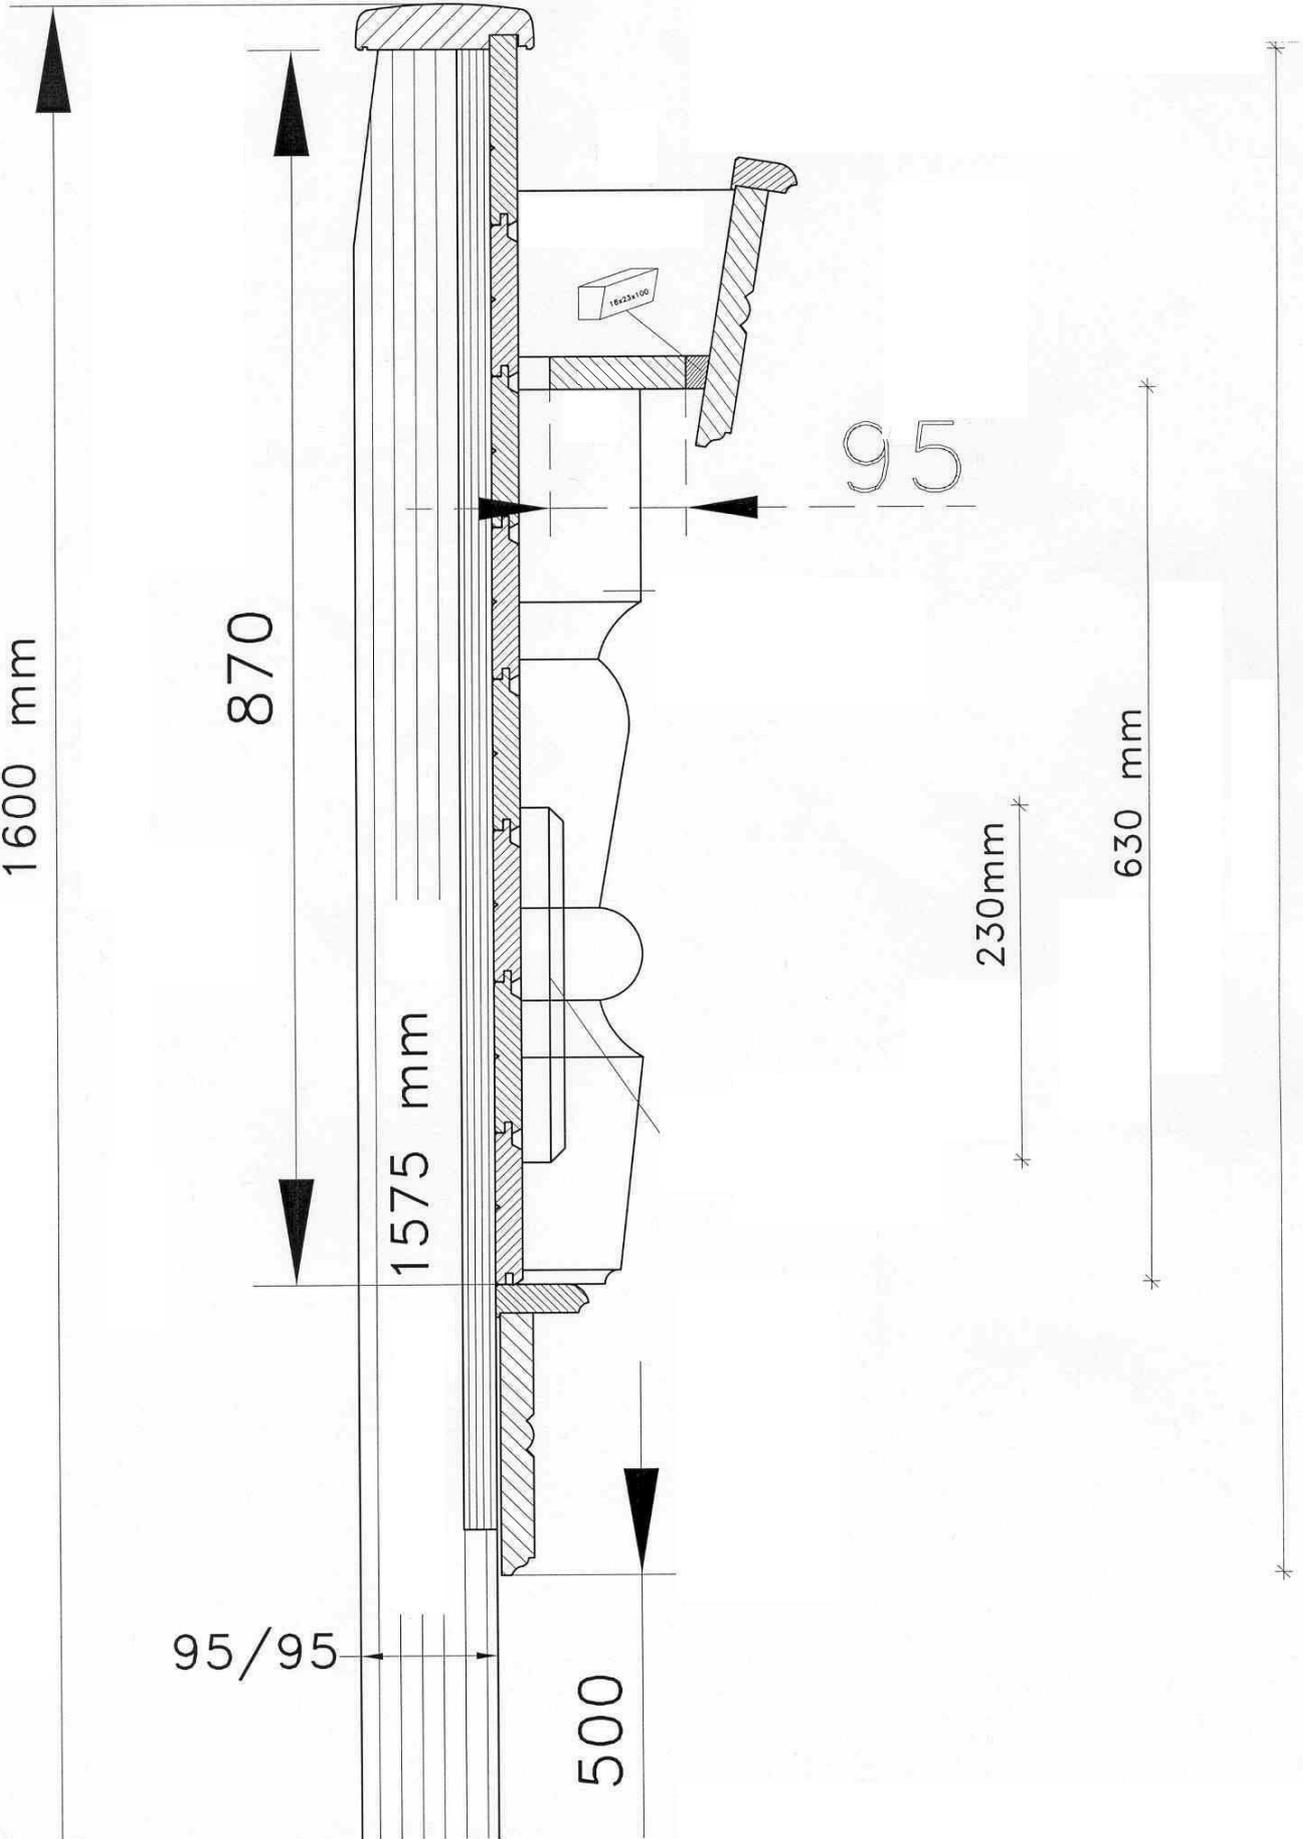
Figure 2: Design of the balcony constructions (vertical section)

Fifteen balcony constructions made of Norway spruce wood (*Picea abies*) with the same design were coated with different coating systems and exposed to natural weathering at Holzforschung Austria in Vienna starting at 20.11.2003. One more balcony construction was left uncoated. The shape of the constructions was triple-sided with the sides facing east, south and west and they comprised no floorings (Fig. 1 and 2). The parts represented typical balcony constructions as widely used in Austria and southern Germany. On the top sides of the hand rails a few patches as commonly used to repair wood defects before coating application were placed into the wood. These constructions were chosen to reflect practical situations rather than standard testing procedures with ideal wood panels and thereby gather experience that is relevant in practice. The 15 coating systems were selected to represent the variety of products available on the market with regard to coating film thickness and transparency. They were applied either with brush, dipping or flow coating technique by industry partners and professional painters with suitable experience. The dry film thickness of the coatings was measured on samples taken from the finished constructions using microscopic measurements on cross sections according to EN ISO 2808, procedure 6A. A characterisation of the coating systems is shown in Table 1.
