Maintenance procedures and definition of limit states for exterior wood coatings

Gerhard Gröll, Michael Truskaller, Laurence Podgorski, Susanne Bollmus,
Florian Tscherne

Gerhard Gröll, Michael Truskaller, Laurence Podgorski, Susanne Bollmus, Florian Tscherne. Maintenance procedures and definition of limit states for exterior wood coatings. *European Journal of Wood and Wood Products*, 2010, 69 (3), pp.443-450. 10.1007/s00107-010-0469-z . hal-00615332

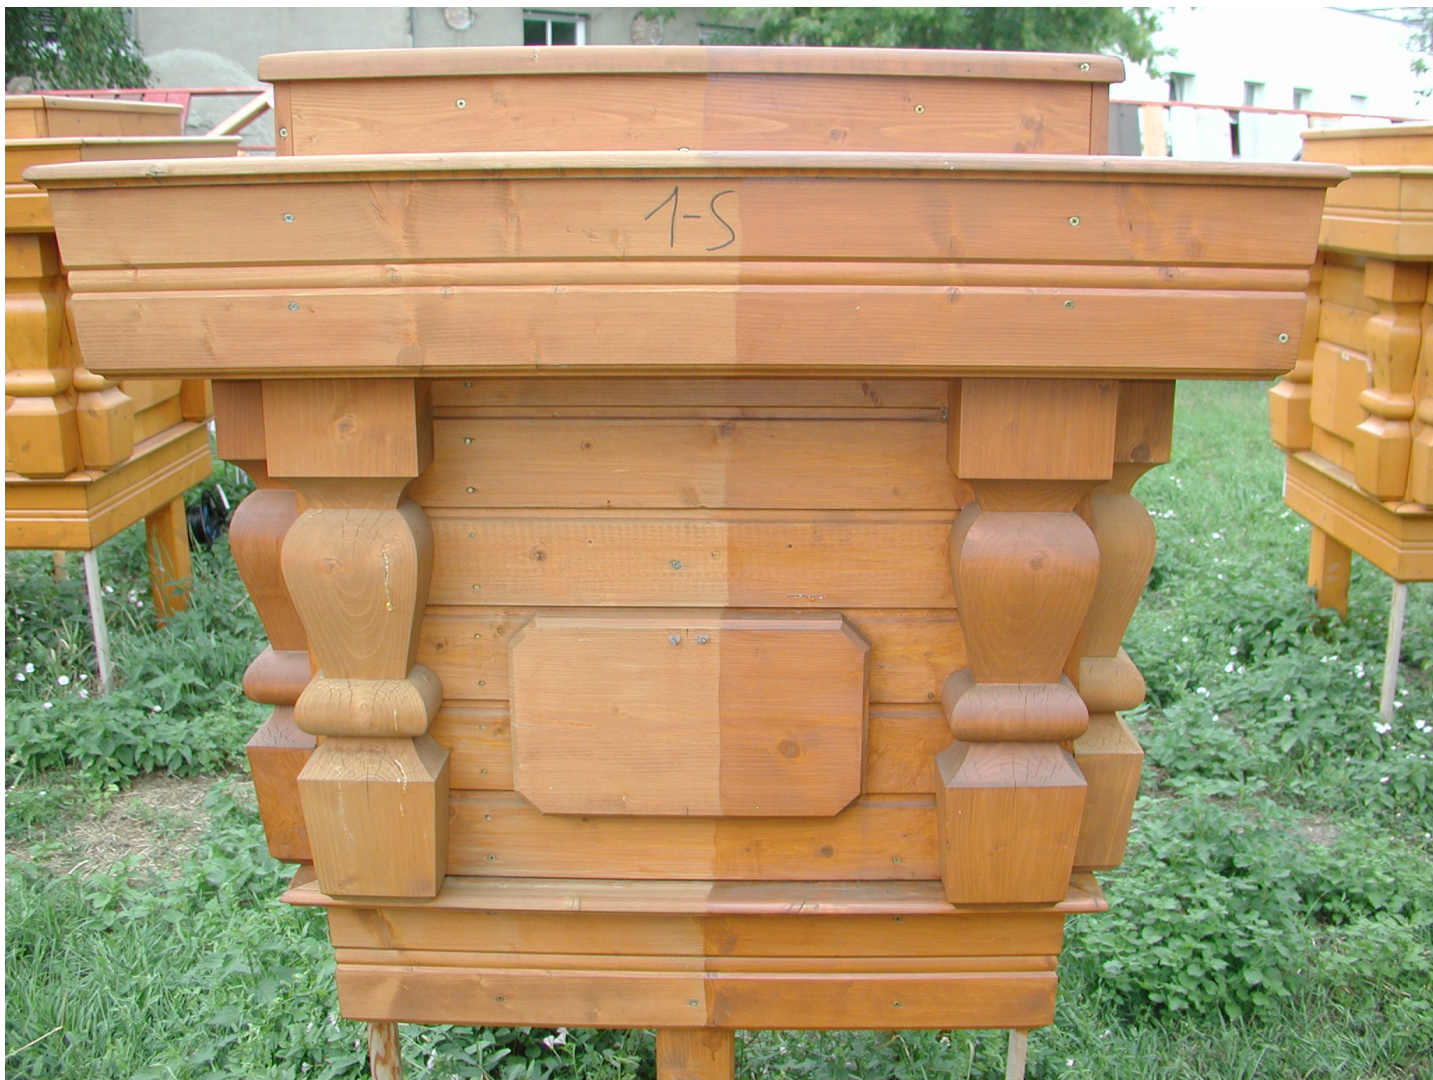
Figure_1

Figure 1: Front view of balcony construction, side exposed to south; left side: original coating; right side: maintenance coating (applied after 18 months of exposure)

After 18 months of natural weathering one half of each side (east, south, west) of the balcony parts was maintained by preparing the surfaces with light sanding, cleaning using a brush with bristles of brass and brush application of a coating material in one layer. For each construction a coating product suitable for the original coating system was used for maintenance. In most cases identical products were used for original and maintenance coating of the parts (Table 1). After 24 months of natural weathering the surfaces of the balcony parts were assessed visually and defects were recorded comparing the surfaces with and without maintenance coating. The development of coating defects after this period of weathering was sufficient to identify if maintenance was done at the proper time or if this action was too early or too late for the individual coating systems.
