Understanding the Dual mobility concept for total hip arthroplasty. Investigations on a multiscale analysis-Highlighting the role of arthrofibrosis

J. Geringer^{a,*}, B. Boyer^{a,b}, F. Farizon^b

Abstract

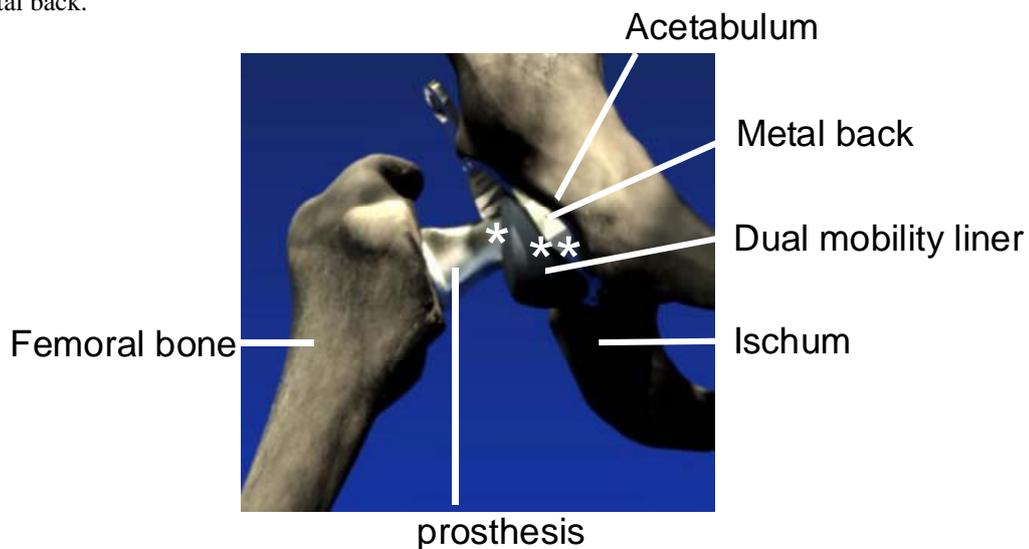
Figure 1 Dual mobility hip implant; *: first mobility between head and cup, concave side for cup; **: second mobility between cup and metal back, convex side for cup

The usual liner-head assembly is constituted only by the first mobility. This new implant enhanced both stability and survivorship because of decreasing dislocations [7-10]. The follow-up studies of dual mobility concept exhibited similar behaviors to classical THA in prosthetic joint lifetime [11-15]. To prevent dislocation due to impingement, the dual mobility concept seems to be the most reliable treatment [16]. The second mobility is believed to be triggered when the femoral neck hits the liner. It lowers liner rim degradations and generation of wear debris. Dual mobility concept is concerned in 30% of THA in France, and is more and more investigated for the implants in US. Considering an extra friction surface, one might expect dual mobility to produce more wear debris than the classical artificial joint; the osteolysis mechanisms might be reinforced. The main key-points related to dual mobility are the understanding of the *in-vivo* biomechanical behavior, the wear rate of UHMWPE involved in the second mobility and the material transfers due to wear and corrosion between the cup and the metal back.

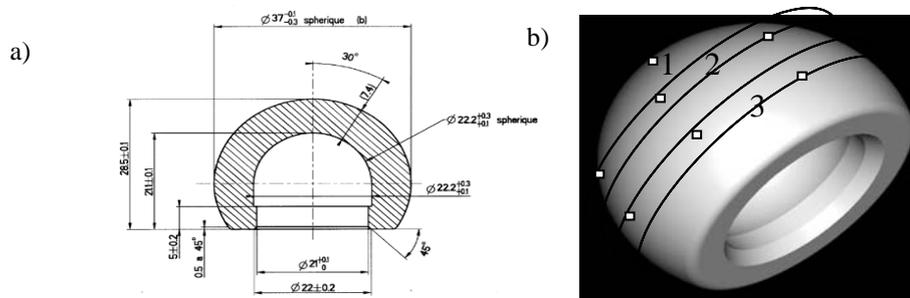
Figure 2 a) Cestilène® (UHMWPE) liner with functional dimensioning and tolerancing; b) zone 1: apex ; zone 2: no-worn zone; zone 3: worn zone

While the explants were selected, macroscopic analysis allowed highlighting a strip wear close to the liner convex side equator. The evolution of the roughness parameters was fruitful for isolating the particular wear zones and for pointing out the significant wear zones. The specific methodology dedicated to this study was established from [24-28]. Thus, in order to characterize quantitatively the wear mechanism at a microscale, the following analyses were practised: analyses of 11 zones on the convex side of each UHMWPE liner, i.e. 5 areas on the no-worn zone (latitude 2 as depicted on Figure 2), 5 areas on the worn zone (latitude 3, Figure 2) and 1 zone on the liner apex.

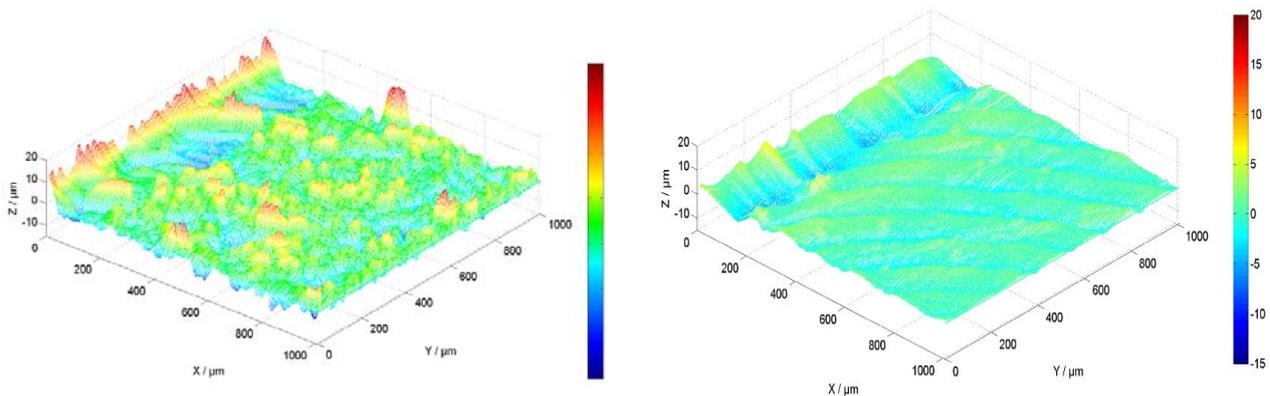
a) worn zone of T1 explant

b) apex zone of T1 explant

Figure 3 a) example of a worn zone close to equator, b) example of apex zone close to the latitude of 40°, the related explant is T1.

The profilometry analyses were investigated using a mechanical profilometer SOMICRONIC®. The measurement interval in X and Y was 4 µm. The images resolution was 256 x 256 points. The raw data were filtered using a least squares plane and a B-spline filter; the cut-off length was of 2 mm. As the surface is spherical, a particular attention was paid on the influence of the area size on the roughness parameters. Moreover, reproductibility was investigated on a single cup. Finally, the maximum area of measurements was chosen equal to 1 mm². 11 zones of 1 mm² for one liner were considered; these analyses were practised on 12 explanted liners and on a reference liner (total of 141 areas). The Figure 3 presents a typical 3D area after

filtering, it is related to the T1 UHMWPE convex area of the worn zone, latitude of 60-80° close to the equator (latitude of the zone 3-Figure 2b), Figure 3a. The Figure 3b is related to the apex zone, summit of the convex area (zone 2-Figure 2b). The software Matlab® allowed drawing surface area from the filtered data. From the comparison of the images, one may notice that the peak heights of the worn zone are higher than the ones of the apex zone. Further results would exhibit the roughness parameters extracted from these topographical data.

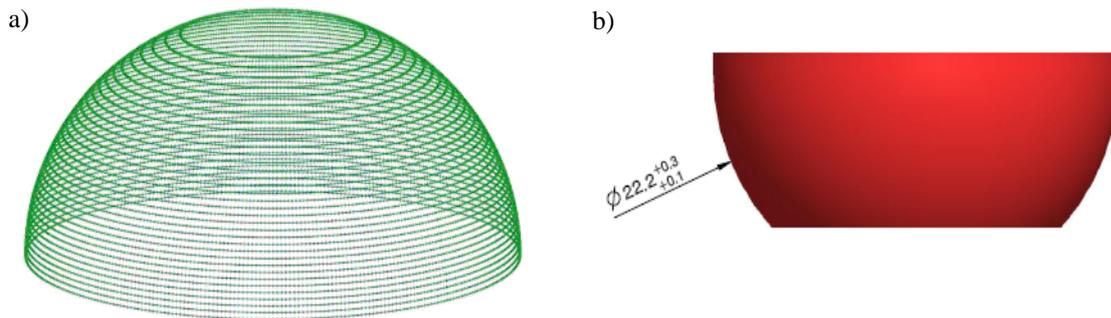
Latitudes	Points per latitude	Total measured points
35	360	12600

Latitudes	Points per latitude	Total measured points
7	120	840

Figure 4 dimensional data, from 3D CMM, of a UHMWPE explanted liner, a) outer surface (second mobility, convex side), 35 latitudes, 360 points per latitude, 12600 measured points; b) inner surface (first mobility, concave side), 7 latitudes, 120 points per latitude, 840 measured points.

A 3 Dimensional Co-ordinate Measure Machine (3D CMM), Mahr[®] MMQ, was used on dual mobility liner convex sides. The main goal of these measurements was to estimate the macroscopic wear of all the UHMWPE explanted liners (convex side), thus this method allowed performing the wear volumes of the convexity. One point per degree, for each latitude, was measured. Distance between latitudes was set at 0.5 mm. More than 10,000 points per explanted liner were acquired thanks to this methodology; it aimed at decreasing the discrepancy on the wear volume. A drawback of this mechanical device was its wider probe (1 mm diameter), involving measured zone crushing. This experiment had to occur later than 3D roughness measurements because of the polishing effect after 3D CMM measurements. Using 3D CMM, liner outer surface was extrapolated and compared to the liner original blueprint, manufacturing tolerances included. Figure 4a presents three-dimensional data from 3D CMM for one explant, convex side.

Moreover, the measurements of the inside volume were carried out on all explanted liners and on the pristine liner. The number of the measured points on the concave side, Figure 4b, is lower than the one on the convex side, due to the space bulk between the 3D CMM stylus and the inner volume of the liner, 22.2 mm. The stylus positioning on the concave side is more difficult than the one on the convex side. Thus the total volume, outside and inner wear volumes, was measured on each explanted liner.

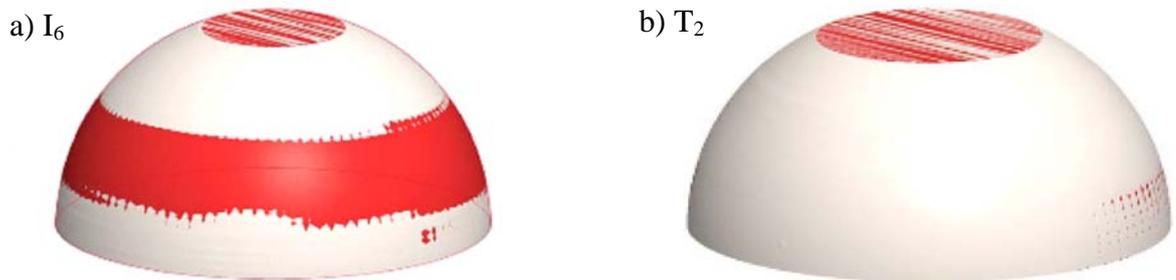
Figure 5 Three dimensional CMM a) Explant I6 ; b) Explant T2 ; the red stripe represents the zone where measured diameter was below the minimal manufacturing diameter.

The twelve explants were analyzed using 3D CMM. The pristine liner was used as reference, calibrating the measurement of wear volume. Figure 5 represents the liner volume, in white, according to the manufacturing minimal diameter. The red stripe corresponds to a zone where the measured diameter was inferior than this minimal manufacturing diameter. Apex was not measured on this experiment. As no wear stripe was found in this zone, we estimated unnecessary to add apex dimensional data. This wear stripe was viewed on all arthrofibrosis-free explants, it is typical to a specific worn zone of a dual mobility liner.

Table 5 presents 3 D convex (second mobility), concave (first mobility) and total wear volumes of dual mobility liners. The average wear volume corresponds to the mean of the minimal and maximal wear volumes that were calculated from the biggest (smallest) radius according to manufacturing data, and the 3D CMM measured volume, actual volume after explantation. Wear in mm^3/year corresponds to the ratio between total wear volume and implant survival, i.e. implant duration. Negative values, for the concave side, probably signify that manufacturing blueprint guidelines were not precisely respected.

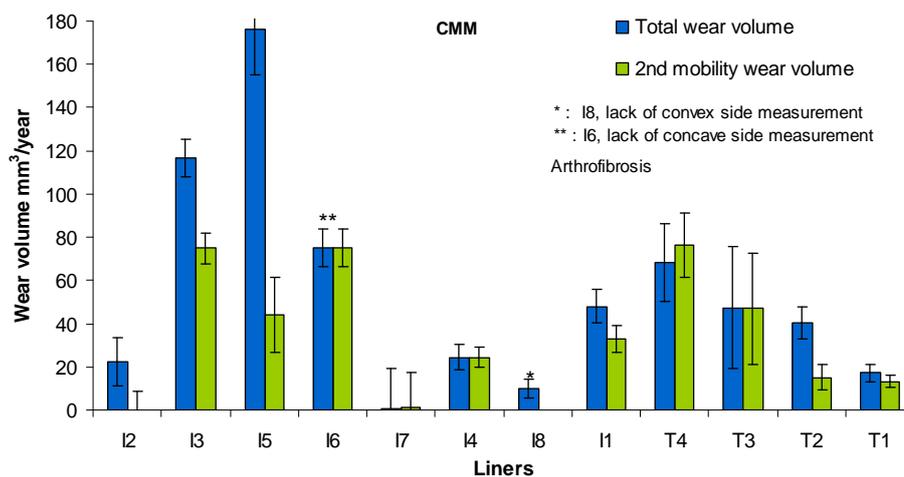
Figure 6 Convex side, wear volumes of dual mobility liners.

The Table 6 exhibits the relevant 3D roughness parameters for differentiating the wear zone from the no-worn zone. As mentioned in Figure 6, wear was approximately located upper to the equator on the convex side of the liner. It is worth noting that Ssk parameter was highlighted.

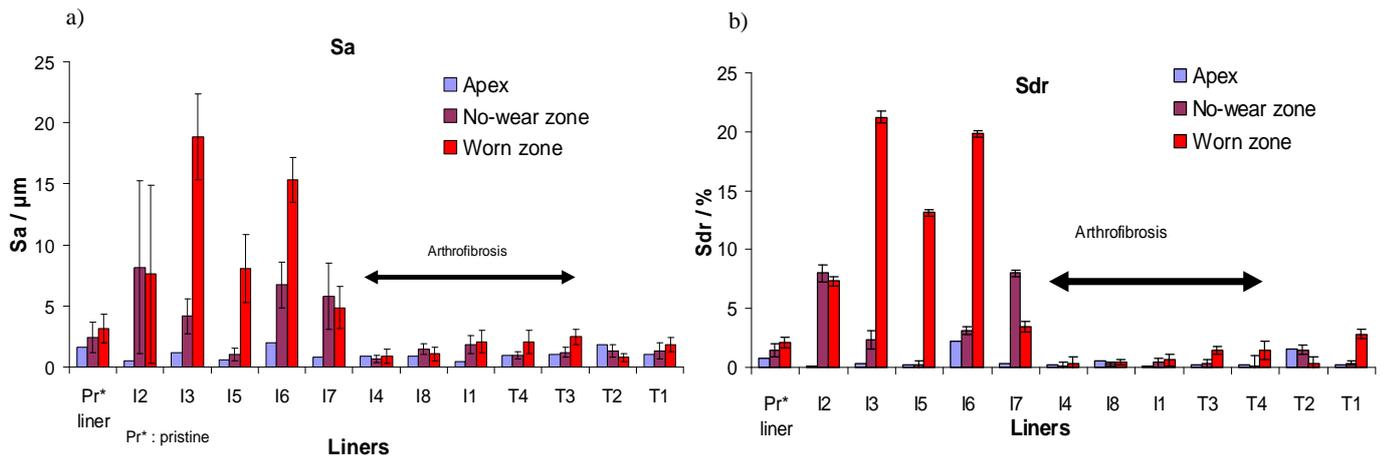
Figure 7 a) S_a values according to liner type; b) S_{dr} values according to liner type.

The Figure 7 shows the evolution of Sa and Sdr parameters according to the liner type. These parameters allowed highlighting the influence of arthrofibrosis.

The most relevant 3D roughness parameters were selected from a statistical analysis. Sa and Sdr highlighted the role of arthrofibrosis, and the metal back impact on the liner surface: polishing effect on the convex side for Ti-6Al-4V metal back and abrasion for 316L metal back. The SEM images confirmed the macroscopic (CMM measurements) and microscopic (3D profilometry) analyses. The comparison with the results from the Figure 6 assessed the fact that arthrofibrosis plays the significant role. In that way, the second mobility is preferentially triggered, Sa and Sdr are low. One might suggest that the convex side is polished during the movement. When both mobilities are triggered, the profilometry analysis, from I2 to I7, highlighted huge values of Sa and Sdr. The friction is not homogeneous and random adhesive friction could be promoted. Only the 316L metal-back allowed this typical behaviour. On the contrary the Ti-6Al-4V alloy did not allow the severe spoiling of the convex side.

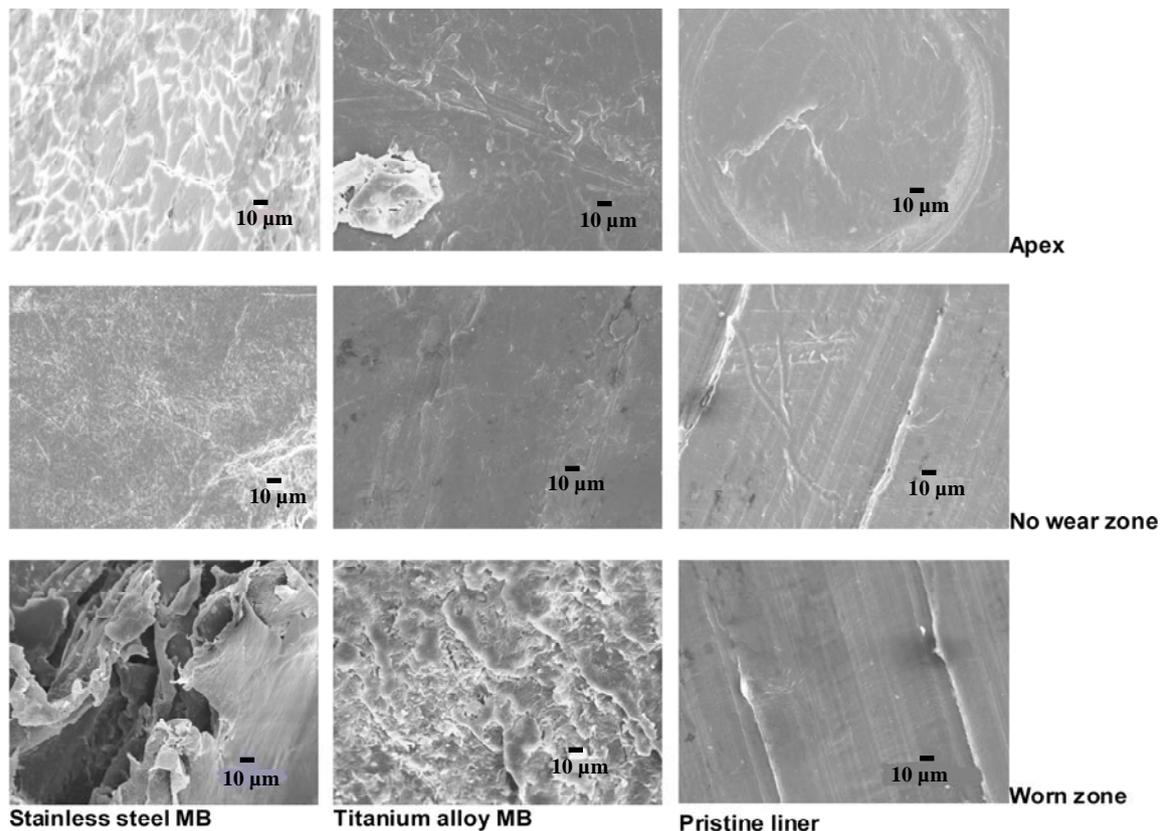
Figure 8 SEM images from convex side dual mobility liners on 3 zones (apex, unworn zone, worn zone), from different types of metal backs (316L or Ti-6Al-4V) and the bulk liner.

2 explants and the bulk liner were analyzed using SEM, on apex, worn zone and no-worn zone. It is worth noting that the worn zone on the stainless steel metal backed liner, i.e. the red stripe identified in the previous section on CMM, presented evidence of a damaging process that could correspond to a material pulling-out or even to a ploughing mechanism. Wear mechanisms of liner, between stainless steel and titanium alloy metallic shells, seemed rather different. One could presume that UHMWPE liner is worn by abrasion and ploughing for stainless steel metal back liners when it is more an adhesion, cracking then flaking mechanism for Ti-6Al-4V metal back. Particles found on the stainless steel MB worn zone image were the size of a millimetre. Finally, no-wear zones, whatever the metal back material, showed a polished zone, in comparison with the bulk liner image.

These observations confirmed the S_a values and even more the differences between worn and no-wear zones. Highest S_a values were found on stainless steel metal backed liners, i.e. the most damaged profiles, according to the stainless steel MB worn zone image. Also, it clearly appeared that this wear stripe was also found on titanium alloy metal backed liners.
