# **Bolted Joints Disassembly: A Field Study for Thermal Influence on Large Diameters**

**Keywords:** threaded fastener, seizure, galling, disassembly, corrosion, maintenance.

## **Abstract.**

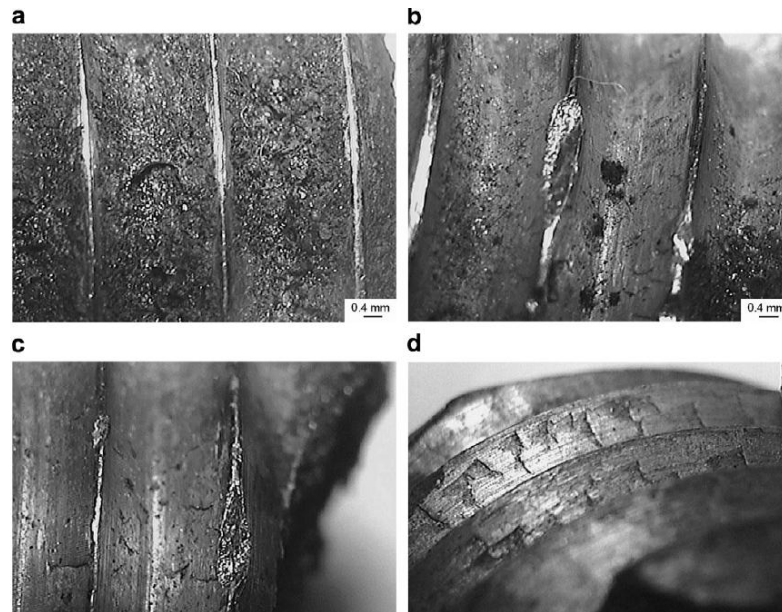
**Figure 1: Details from the threads of the stud failed: (a, b) Pits and corrosion products; (c, d) microcracks at the surface. [4]**

presence of vibrations. In contact with surfaces, water reacts with the metal to form oxides ( $\text{Fe}_2\text{O}_3$ ,  $\text{Cr}(\text{OH})_3$ ,  $\text{Cr}_2\text{O}_3$ ,  $\text{NiO}\dots$ ). Vibrations or small movements that may exist in the joint accelerate this phenomenon by exposing non-corroded surfaces. This can lead to corrosion pitting and micro cracks on the threads (Fig. 1). It causes and changes conditions of friction between the internal and external threads and this also weakens screws or studs.

Bolts and studs used for assembly in petrochemical industries are usually made of alloyed steel according to standard ASTM 193 B7 [6]. On such elements, the anticorrosion coating is thin and easily damaged during assembly. If some preconizations are not followed during assembly (lubrication, adjustment, maximum torque...), corrosion may appear and this even though there is a coating steel (Ni-Cr-Zn or Cd) [4].

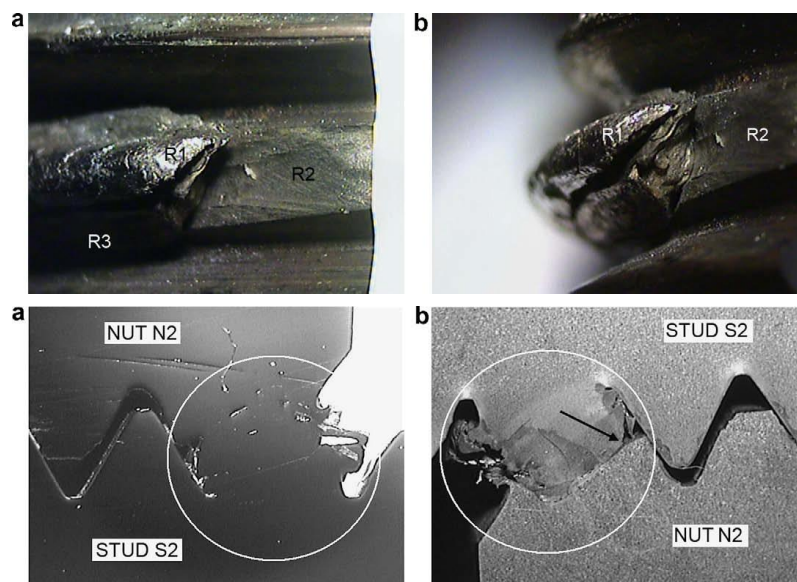
**Figure 2: Cracked stud and cold welding between threads [4]**

The galling phenomenon occurs when there is a large difference in hardness between the assembled parts or when the lubrication is insufficient during the assembly [7]. Inadequate functional clearance can also foster this phenomenon by inducing very high stresses at the contact zone between the two parts. The result is the same when exceeding the recommended tightening torque [8]. The galling is characterized by a tearing of material on one of the parts or by the creation of a weld between the two threads.

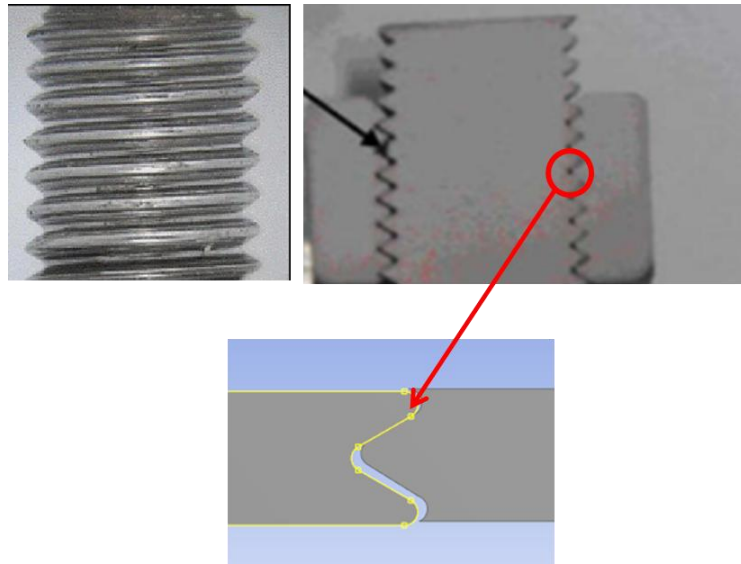
perform those simulations, the contact between a stud and its bore was modeled on a grip length of one thread pitch by using the finite element modeling software ANSYS® (fig. 3).

**Figure 3: Model of thread**

The thread profile is defined by ISO standard [19]. A 6 mm thread pitch is chosen (size commonly used). It is a 2D and axisymmetric model, induced by the part's geometry. The studied area is considered to be on the middle of the threaded zone. A first set of simulations is performed to quantify the diameter's reduction in threads region according to the dimensions of the stud. It is considered that the bore inside the stud is kept at a temperature of  $-180^{\circ}\text{C}$  by applying liquid nitrogen. The results of the simulation are given in table 1, with the temperature of the bore and the threads after cooling.

Additional simulations are performed for temperatures around  $-180^{\circ}\text{C}$ . In this model, threads are welding by seizing. Some local constraints of several hundred MPa are noticed at the contact between the threads (around 350 MPa). To determine whether the thermal effect will be well present and effective, a series of experiments is required. Disassembling tests of elements in real working conditions are planned. The results of those tests would lead to a conclusion on the effectiveness of this method of disassembling. In the next section, the experimental protocol that will be implemented is introduced.
