Links between machining parameters and surface integrity in drilling Ni-superalloy

Keywords: Udimet 720, Drilling, Surface Integrity, Process Monitoring,

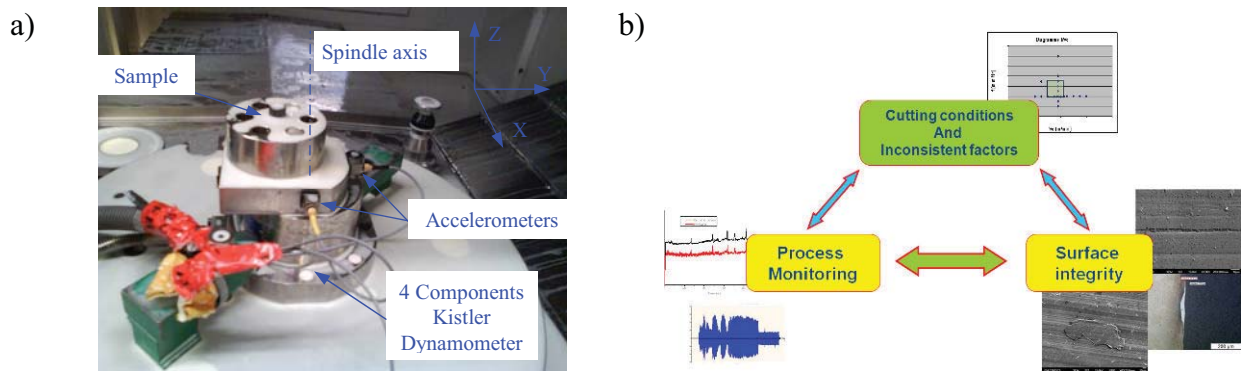
Finally, we designed an assembly to manage the drilling of 6 holes per bar and to always make those holes at the center of the dynamometer. In this type of dynamometer, the torque is measured by a sensor and not calculated as in a 3 components dynamometer (figure 1a).

Figure 1: a) Experimental set up, and b) Experimental plan

The objective of this work is to establish the relations through the cutting conditions between process monitoring signals and surface integrity anomalies (figure 1b). For our experimental procedure, we chose the first part of COM methodology to define a first domain of cutting conditions. We didn't perform the tool life study as explained in the second part of the norm.

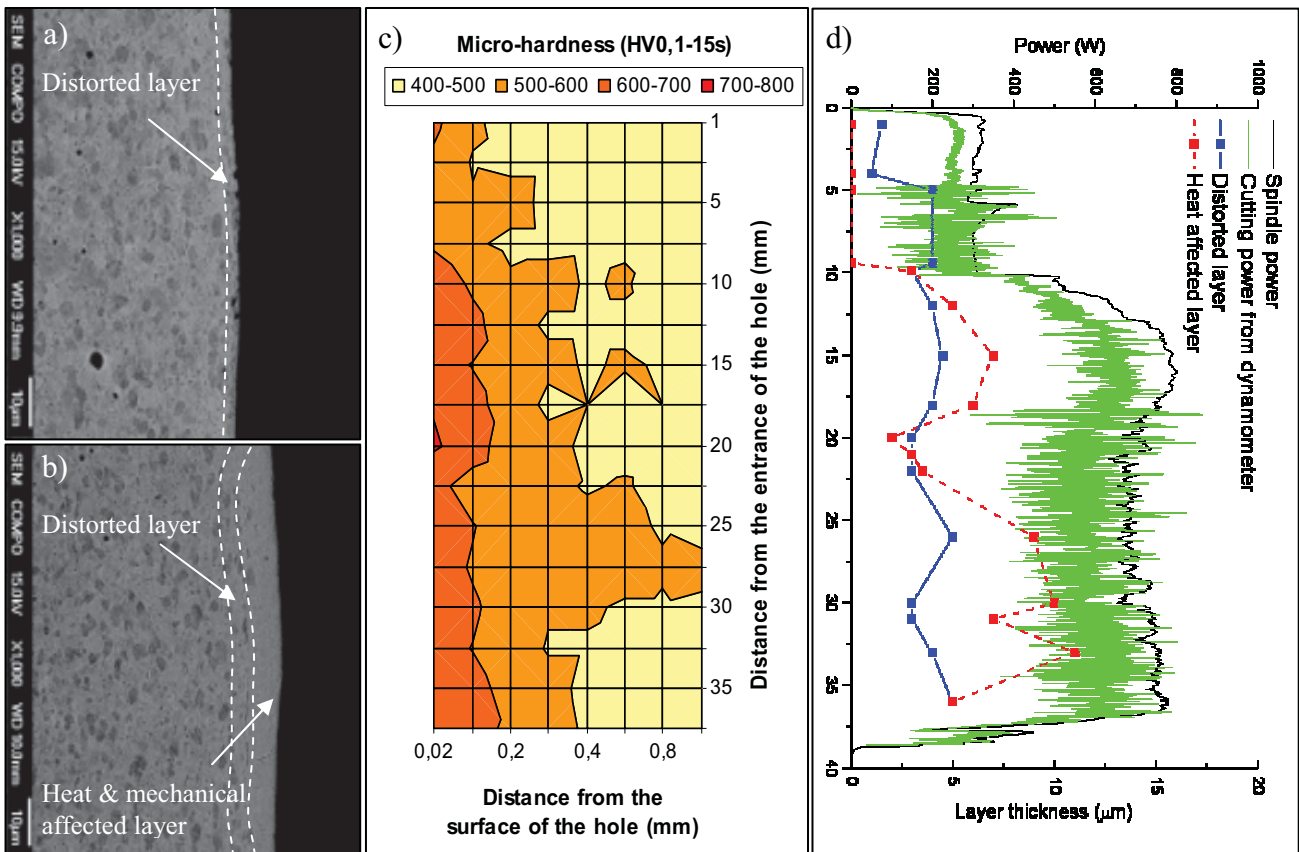
Figure 6 presents another example of comparison between two sensor signals and two microstructure anomalies. Along the hole we observe two similarities. The first one is a correlation between the thickness of a distorted layer and the appearance of a rapid variation of cutting power extracted from dynamometer (this observation can also be made with the torque signal). The second

one is the thickness of a heat affected layer at the same time as the cutting power increases (measured by both systems). Figures 6a and 6b show the difference in microstructure at 3 and 31mm from the hole entrance. In figure 6a, we observe a very thin distorted layer, contrary to figure 6b where we notice an important white layer and as well as a distorted layer. A micro-hardness (figure 6c) map has been drawn to show the influence of the mechanical effect in the depth of the material. This correlation between power signal and microstructure metallurgical changes was also found in three other holes (high cutting speeds on figure 4) but we could not determine exactly the cause of the sudden power change.

Figure 6: Microstructure at a) 3 mm and b) 31 mm from the input of the hole, c) Micro-hardness map along the hole, and d) Power signals comparison with thickness of affected layers

On figure 6b, we observe a distortion of primary γ' and a dissolution of primary and secondary γ' phases which indicates a local overheating and mechanical stresses. This analysis was correlated with an X-ray map performed with Energy Dispersive Spectrometry (SDD BRUCKER) and by micro-hardness profile where we observe the strain hardening in sub surface. More analysis with residual stresses measurements will complete those observations.
