# An automatic method to detect defaults in the measurement chain of a sound level meter, used for unattended noise measurements

# ACOUSTICS 2012

E. Aflalo<sup>a</sup>, F. Dupont<sup>a</sup>, P. Cellard<sup>b</sup> and J.-N. Durocher<sup>b</sup>

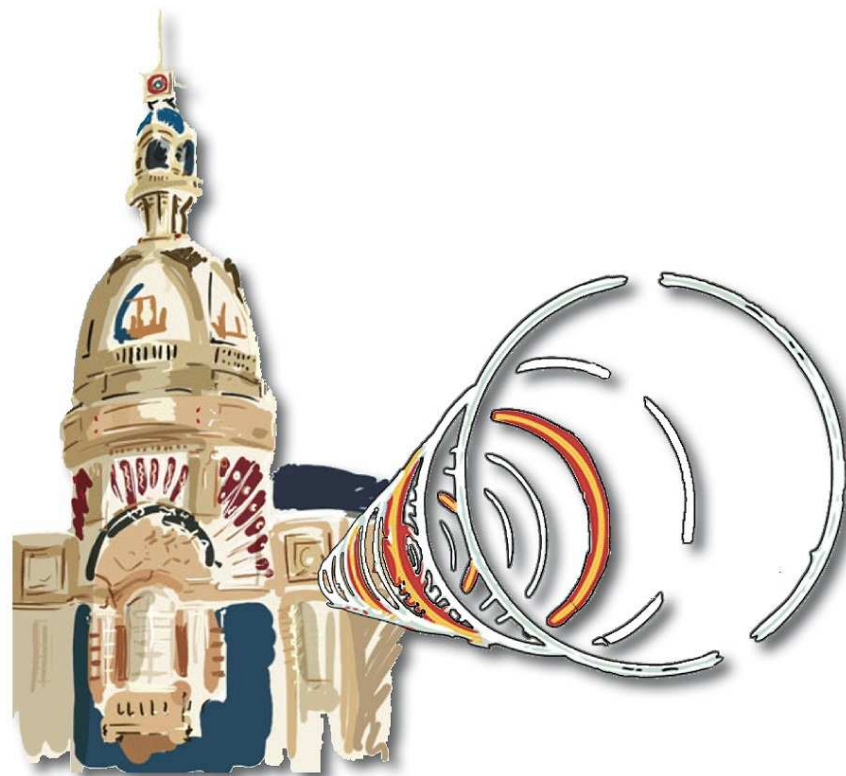
Fig. 1: microphone with damaged membrane

Fig. 1 shows a picture of a damaged microphone and Fig.2 shows the corresponding frequency response. In this particular example, the frequency response proves that the microphone is fully unusable even though its sensitivity at 1000 Hz is not affected. A single calibration at 1000 Hz would therefore not detect the microphone degradation.

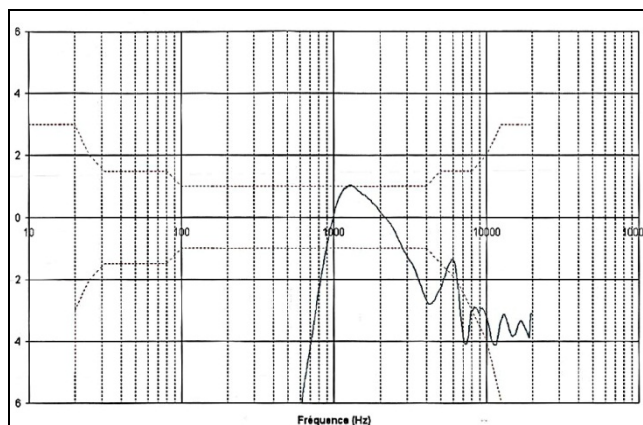
Fig. 2: corresponding frequency response

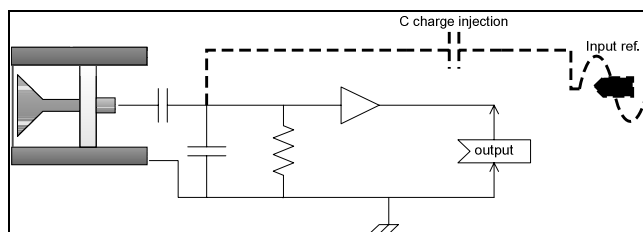
This test consists in injecting a stable reference signal through a reference capacitor that “simulates” an acoustic signal at the microphone output (see the dash lines in Fig. 3):

Fig 3: charge injection principle

The reference signal is a frequency user defined sine at a selectable level between 0 and 5 V peak. The capacity for the reference C charge injection is typically around 0.2 pF.

Charge injection will behave as an impedance comparison between the condenser microphone and C charge injection reference capacitor. If the impedance of the microphone is changed (typically a mechanical damage of the active part of the membrane that will change its capacity) the charge injection method will detect it.

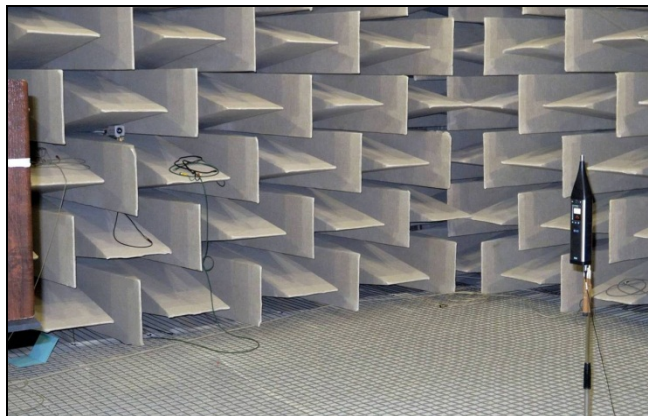
Tests are performed in one of the anechoic rooms at LNE (Laboratoire National d'Essais), the selected instrument, DUO [4], is used in vertical position:

Fig. 4: Test set-up with DUO in vertical position

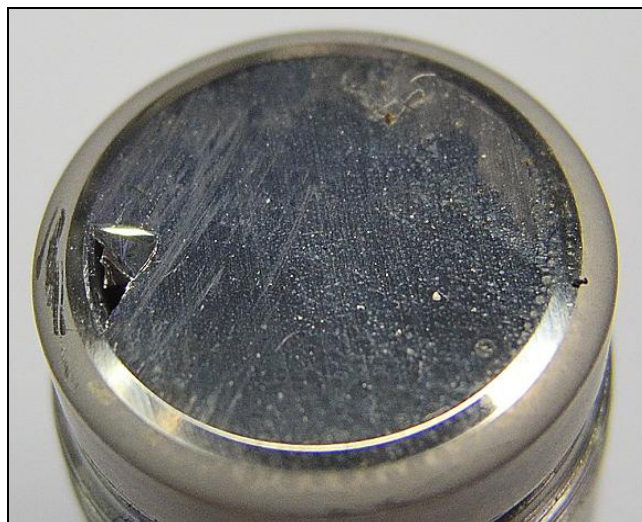
Fig. 5: membrane punched

Multi-frequencies charge injection response is sensitive to this default; the mechanical damage has changed the capacity of the microphone.

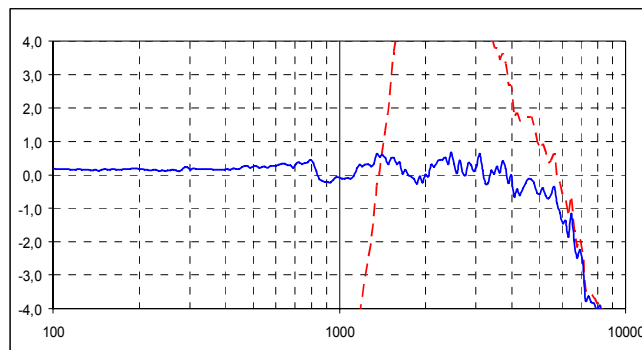
Fig. 6: corresponding frequency response

- A weighted background noise level: Not significant
- Sensitivity @ 1 kHz: -7 dB
- Multi-frequencies charge injection response @ 250 Hz, 500 Hz, 1 kHz, 2 kHz and 4 kHz: From -0.36 dB to -0.93 dB

This case is very similar to the example given in the introduction but with a shifted frequency response. Hopefully in that case the calibration procedure will detect the default.

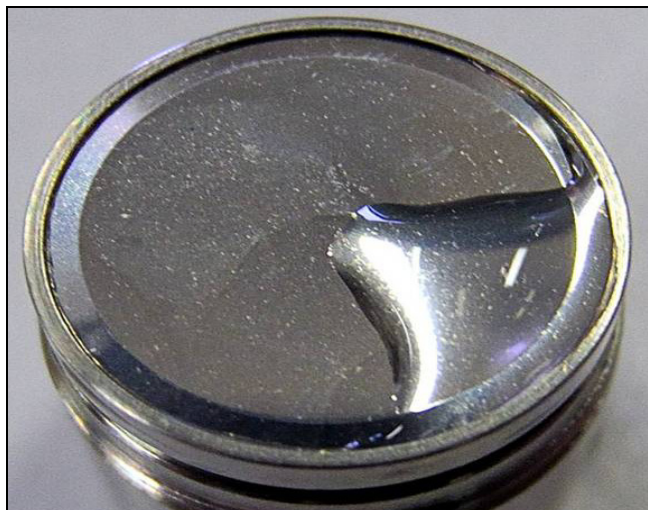
Fig. 7: water drop on the membrane

The multi-frequencies charge injection response shows a significant difference, clearly indicating a default in the system (mechanical change of the membrane due to the weight of the water drop).

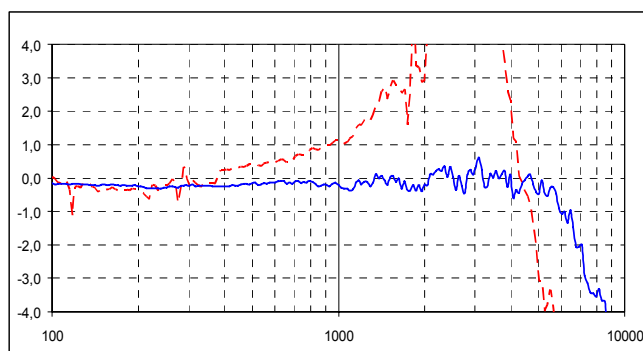
Fig. 8: corresponding frequency response

- A weighted background noise level: +3 dB
- Sensitivity @ 1 kHz: +0.5 dB
- Multi-frequencies charge injection response @ 250 Hz, 500 Hz, 1 kHz, 2 kHz and 4 kHz: 1.45 dB@4 kHz

Background noise has slightly increased, but the absolute value of 21 dBA is not easy to measure under normal conditions. The increase of sensitivity shows there could be instability in the system, but the displayed value (+0.5dB change) could be linked to changes in temperature, humidity and/or barometric pressure. The frequency response is altered and reacts as an increase of mass with a resonant frequency around 3 kHz.

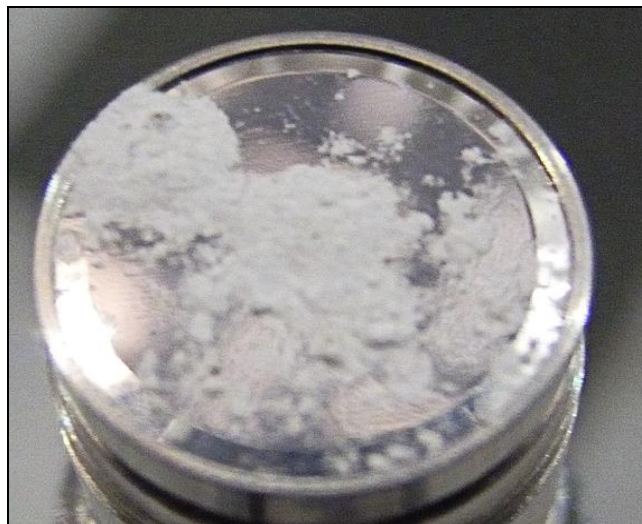
Fig. 9: light dust on the membrane

This experimentation shows it is better NOT to clean a microphone, to avoid any risk of damage during cleaning.

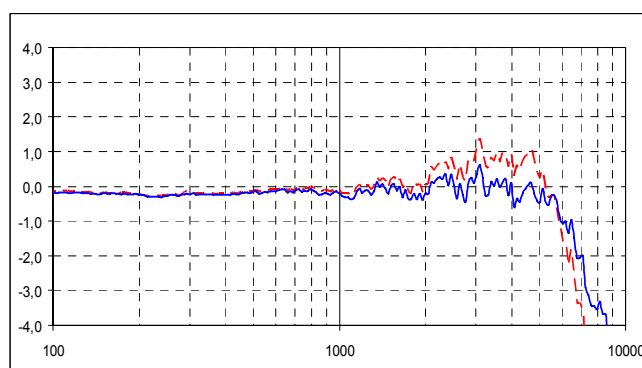
Fig. 10: corresponding frequency response

- A weighted background noise level: Not significant
- Sensitivity @ 1 kHz: Not significant
- Multi-frequencies charge injection response @ 250 Hz, 500 Hz, 1 kHz, 2 kHz and 4 kHz: Not significant

No indicator is significant, and the frequency response does not show a significant difference either. Dust on the membrane will almost have no incidence on the measurement quality.

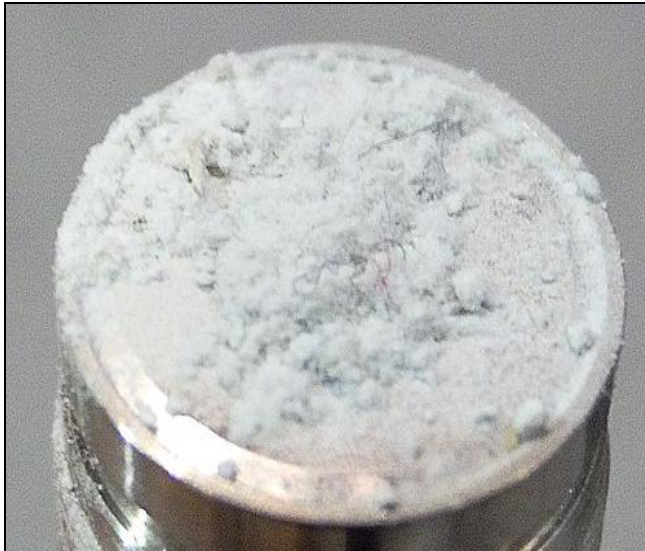
Fig. 11: heavy dust on the membrane

Multi-frequencies charge injection response detects a slight difference due to the weight of dust.

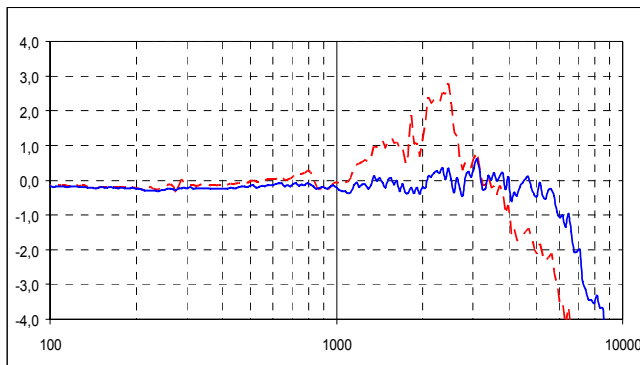
Fig. 12: corresponding frequency response

- A weighted background noise level: Not significant
- Sensitivity @ 1 kHz: Not significant
- Multi-frequencies charge injection response @ 250 Hz, 500 Hz, 1 kHz, 2 kHz and 4 kHz: + 0.38 dB @4 kHz

This case is over the acceptable limits of dust on a membrane! The frequency response is altered and reacts as an increase of mass with a resonant frequency around 2.5 kHz.

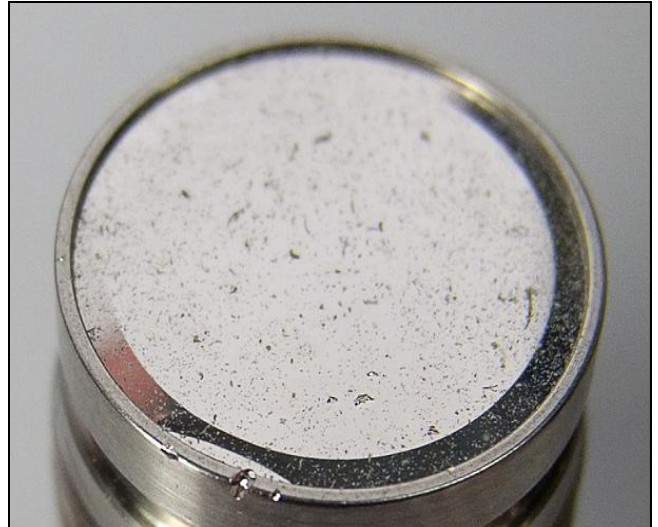
Fig.13: shock on the edge of the membrane

Multi-frequencies charge injection response does not detect any default because the active part of the membrane is not affected.

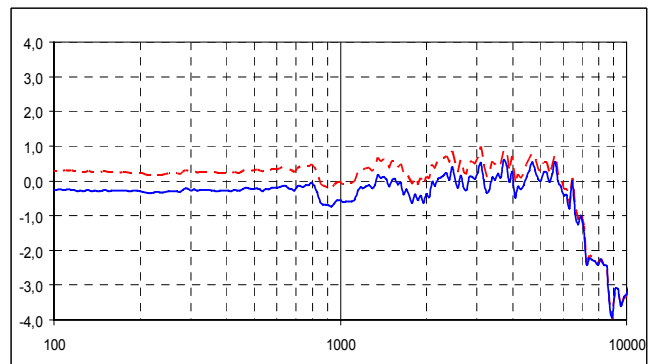
Fig. 14: corresponding frequency response

- A weighted background noise level: Not significant
- Sensitivity @ 1 kHz: Not significant
- Multi-frequencies charge injection response @ 250 Hz, 500 Hz, 1 kHz, 2 kHz and 4 kHz: Not significant

This example is one of the most common damage of a microphone when a sound level meter is used in the field. The frequency response only shows a small increase of the sensitivity of around 0.3 dB on the whole frequency range. In fact the only consequence of this default is a lower tension of the membrane without real effect on the measurement.

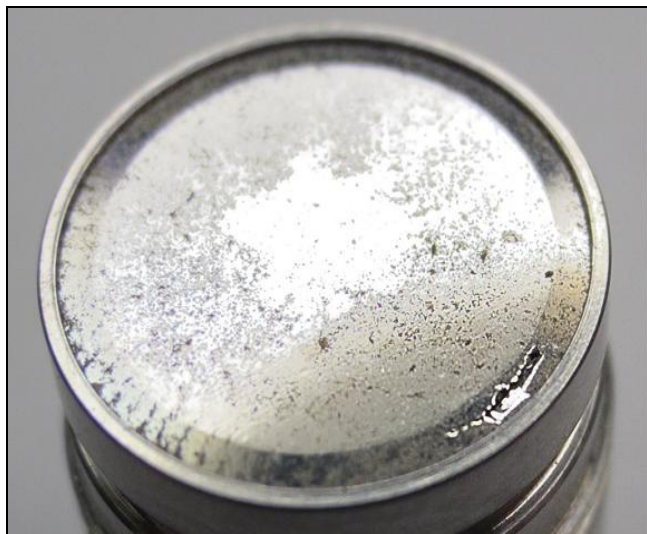
Fig. 15: small cut on the edge of the microphone

Multi-frequencies charge injection response does not detect any default because the active part of the membrane is not affected.

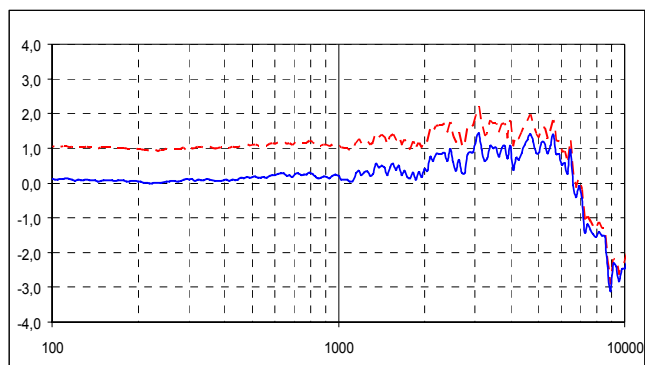
Fig. 16: corresponding frequency response

- A weighted background noise level: Not significant
- Sensitivity @ 1 kHz: + 1 dB
- Multi-frequencies charge injection response @ 250 Hz, 500 Hz, 1 kHz, 2 kHz and 4 kHz: Not significant

The frequency response shows an increase of the sensitivity of around 1 dB on the whole frequency range. The consequence of this default is a lower tension of the membrane and is detected by the sound level calibrator.

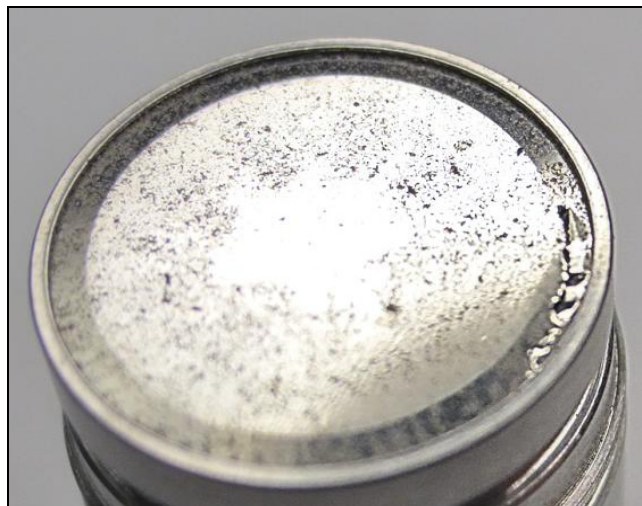
Fig. 17: large cut on the edge of the microphone

Multi-frequencies charge injection response does not detect any default because the active part of the membrane is not affected.

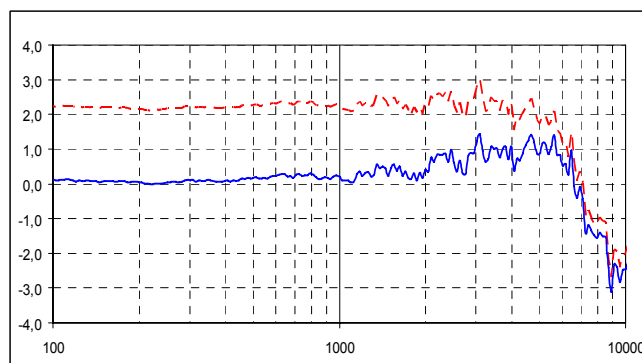
Fig. 18: corresponding frequency response

- A weighted background noise level: Not significant
- Sensitivity @ 1 kHz: + 2 dB
- Multi-frequencies charge injection response @ 250 Hz, 500 Hz, 1 kHz, 2 kHz and 4 kHz: Not significant

The frequency response shows an increase of the sensitivity of around 2 dB on the low and middle frequency ranges. The consequence of this default is a lower tension of the membrane and is detected by the sound level calibrator.

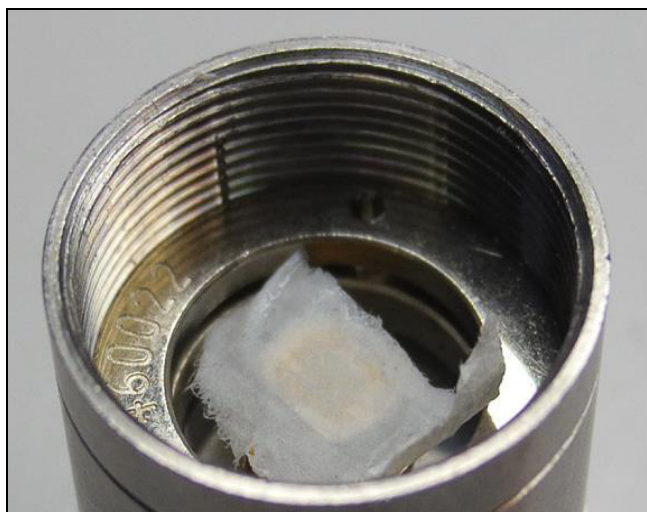
Fig. 19: humid paper on the inner pin of the microphone

This example illustrates a default that can happen when a sound level meter has been in use for several months without periodic maintenance. Despite the fact the connectors are gold plated, some corrosion might occur, especially if the contacts have been touched by fingers. The frequency response shows a high-pass filter effect.

This default is detected by an increase of background noise and by multi-frequencies charge injection response. The impedance of the equivalent microphone has drastically changed, that explains the high sensitivity to multi-frequencies charge injection response.

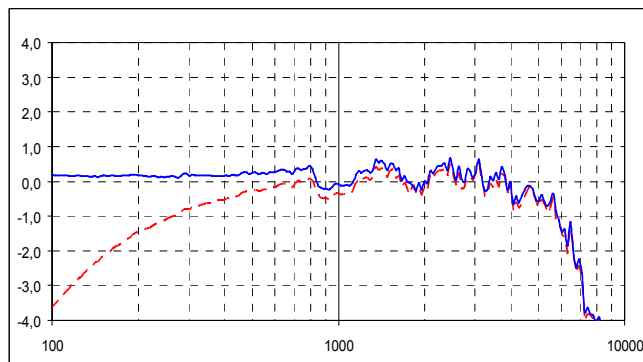
Fig. 20: corresponding frequency response

- A weighted background noise level: + 20dB
- Sensitivity @ 1 kHz: - 0.7dB
- Multi-frequencies charge injection response @ 250 Hz, 500 Hz, 1 kHz, 2 kHz and 4 kHz: > 6 dB on all frequencies

The decrease of sensitivity shows there could be instability in the system, but the displayed value (-0.7 dB change) could be linked to changes in temperature, humidity and/or barometric pressure.
