## Impact of floor drain on floating floor acoustic performance

J.-B. Chene and P. Kerdudou

Centre Scientifique et Technique du Bâtiment,  
jean-baptiste.chene@cstb.fr

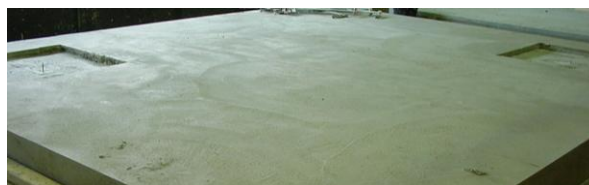
Figure 1: Concrete test floor (180mm in thickness)

To study all these systems, a concrete floor slab of 15 m<sup>2</sup> in surface area and 180 mm in thickness including two pre-prepared shower installation hollowed zones (size 900x900x60 mm<sup>3</sup>; see Figure 1) has been fabricated and acoustic measurements were carried out in reception room complying with the ISO 140-1 standard.

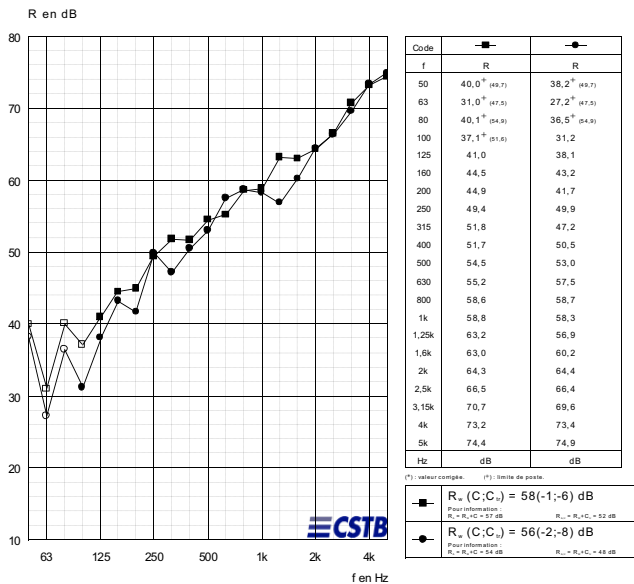
Figure 2: Effect of floor drain body and outfall tube sealed with mortar or not (■ Sealed; ● not sealed).

No significant decrease of airborne sound insulation has been measured or calculated for these different cases. Figure 2 shows the effect of two different mounting conditions for the drainage channel and siphon body sealed or not with mortar in the floor shower installation hollowed zone (it should be noticed that the non sealed situation is not allowed). The basic floor slab of 180 mm in thickness was tested totally filling the pre-prepared shower installation hollowed zones with mortar and an acoustic performance corresponding to  $R_w(C;C_{tr})=59(-2 ; -8)$  dB was obtained.

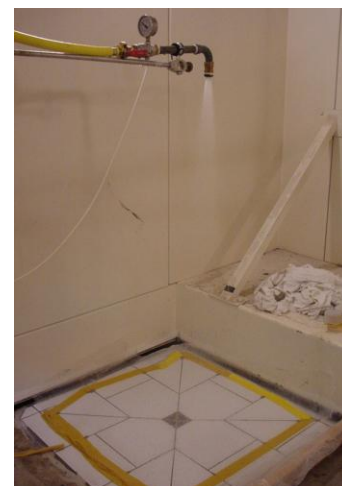
Figure 3: Measurement setup for evaluating the water jet noise level (source: reference water jet (INS) at 2 m oriented to the center of the shower area).

A lot of attention was paid to the acoustic issue related to service equipment noise associated to water jet hitting the shower area, since the measured levels on the five considered systems did not meet the French regulation requirement. Figure 3 shows the measurement setup.

The water jet was produced with the reference water jet source (INS) at a pressure of 3 bars (flow rate of 0.22 l/s) as defined by the EN 15657-1draft standard. However, it is questionable that it represents a realistic source. Therefore, the measurements were also performed with a standardized hand shower head used to test if shower enclosures are

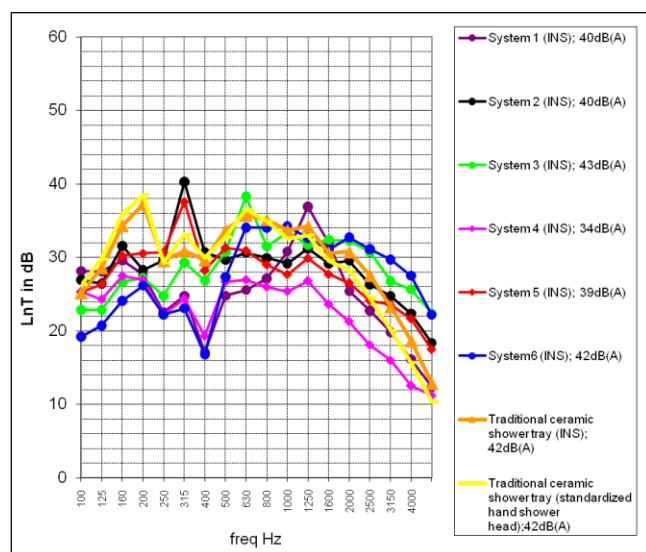
Figure 4: Calculated  $L_{nAT}$  for several shower systems under water jet excitation.

Figure 4 presents the main measurement results in terms of service equipment noise  $L_{nAT}$  calculated for a small bedroom (10 m<sup>2</sup> in surface area) located diagonally below the bathroom.

Indeed, this noise problem generated by the water jet hitting the shower area is not specific to the accessible shower systems; a full decoupling would be necessary to solve that problem.

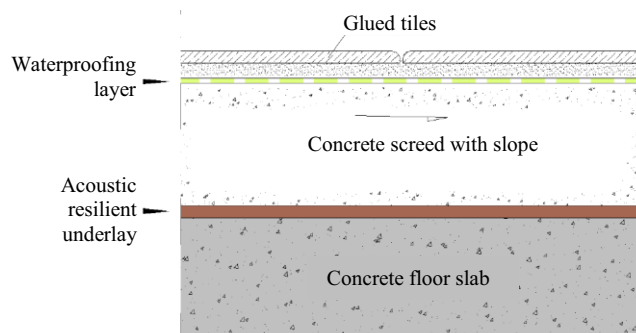
Figure 5: Position of the waterproof layer and of the acoustic resilient underlay.

The first question was the position of the waterproof layer regarding to the acoustic resilient underlay. Since no acoustic resilient underlay is, at this time, compatible with water, the only solution was to put the waterproofing layer on the floating screed and the acoustic resilient underlay

under the floating screed as expected. This is shown in Figure 5.

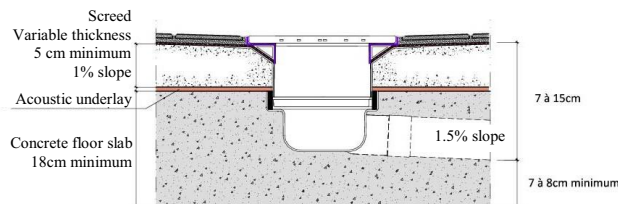
Figure 6: Mounting example of a floor drain with a concrete floating screed [1].

Then two main questions arise. The first one concerns the structural short cut that could exist between the floor drain body (sealed in the supporting floor slab) and the floor drain upper part sealed in the floating screed (see Figure 6). The second one is associated to the peripheral treatment that should include the four sides upstand of both the acoustic resilient layer and the waterproofing layer. A solution is proposed in Figure 7.

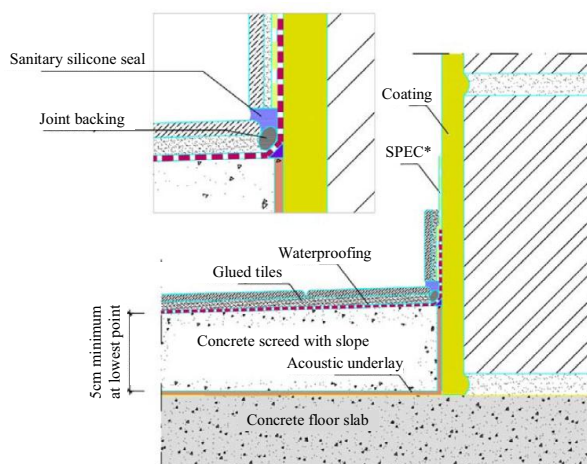
\* under tile water protection system

Figure 7: Example of a peripheral treatment including both acoustic and waterproof aspects [1].

On the two systems tested, the mounting conditions were very good, and therefore no decrease in measured performance was obtained with the peripheral treatment. However, it is believed to be a key issue since bad mounting conditions could greatly affect the acoustic performance (decreasing it). Figure 7 shows a good mounting solution but it does require a really good skill in order to realize it correctly.

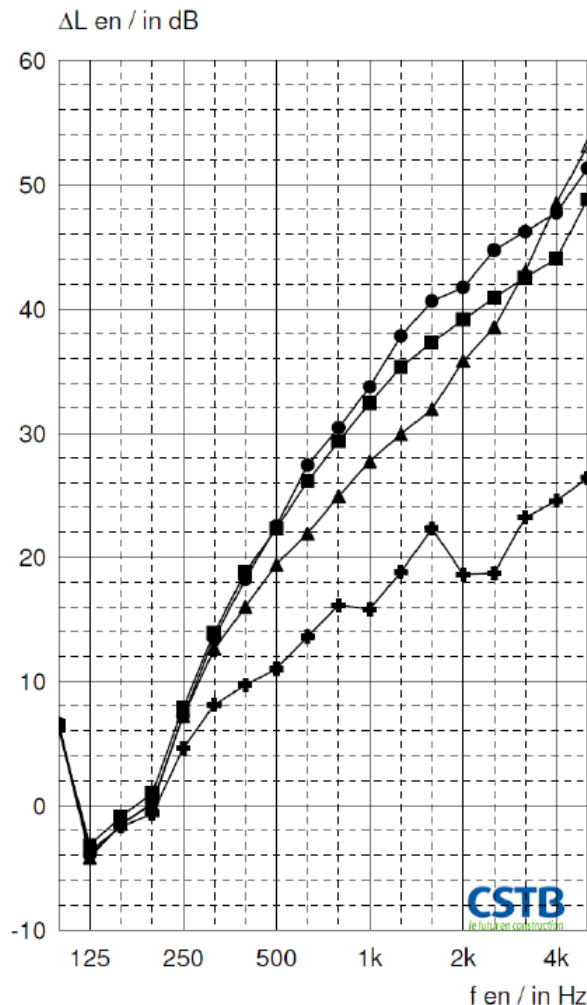
Figure 8: Impact on  $\Delta L$  of floor drain upper part rigidly connected with floor drain body.

Figure 8 shows the impact noise improvement  $\Delta L$  obtained with the O-ring joint system; the curve marked with crosses corresponds to the case when the floor drain upper part is sealed with plaster to the body ; a 4 dB decrease in obtained on the global value.

The effect of the drain floor upper part short-cut as shown in Figure 8 appears mainly in the middle and high frequency range. Therefore it was decided to try using the new alternative method for the evaluation of the impact noise improvement  $\Delta L$  of floor covering (EN 16251-1 draft standard). Indeed, this method is not applicable for the

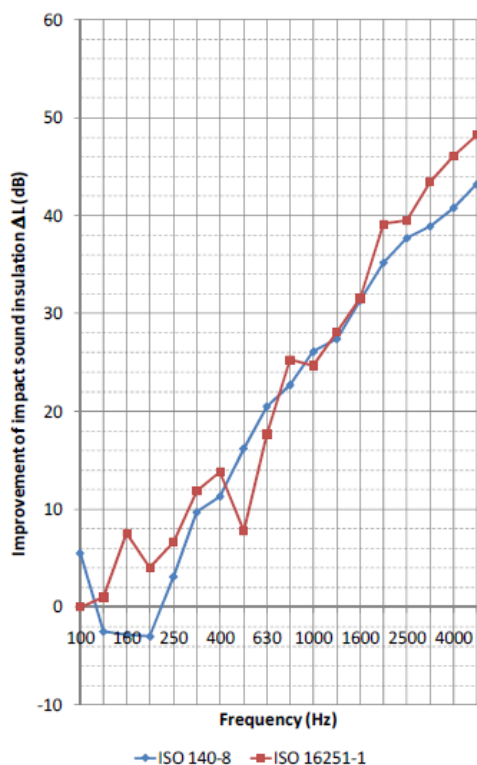
Figure 9: Comparison of impact noise improvement obtained with ISO 140-8 standard and ISO 16251-1 draft standard for a concrete floating screed.

evaluation of a concrete floating screed due to the low frequency system behavior; however as shown in Figure 9 [2] it is possibly usable in the middle and high frequency range.

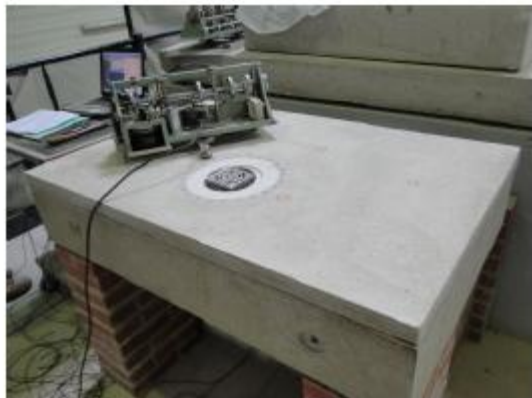
Figure 10: Test setup for the ISO 16251-1 draft standard adapted to integrate a floor drain.

Therefore, the floor drain was mounted in a similar way (without waterproofing layer and tiles) in the concrete slab corresponding to the facility scale of the ISO 16251-1 draft standard [3] (i.e. a concrete slab of 1200x800x200 mm<sup>3</sup>), as seen in Figure 10.

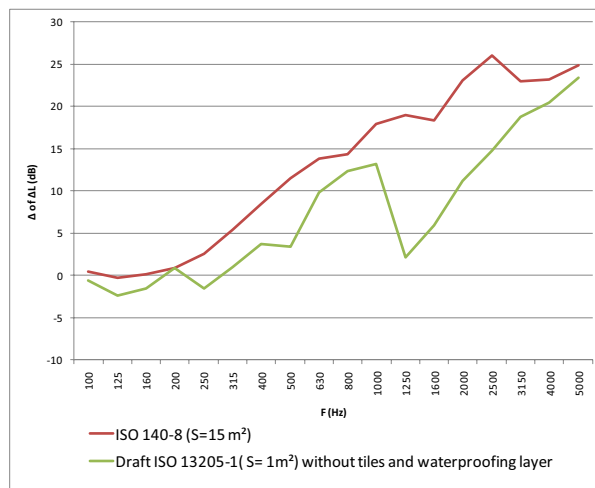
Figure 11: Effect of the floor drain upper part sealing tested both with ISO 140-8 standard and ISO 16251-1 draft standard.

With this new method, the measurements were again performed with the two different floor drain systems considered and tested on full scale concrete slab (15 m<sup>2</sup>). Results are very interesting since the same behavior is observed for the two different measurement setups, even if in the reduced size experimental setup the tiles and the waterproof layer were not implemented. Figure 11 presents the measurement results on O-ring joint floor drain system with the plaster seal between the floor drain upper part and the body obtained with the two different methods (full and limited setups). Behaviors are in good agreement and it seems possible to use the ISO 16251-1 draft standard approach to obtain a decoupling criteria for floor drain mounted with a concrete floating screed system.
