# Sandwich composites impact and indentation behaviour study

B. Hachemane<sup>a,\*</sup>, R. Zitoune<sup>b</sup>, B. Bezzazi<sup>a</sup>, C. Bouvet<sup>c</sup>

## ABSTRACT

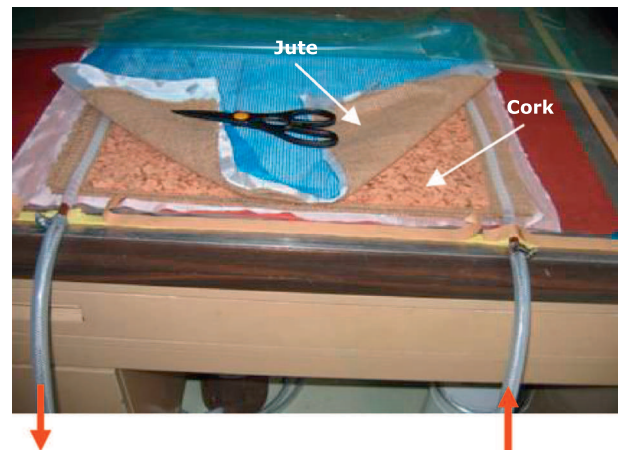
Fig. 1. Manufacturing process by infusion of sandwich panels.

The employed material is a sandwich composed of jute–epoxy skins and cork core, manufactured by one-shot infusion method. In this case, the jute woven skins and the cork core are infused in only one step, as shown in Fig. 1. The skins are laid-up with a [0°]<sub>s</sub> stacking sequence. The skin mechanical properties are given in Table 1 [1]. Three cork densities are studied with the following values 160, 270 and 310 kg/m<sup>3</sup>. These values correspond to a 4–16, 3–5 and 1–2 mm granulate size respectively. The employed epoxy resin is referenced as LY5052, associated to its HY5052 hardener. When the infusion is completed, the obtained sandwich is polymerised in a oven at 80 °C during 12 h. The Table 2 gives the sandwich specimen’s final dimension manufactured with the mentioned materials (see Fig. 2).

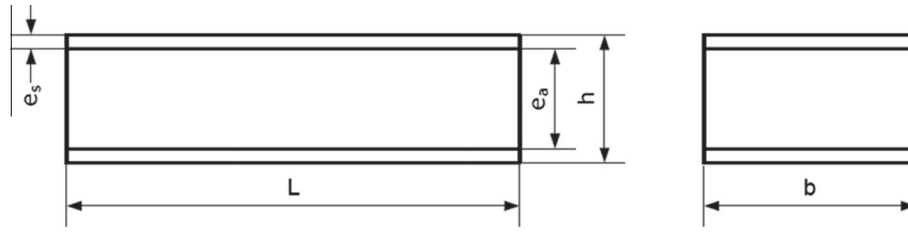
**Fig. 2.** Geometry of sandwich panel.

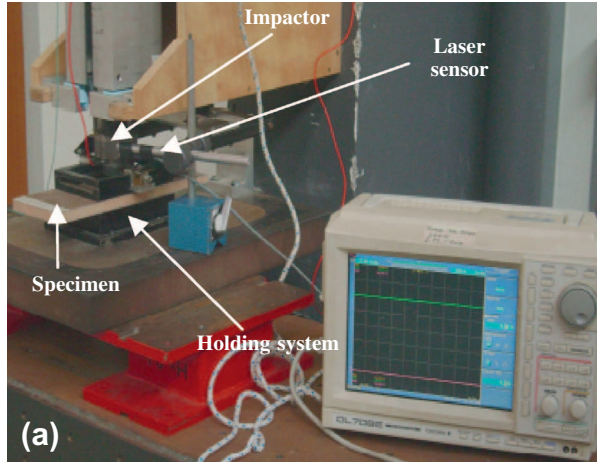
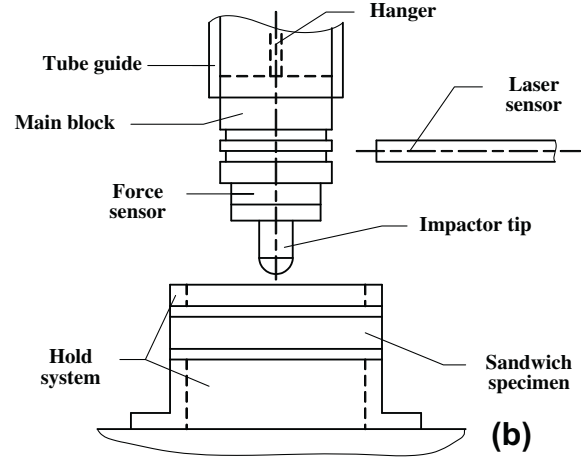
**Fig. 3.** Impact equipment. (a) Experimental device with recording system and (b) device scheme.

The experimental equipment used for the impact tests is illustrated in Fig. 3. It is mainly composed by a guide column supporting a Kistler force sensor equipped with an impactor. Two laser sensors and an oscilloscope are the measuring devices. A rigid table with a 125 × 75 mm<sup>2</sup> window holding system, where the sandwich plates are held to complete the parts of the equipment.

The impactor is composed by a 2 kg free falling main block coupled with a 10 KN force sensor and a 12.7 mm diameter hemispherical tip. The first laser sensor allows calculating the starting contact velocity; meanwhile the second gives the displacement

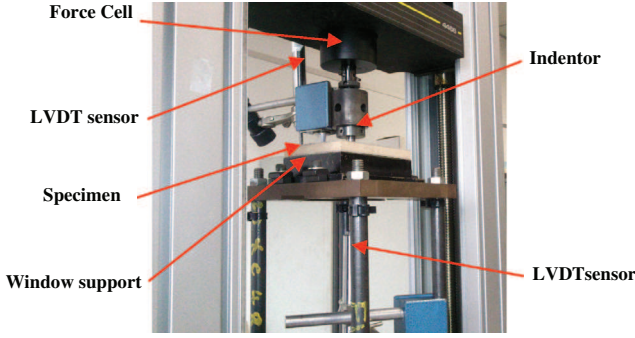
Fig. 4. Equipment arrangement for indentation testing.

For quasi-static indentation tests, we used a 4206 Instron machine. The machine force sensor (10 kN) provides the force signal applied to the specimen. The indenter is identical to that used in

impact tests. The indenter displacement  $s(t)$  is controlled by those of the testing machine crossbar, while loading and unloading test speeds are 2 mm/min. The indenter displacement and the opposite side deflection are measured by two LVDTs installed parallel to the vertical axis (Fig. 4). The displacements are obtained through the respective conversion factors. Among other things, Solatron LVDTs types BS25 were used during testing. The three signals (force and two displacements) are recorded by the data acquisition system Yokogawa DL708.

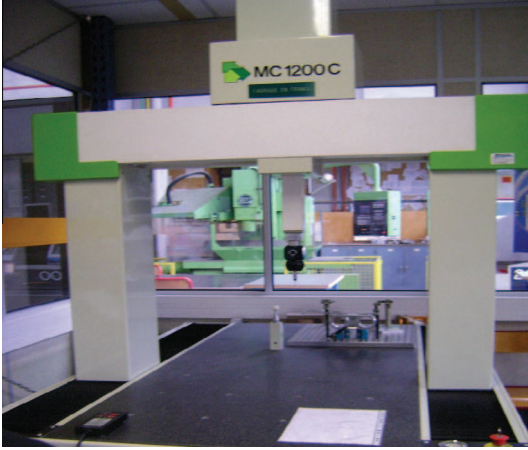
Fig. 5. Three-dimensional measuring machine "MC 1200C".

After the impact and the quasi-static indentation tests, the permanent indentation depth are measured using a three-dimensional measuring machine "MC 1200C" (Fig. 5). To measure the indentation depth, the machine is equipped with an electronic probe with which we crate plate upper surface referential representing the zero level. Then, the probe scans the damaged zone and gives the indentation depth.

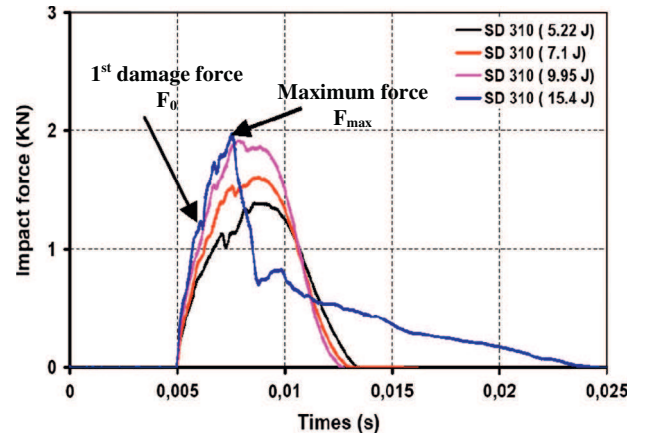
Fig. 6. Temporal impact force curves for the SD 310 composite sandwich.

The results in Fig. 6 show the evolution of the impact force vs. time for four impact energies, obtained on a SD 310 sandwich plate. It is noticed that for impact energies below 15 J, these curves are not far removed from a sine wave. The impact test performed with energy of 15 J resulted in a damage of the non-impacted skin. From Fig. 6, two critical values can be distinguished, the first one relates the first damage force, and the second one represents the maximum impact force recorded by the force sensor, which are noted as  $F_0$  and  $F_{max}$ , respectively. For a  $310 \text{ kg/m}^3$  cork density, the first damage force increases with impact energy. This growth is about 40% when the impact energy increases from 5.22 to 9.95 J.

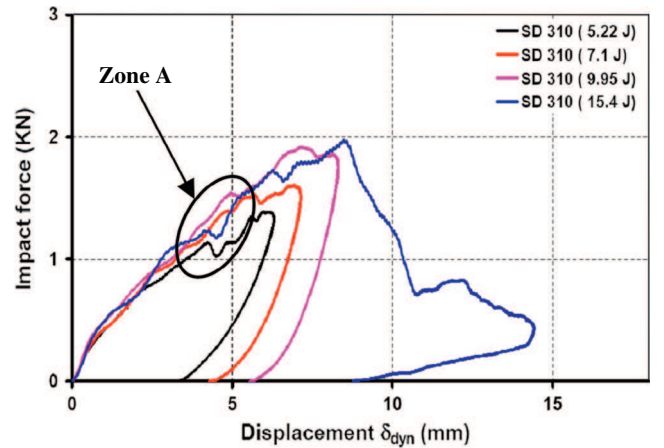
Fig. 7. Impact force vs. impactor displacement curves for the SD 310 composite sandwich.

Fig. 7 shows the impact force evolution vs. the displacement calculated from Eq. (3) for a SD 310 sandwich plate. Up to a displacement of about 0.25 mm, dynamic effects due to the plate iner-

tia can be observed. In the following analysis, they will be neglected. Subsequently, we recorded a linear force evolution (plates bending stiffness being of the order of 0.74 KN/mm) until approximately 0.6 mm displacement where variations begin to appear. They are caused by the specimen's damage onset. A second linear evolution follows with a 0.25 KN/mm slope which is much lower compared to the first one, this means that the plate rigidities decreases. Nevertheless, the force continues to increase despite other minor damage formation. When the maximum displacement is reached, the force begins to decrease steadily to zero.

After the appearance of the first damage, a slight drop in the sandwich plate linear stiffness is registered, noted as zone A (Fig. 7). During a short time, the plate returns to its linear stiffness with the appearance of several oscillations followed by a gradual increase in the force signal. This can be explained on one side by the numerous damages caused by the impactor penetration into the specimen, and on the other hand, by the increment of the cork density due to the compression phase which leads to a compression modulus growth. The compression phenomenon was demonstrated in previous works during quasi-static compression tests on natural cork [22]. Also, during the compression phase, three phenomena corresponding respectively to the elastic bending, the buckling and the crushing of the cell walls are identified. The oscillations observed in Fig. 7 may be related to the buckling phenomenon. Also, it is noticed that the residual displacement for SD 310 sandwich laminates increases with the impact energy;

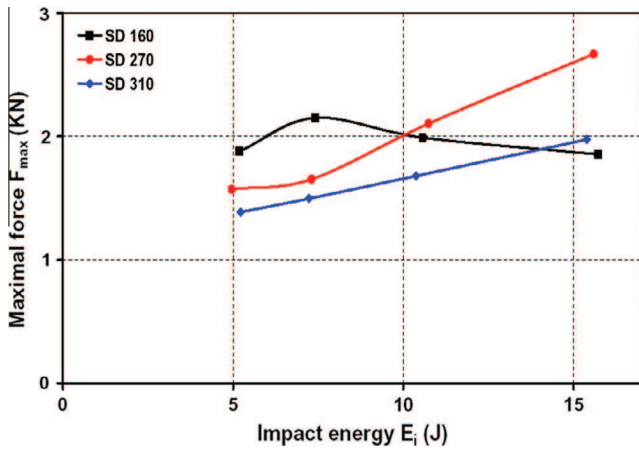
Fig. 8. Maximum force  $F_{max}$  vs. impact energy.

The levels of maximum force recorded by the sensor are strongly influenced by the cork density. As shown in Fig. 8, the

maximum force decreases from 1654 to 1497 N when the cork density increases from 270 to 310 kg/m<sup>3</sup> for 7 J impact energy. This can be explained by the fact that low cork density increases the grain size which results into a higher porosity. This implies that during the manufacturing of the sandwich plates, the resin infiltrates into the pores increasing the local rigidity of the material, as shown in Fig. 9. However, for the lowest cork density, SD 160, the force distribution recorded as a function of impact energy shows a random distribution. This distribution may be related to the impactor/target local contact area, which can occur either over a cork grain as shown in Fig. 9a, or over a cork-resin interface as illustrated in Fig. 9b, or totally on a rich zone of resin as indicated in Fig. 9c. Concerning the other densities, this observation is not completely true as seen in Fig. 9c. In the latter, the plate consists with a small cork grain sizes. This does not allow a large amount of resin infiltration to the plate inside. By cons, for Fig. 9a and b,

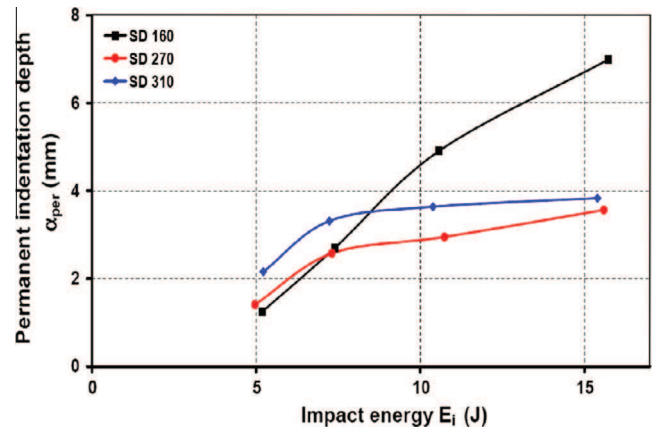
Fig. 10. Permanent indentation vs. impact energies.

The plot in Fig. 10 shows the permanent indentation depth  $\alpha_{per}$  evolution for the three sandwich materials as a function of the impact energy. When the impact energy rises from 5 to 7 J, a significant increase in permanent indentation depth is recorded for all tested densities. It is also noticed that for the impact energies superior to 7 J, the permanent indentation depth increases slowly for the SD 270 and SD 310 sandwich laminates. However, for the SD 160 sandwich, the permanent indentation depth increases significantly until the total specimen rupture. This difference may be related to the difference of energy dissipated by the three materials as well as to the energy dissipation modes.

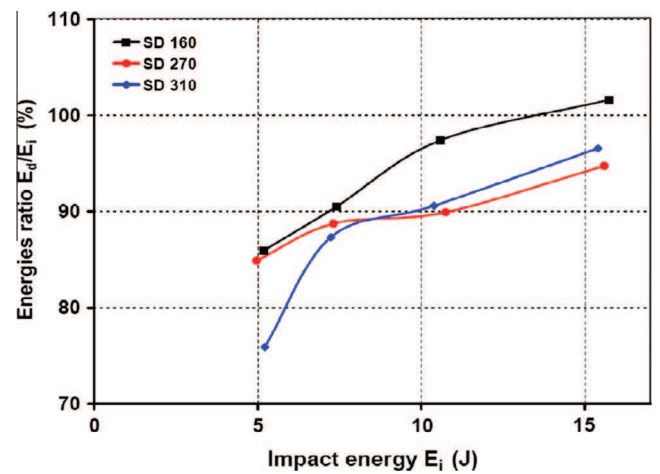
Fig. 11. Energies ratio  $E_d/E_i$  for the different sandwich materials.

The results of Fig. 11 show the cork density and the energy of impact influence on the sandwich dissipated energy-impact ratio  $E_d/E_i$ . It is observed that an increase in the cork density causes a decrease of the energies ratio. For 5 J impact energy, the cork density transition from 310 to 160 kg/m<sup>3</sup> raises the  $E_d/E_i$  ratio from 76% to 86%. If the impact energy grows, this trend is still observed but the difference is less important. As it can be seen, the  $E_d/E_i$  ratio only raises by 3.2% with 7 J impact energy.

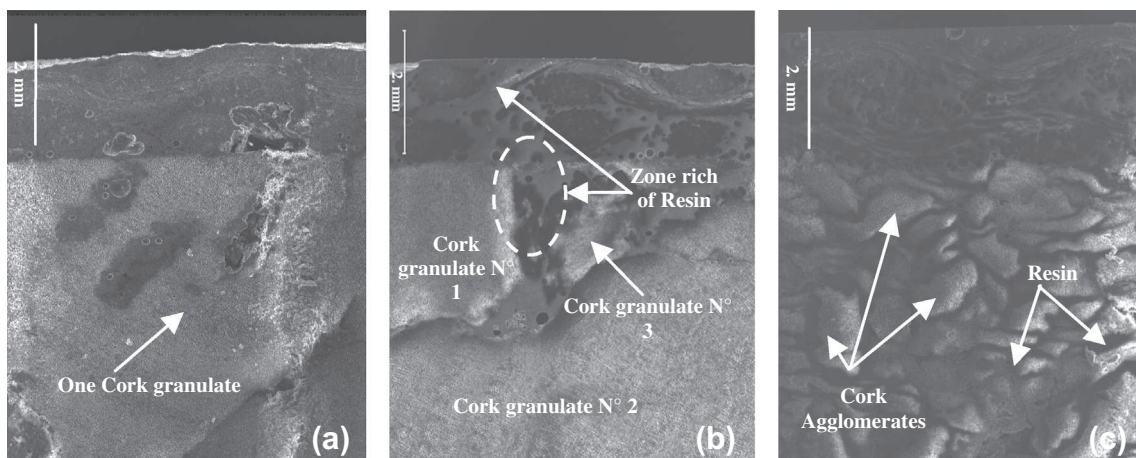
Fig. 9. SEM observation of sandwich SD 160 and SD 310. (a) SD 160 with one cork agglomerate, (b) SD 160 with 3 cork agglomerates, and (c) SD 310 with various cork agglomerates.

the cork have very high grain sizes so impressive pores are filled with resin during the plate manufacture by vacuum infusion.

Fig. 14 shows the maximum force evolution for impact and indentation tests. Generally, the maximum force values were greater during the impact tests (about 11.17%, 1.85% and 10.32% for SD 160, SD 270 and SD 310 respectively). In Fig. 14b, the maximum force value for impact test is lower than that of the indentation one. This can be explained, as it has been suggested previously, by the impactor/plate contact area which can occur either over a cork grain (Fig. 9a) or over a cork-resin interface or totally on rich zone of resin (Fig. 9b).

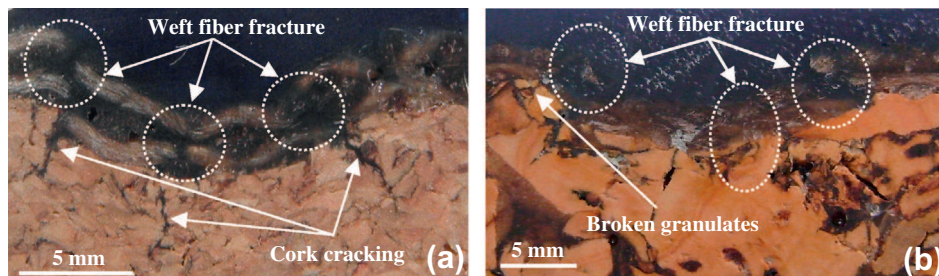
**Fig. 12.** Cross section photographs showing the damage state for two sandwich laminates with 7 J of impact energy. (a) SD 310 sandwich and (b) SD 160 sandwich.

In Fig. 12, it is shown the post-impact damage state of the sandwich panels for 7 J impact energy. The cork damaged areas, for the SD 310 sandwich laminates, are manifested by the presence of cracks between granulate interfaces, as observed in Fig. 12a. However when the density is lower than 310 kg/m<sup>3</sup>, in addition to interface granulate cracks, cracks through the cork granulates and cork failure by compression are also observed (Fig. 12b). In the case of rovimat/polyester-PVC foam sandwich panels impact ( $E_i$  is of the order of 200 J), core damage leads to  $\pm 45^\circ$  transverse shear failure in the foam. This is due to the failure propagation at the core/skin sandwich material interface [23].

Concerning the impacted skins, the observed damage is produced by two loading modes. At the impactor centre, compressive laminate fracture is noticed for all sandwich panels. However, shear damages are detected near the impacted area.

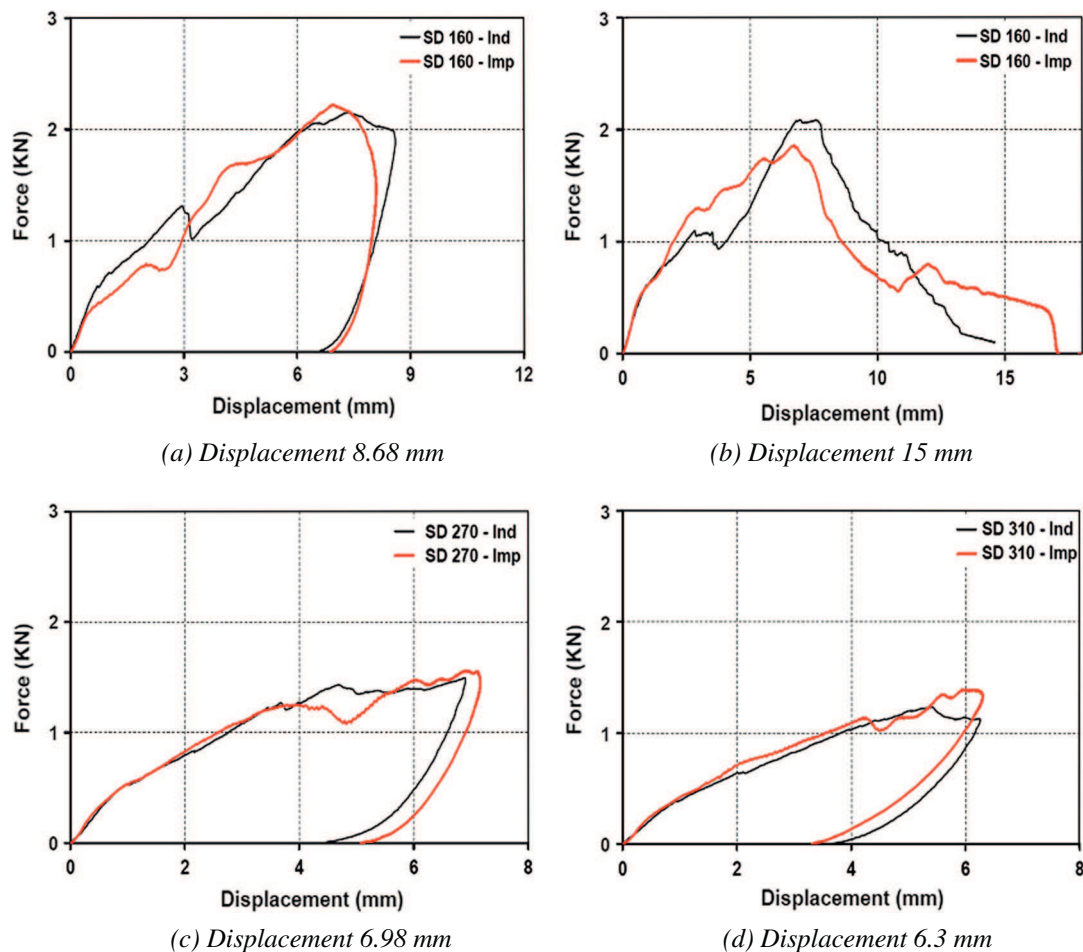
**Fig. 13.** Comparison of the force–indenter displacement curves for the indentation and impact tests on the jute/epoxy-cork sandwich laminates.

The static and dynamic tests have a common parameter, i.e., the maximum indenter displacement. Thus, a good opportunity is given to compare the results of both test types. First, a force-displacement curves comparison is performed for tests with the same maximum displacement (Fig. 13). The curve slopes (specimens bending stiffness  $\frac{\partial F}{\partial \delta}$ ) for the two linear sections are identical for static and dynamic loading. As the load is more stable during indentation tests compared to the impact, the generated forces are better distributed over the plate.

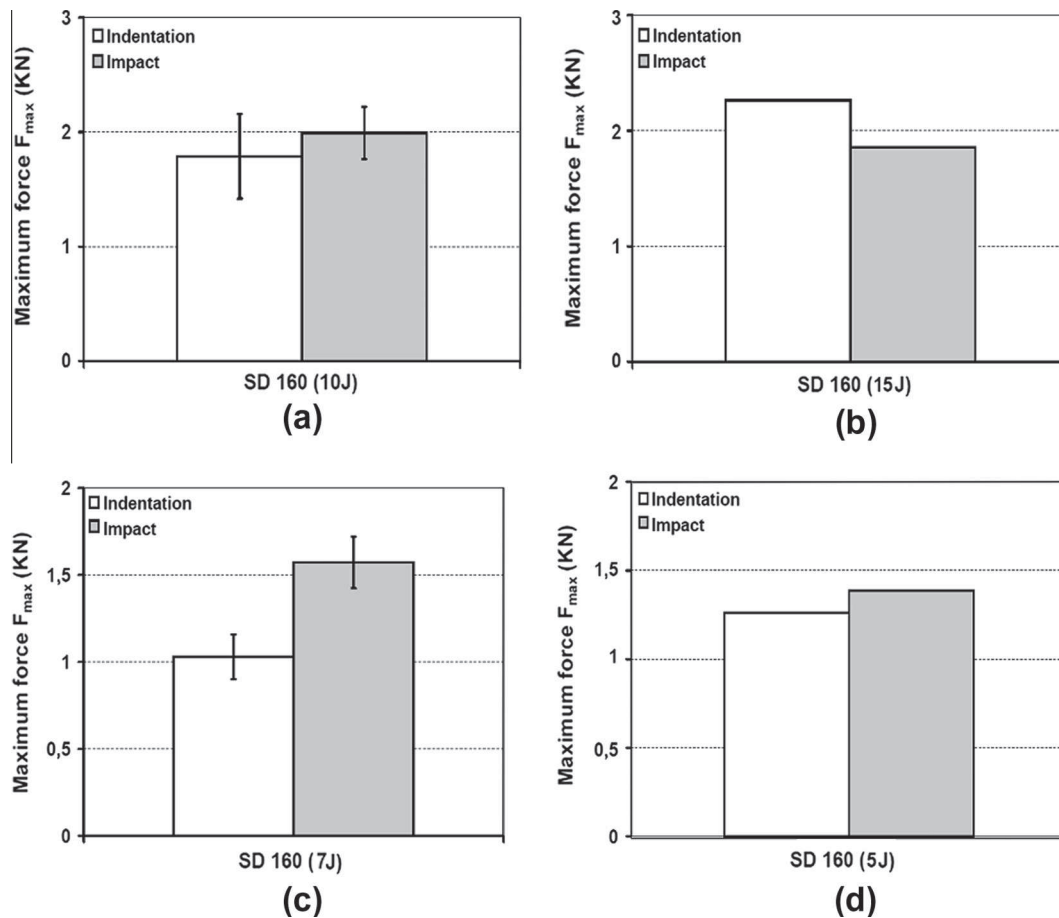
Fig. 14. Comparison of dynamic and static tests with respect to the maximal force.

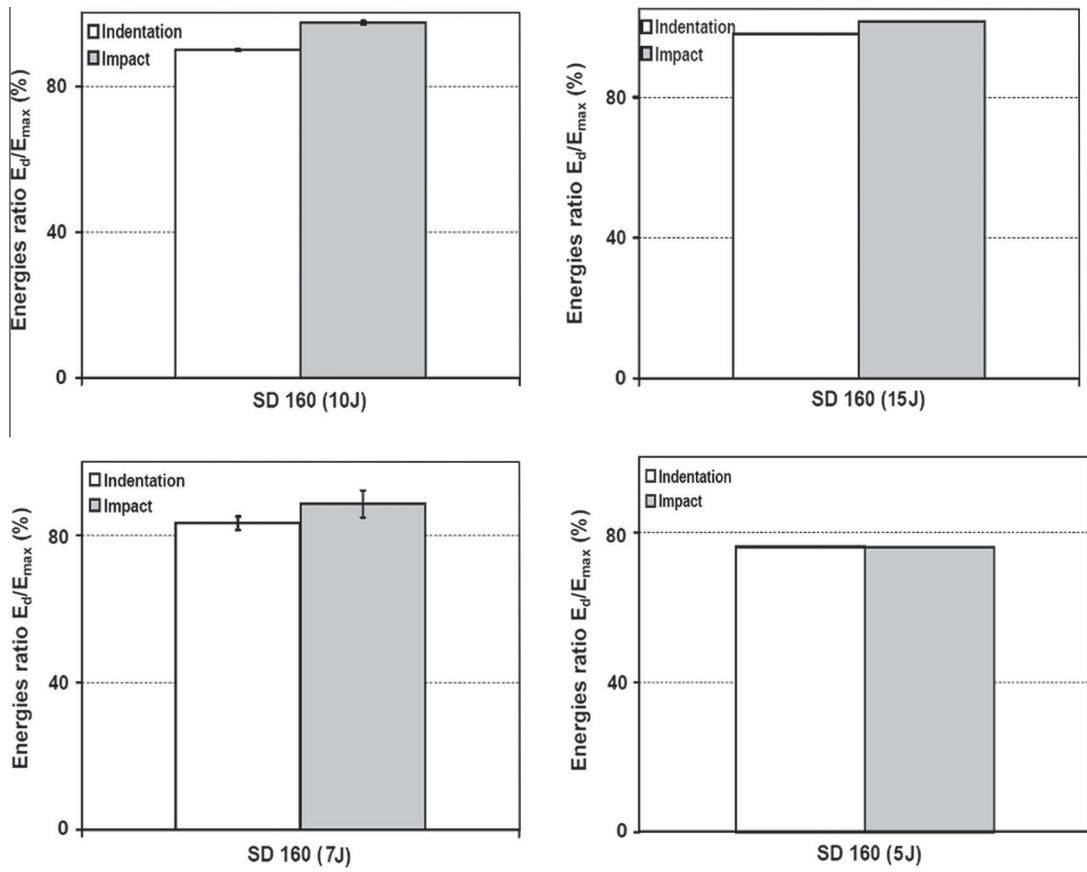
Fig. 15. The energies ratio " $E_d/E_{max}$ " as function of the maximal energy.

The greater the area in the indentation hysteresis cycle, the larger the energy dissipated by the plate. This dissipated energy is due to the damage formation in the specimen. A comparison of the “ $E_d/E_{\max}$ ” energies ratio based on the maximum energy is illustrated in Fig. 15. It should be noted that this ratio is generally higher in impact than in indentation tests (between 3.61% and 8.25% for SD 160, and 6.29% for SD 270). This difference may be related to the kinematics deformations, which is faster in the impact tests compared to the indentation ones. During dynamic tests, the effort exerted on a microscopic element increases rapidly that does not leave enough time for the load transfer.

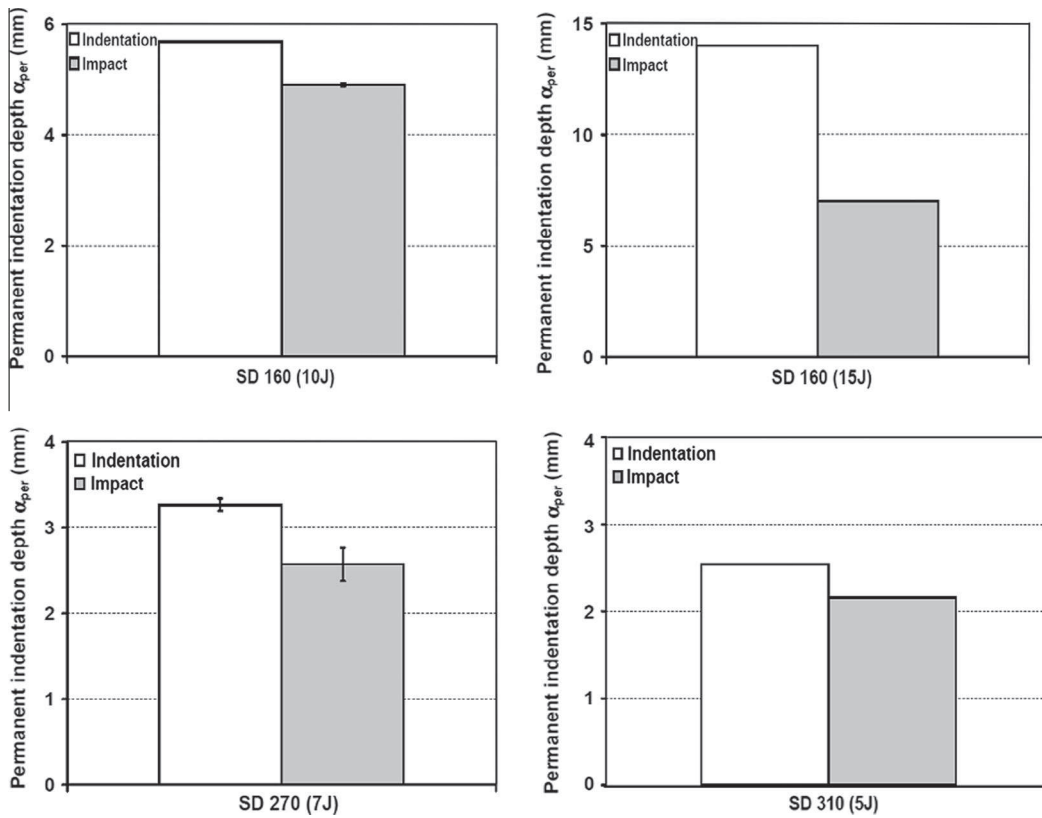
Fig. 16. Permanent indentation depth histograms for the jute/epoxy-cork sandwich laminates.

Although the energy dissipation is higher for dynamic tests, the permanent indentation depth “ $\alpha_{\text{per}}$ ” is larger during the quasi-sta-

tic indentation (Fig. 16). The permanent indentations generated by indentation tests are 16% deeper for SD 160, 27% for SD 270, and 17% for SD 310 compared to those of impact tests.

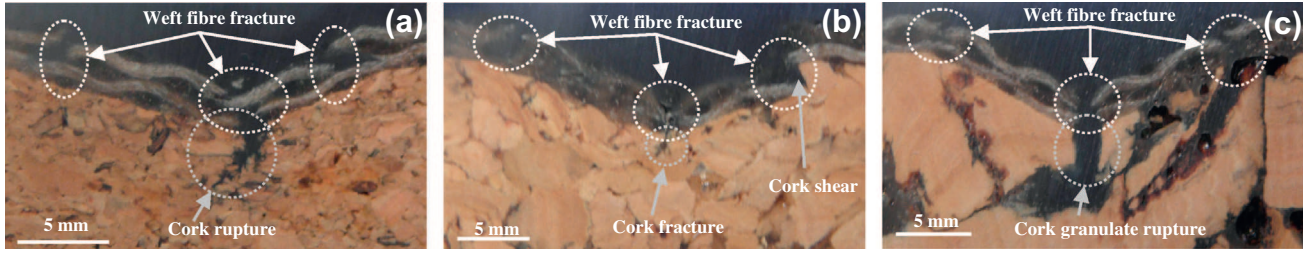
**Fig. 17.** Cross section photographs showing the damage state for three sandwich laminates after indentation tests. (a) SD 310 Sandwich, (b) SD 270 Sandwich, and (c) SD 160 Sandwich.

Fig. 17 shows the post-indentation damage on sandwich panels. Sandwich SD 310 cork damage manifests by the intergranular cracks (Fig. 17a). However, when the cork density is less than  $310 \text{ kg/m}^3$ , intergranular cracking is replaced by a cork grain crack (Fig. 17b) or grain rupture (Fig. 17c). Concerning the impacted skin, the observed damages are generated by two loading types: laminate compression fracture in the indenter centre for all the sandwich panels with skin shears on the vicinity of the damaged area.

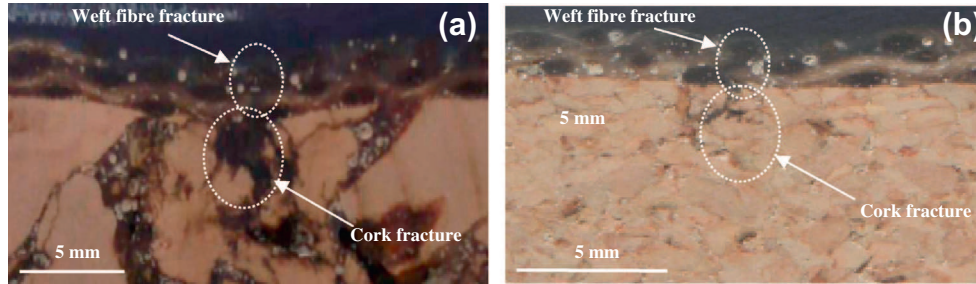
**Fig. 18.** Cross section photographs showing the damage state for two sandwich laminates after first indentation damage. (a) SD 160 Sandwich and (b) SD 310 Sandwich.

During the jute/epoxy-cork sandwich material indentation loading, the first damage to appear is upper skin compression cracking (indentation) at the impact zone followed by cork intergranular cracking (Fig. 18). By increasing the applied force, it appears a shear of the upper skin near the impacted area as well as cork cracks (Fig. 17a) and/or cork grain failure (Fig. 17b and c). This damage scenario can be easily adopted for dynamic loading such as impact test.
