Sandwich composites impact and indentation behaviour study

Belkacem Hachemane, Redouane Zitoune, Boudjema Bezzazi, Christophe Bouvet

Belkacem Hachemane, Redouane Zitoune, Boudjema Bezzazi, Christophe Bouvet. Sandwich composites impact and indentation behaviour study. *Composites Part B: Engineering*, 2013, vol. 51, pp. 1-10. 10.1016/j.compositesb.2013.02.014 . hal-00859791

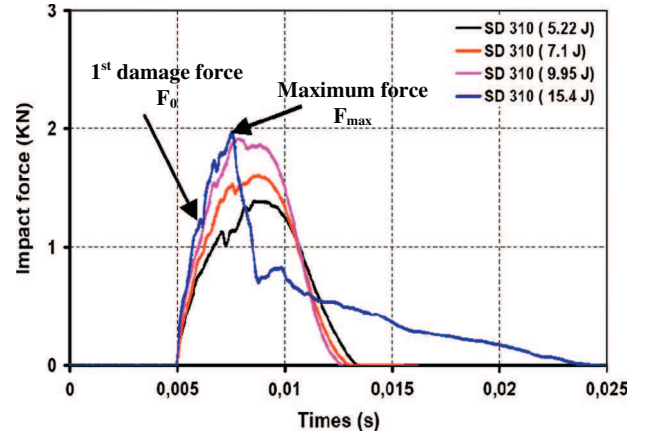
The results in Fig. 6 show the evolution of the impact force vs. time for four impact energies, obtained on a SD 310 sandwich plate. It is noticed that for impact energies below 15 J, these curves are not far removed from a sine wave. The impact test performed with energy of 15 J resulted in a damage of the non-impacted skin. From Fig. 6, two critical values can be distinguished, the first one relates the first damage force, and the second one represents the maximum impact force recorded by the force sensor, which are noted as F_0 and F_{max} , respectively. For a 310 kg/m^3 cork density, the first damage force increases with impact energy. This growth is about 40% when the impact energy increases from 5.22 to 9.95 J.

Fig. 6. Temporal impact force curves for the SD 310 composite sandwich.

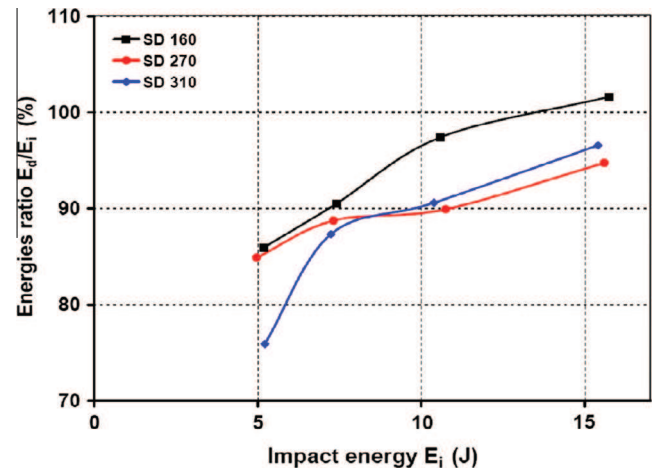
Fig. 11. Energies ratio E_d/E_i for the different sandwich materials.

The results of Fig. 11 show the cork density and the energy of impact influence on the sandwich dissipated energy-impact ratio E_d/E_i . It is observed that an increase in the cork density causes a decrease of the energies ratio. For 5 J impact energy, the cork density transition from 310 to 160 kg/m³ raises the E_d/E_i ratio from 76% to 86%. If the impact energy grows, this trend is still observed but the difference is less important. As it can be seen, the E_d/E_i ratio only raises by 3.2% with 7 J impact energy.

With the less dense cork, the resin quantity which infiltrates the pores is more important. Therefore an increment in the resin quantity results in a change of the material proprieties. In this case, the local stiffness is not the same and thus its ability to absorb energy. Table 3 summarises the main performed impact test results.

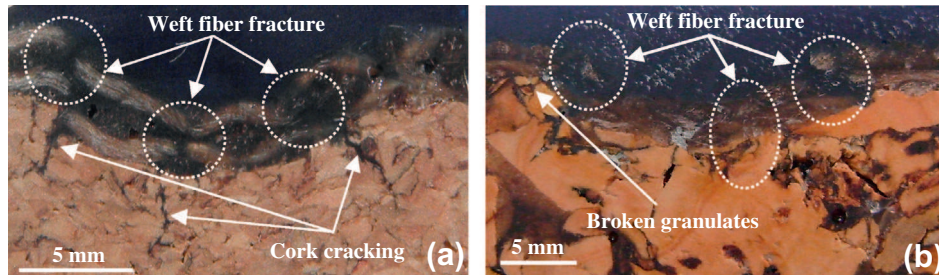
Fig. 12. Cross section photographs showing the damage state for two sandwich laminates with 7 J of impact energy. (a) SD 310 sandwich and (b) SD 160 sandwich.

In Fig. 12, it is shown the post-impact damage state of the sandwich panels for 7 J impact energy. The cork damaged areas, for the SD 310 sandwich laminates, are manifested by the presence of cracks between granulate interfaces, as observed in Fig. 12a. However when the density is lower than 310 kg/m³, in addition to interface granulate cracks, cracks through the cork granulates and cork failure by compression are also observed (Fig. 12b). In the case of rovimat/polyester-PVC foam sandwich panels impact (E_i is of the order of 200 J), core damage leads to $\pm 45^\circ$ transverse shear failure in the foam. This is due to the failure propagation at the core/skin sandwich material interface [23].

Concerning the impacted skins, the observed damage is produced by two loading modes. At the impactor centre, compressive laminate fracture is noticed for all sandwich panels. However, shear damages are detected near the impacted area.

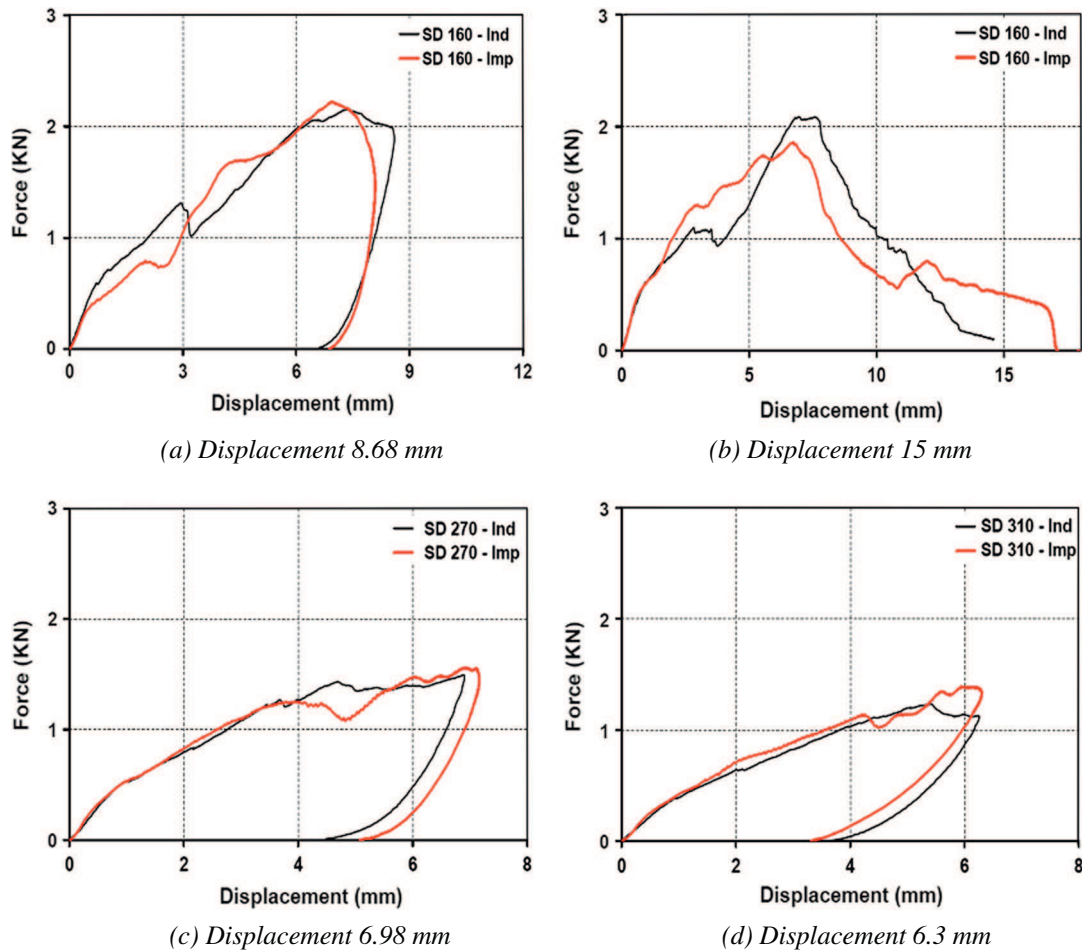
Fig. 13. Comparison of the force-indentor displacement curves for the indentation and impact tests on the jute/epoxy-cork sandwich laminates.

The static and dynamic tests have a common parameter, i.e., the maximum indenter displacement. Thus, a good opportunity is given to compare the results of both test types. First, a force-displacement curves comparison is performed for tests with the same maximum displacement (Fig. 13). The curve slopes (specimens bending stiffness $\frac{\partial F}{\partial \delta}$) for the two linear sections are identical for static and dynamic loading. As the load is more stable during indentation tests compared to the impact, the generated forces are better distributed over the plate.

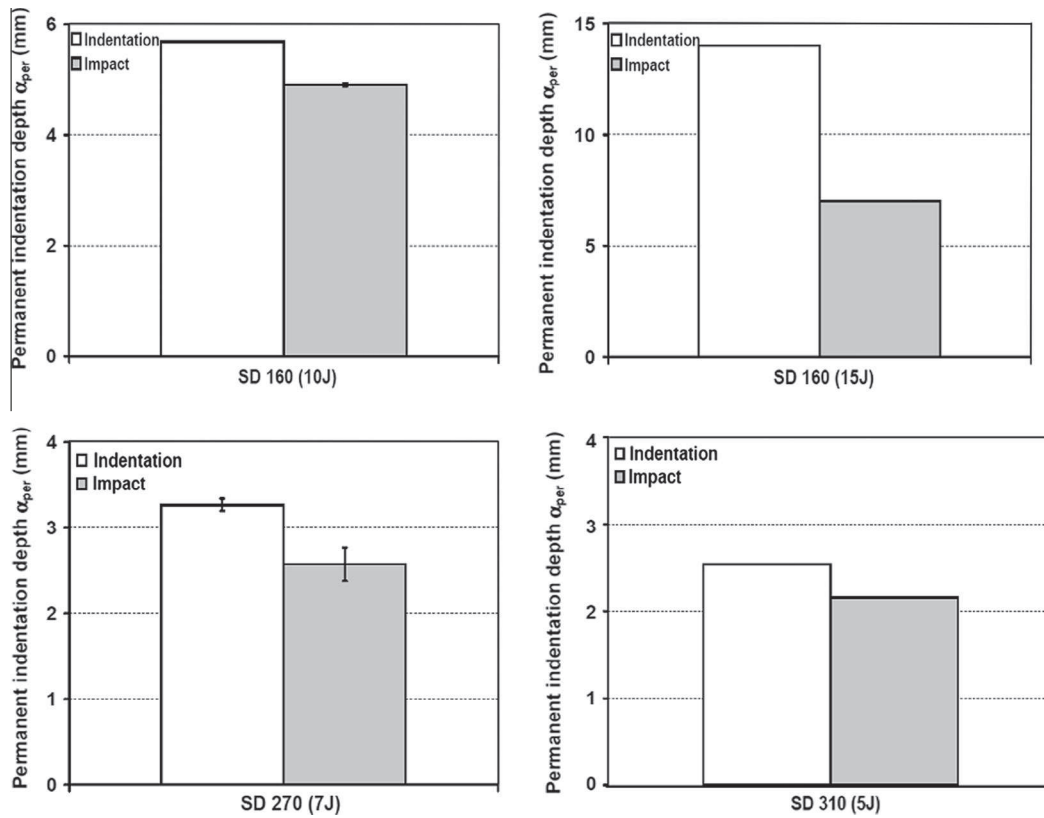
Fig. 16. Permanent indentation depth histograms for the jute/epoxy-cork sandwich laminates.

Although the energy dissipation is higher for dynamic tests, the permanent indentation depth “ α_{per} ” is larger during the quasi-sta-

tic indentation (Fig. 16). The permanent indentations generated by indentation tests are 16% deeper for SD 160, 27% for SD 270, and 17% for SD 310 compared to those of impact tests.
