Mechanical and barrier properties of MOCVD processed alumina coatings on Ti6Al4V titanium alloy

Yannick Balcaen, Nicoleta Radutoiu, Joël Alexis, Jean-Denis Béguin, Loïc Lacroix, Diane Samélor, Constantin Vahlas

Yannick Balcaen, Nicoleta Radutoiu, Joël Alexis, Jean-Denis Béguin, Loïc Lacroix, et al.. Mechanical and barrier properties of MOCVD processed alumina coatings on Ti6Al4V titanium alloy. *Surface and Coatings Technology*, 2011, vol. 206, pp. 1684-1690. 10.1016/j.surfcoat.2011.09.056 . hal-00866330

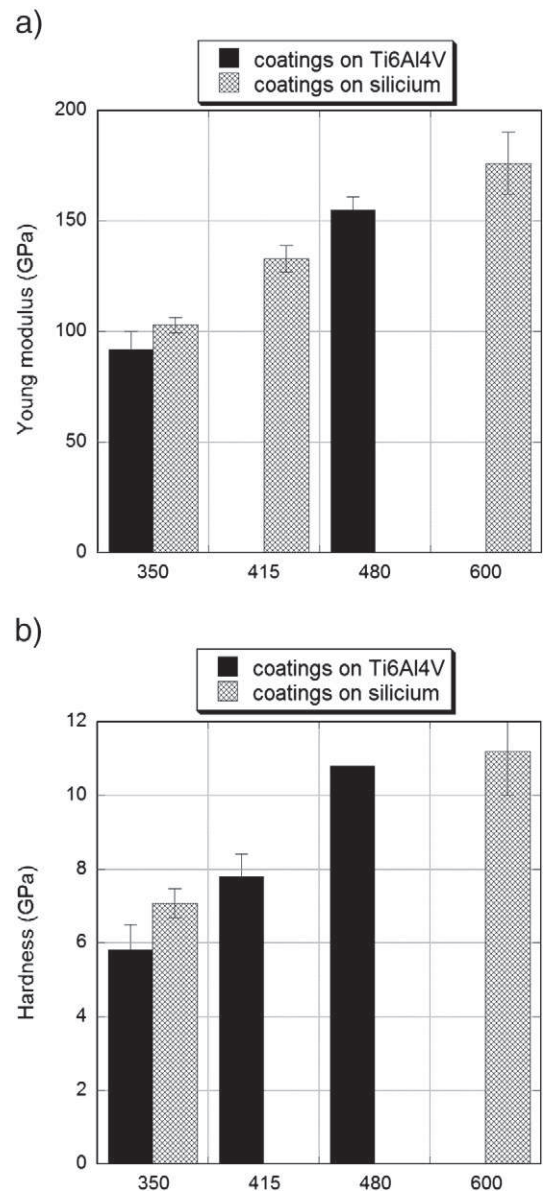
Fig. 3. Young's modulus (a) and hardness (b) of the coatings processed on Si and on Ti6Al4V for different deposition temperatures.

of the coatings. For this reason, nanoindentation tests were also performed on commercial bulk alumina and on the same coatings deposited on silicon (Fig. 3). The hardness and Young's modulus obtained by nanoindentation on bulk samples are consistent with the results given in literature [17]. The hardness and the rigidity of 92% and 96% pure alpha alumina are equal to $H_{92\%} = 20 \pm 6$ GPa, $E_{92\%} = 320 \pm 50$ GPa and $H_{96\%} = 33 \pm 3$ GPa, $E_{96\%} = 423 \pm 37$ GPa, respectively. Whatever the nature of the substrate, the hardness and rigidity of the films increased with increasing the deposition temperature up to 480 °C. In addition, the hardness and Young's modulus of coatings prepared on silicon substrate confirm the values obtained for the coatings on titanium substrate. Therefore, the nanoindentation technique and the selected test parameters are relevant and the low values obtained for the coatings compared to bulk alpha alumina are attributed to differences of the microstructure of the samples. Depending on the deposition temperature, the increased hardness and rigidity seem to correspond mainly to an increase in the purity of the amorphous alumina deposits. Haanappel et al. also showed that the hardness of alumina coatings prepared by Low Pressure MOCVD and Atmospheric pressure MOCVD increases when the deposition temperature increases from 250 °C to 450 °C [18]. They attribute this increase to the disappearance of the amount of the OH group and in particular to the decrease of boehmite (AlO(OH)).
