## A realistic testing of a shipboard wireless sensor network

Hussein Kdouh, Christian Brousseau, Gheorghe Zaharia, Guy Grunfelder,  
Ghaïs El Zein

Hussein Kdouh, Christian Brousseau, Gheorghe Zaharia, Guy Grunfelder, Ghaïs El Zein. A realistic testing of a shipboard wireless sensor network. *Military Technical Academy Review*, 2013, 23 (2), pp.107-120. hal-00873160

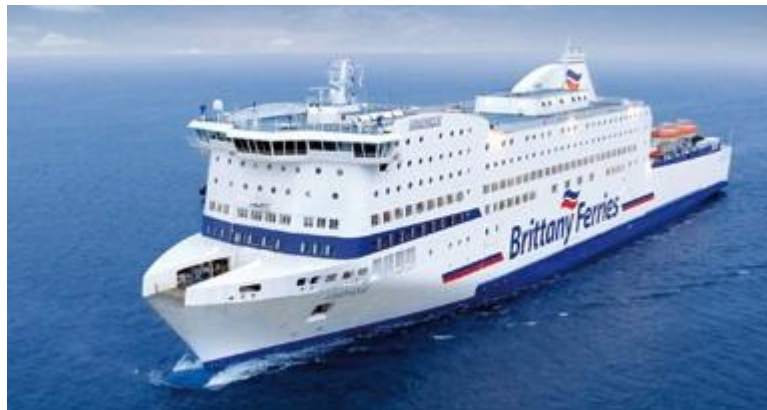
The network test has been carried out on board "Armorique" vessel (illustrated in Fig. 1), which is a modern ferry from the Brittany Ferries company. This 29500-tons vessel is characterized by a length of 168.3 m, a beam of 26.8 m and a capacity of 1500 passengers [6]. The deckhouse of "Armorique" consists of the bottom deck which contains the main and the auxiliary engine rooms; the second deck which houses the control room; the third, the fourth and the fifth decks which are the vehicles parking; the sixth and the seventh deck which contain self service restaurants, shopping and entertainment areas; the eighth and the ninth decks which house the

Fig. 1 Picture of the Armorique ferry.

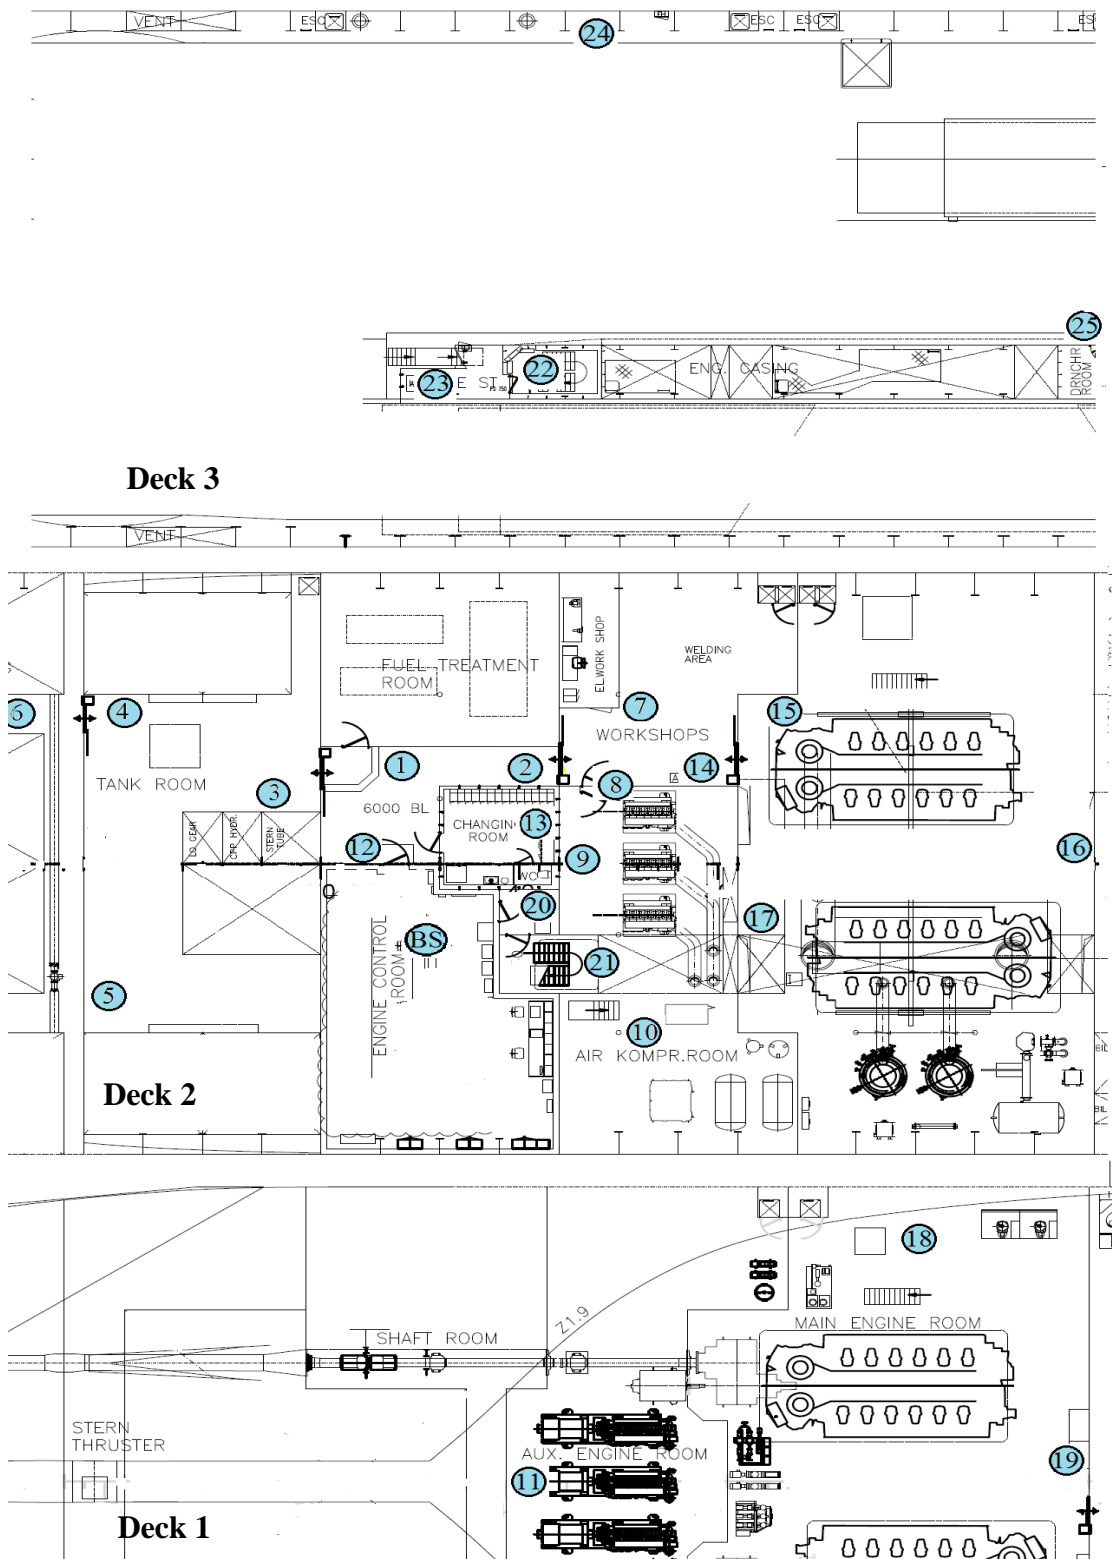
Although MicaZ nodes have the same capacities and resources, three types of nodes in our deployment may be distinguished according to the node locations: “Stairway” nodes located in the stairway connecting Deck 2 and Deck 3, “hatches nodes” located in front of watertight doors, and “peripheral nodes” located in different rooms near the real sensors of the current monitoring system. The deployed WSN is composed of 25 sensor nodes. Table 1 shows the distribution of nodes between these three defined categories and Fig. 2 shows a planar view of nodes locations on a map of “Armorique”. The gateway node was placed in the control room in Deck 2 and connected to a laptop (running MoteView) via a USB connection.

Fig. 2 Locations of the WSN nodes on board “Armorique”.

Previous results show that doors and stairways are the main and probably unique sources for radio leakage between adjacent rooms and adjacent decks respectively. Based on these conclusions, sensor nodes of the WSN on board the “Armorique” are placed in front of doors and in stairways to maintain the connectivity in the network and to provide full radio coverage of studied area.

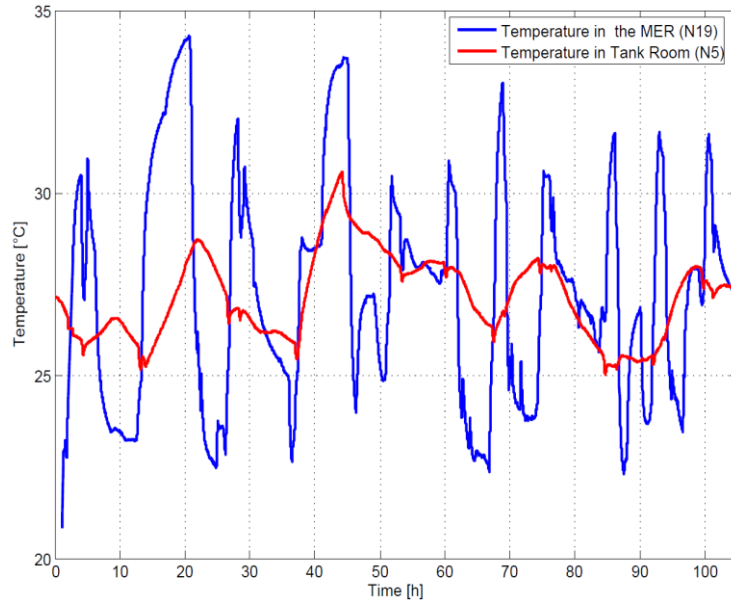
Fig. 3 and Fig. 4 show the evolution of temperature and vertical acceleration in the tank room and the MER during tests. Blue curves are data sent by node N19 located in the MER and red curves are data sent by node N5 located in the tank room. As shown in Fig. 3, the temperature in the MER increases and decreases alternately. It can be noticed that the temperature in the MER increases during stopovers and decreases during sailings due to the location of N19 near to Air Conditioners (AC) of the MER. AC are used to compensate the increasing of temperature due to the machines in the MER. As these engines are turned off during stopovers, then AC are also stopped. Changes of temperature in the tank room which does not contain engines and AC are smaller and do not depend on the sailings schedule.

Fig. 3 Time-variation of the temperature (in °C) in MER and the tank rooms.

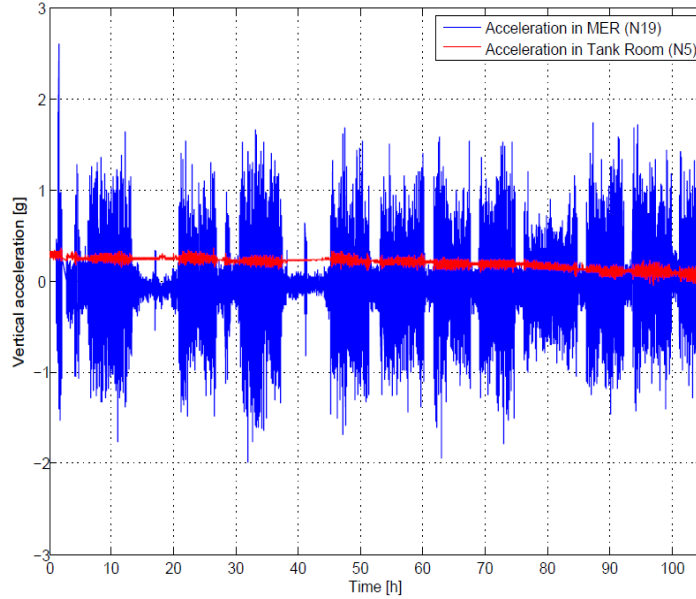
On the other hand, Fig. 4 shows the evolution of the vertical acceleration in the MER and tank room. The difference between the blue curve (MER) and the red one (tank room) is significant. Vertical acceleration in tank room is almost constant during the test. This value presents some small oscillations during sailings corresponding to vertical motion of the ship in the sea. However, the difference between sailings and stopovers is more significant in the MER. Machines oscillations in the MER during sailings cause this big difference between values of vertical acceleration in the two periods.

Fig. 4 Time-variation of vertical acceleration (in g) in the MER and the tank rooms.

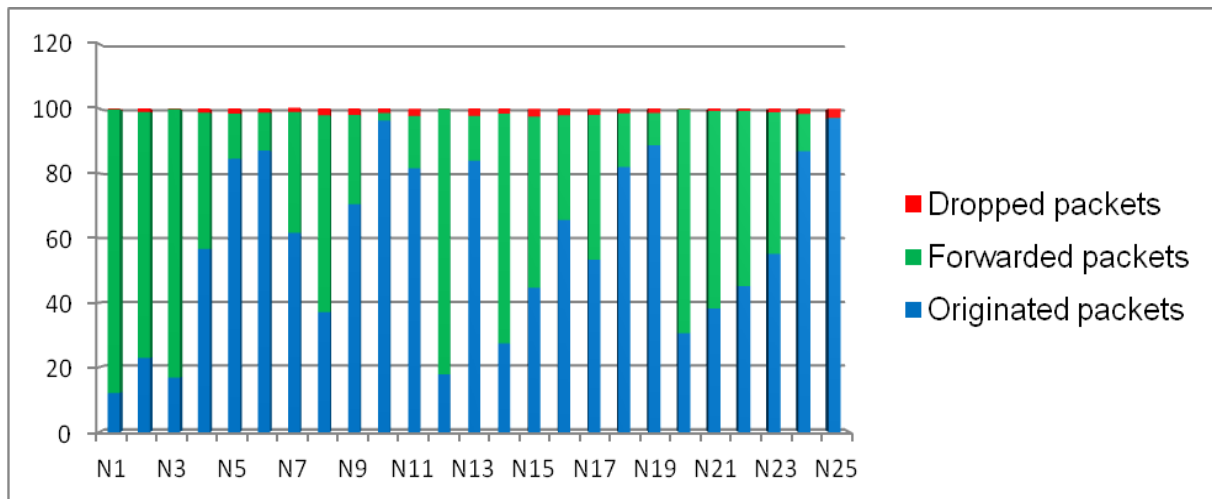
Fig. 5 shows the percentage of originated packets, forwarded packets and dropped packets for each sensor node. Originated packets include all data, node health; neighbor health and route update packets originated by the node. Health packets contain information about how well the mote is performing in the mesh network, specifically radio traffic. Other health packet information includes battery voltage and the parent's RSSI data. Forwarded packets are the packets that the node has forwarded from other nodes. Dropped packets are the packets that the node has dropped. According to the XMesh protocol, packets are considered to have been dropped when a packet has been retransmitted 8 times without receiving the acknowledgement.

The results of Fig. 5 show that more than 97% of data packets have successfully arrived to the base station, which reflects a significant reliability of the network. Results indicate also that the percentages of forwarded packets were high for nodes N1, N2, N3, N4, N7, N9, N10, N12, N14, N15, N16, N17, N20, N21, N22 and N23 (hatches and stairways nodes). These nodes were located near the watertight doors and in the stairways in order to route sensing data coming from rooms. Among these routers, N1, N2, N3, N12 and N20 have the maximum values of forwarded packets. This is explained by their locations in the radio range of the gateway node.

Fig. 5 Percentage of dropped, forwarded and originated packets for each node after the network test on board “Armorique”.

Although the dynamic environment on board "Armorique", we can clearly remark that movement of persons (passengers and crew members) and objects (frequent door closing, charge and discharge of parking, etc.) did not affect the reliability of the network (in terms of packet delivery ratio). This shows the constructive aspect of the metallic shipboard environment, which creates multiple propagation paths for the radio waves, and allows the successful arrival of data packets even if the Line-of-Sight is blocked. Moreover, stairway nodes have been selected as parent nodes by peripheral nodes in the parking. Hatches nodes are also selected by peripheral nodes. This confirms the previous conclusion saying that paths followed by data packets are predictable.

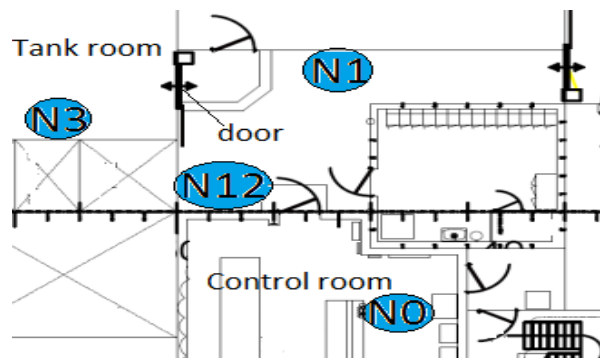
We tried to close the maximum number of watertight doors during the test to simulate the worst case. However, some doors remained opened by the crew members. Therefore, some connections between nodes separated by more than one watertight door have been detected. Previous results have shown that two nodes separated by two closed watertight doors cannot communicate. For example, node N3 has selected the gateway node N0 as its parent node for 76 % of packets and nodes N1 and N12 for the remaining packets (Fig. 6). Establishment of links N3-N1 and N3-N12 is coherent, since the two sides of these connections are separated by only one watertight door. However, the connection between N3 and N0 is not possible if the watertight door of between the tank room and the control room was maintained closed.

Fig. 6 N3 and its parent nodes.

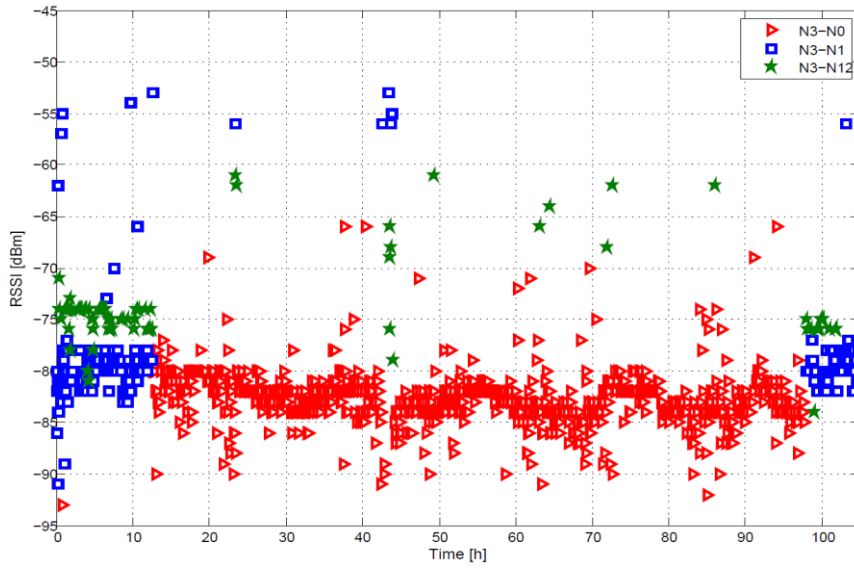
To verify the existing configuration when this link was established, the evolution of RSSI corresponding to links between N3 and its parent nodes is studied. Fig. 7 shows its time-evolution. It can be seen that N3 has selected N1 or N12 until  $t = 12$  hours and it switches to N0 between  $t = 12$  and  $t = 99$  hours when it re-switches to N1 or N12. In addition, most of RSSI values corresponding to link N3-N1 are grouped around a mean value of  $-80$  dBm. Some values increase to  $-55$  dBm after  $t = 12$  hours. N1 and N3 are separated by one door. The gap of 25 dB between the two levels of RSSI corresponding to link N3-N1 represents the power loss due to the closing of this door. The status of this door (opened or closed) can be simply determined by seeing the RSSI level of N3-N1. It can be noticed that N3 has switched to N0 when the door was opened and link N3-N0 remains established until the door closure at  $t = 100$  hours. Therefore, when N0 was the parent node of N3, only one door (control room door) was closed and link N3-N0 has stopped when the second door was closed. It is also worth mentioning that

most of RSSI values of link N3-N0 are grouped around a mean value of -83 dBm. Some values reach -65 dBm. This gap of 18 dB is due to the opening of the control room door.

Fig. 7 Time-evolution of RSSI (in dBm) for the links between N3 and its parent nodes.

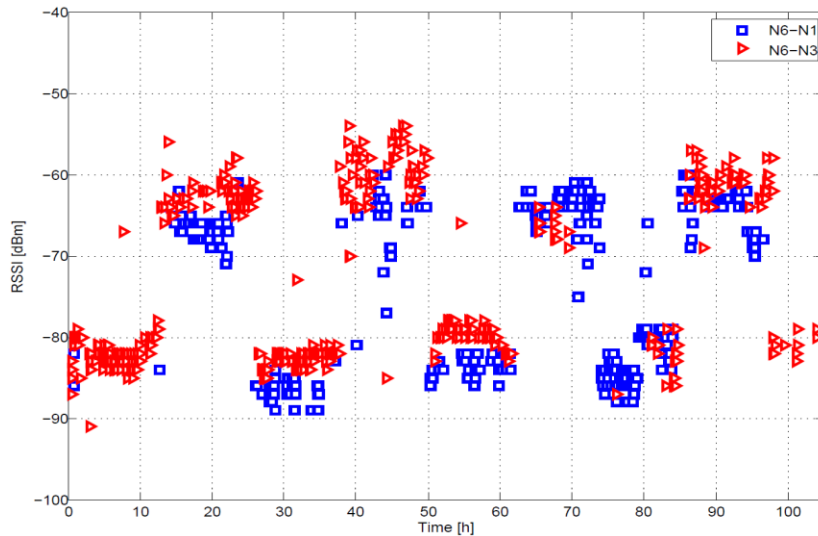
Although we tried to maintain most of watertight doors closed, the status of several doors has frequently changed during the measurement test. The analysis of RSSI measurements between the pairs of sensor nodes located in different rooms allows estimating the supplementary path loss due to the watertight door closure. For example, node N6 has mainly selected N3 and N1 as its parent nodes. The common watertight door between the tank room and the rudder gear room is placed on the direct path N6-N3. Similarly, as shown in Fig. 2, the watertight door between the tank room and “6000BL” room is placed on the direct path N6-N1. Fig. 8 shows the RSSI measurements of links N6-N1 and N6-N3. It can be seen that these two links have the same behavior with a slowly higher level of N6-N1. The little difference between RSSI levels proves that the watertight door of “6000BL” room was opened when N6-N1 was established. Therefore, the gap between the two main levels of RSSI in Fig. 8 corresponds to the excess path loss due to the closing of the door between the rudder gear room and the tank room. The link N6-N3 has an upper level with a mean value of -60 dBm and a lower level with a mean value of -84 dBm, which leads to an excess path loss of 24 dB. Similarly, the link N6-N1 has an upper level of -65 dBm and a lower level of -88 dBm, which leads to an excess path loss of 23 dB.

Fig. 8 Time-evolution of RSSI (in dBm) for the links between N6 and its parent nodes.

The same procedure has been followed to find the RSSI attenuation of all doors in the covered area. All these measurements have shown that the excess path loss due to closing a watertight door is bounded between 17 and 25 dB. This result is consistent with the value of excess path found with the previous measurement results.

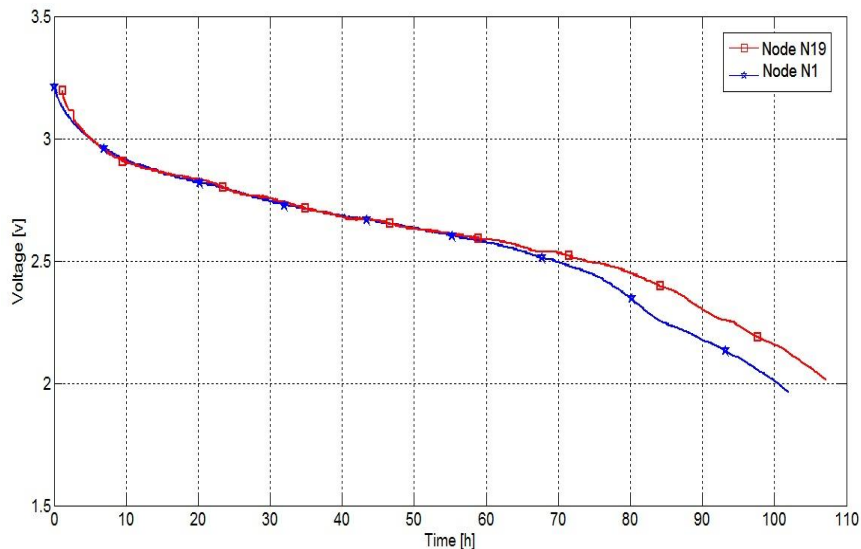
Although the high power consumption mode of XMesh was used, the evolution of power consumption of sensor nodes during the network test has been studied. The objective is not to determine the power consumption of nodes, but to compare the voltage evolution of peripheral and critical nodes. It is expected that power consumption of critical nodes such as N1, N3 and N20 will be clearly greater than that of peripheral nodes such as N18, N19 and N25. However, results indicate a small difference between power consumptions. The voltage drops of nodes N1 and N19 are depicted in Fig. 9. N1 and N19 have similar number of originated packets, but N1 has forwarded a number of packets 65 times greater than that forwarded by N19. Since the transmission and reception are the two main factors that increase the power consumption of a sensor node, N1 must have a greater consumption and it will die before N19. Nevertheless, **Fig. 9** indicates a slightly larger power consumption and a slightly shorter lifetime for N1. This similarity may be explained by the overhearing problem, by which nodes waste energy in receiving all packets that are transmitted in their neighborhood even if they are intended for other nodes. Another factor may be the small route updates interval time where sensor nodes consume energy in collecting health data about their neighbors. A power control mechanism must be developed in order to enlarge the shipboard WSN lifetime. As sensor nodes send their sensing data mainly via hatches nodes or stairway nodes (critical nodes) and the links established have shown good stability and quality, it will be useful to reduce the route updates frequency to save energy.

Fig. 9 Time-evolution of the voltage for nodes N1 and N19.
