## **Aeronautics composite material inspection with a terahertz time-domain spectroscopy system**

# Aeronautics composite material inspection with a terahertz time-domain spectroscopy system

**Abstract.** The usability of pulsed broadband terahertz radiation for the inspection of composite materials from the aeronautics industry is investigated, with the goal of developing a mobile time-domain spectroscopy system that operates in reflection geometry. A wide range of samples based on glass and carbon fiber reinforced plastics with various types of defects is examined using an imaging system; the results are evaluated both in time and frequency domain. The conductivity of carbon fibers prevents penetration of the respective samples but also allows analysis of coatings from the reflected THz pulses. Glass fiber composites are, in principle, transparent for THz radiation, but commonly with significant absorption for wavelengths >1 THz. Depending on depth, matrix material, and size, defects like foreign material inserts, delaminations, or moisture contamination can be visualized. If a defect is not too deep in the sample, its location can be correctly identified from the delay between

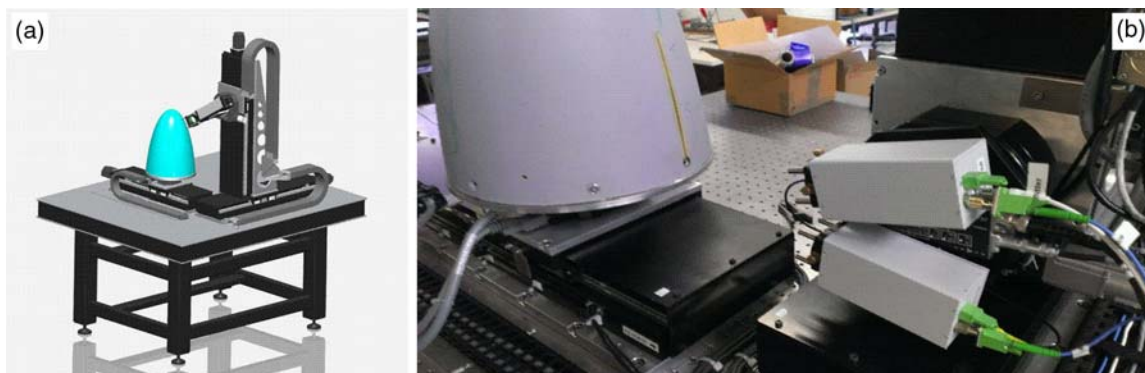
**Fig. 1** The DOTNAC three-dimensional (3-D) scanner platform; schematic drawing with mounted FMCW sensor head (a), photograph of mounted TDS sensor and test radome (b).

scanner unit, alternatively to an FMCW transceiver head (see Fig. 6). The focal distance of the THz optics is 200 mm to match the working distance of the scanner. The focusing lenses can easily be dismantled to allow the use of other optics, for example, with sharper focusing for enhanced spatial resolution. Also mounted on the baseplate is a trans-impedance amplifier for signal preprocessing. With the maximum specified phase offset modulation voltage, our ECOPS system can scan a time window of 146 ps at 100-Hz modulation frequency. This range is calibrated with a nonlinear frequency-doubling crystal on which the beams of master and slave laser are collinearly overlapped. Note that within our measurement accuracy, the delay-voltage
