# Study of tearing behaviour of a PWR reactor pressure vessel lower head under severe accident loadings

Vincent Koundy<sup>a,\*</sup>, Cataldo Caroli<sup>a</sup>, Laetitia Nicolas<sup>b</sup>, Philippe Matheron<sup>b</sup>, Jean-Marie Gentzbittel<sup>c</sup>, Michel Coret<sup>d</sup>

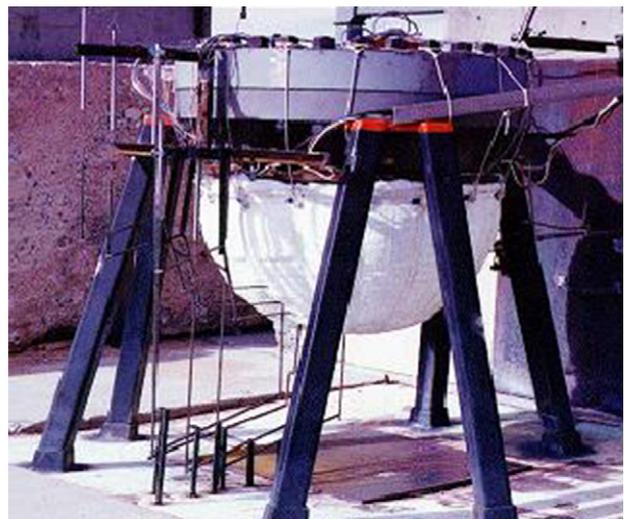
Fig. 1. LHF 1/5-scale lower head failure test apparatus.

In the framework of an experimental research programme on RPV failure behaviour concerning the relocation of corium to the lower head, SANDIA National Laboratories carried out two integral experimental programmes "LHF" (1994–1999) and "OLHF" (1999–2002) (Chu et al., 1998; Humphries et al., 2002). The second programme was an extension of the first, and was carried out within an international OECD framework. Eight tests were carried out in the LHF programme (see Fig. 1) and four tests in the OLHF programme. The same type of 1/5-scale RPV lower head was used in the two programmes. However, it should be noted that the vessel wall thickness in the OLHF tests was twice that in the LHF experiments in order to study the influence of the wall temperature gradient.

Several spatial temperature heat flux distributions were used, namely edge-peaked distributions (corresponding to the edged-peaked heat flux distribution of a convecting molten pool), centre-peaked distributions (reminiscent of the hot spot in the TMI-2 accident) and uniform distributions (scenarios where core melt gradually relocates to the lower head). The experimental protocol imposed a fixed rate of temperature increase until rupture of the lower head occurred.

The LHF Tests were carried out at constant pressure (seven tests at 10 MPa and one at 5 MPa). Two of these tests were intended to study of the behaviour of the tubular penetrations. As for the OLHF tests, only uniform heating was used and two pressure levels were considered, 5 MPa and 10 MPa. The last two tests of the OLHF series were dedicated to study the influence on the failure mode of a rapid pressure transient from 5 to 10 MPa and to investigate the effect of the penetration on failure behaviour (pressure of 5 MPa). Tests with penetrations generally led to leakage from welds between the vessel and tube penetrations, this led to test interruption due to depressurisation.

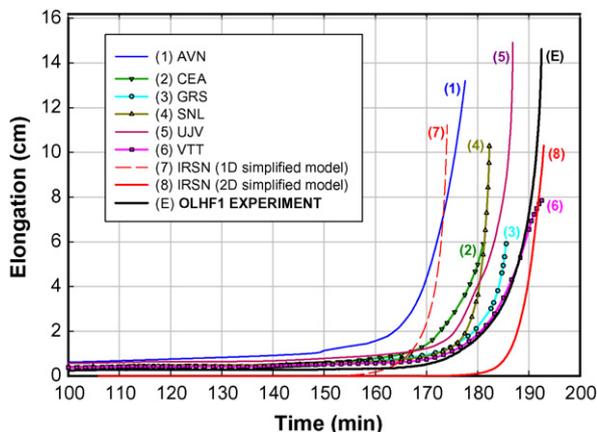
Fig. 2 shows a comparison of the final OLHF1 lower head elongation estimated by different models. The curves (8) and (E) correspond to the IRSN 2D simplified model calculation and the experimental result, respectively. Discrepancy of failure times (maximum uncertainty not exceeding 15%) is regarded here as satisfactory, taking into account the uncertainty of the choice of the initial time ( $t=0$ ) and the onset of non-linear creep deformation

Fig. 2. Comparison of the OLHF1 lower head elongation using different models.

determined by different models. However, a study of the sensitivity of the material properties which takes into account the uncertainty in the material property variation (tensile property fitting parameters, creep coefficients) carried out by Nicolas et al. (2003), showed that the maximum discrepancy relating to failure time could be as high as 33%.

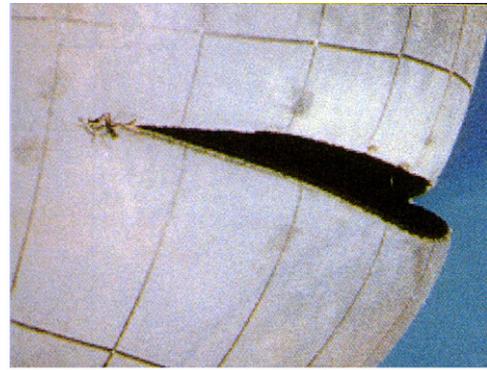
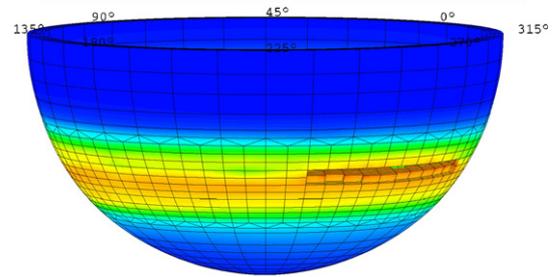
Fig. 3. Post-test view of LHF 3 and simulation result.

First applications of this model (OLHF Seminar, 2002) to the LHF test 3 (Chu et al., 1998) and OLHF test 1 (Humphries et al., 2002) shown a good agreement between the global behaviour of the vessel, the failure location and final breach size (Figs. 3 and 4) with the experimental results.

The best results were obtained in the OLHF1 test using a strain criterion with a failure value deduced from the experimentally determined local strain at the failure site. For the LHF3 test, the best results were obtained using a ductile damage criterion obtained from characterization creep tests. Therefore, different tearing criteria were chosen for the LHF and OLHF materials (SA533B1 steel) and this was shown to be consistent with differences observed between the two materials. Indeed Humphries et al. (2002) indicated that at high temperature (1260 K), the LHF material seems to be more “brittle” than the OLHF material:

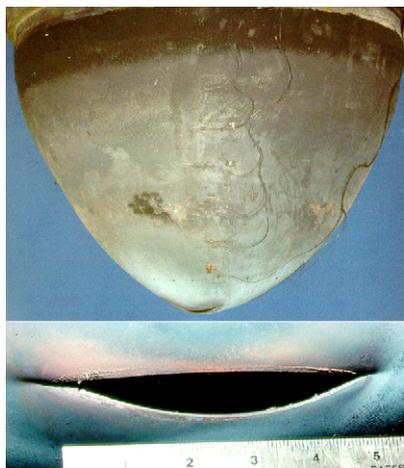
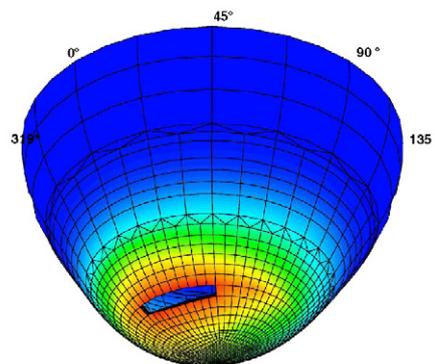
Fig. 4. Post-test view of OLHF 1 and simulation result.

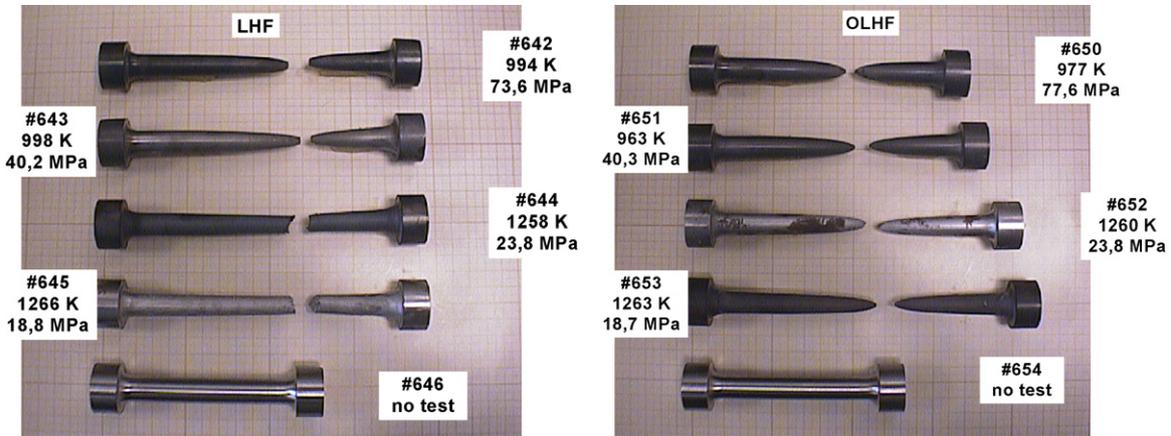
Fig. 5. Characterization creep tests on LHF/OLHF steels.

- LHF specimens showed very little necking (Fig. 5) compared to OLHF specimens at the same temperature (1260 K),
- failure time is doubled for OLHF specimens and their minimum creep speed is half that of LHF specimens,
- elongation at rupture is 50% greater for OLHF specimens.

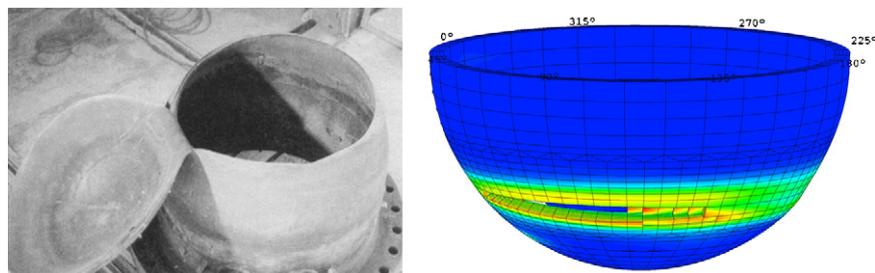
Fig. 6. Post-test view of LHF5 and simulation result.

Recent work on the interpretation of LHF5 test shows that the complete circumferential unzipping of the vessel that was observed could not be predicted with the 3D breach propagation model (Fig. 6).

The most interesting difference between the LHF 5 & 3 tests is that a limited circumferential rip occurred in test LHF 3 at about 1000 K whereas in test LHF 5, an unplanned pressure transient at about 1000 K led to a dramatic failure with complete circumferential unzipping of the vessel at approximately 1100 K (a temperature where the LHF material becomes “brittle”). To improve predictions, further investigations and work are required on the tearing criterion; this is thus the objective of our current joint research programme.

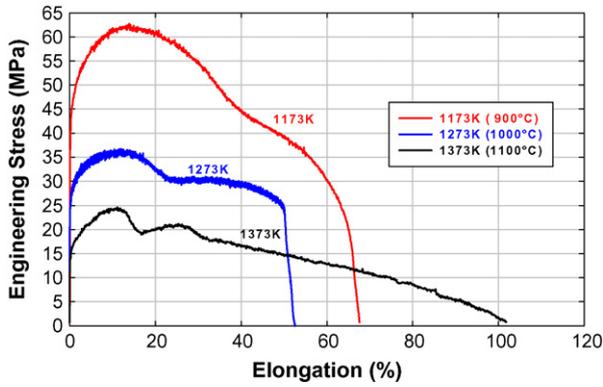
Fig. 7. High temperature tensile test curves for material B (strain rate:  $5 \times 10^{-4} \text{ s}^{-1}$ ).

Tensile testing was performed on the three materials under vacuum at different strain rates from 1073 K to 1373 K (at 100 K intervals). The total elongation and the reduction of area after fracture were used as a measure of the hot ductility. Deformation to fracture was carried out at strain rates in the range  $10^{-3} \text{ s}^{-1}$  to  $10^{-5} \text{ s}^{-1}$ . Fig. 7 shows tensile curves for the material B at 1173 K, 1273 K and 1373 K using a strain rate of  $5 \times 10^{-4} \text{ s}^{-1}$ . This figure indicates that the amount of elongation is a minimum at 1273 K (1000 °C).

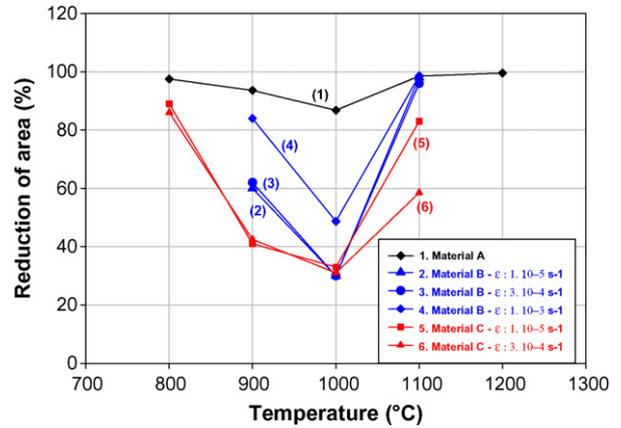
Fig. 8. Variability of the reduction of area as a function of temperature and strain rate for the three materials.

The reduction of area as a function of temperature and strain rate for the materials A, B and C can be seen in Fig. 8. One can see that high sulphur containing materials (materials B and C) exhibits a reduction in ductility at around 1000 °C (1273 K). This corresponds to a decrease in the reduction of area (necking) from 90% to 30%. In contrast the low sulphur containing material (material A) shows a constantly high level of ductility over the entire temperature range.

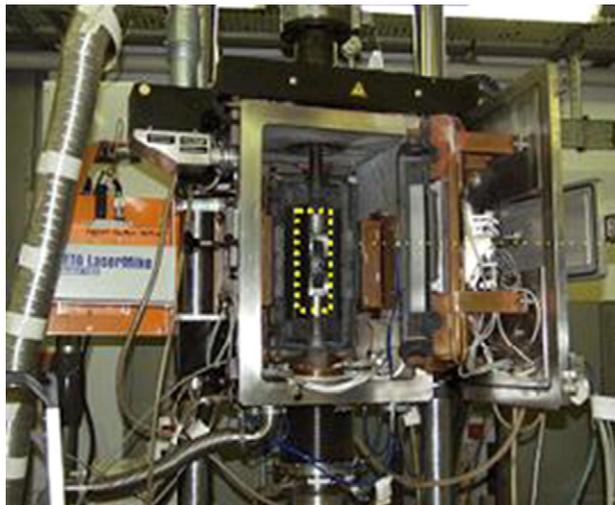
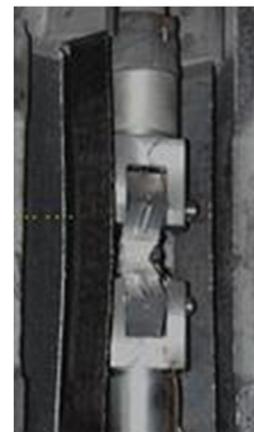
Fig. 9. Furnace installed on a servo-hydraulic INSTRON test bench.

The high temperature tests were all made in the same furnace under vacuum or under inert atmosphere (argon) conditions, on a servo-hydraulic INSTRON test bench as shown in Fig. 9.

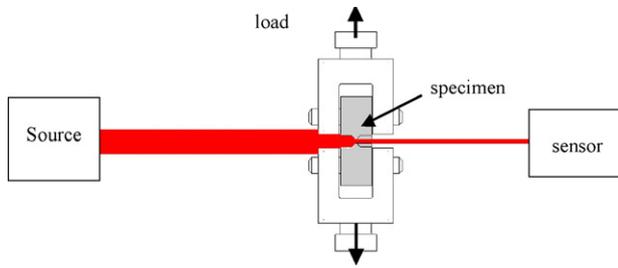
Fig. 10. Measurement of the crack opening displacement by a laser scan micrometer.

The Electrical potential drop measurement (EPD), in the vicinity of the notch has been used to determine the propagation of the crack. The opening of the notch was determined by means of a laser scan micrometer (Fig. 10).

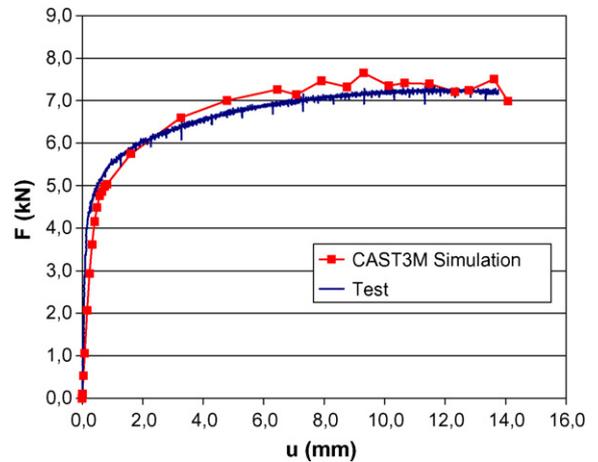
Fig. 11. Simulation of CT 701-9h specimen (1173 K, 16MND5 RUPATHER steel).

- comparison of initial results for the two materials shows that this approach is appropriate to characterize the observed difference in ductility at high temperatures (Figs. 11 and 12),

- the numerical simulations (Figs. 11 and 12) are able to accurately reproduce the behaviour of the specimens at high temperatures. The simulations were performed with the preliminary 3D model (using Cast3m) with a modified plasticity model that takes into account plastic strain rate and assumes that failure propagation takes place in a similar way to that observed experimentally.

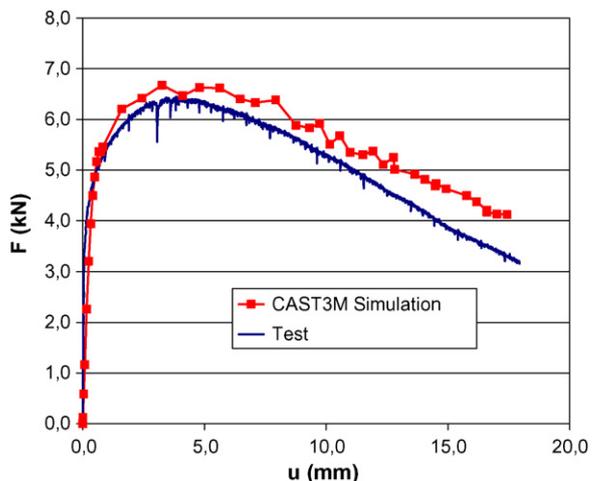
Fig. 12. Simulation of CT 704-a specimen (1173 K, 16MND5 KRAKATO steel).

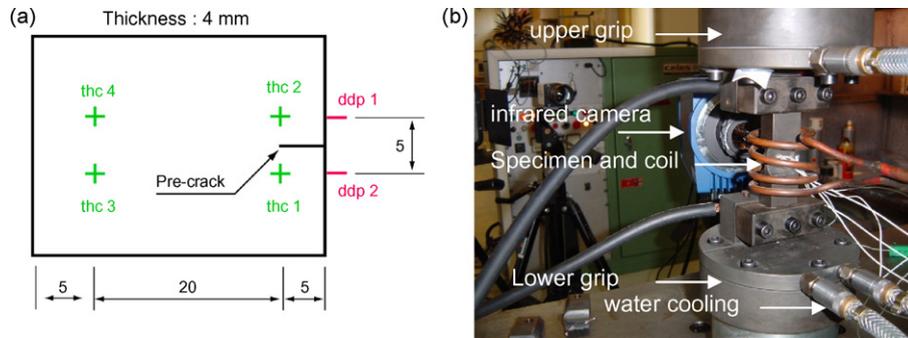
Fig. 13. (a) Geometry and thermocouple positions. (b) Experimental set-up.

In the tests performed, the specimen used a very simple geometry, the applied load was well defined and the temperature field was homogeneous. The specimen geometry used was a plate of 4 mm thickness and 30 mm width (Fig. 13a).

Induction heating was used to heat the specimen. The 6 kW generator enables heating of the specimen to over 1273 K if necessary. The temperature field was measured simultaneously by 4 thermocouples welded onto the specimen (as shown in Fig. 13a) and a CEDIP infrared camera. The maximum acquisition speed of the camera was  $500 \text{ images s}^{-1}$ . As can be seen in Fig. 13b, the specimen is fixed at both ends by water-cooled grips.

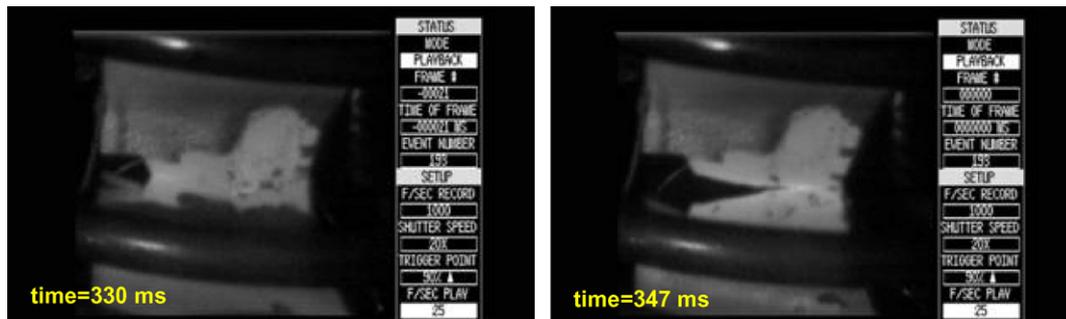
Fig. 14. Images of crack propagation until rupture.

An example of the results is shown in Fig. 14. In the first image we can observe the opening of the pre-crack caused by creep. On the second image we can see crack evolution up to rupture. Using a series of such images, it is easy to determine the crack speed by determining how far the crack propagates with time. The methodology presented has been used to compare the behaviour of the different 16MND5 materials. These results are invaluable for the validation of numerical simulations.
